Building Assessment for the Ulysses Town Hall
Prepared by Blake Reid
January 25, 2016

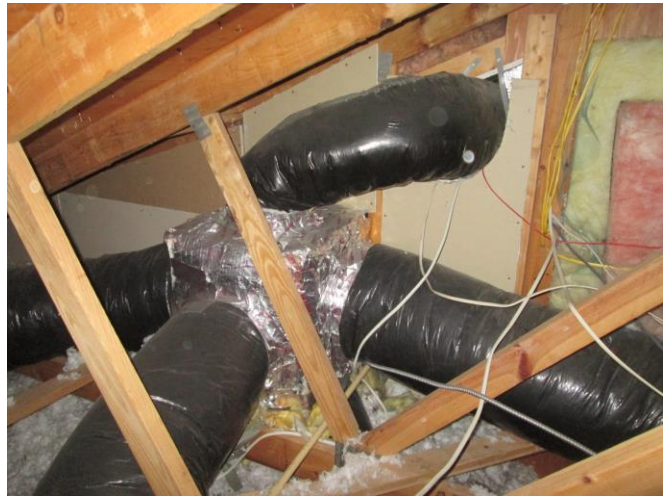
- Since the unit operates nearly constantly, and is delivering warm air at a near-constant rate, it highlights flaws in the duct system. The duct system is:

- Not designed. It shows signs of being haphazardly installed, which contributes to over-delivery of warm air to some locations (upstairs), and under-delivery to others.

- Leaky. Connections are poor, and therefore a great quantity of conditioned air is not being delivered to its intended areas. Holes in the duct system are, essentially, pressurized air leaks. This puts stress on the system, as it

must work harder to overcome the accompanying energy waste and system efficiency loss.

- Outside. Much of it is contained within the attic, which is near outdoor temperatures in the winter. “Outside” represents exactly the wrong place to install a space-conditioning distribution system.
- Under-insulated. The flexible ductwork has a thin layer of insulation on it, but it is insubstantial.
- Largely made of flexible ductwork. “Flex duct” can be installed in an acceptable manner, but when it is loosely laid with bends and sags, it contributes to reduced airflow and increases stress on the system. It is best used a sound attenuation material to connect the last few feet of a duct run to a diffuser.

- Replace the duct system in the attic with a **professionally-designed, metal duct system. Insulate it with closed-cell spray foam**, which will both insulate and seal the ductwork. This treatment is intended to “future-proof” the duct system; when it comes time to replace the heating/cooling system, it is recommended to install a heat pump, either an air-source or ground-source (geothermal) unit. This will complete the disconnection from fossil fuels.

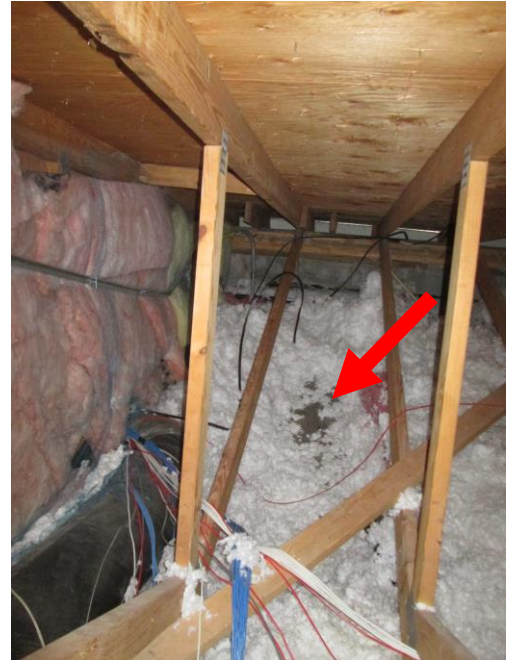
- The attic is insulated with about 12” of blown fiberglass. Its actual depth varies, and there are occasional thin spots (red arrow). The total R value is likely less than R-30. The Department of Energy recommends an attic insulation level of up to R-60 in this climate.
- The infrared scan indicates that the ceilings in the upstairs are insulated.
- The wall between the living space and the attic is poorly insulated. There are gaps in the insulation layer (red arrow, below), and the choice of material is substandard. Fiberglass batting performs best when it is enclosed on all sides with an airtight layer, which prevents air movement from washing heat away from the surface.

- When the duct system is rebuilt and insulated with spray foam, insulate the wall with spray foam as well.
- Install blown cellulose over the existing insulation to augment the insulation level to R-60.

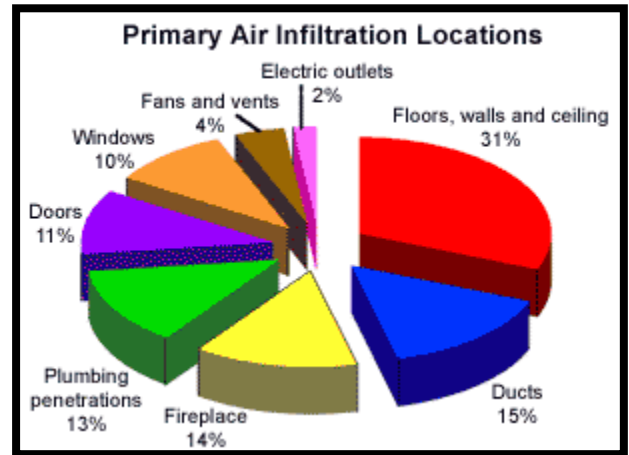
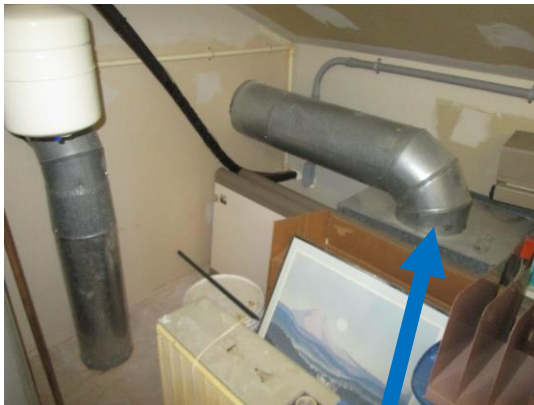
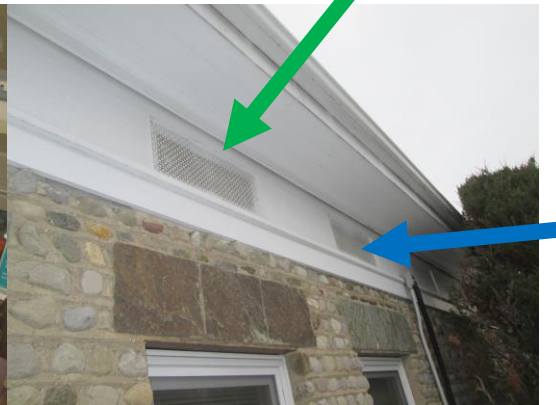
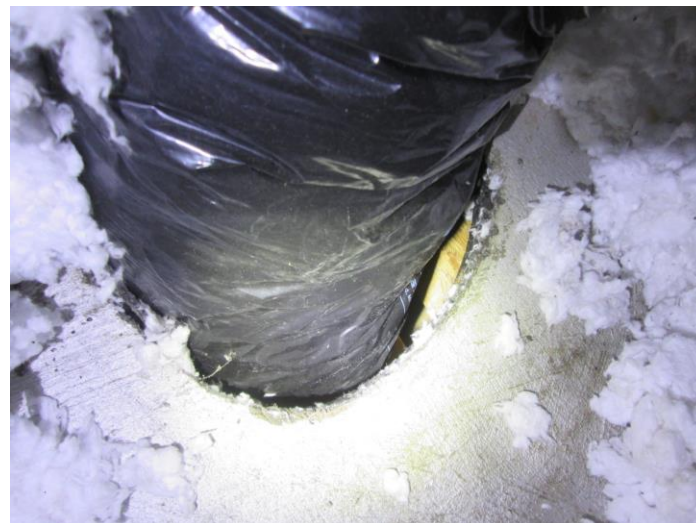
- Air leakage rates are presumed to be extremely high, due to the observation of several extraordinarily-sized holes in the air barrier. A robust, airtight layer is important because in order to condition the indoor environment, we must first control it.
- Three particular examples stood out:
 - The return air duct system for the furnace is connected to the outdoors. This appears to be a well-intentioned attempt at implementing a ventilation strategy, but it is unreliable & uncontrolled (blue arrows, both pointing to the same opening).
 - Another opening to the outside (green arrow), similar to the above but not connected to anything, simply a hole between the inside & outside.
 - In the old roof through which the duct installers cut large holes. The holes are not sealed around the ductwork, and therefore represent many pathways through which conditioned air escapes.

- Disconnect the return duct system from the outside air intake when the duct system is reconfigured. Seal both holes from the interior.
- Seal the penetrations through which ducts travel from the attic to the conditioned space.

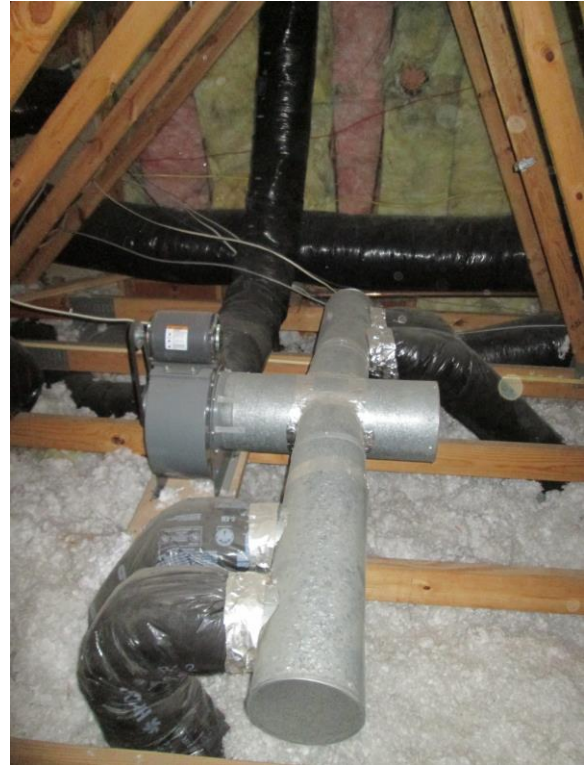
- A curious contraption was observed in the attic (picture, right). It appears to be a ventilation system; a duct extends upwards, through the roof. It is attached to a belt-driven fan, which presumably brings roof air into the attached ductwork, where it is distributed to the building through the four attached duct runs. No attempt was made to operate it or verify where the ducts terminate. It is recommended not to use it, as it is not entirely clear that the structure requires a ventilation system at all.

- It is reasonable to assume that since there is no basement, full kitchen, or bathing facilities, a needs assessment for a ventilation strategy would best be pursued *after* the previous recommendations are implemented.
