**Adler Consulting,**

March 14, 2006

Re: Review of Montrose Station Road  
Town of Cortlandt, New York

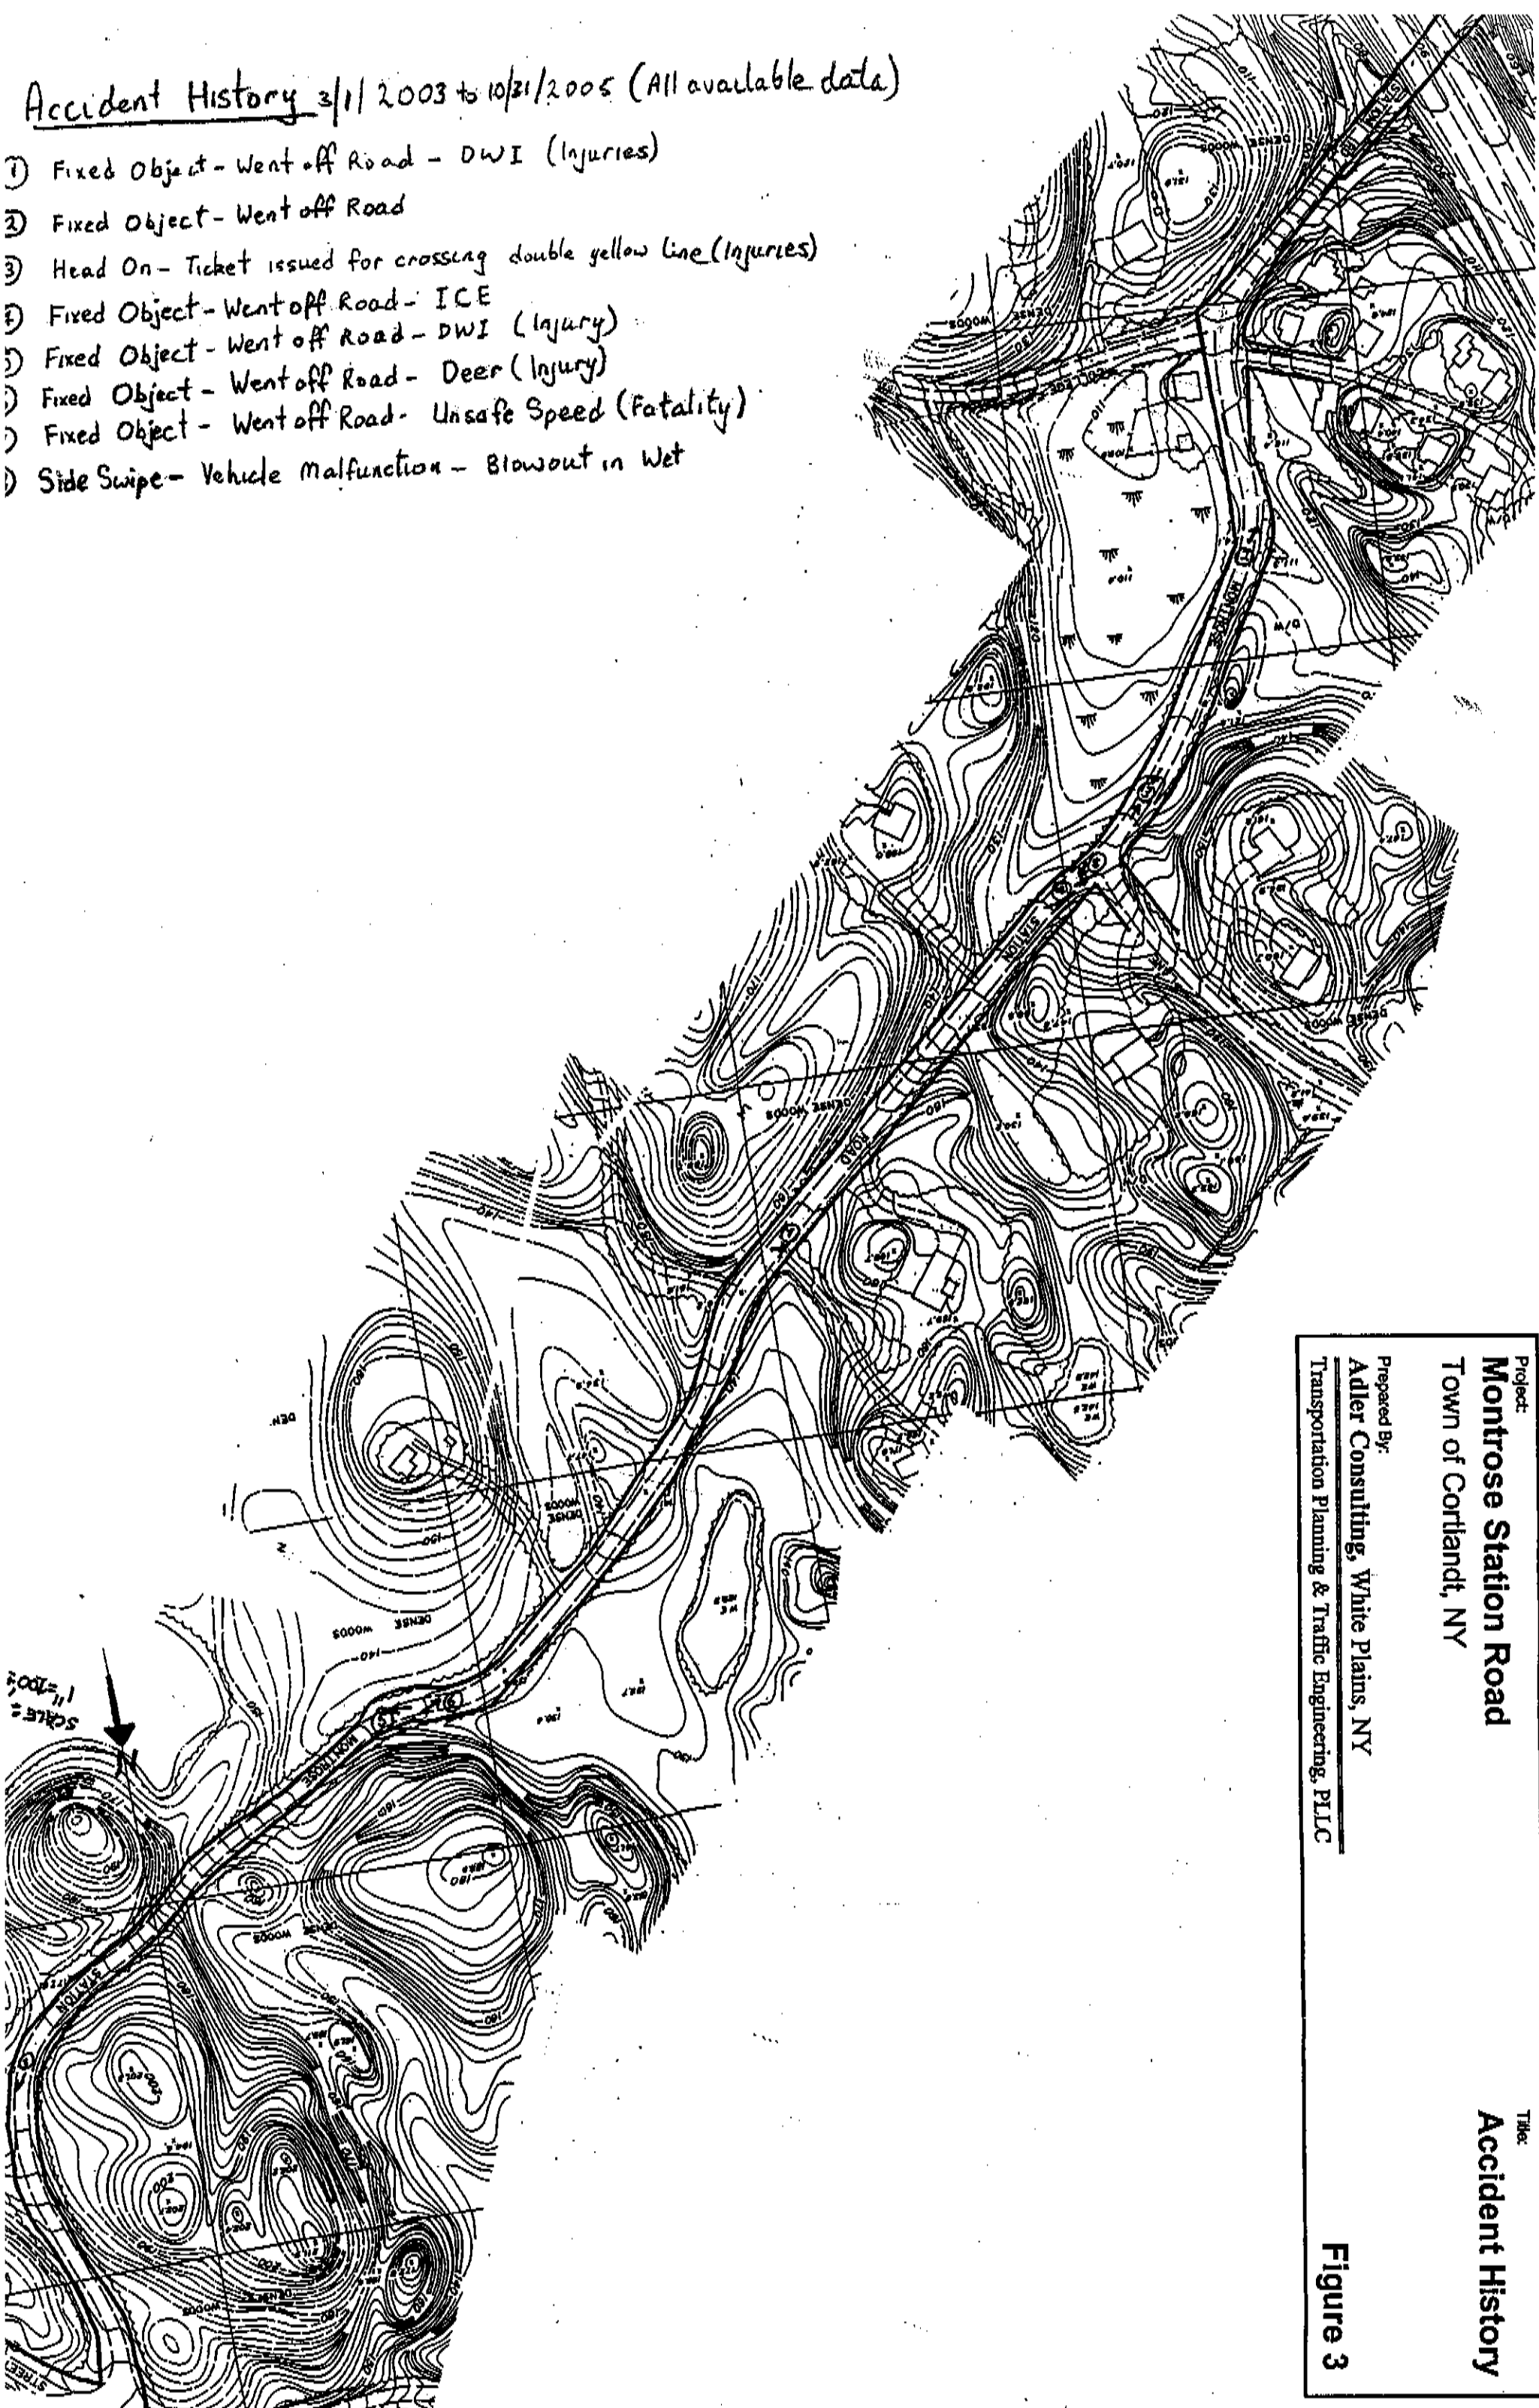
Project: <b>Montrose Station Road</b> Town of Cortlandt, NY	Title: <b>Accident History</b>
Prepared By: <b>Adler Consulting, White Plains, NY</b>	
Transportation Planning & Traffic Engineering, PLLC	
	<b>Figure 3</b>

A review of the individual accident reports is presented in Figure 3. As can be seen from the Figure, all of the accidents occurred at or near curved sections of the roadway, although no more than three occurred at any one location. Two of the accidents involved an intoxicated operator and one involved an animal action. All three of these accidents resulted in injuries. While it is difficult to specifically address the underlying cause of such accidents, the probability of the occurrence or the severity of such accidents would be reduced if the prevailing vehicles' speeds on Montrose Station Road could be reduced. Of the remaining five accidents, two occurred on a snowy or icy pavement, while one, which involved speeding, occurred on a wet pavement.

One of the accidents (accident No. SPPA96000137) resulted in a fatality. This accident, which involved a single vehicle traveling in a southwesterly direction, occurred on a dry pavement in daylight hours at a combination of curves. This was the only accident in the study period reported at this location. A warning sign with a 25mph advisory panel is posted approximately 350 feet in advance of the curves, which, based on Table 230-1 of New York Codes Rules and Regulations Title 17B, Part 230.2, is an appropriate distance to advise motorists traveling between 40 and 40 mph.

- 1) Fixed Object - Went off Road - DWI (Injuries)
- 2) Fixed Object - Went off Road
- 3) Head On - Ticket issued for crossing double yellow line (Injuries)
- 4) Fixed Object - Went off Road - ICE
- 5) Fixed Object - Went off Road - DWI (Injury)
- 6) Fixed Object - Went off Road - Deer (Injury)
- 7) Fixed Object - Went off Road - Unsafe Speed (Fatality)
- 8) Side Swipe - Vehicle Malfunction - Blowout in Wet
