Town of Dover

Road-Stream Crossing Management Plan

Produced by
The Housatonic Valley Association
2019

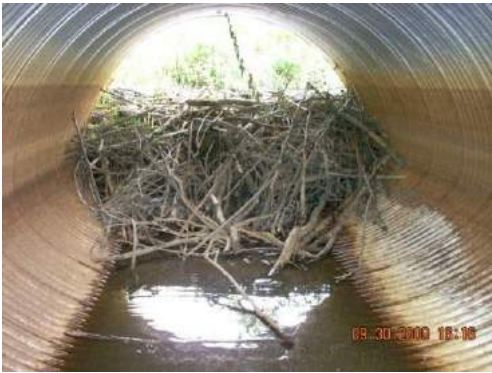
Undersized culverts, which constrict flow, are almost irresistible to beavers. Source: www.martinezbeavers.org/wordpress

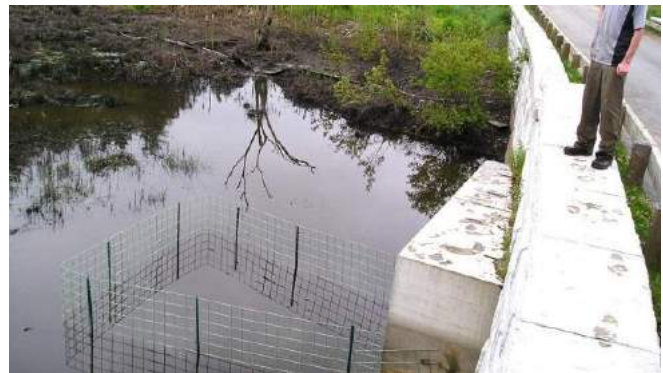
Culvert fences are the most commonly used beaver device by the Forest Service, however they may block fish passage. USFS concludes that the best solution is culvert replacement. Source: www.beaversolutions.com

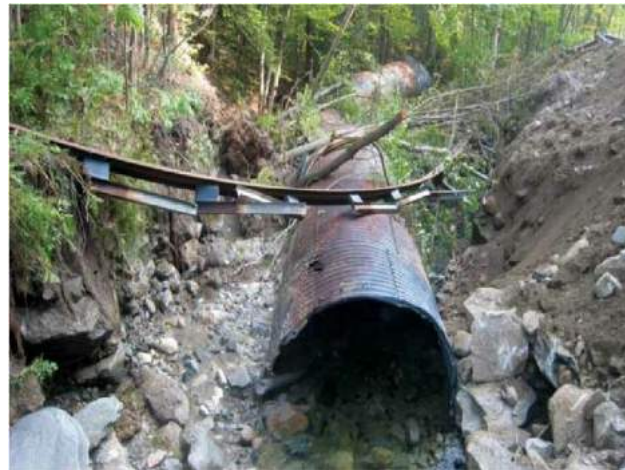
Road failure at a 3-m culvert placed within a 6-m bankfull width stream, GMNF

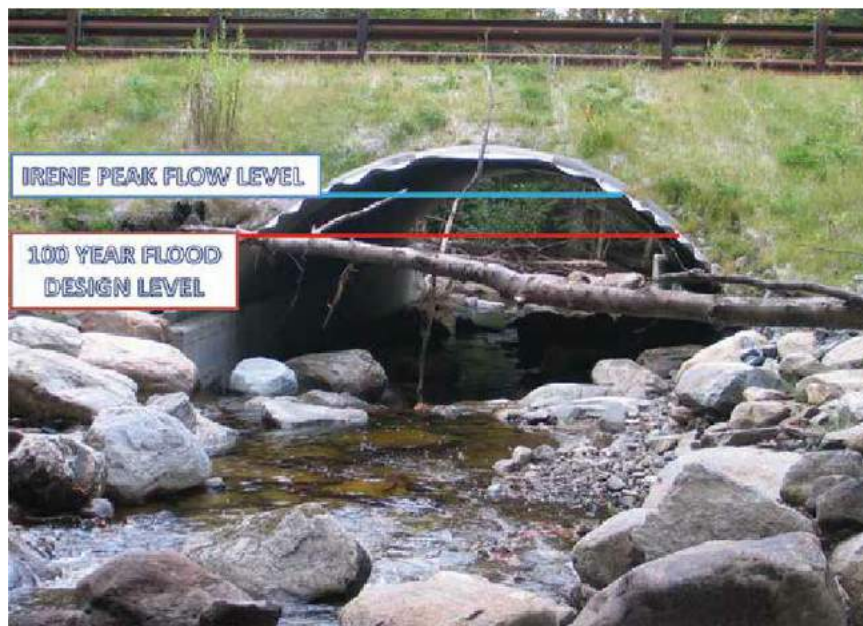
Replacement open bottom arch structure utilizing Stream Simulation Design after Tropical Storm Irene. Notice that there was no damage to the structure or road caused by the storm.
