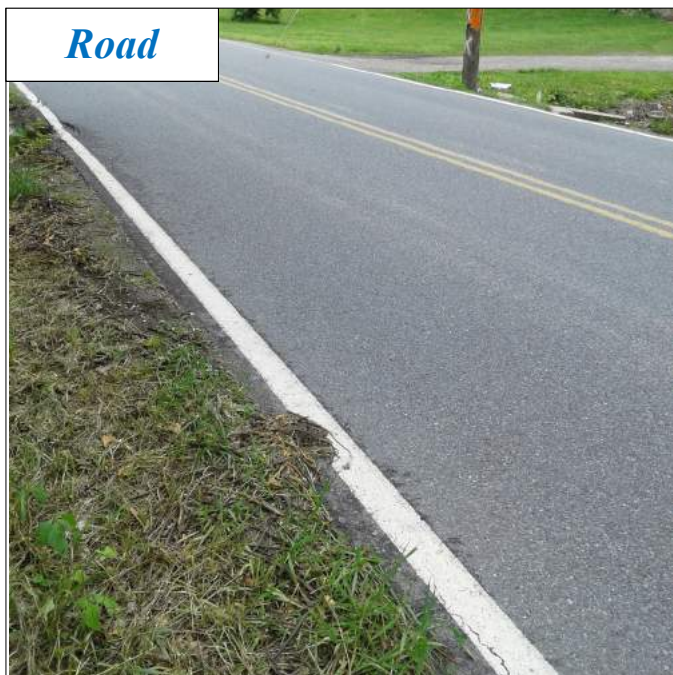
Crossing Comments: Poor Condition. Spoke to resident who believes guardrail should be added and said many accidents occur at this turn and the cars flip into the stream. Usually

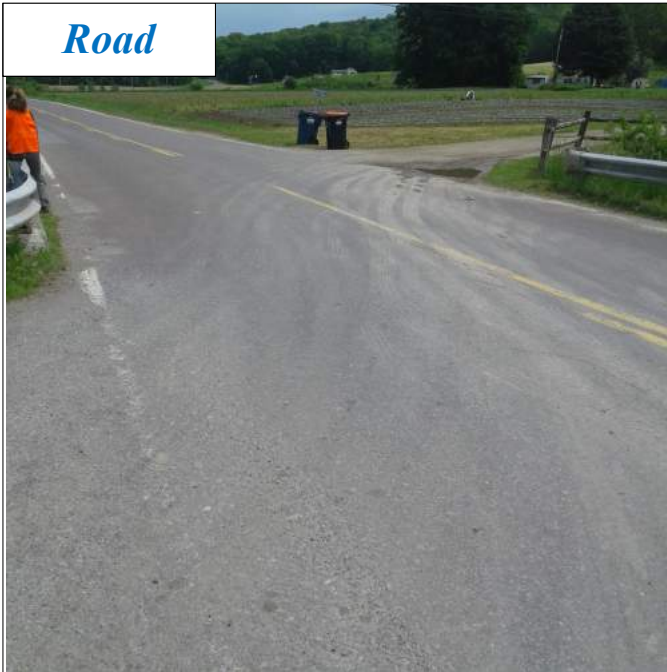
Crossing Comments: Limited access to property, spoke to adjacent landowners who noted beaver damage, bridge did flood in 1955
