Village of Irvington Flood Study March 2011

for the
Village Board
&
Community

Prepared by
Hahn Engineering
Brewster, NY

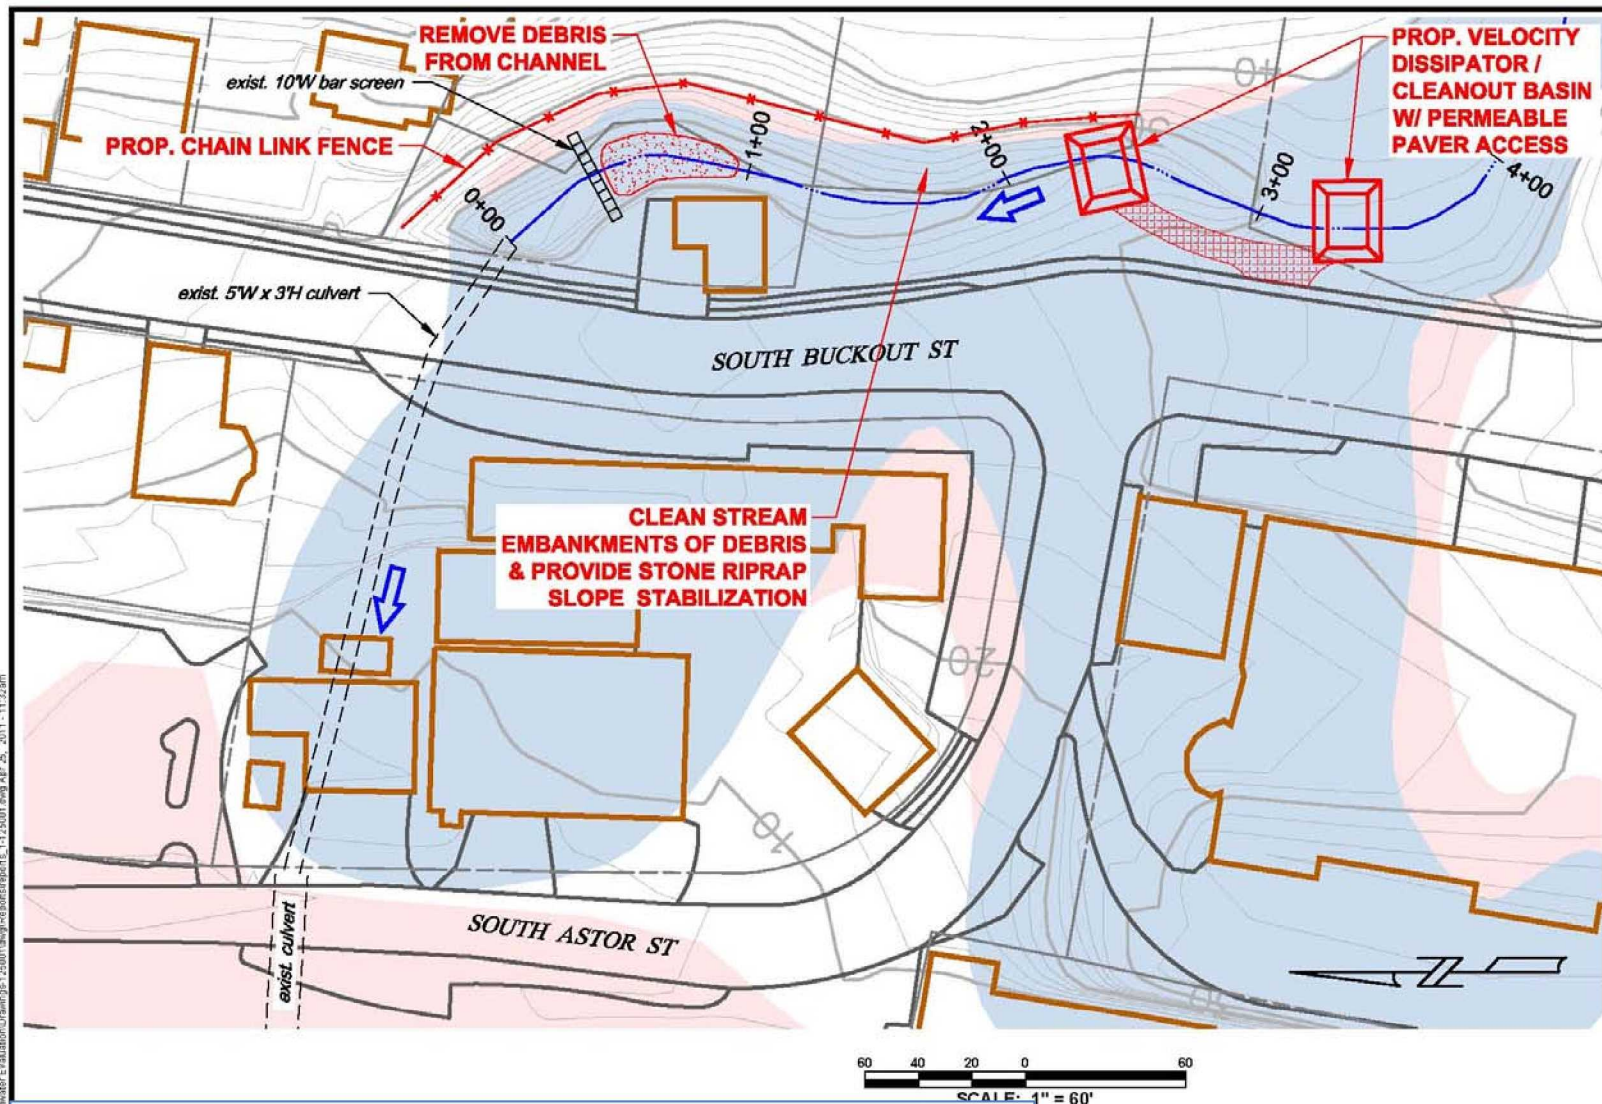
(ALTERNATIVE #1)	SCALE 1" = 60'	DATE 08/27/10
STUDY STCHESTER COUNTY, NY	DRAWING NO. 1A	SHEET NO. OF

- ESTIMATE \$300,000.
- CULVERT TO BE SURVEYED TO VERIFY CAPACITY.

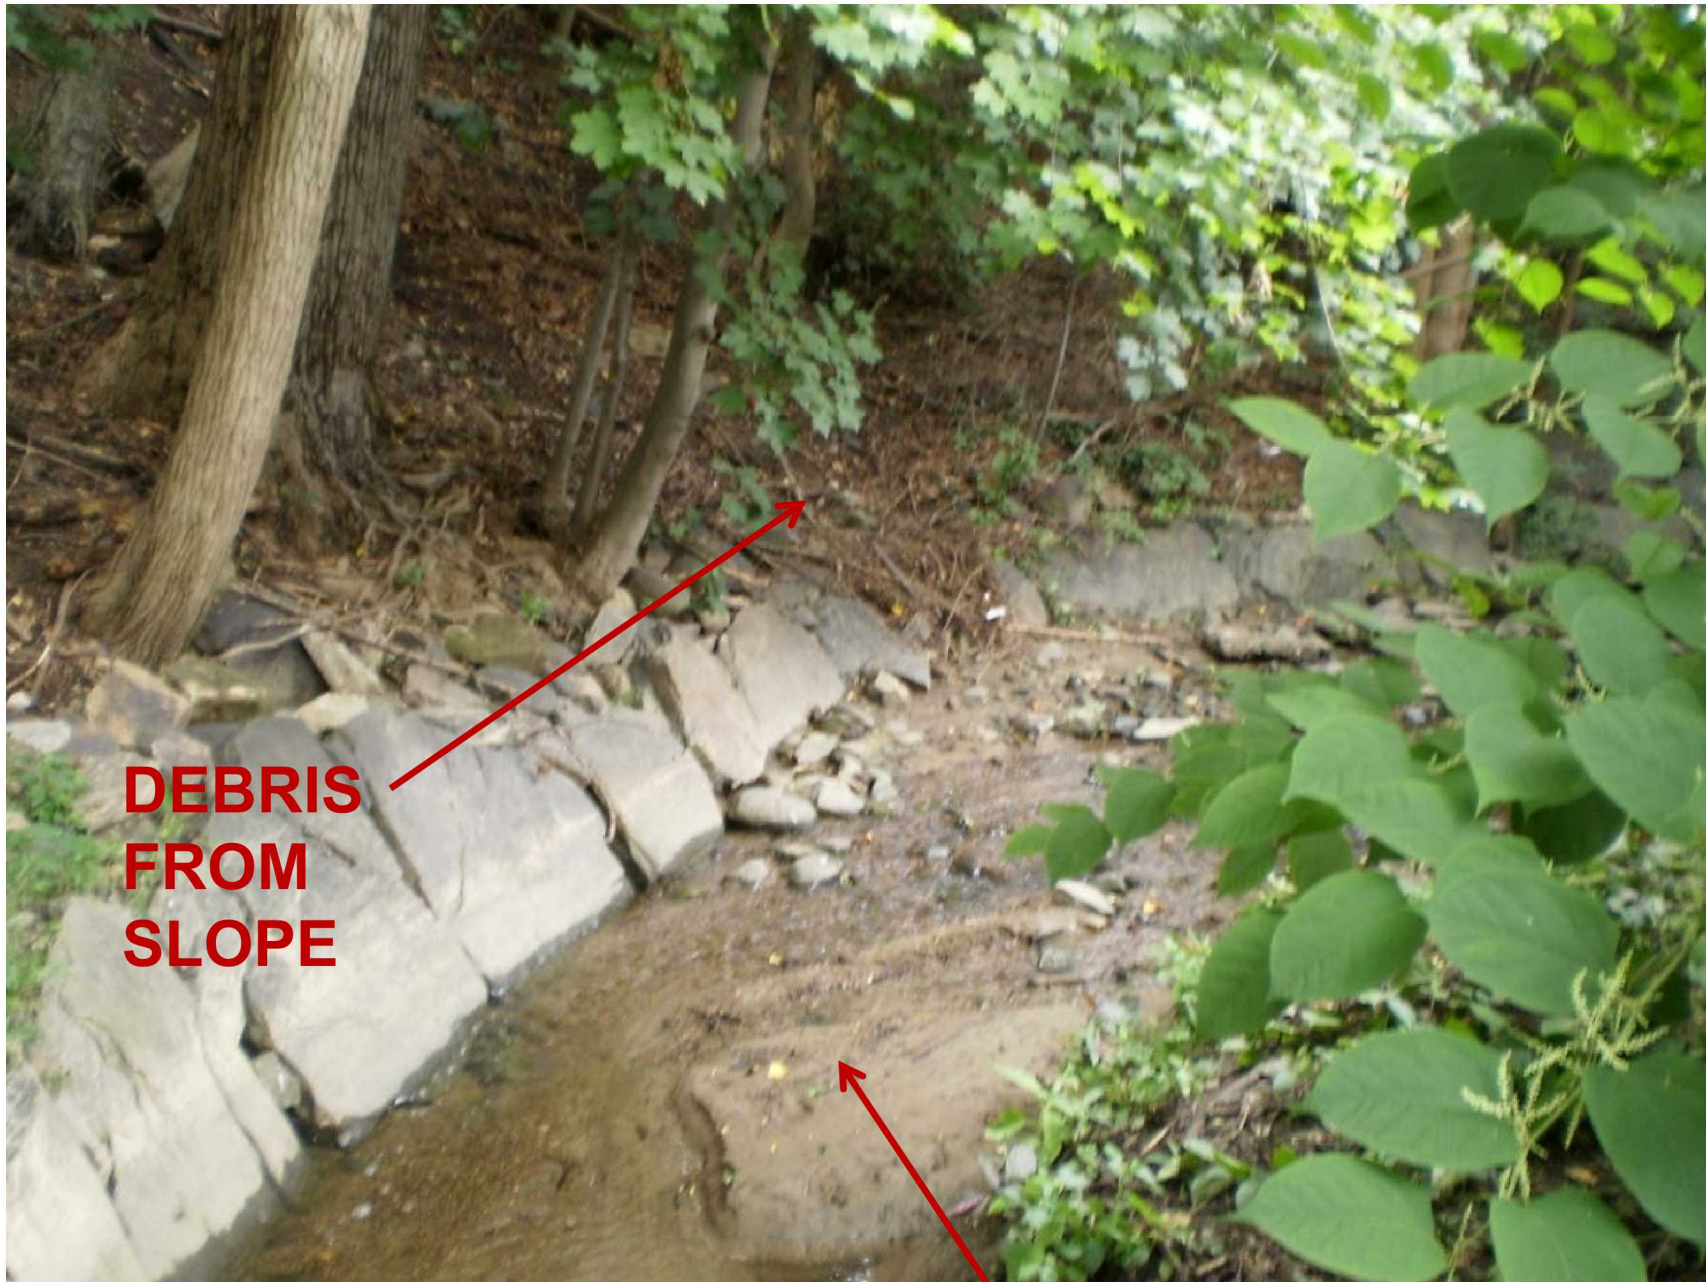
**SEDIMENT
ACCUMULATION**

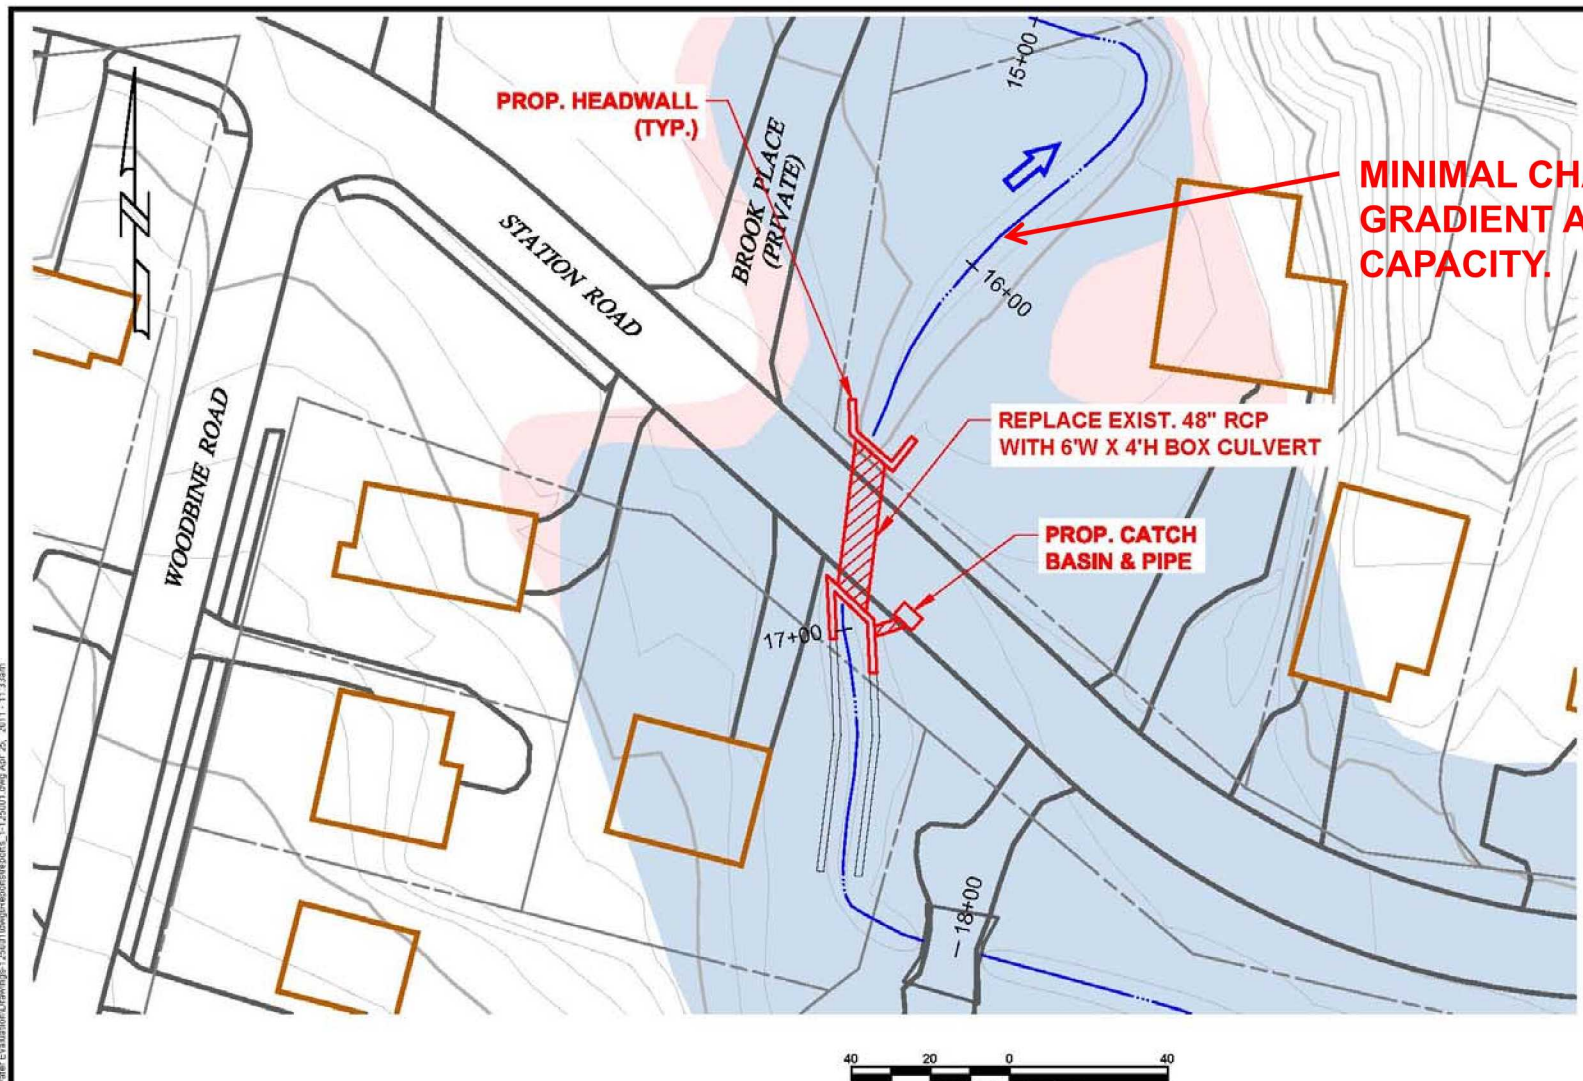
PLAN #2	SCALE 1" = 40'	DATE 08/27/10
UDY CHESTER COUNTY, NY	DRAWING NO. 2	SHEET NO. OF

- ESTIMATE \$220,000.
- POTENTIAL DOWNSTREAM IMPACT, SURVEY AND ADDITIONAL ANALYSIS REQUIRED.

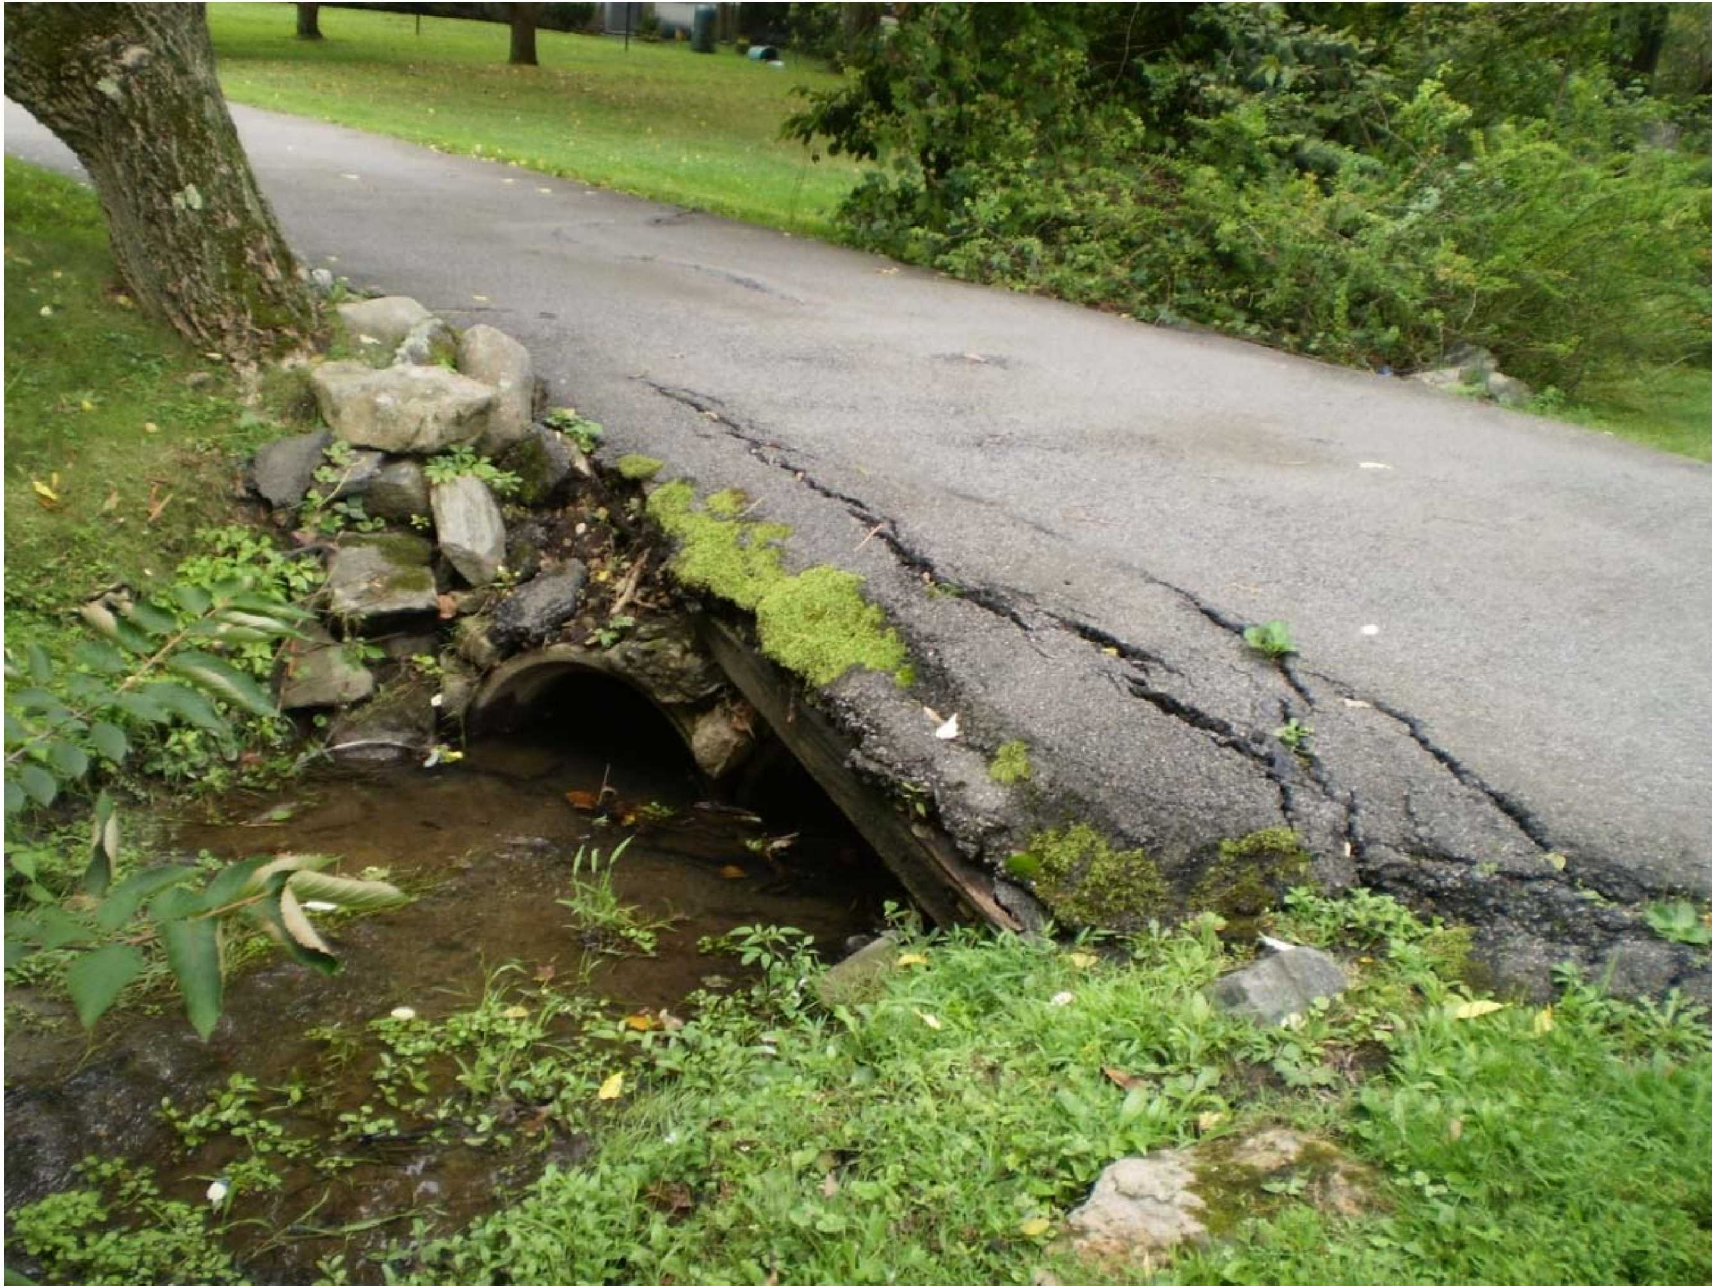
SEDIMENT ACCUMULATION IMPEDES FLOW.

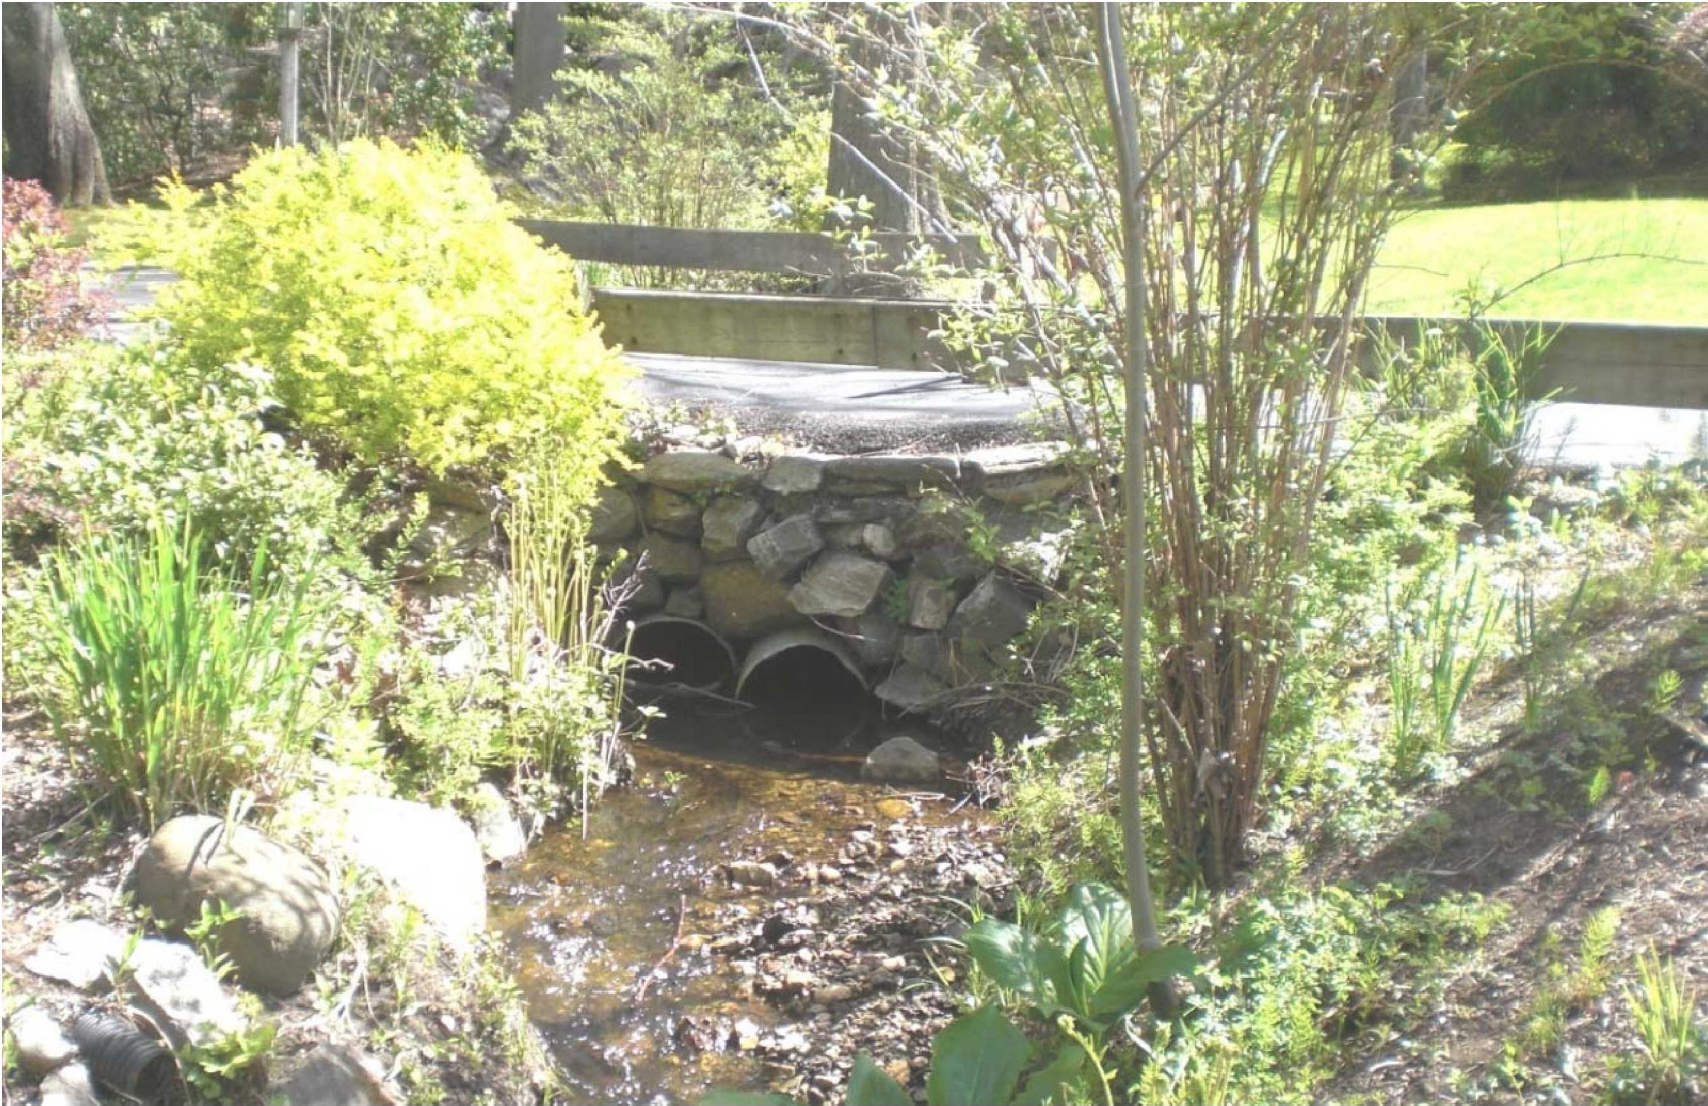
Sediment Accumulation Reduces Pipe Capacity

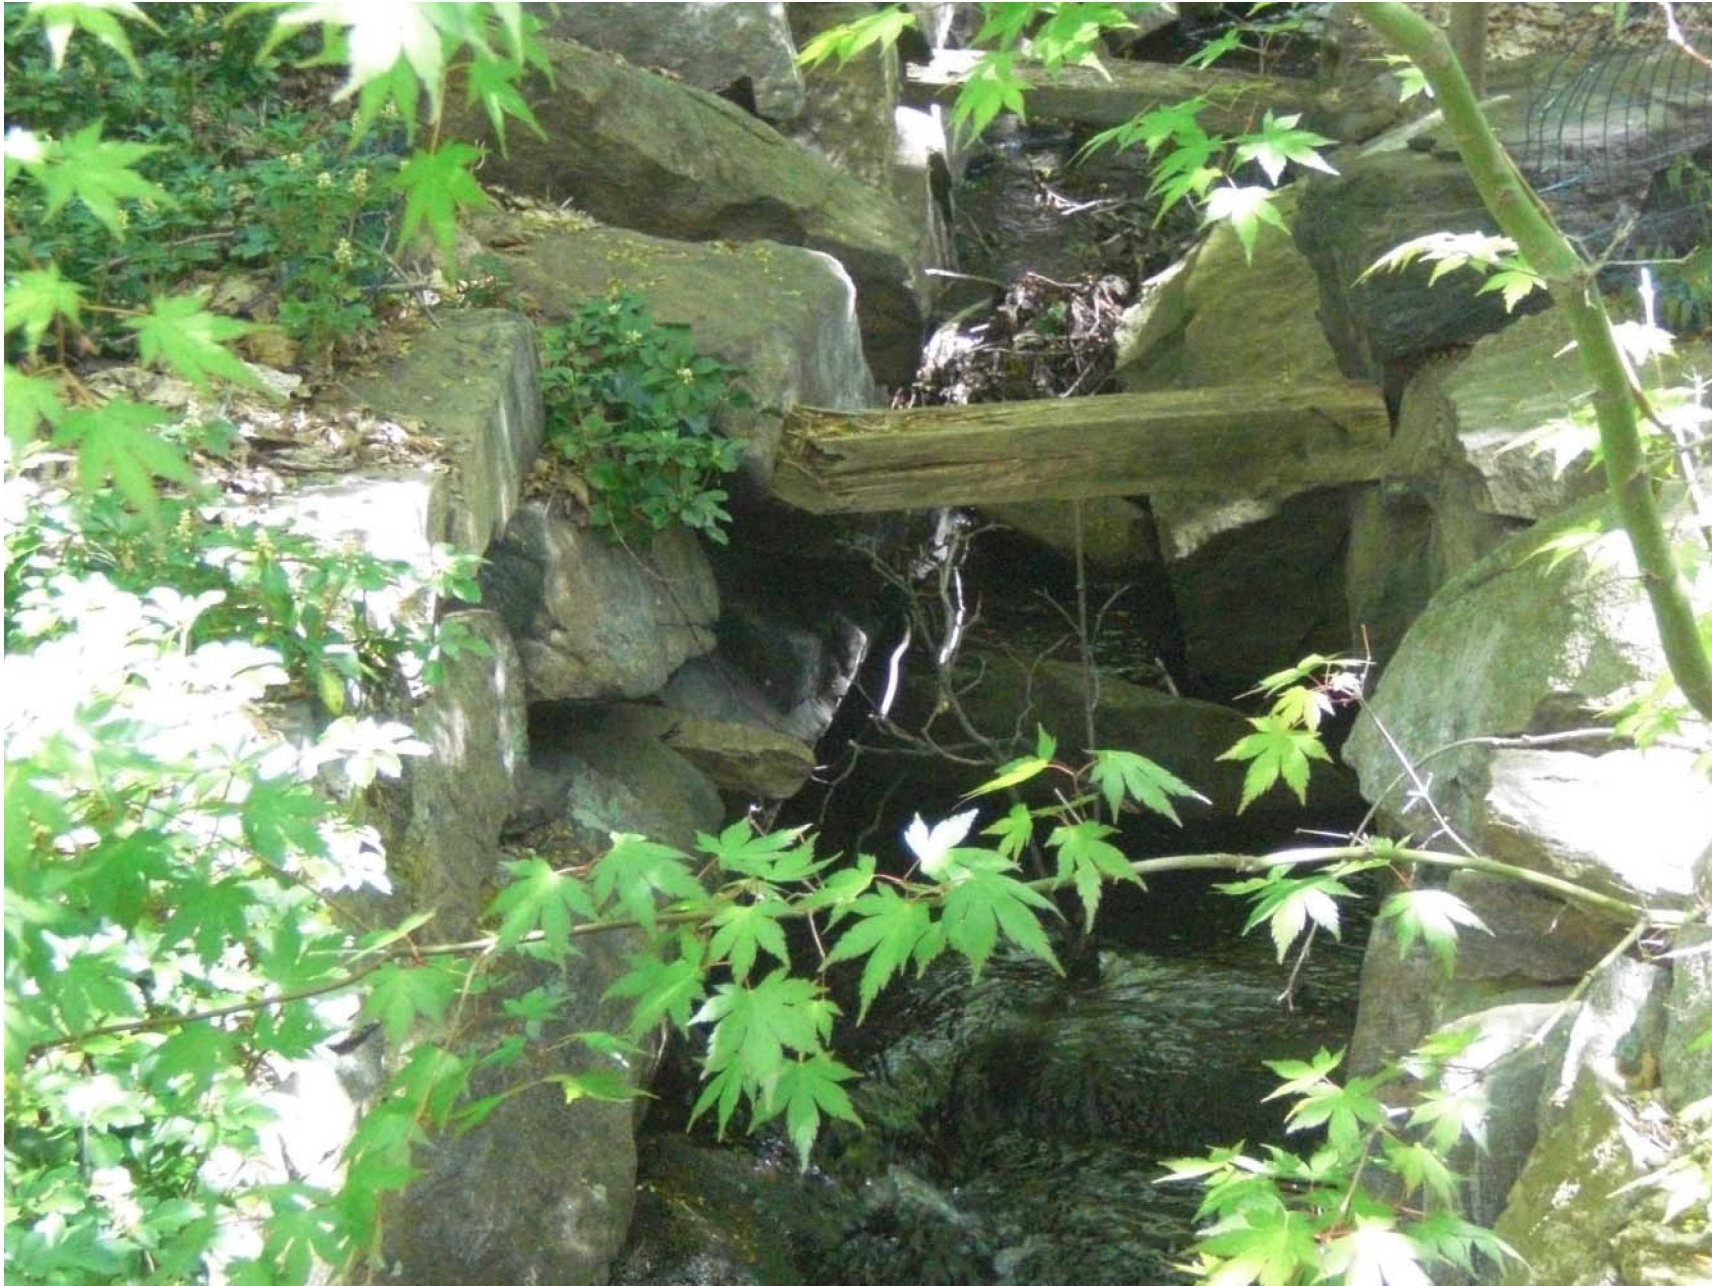
Channel failure

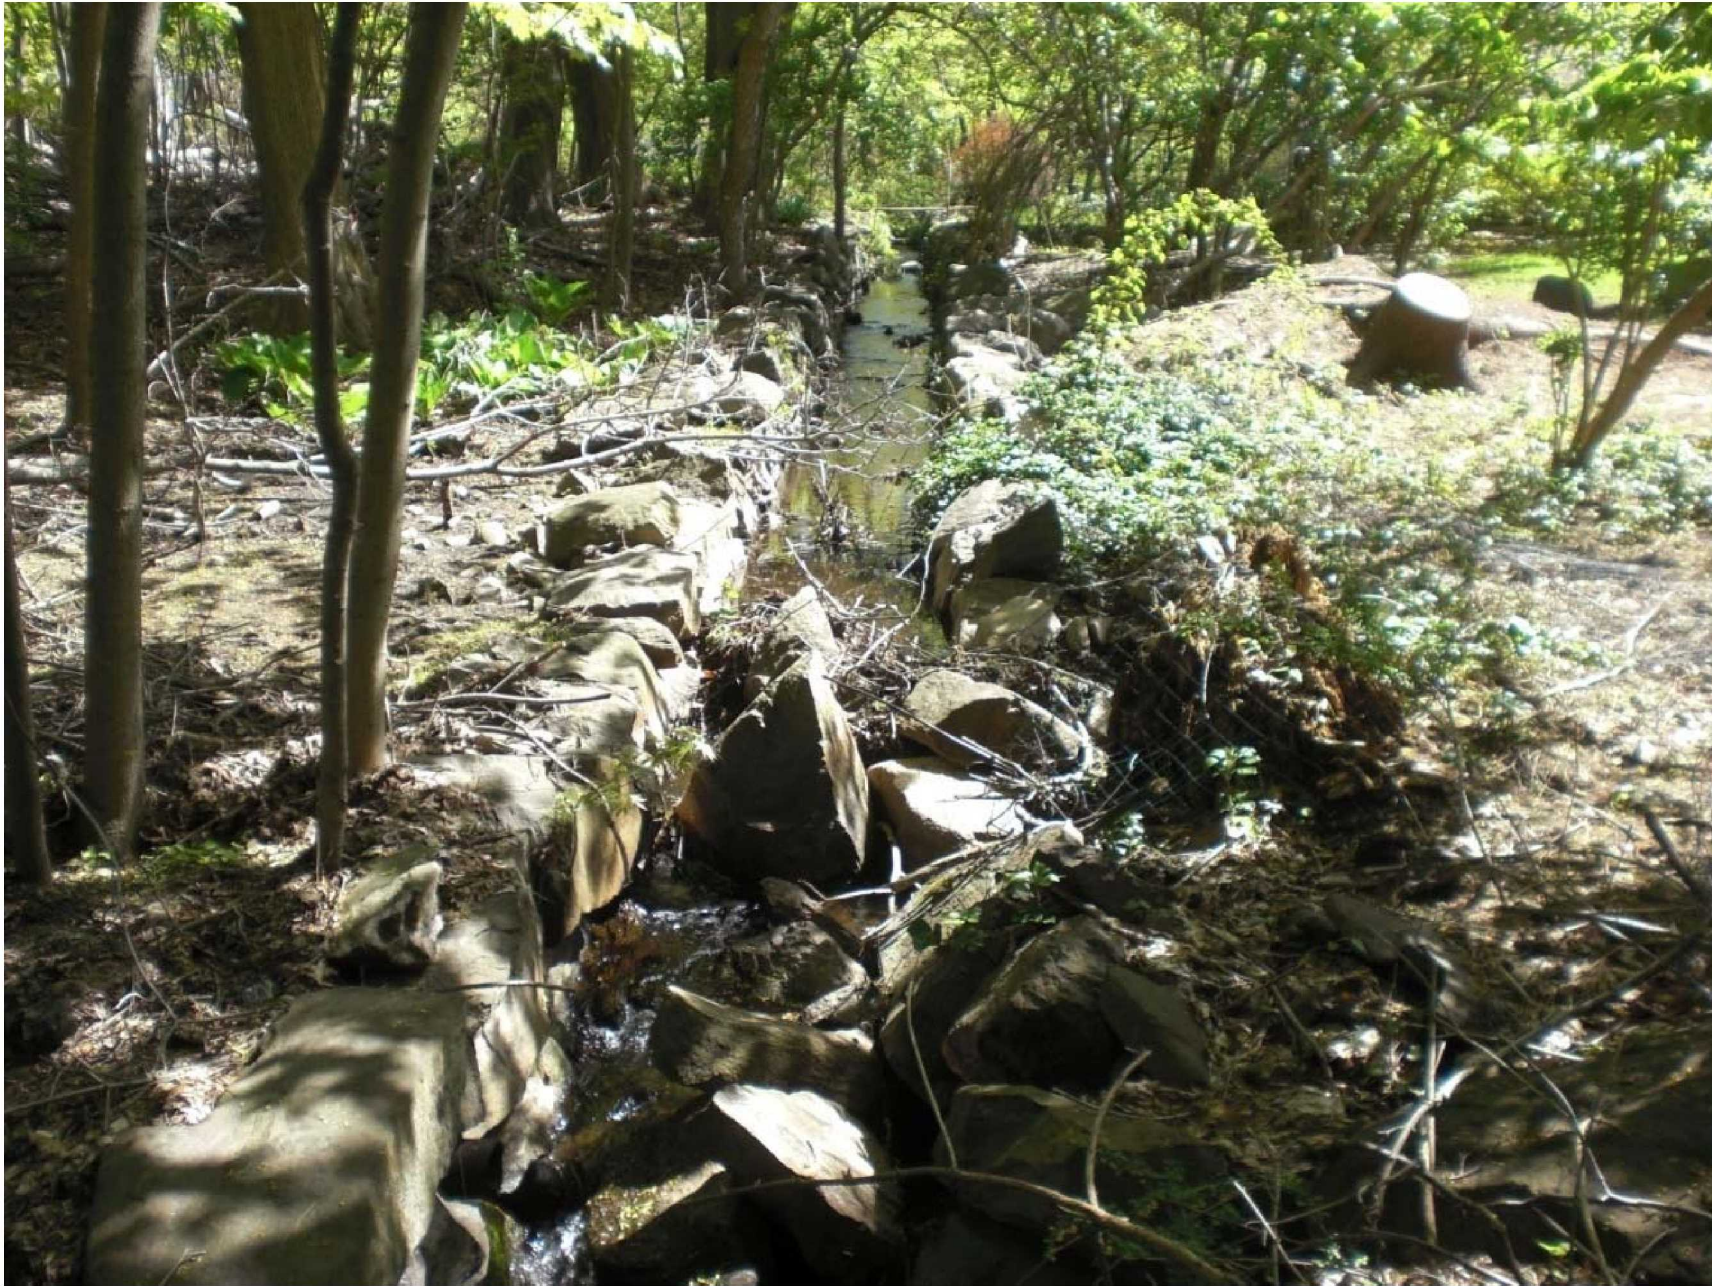
Channel failure

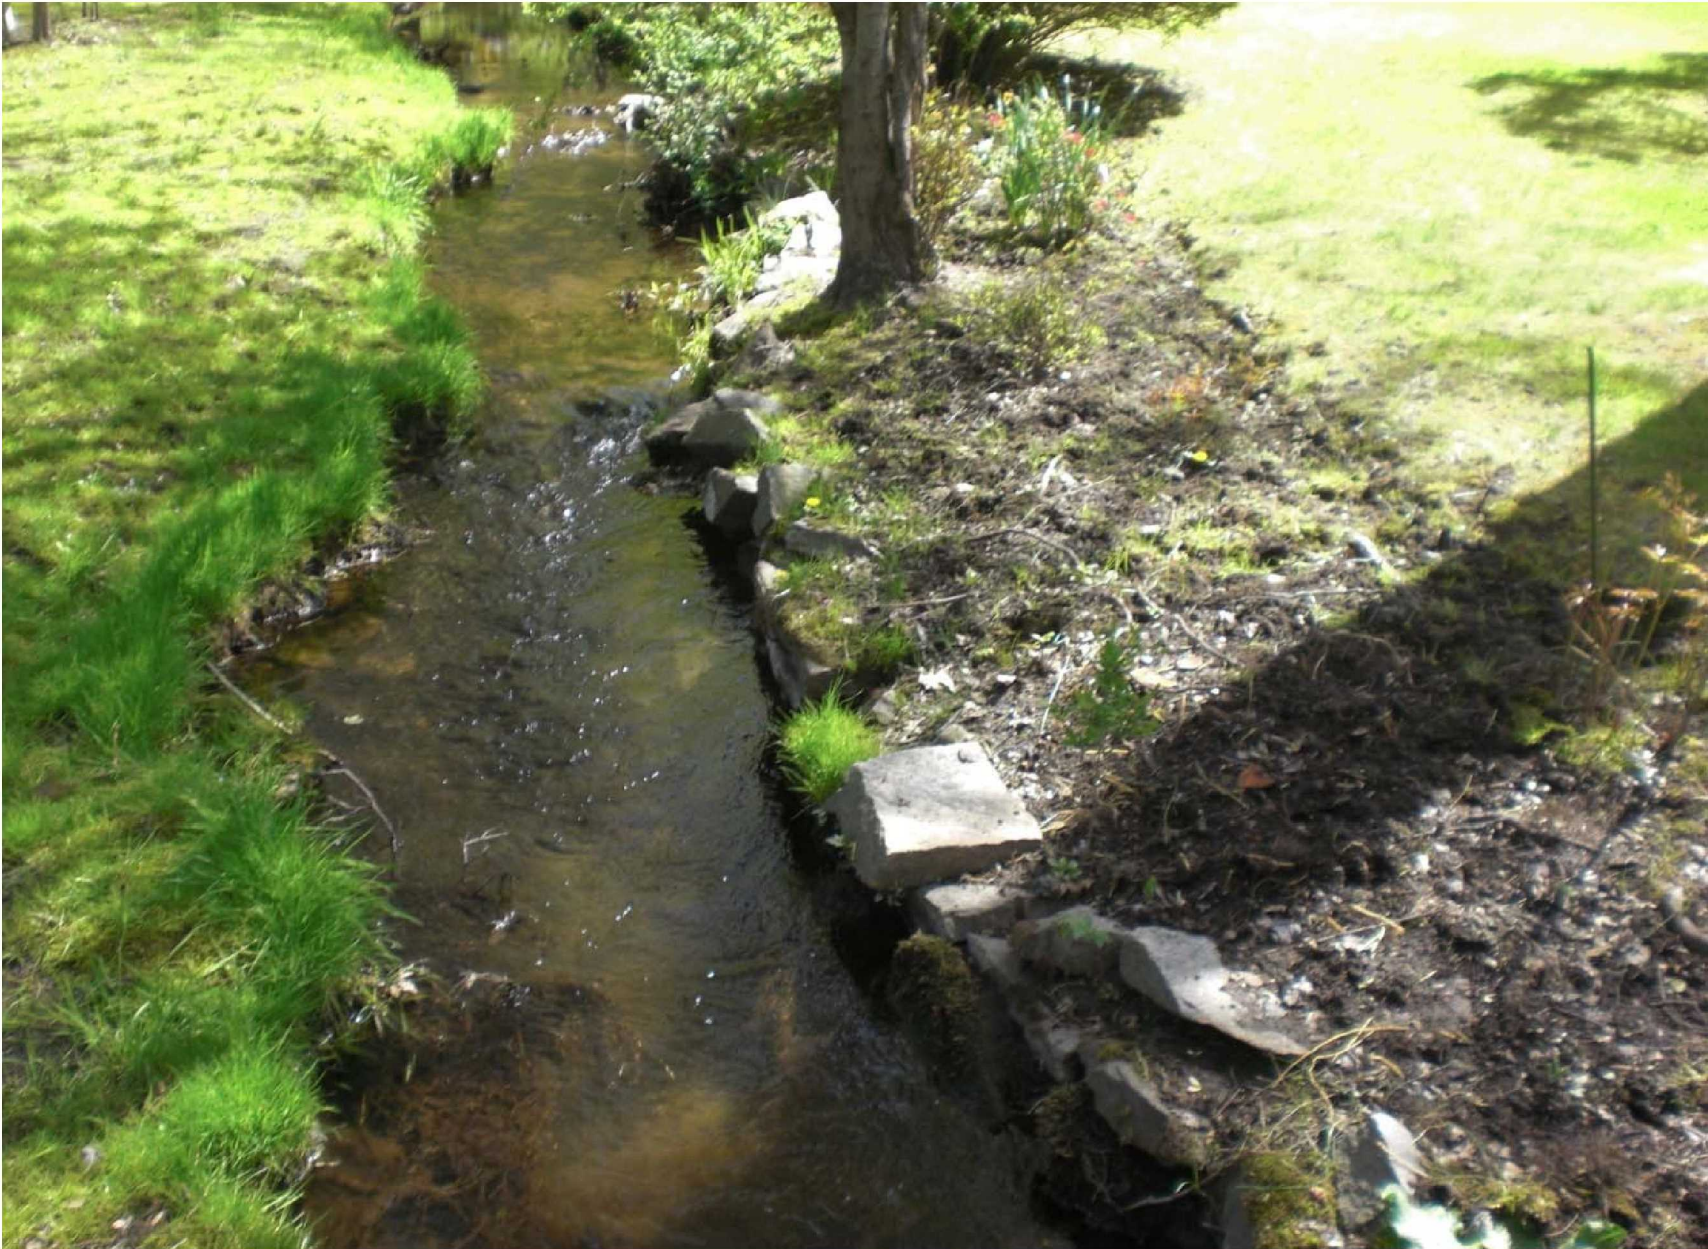
Harriman Road-Stream has limited capacity

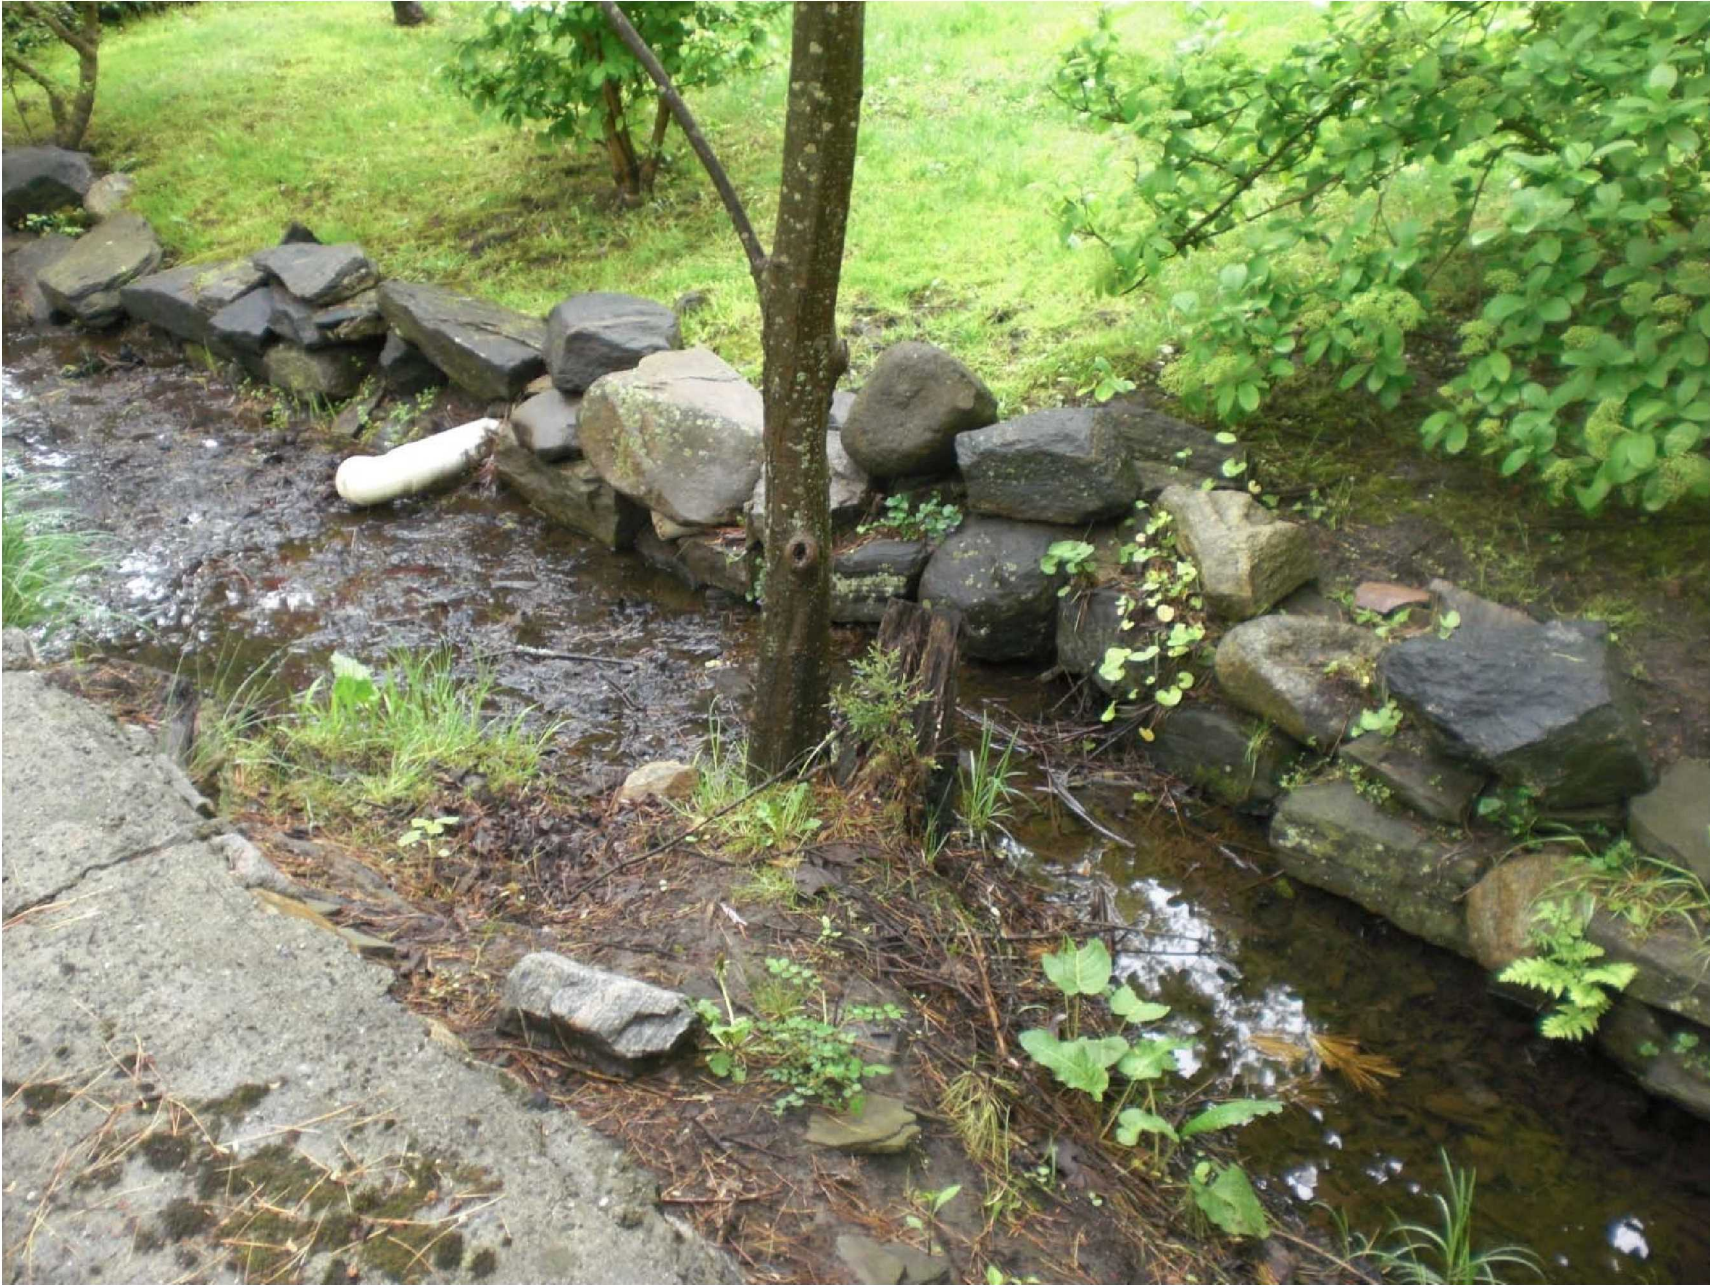
**Sediment Buildup, Vegetation, and
channel failure**

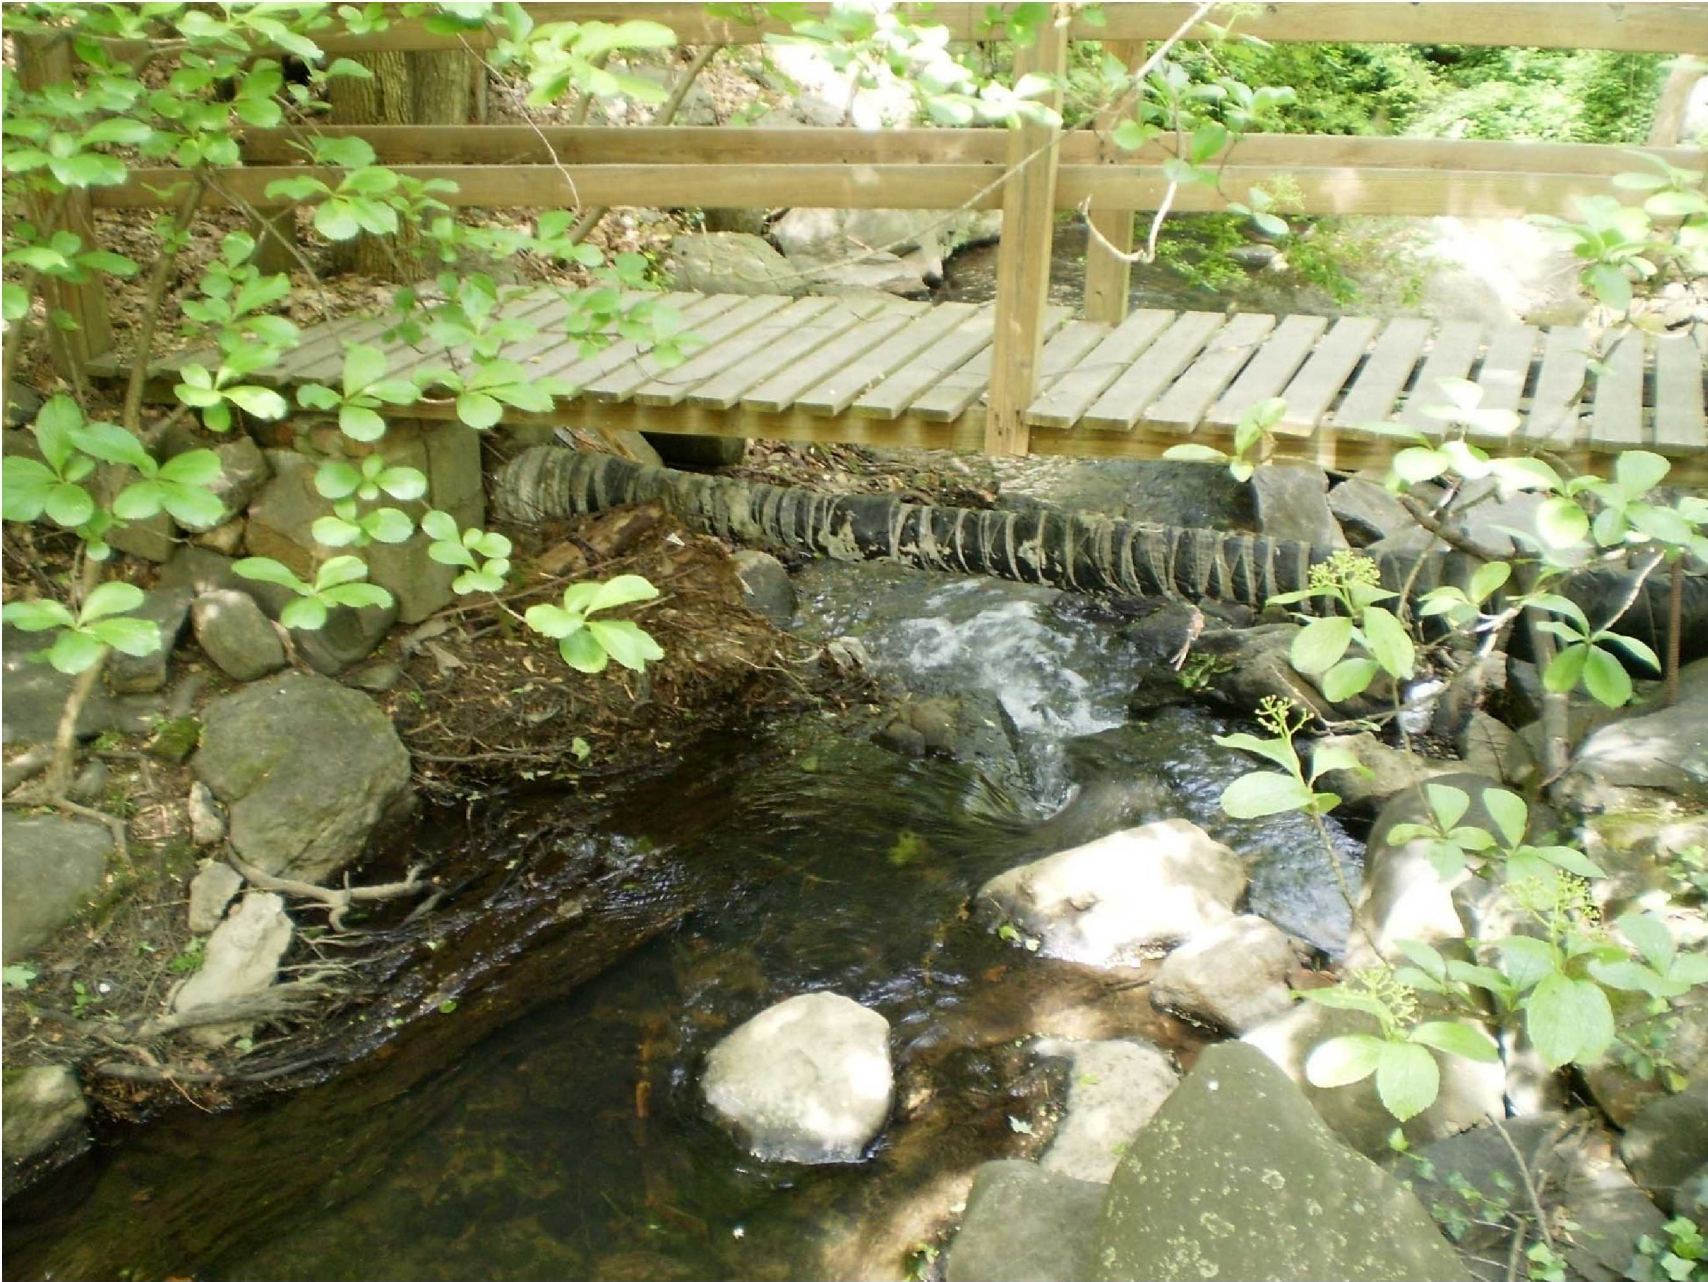
**Sewer service and walkway
impedes flow.**
