## Irvington Village Hall – Energy Audit

Village of Irvington

85 Main St, Irvington, NY

Re:     Irvington Village Hall, Irvington, NY 105331  
       Energy Audit Report

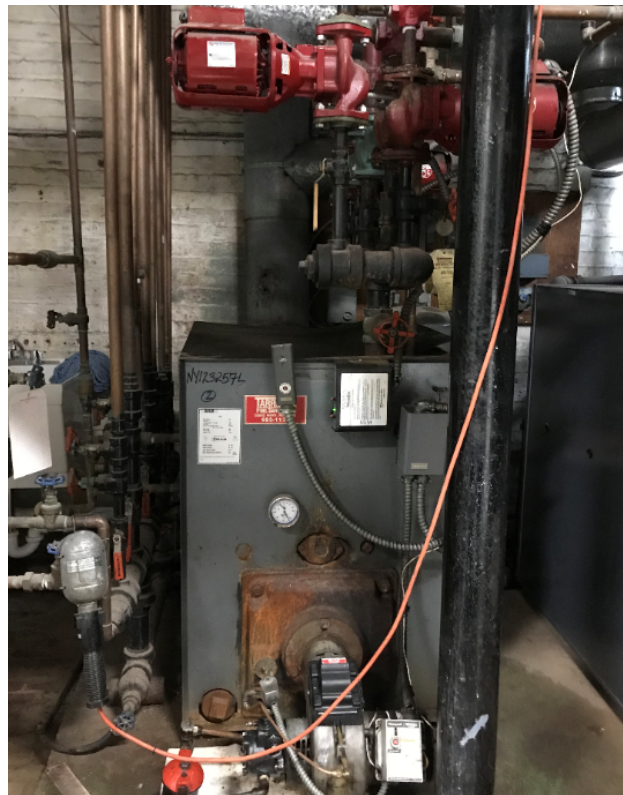
Heating for the Village Hall and Police Department is provided by a 298 kBTU/hr oil-fired hot water boiler, which is rated for an input of 3.00 GPH of oil (approx. 420 kBTU/hr). The hot water supply header branches into (7) zones consisting of hot water baseboard heaters and radiators, with each zone controlled by a circulator pump tied to a space thermostat. Thermostat types were a mix of programmable digital and simple dial thermostats. All visible piping serving this boiler was uninsulated.

Photo 1: Boiler serving Village Hall and Police Department

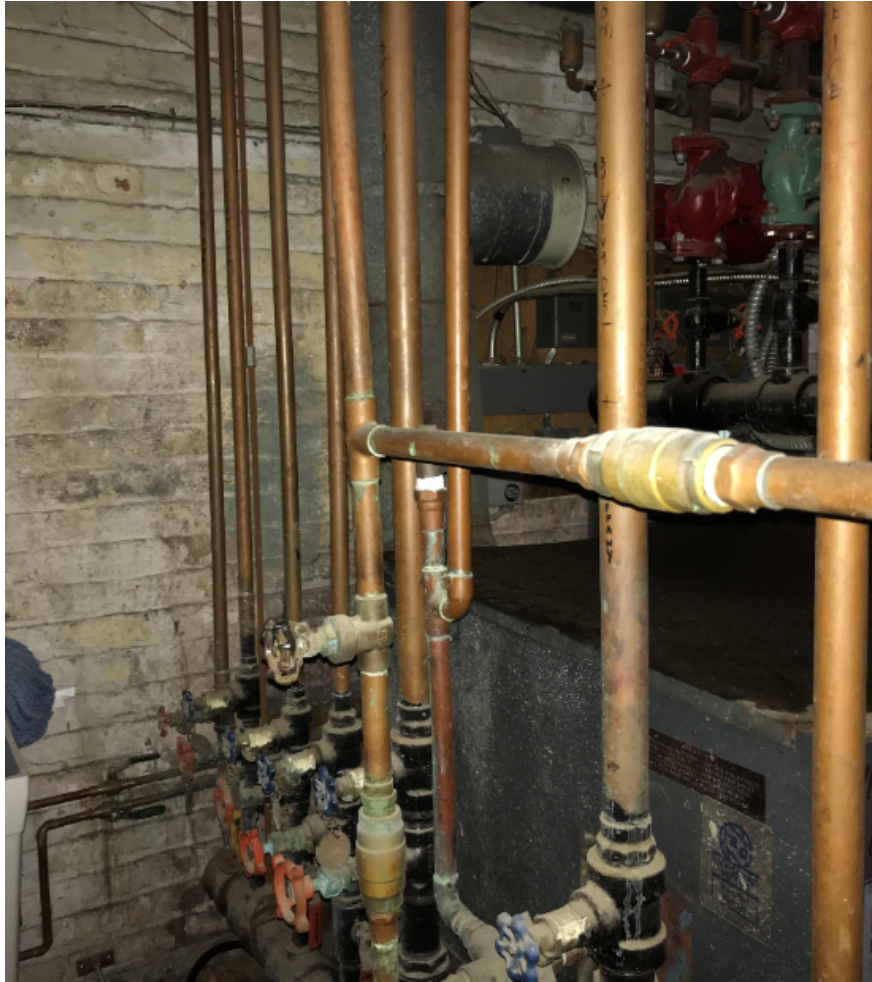
**Photo 2: Uninsulated Hot Water Piping**

1. Insulate steam and hot water piping.
2. Repair damaged insulation on exterior refrigerant piping and provide weatherproof jacketing.
3. Reconfigure condenser farm to allow for proper airflow.
4. Install light switches with vacancy sensors in occupied spaces.
5. Replace dial thermostats with programmable thermostats.
6. Implement maintenance protocols listed in Appendix F.
7. Provide weatherstripping for fire door in Court Room, entry door in Detective's Office, Police Control Room.

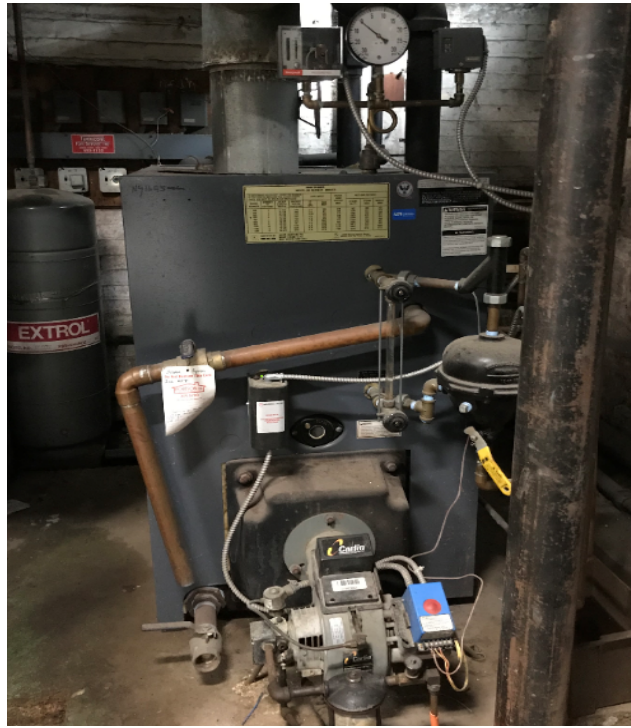
Heating for the Theater is provided by a 634 kBTU/hr oil-fired steam boiler, which is rated for an input of 5.50 GPH of oil (approx. 770 kBTU/hr). The theater is controlled as a single zone consisting of two-pipe vented radiators. The boiler is controlled by a single space thermostat located in the theater main seating area, but each radiator has a Vari-Valve adjustable vent that can be used to control the heat output of a given radiator. All visible piping serving this boiler was uninsulated. Equipment is currently serviced on an as-needed basis, and recommended thorough maintenance protocols are provided in **Appendix F**.

Photo 3: Boiler Serving the Theater

1. Replace existing boilers with gas-fired condensing boilers.
2. Insulate Storage Room, Police Control Room, furring wall.
3. Replace entry doors to Court Room.

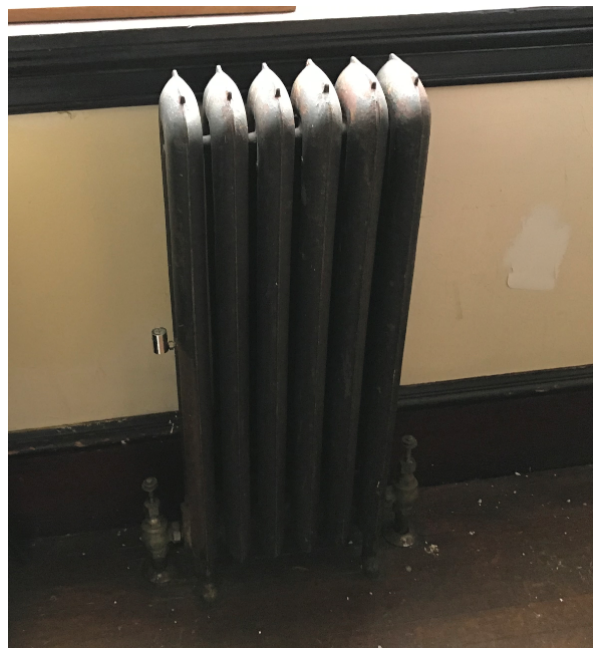
Photo 4: Typical Steam Radiator in Theater

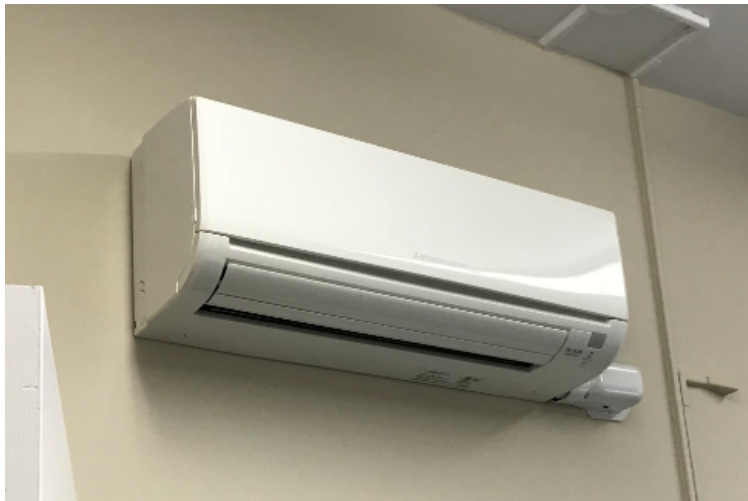
Photo 5: Typical Indoor Evaporator

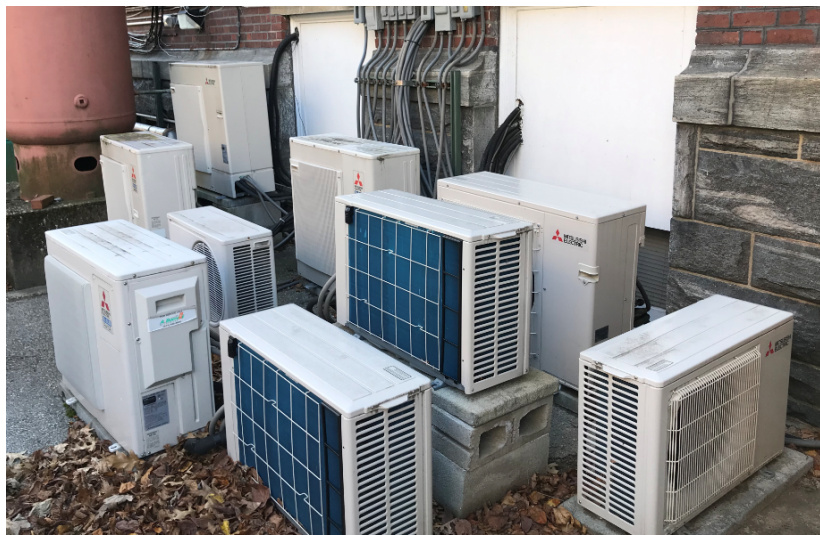
Cooling is provided to the Police Department and Village Hall offices by single and multi-split heat pump AC units, consisting of indoor wall-mounted evaporators and outdoor condensers. Most of the outdoor condensers were located in an alley on the side of the building. Most of the exterior piping insulation appeared to be severely damaged due to exposure to the elements. The layout of this condenser farm appeared to be problematic, as many of the condenser fans were either blocked or discharging air into the intake of another condenser. An inventory of these units can be found in **Appendix B**. Equipment is currently serviced on an as-needed basis, and recommended thorough maintenance protocols are provided in **Appendix F**.

Photo 6: Outdoor Condenser Farm

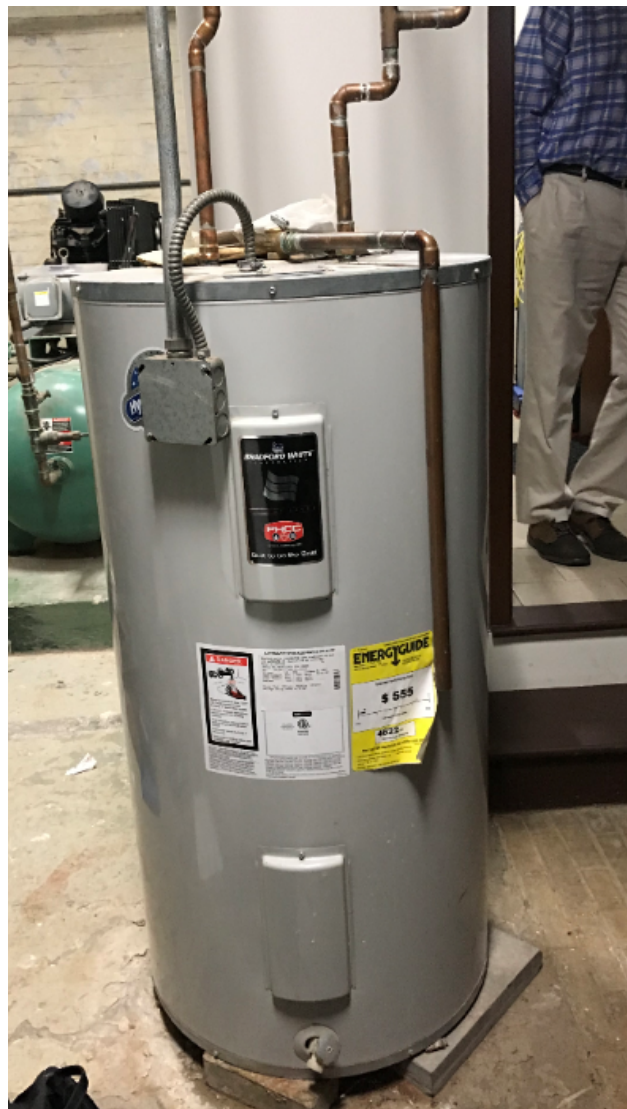
Domestic hot water for bathrooms is provided by a 4500-watt electric storage hot water heater. All visible piping serving this water heater was uninsulated.

Photo 7: Storage Hot Water Heater

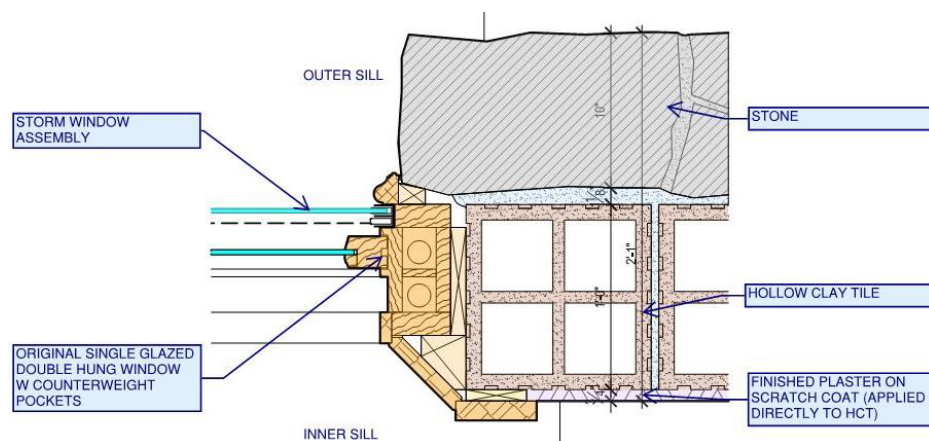
Figure 1: Plan Detail at Basement Jamb

The basement wall is assumed to have 12" of hollow clay tile with finished rusticated stone of approximately 10" thickness. Certain assumptions were made in the recreation of this wall, notably that there is no insulation, the plaster finish is applied directly to the hollow clay tile, without wood furring strips which could benefit marginally the performance of this wall. The following is a calculation of the R value of this wall:

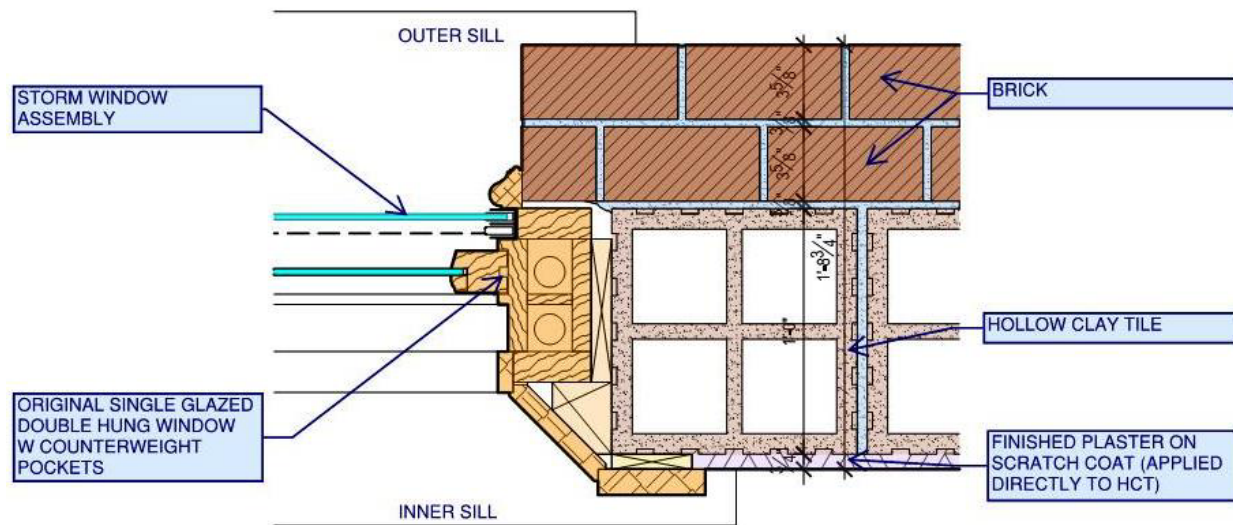
Figure 3: Plan Detail at 1<sup>st</sup>, 2<sup>nd</sup> Floor Jamb

At the first floor, the wall comes slightly narrower, with what is assumed to be 2 wythes of brick. The same assumptions regarding the interior finishing were made. With un-insulated walls there is a consistent flow of heat in the winter outwards which has the beneficial effect of maintaining moisture control of the porous materials used in the wall assembly.

The R value calculation for this modest change in material and thickness has no effect on the performance of the wall, and the R value for the entire building wall assembly is R 6.4.

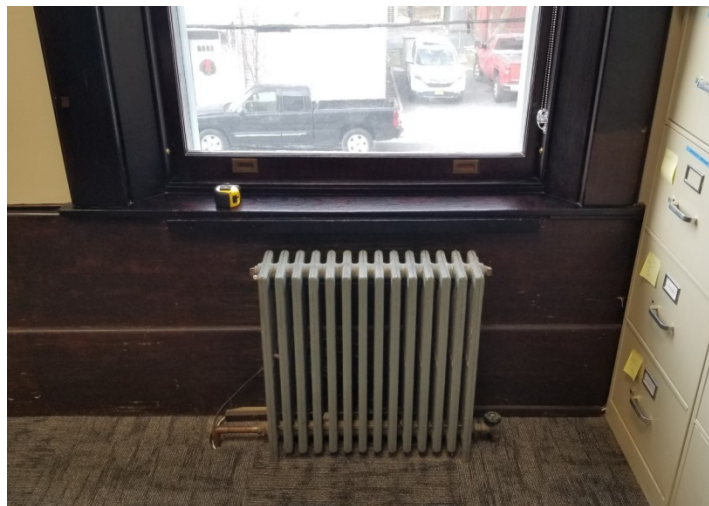
The existing windows are historic wood sashes with single glazing configured as 1/1. The R-value of these windows shall be assumed to be R 1. Many of these windows are large format windows and all have counter-weights and chain pockets for ease of operation. The counter-weight pockets are uninsulated and generally are not sealed well, and thus contribute to heat loss in the winter and cooling loss in the summer. The addition of aluminum storm windows would typically increase the R value to R 1.79 of the entire glazing assembly. This will yield a U value of .59. At the date of the inspection it was noted that several of the storm windows were open even though it was late fall. It is safe to assume that the operation of the storm windows by occupants is uncommon, and therefore this contributes to the building's energy loss. The tripartite division of the glazing on the exterior of the storm windows is inconsistent in material and configuration with the historic 1/1 double hung sashes.

Photo 8: Typical Original Windows (Offices)

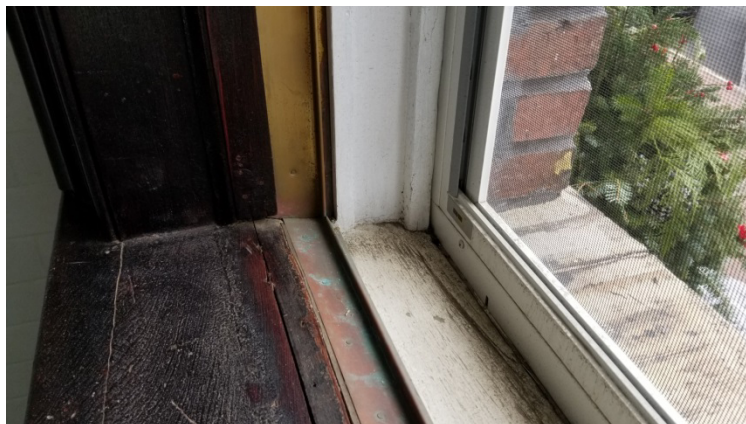
Photo 9: Typical Original Window with Storm Window

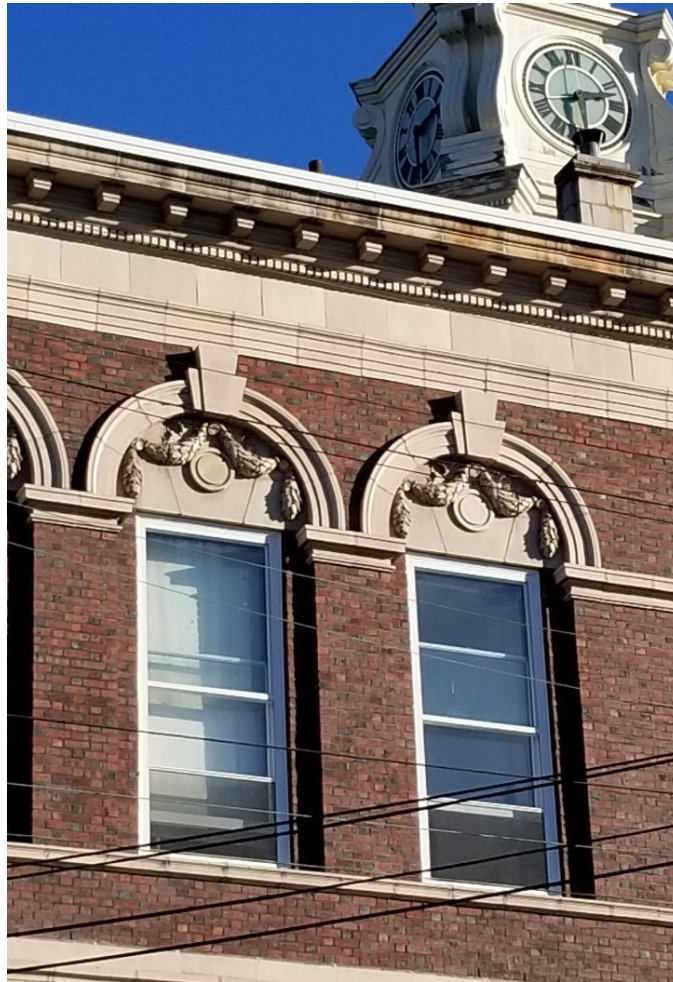
Photo 10: View of Exterior Showing Storm Window. The 2<sup>nd</sup> Floor original sash appears to be open

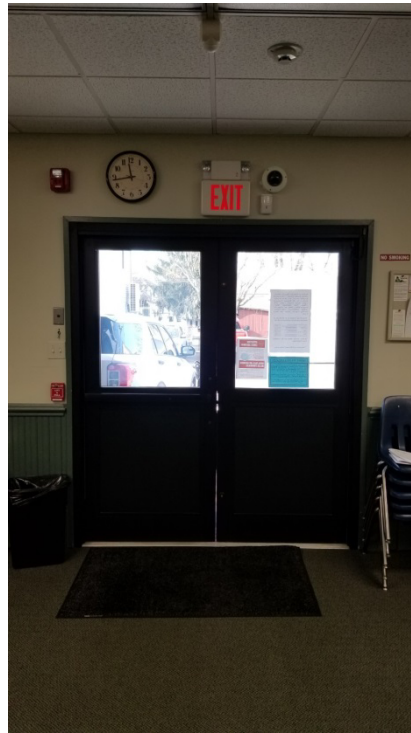
The doors of the building are a mix of new and old. The original entry doors are 2 ¼" rail and stile hardwood panel doors, some with single glazing. They do not provide a good seal and no substantive weather stripping was noted. The entry door to the detective sergeant's office has single glazed lights, and no weather stripping. The entry doors to the village court room were non-thermally broken extruded entry storefront doors with glazing in anodized aluminum. No astragals were installed on the active door, and no substantive weather stripping was noted. This door was cold to the touch on the interior. The entry door to the police control center can be similarly described. The additional hollow metal door inside separating it from the lobby adds a physical barrier, but not a thermal barrier for the occupants working in the control room. Given the state of doors and their installation, R 1.79 is estimated and shall be used in calculations.

Photo 11: View of Village Court Doors. Note daylight at lock, bottom and meeting of doors.

3. Replace entry doors to village court with thermally broken wood doors with insulated glass lights. Assure that proper weather stripping is installed at head, jambs, strike, and saddle. In lieu of this, build an air lock for these doors, but provide robust weather stripping and gasketed saddle, and gasketed astragal at active door. For window at western façade, provide weather stripping at window, or consider a new thermally broken window properly air sealed at opening.

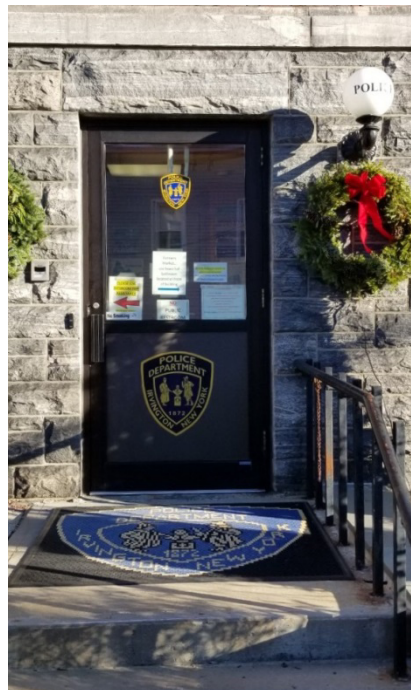
Photo 11: View of Entry to Police Control Center

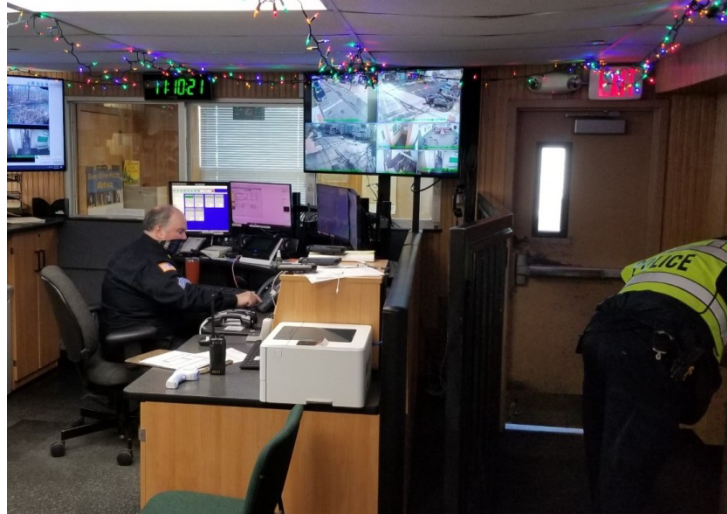
Photo 12: View of Police Control Center. Note daylight from below door

5. At the police control room, the existing 2x4 stud wall that separates the lobby from the booking room should be insulated with R 13 insulation. The lobby side is perhaps best for this installation and air sealing should be executed as well. The entry door should have a gasketed saddle, and weatherstripping should be installed at the perimeter of the door. Due to the constant use of these doors, coordinate with mechanical contractor and relocate the thermostat for proper functioning of the building's steam heat system.

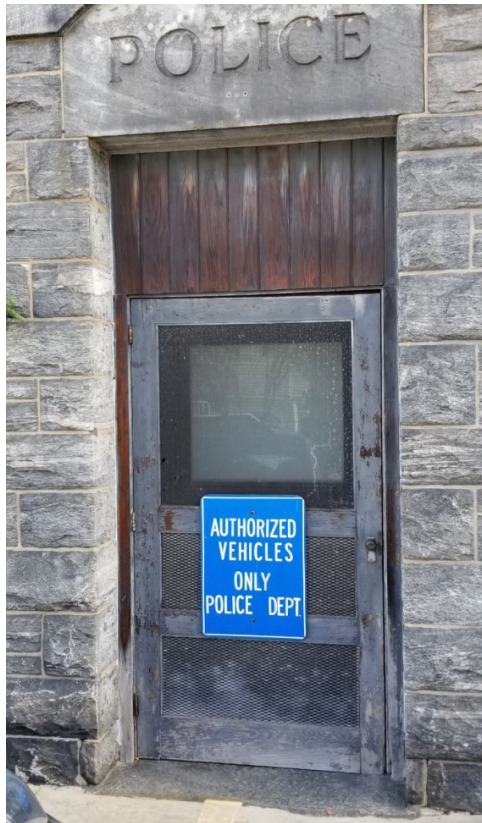
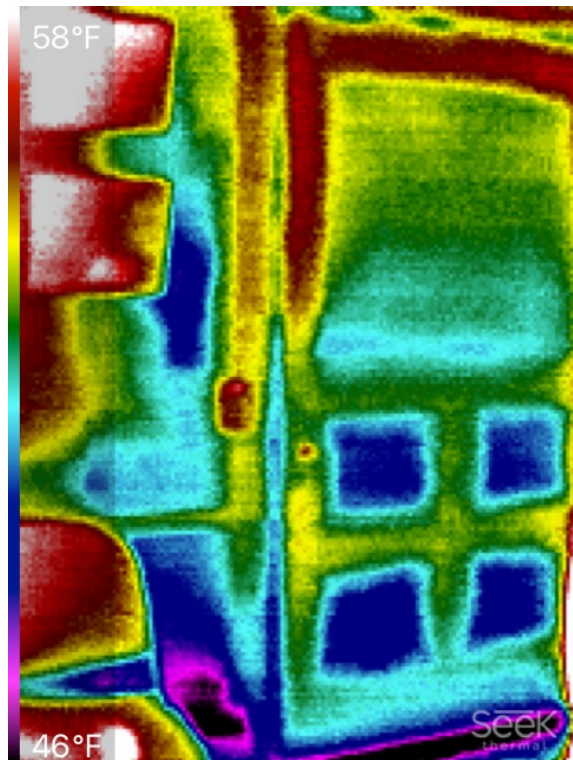
Photos 13 & 14: View of Entry to Detective Sergeant's door, and a thermal image of the interior of this door. Significant heat loss is noted at perimeter, at the wood panels which are thinner, and at the single glazing.

4. Weatherstrip the entry door to the detective sergeant's office. Provide a gasketed saddle to prevent air penetration from outside. At the window use expandable foam and non-mold silicone to enclose and seal the service penetrations for the heat pump in the jamb of the window.

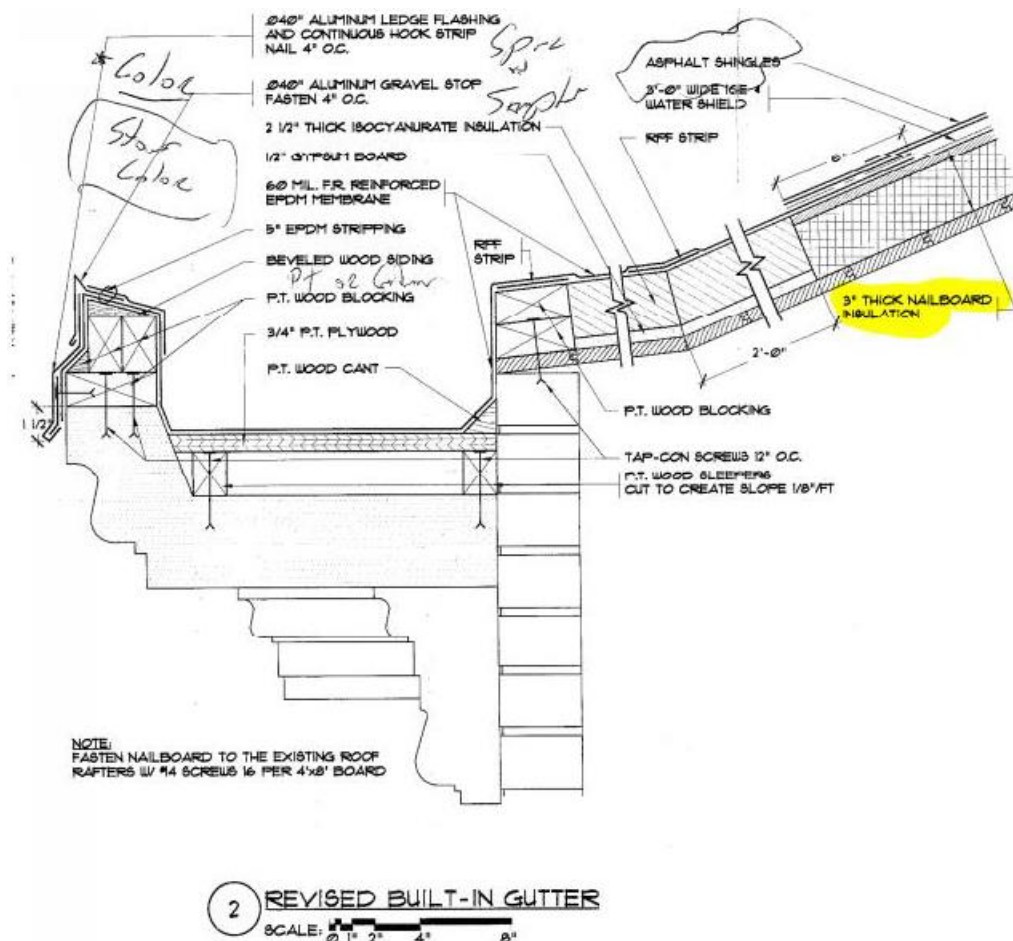
Figure 5: Section Detail Through Roof From 2004 Renovation

The typical roof section that was prepared by Watsky Associates in their set of drawings for renovation work implemented in 2004 indicates that the main roof assembly consists of 3" thick nail board insulation mounted directly on existing decking. A 3" nail board insulation typically has 2½" of EPS insulation with ½" OSB decking. For this evaluation, this assembly was considered the main configuration for evaluating the entire roof R value. Furthermore, the entire northern addition of the elevator and fire stairs was also discounted from this evaluation as these spaces are unconditioned, north facing, and therefore do not provide a critical additional barrier to energy loss through the northern wall. The footprint of the building is approximately 5515 square feet, but the slope of the roof will increase that area to approximately 5650 SF with a correction factor. The theater space is not commonly used due to the difficulties in conditioning the space. The existing steam radiator system provides heat but there is no cooling. The space is used only in the transitional months where heavily conditioned space is not required.

- There is no insulation between the roof decking and the ceiling which appeared to be original in our survey. The entire theater floor and the associated spaces at its perimeter and at the mezzanine did not appear touched by any renovations other than the installation of new seating.
- The R value derived for this assembly shall be used for the entirety of the roof although there are skylights and areas where additional insulation may or may not exist.

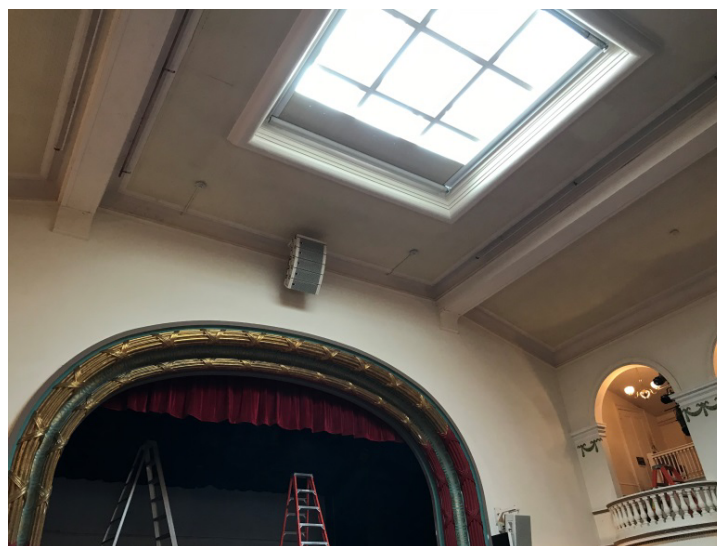
Photo 15: View of Theater & Roof with Skylight

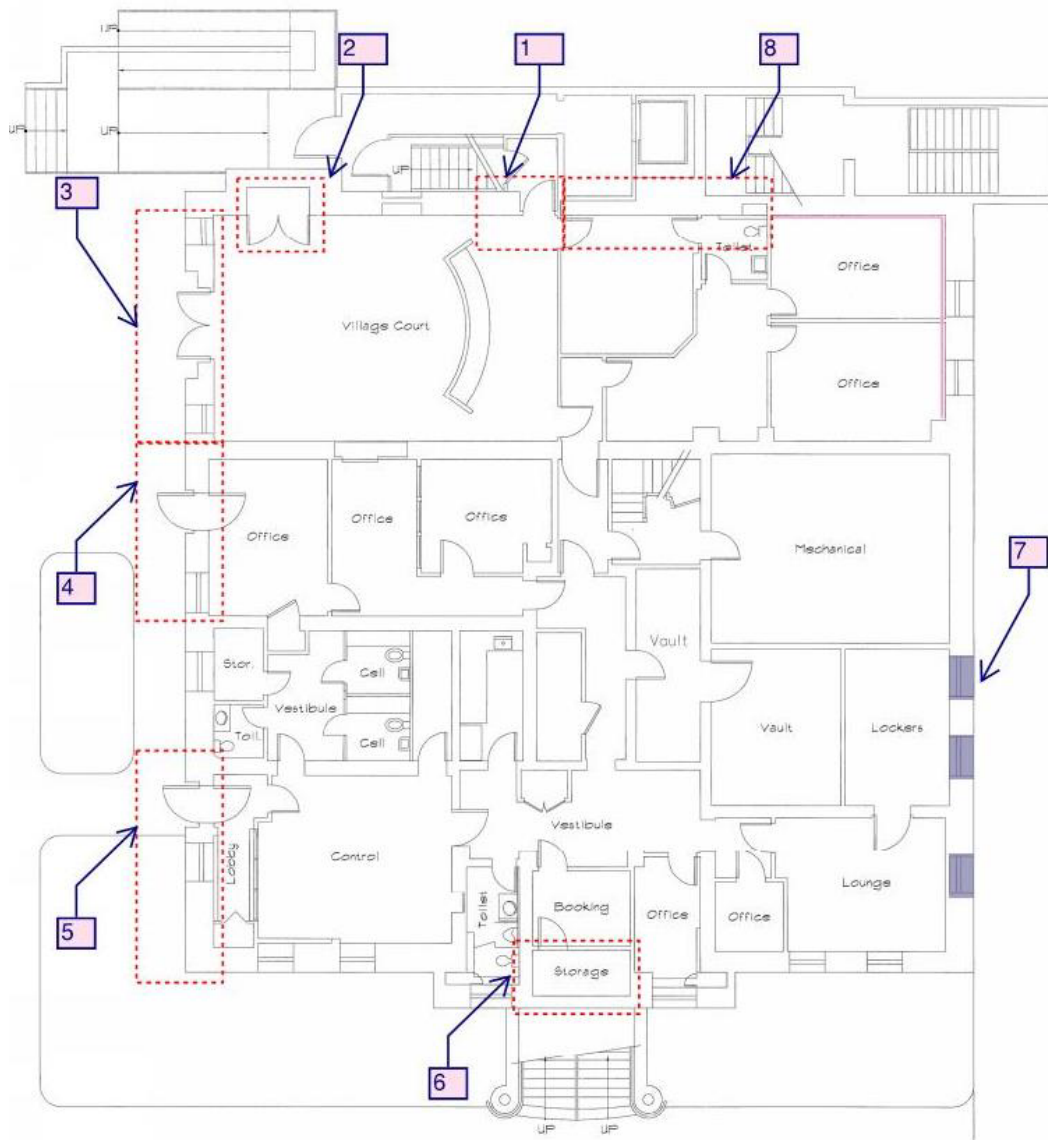
Figure 11: Basement Plan

1. Provide weather stripping for HM fire door in village court room.
2. Insulate and provide air sealing in closet at all three sides & at ceiling to prevent heat loss through the masonry wall. The probability of a thin brick wall exposed to north fire stair elevator addition is high.
