Eastwood Road Culvert Replacement

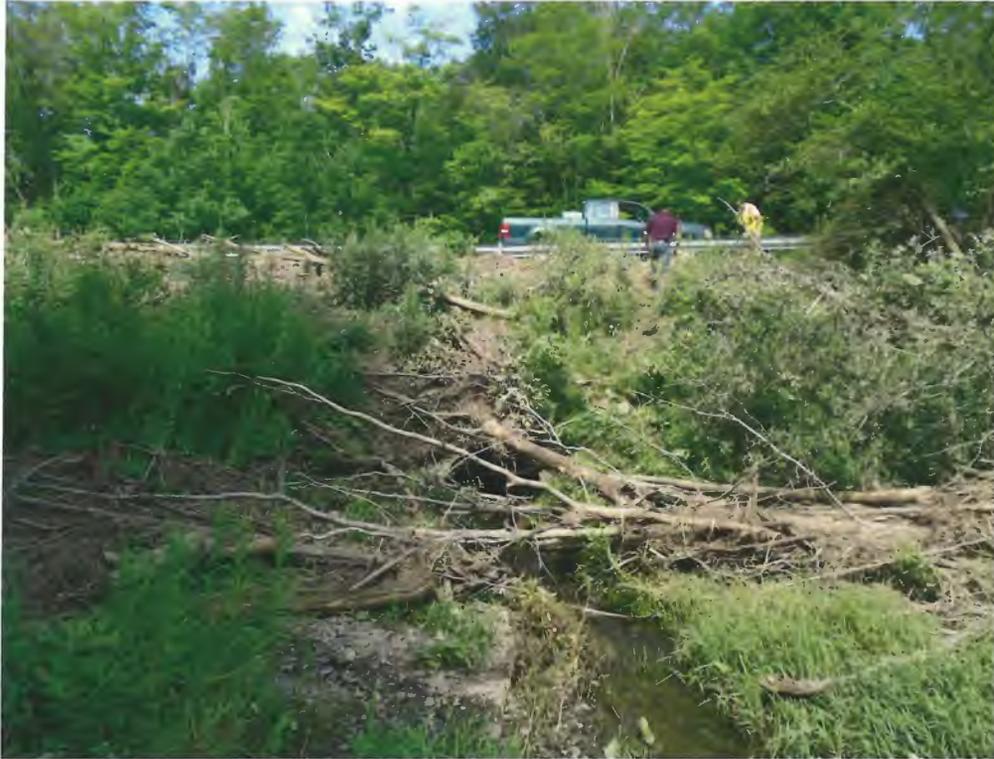
Existing 48" culvert pipe inlet, facing west (downstream)
Debris present from recent storm that overtopped road.

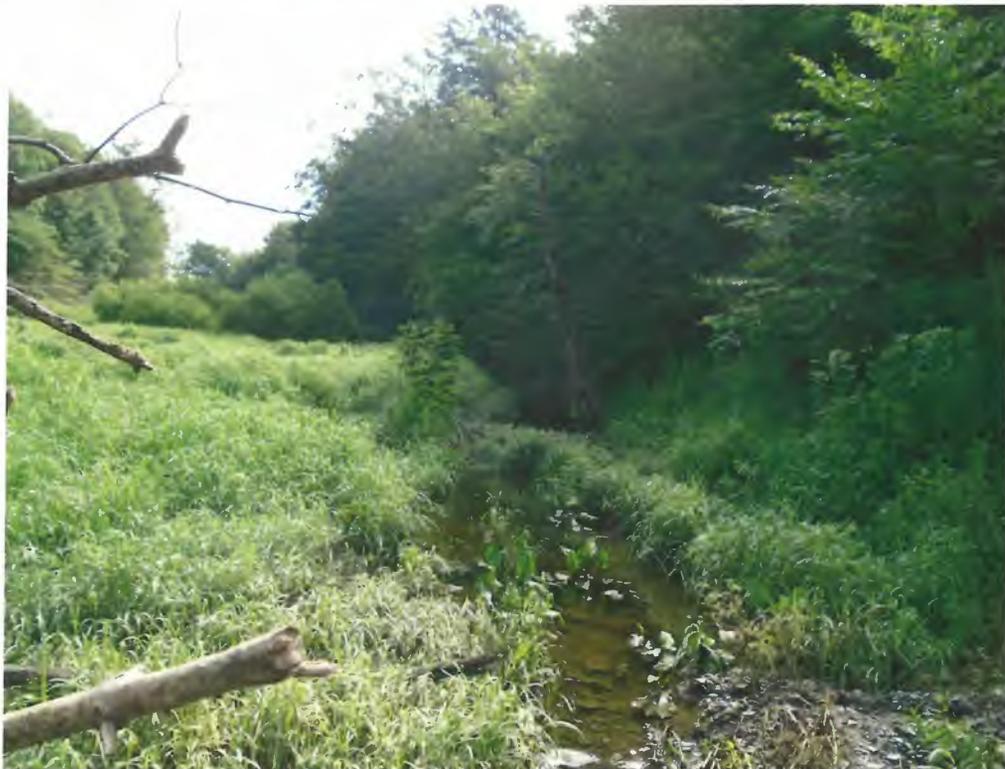
Facing east (upstream) from existing 48" culvert pipe inlet

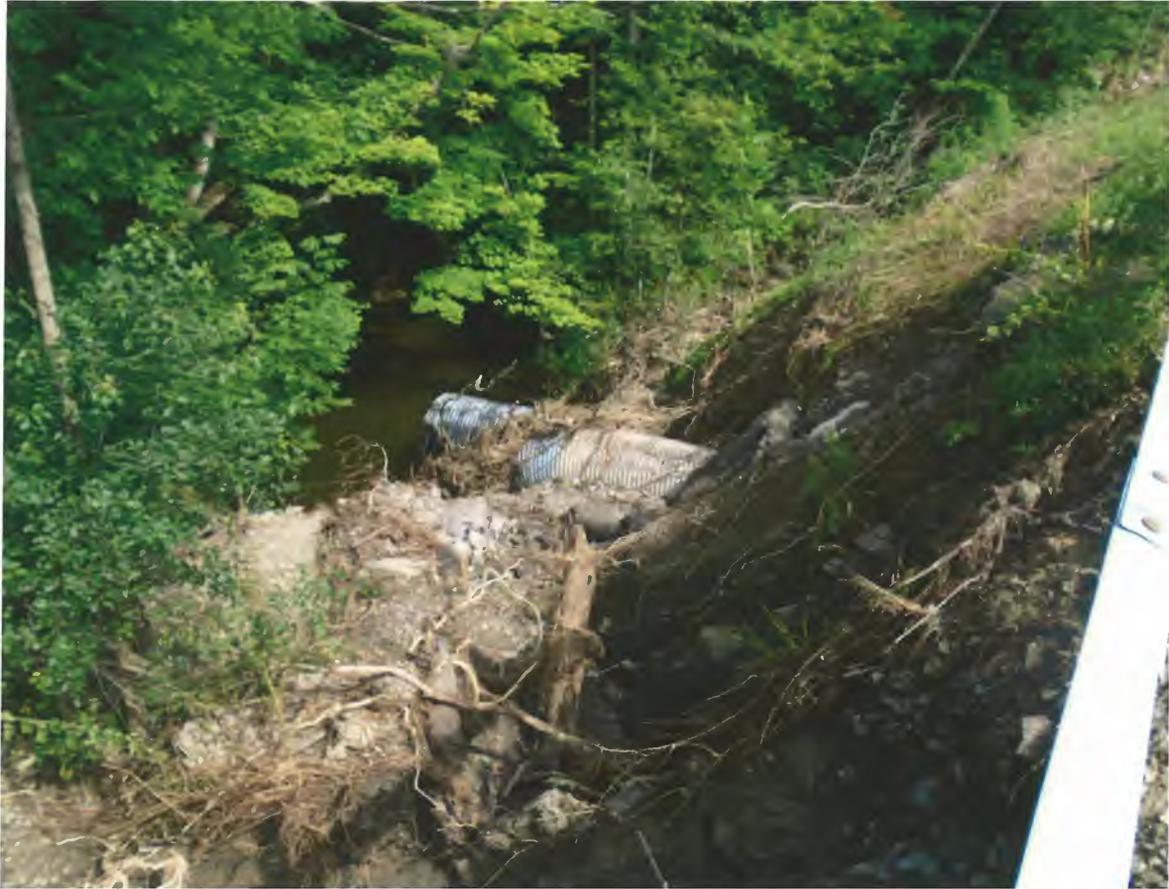
Existing 48" culvert pipe outlet, facing west (downstream)

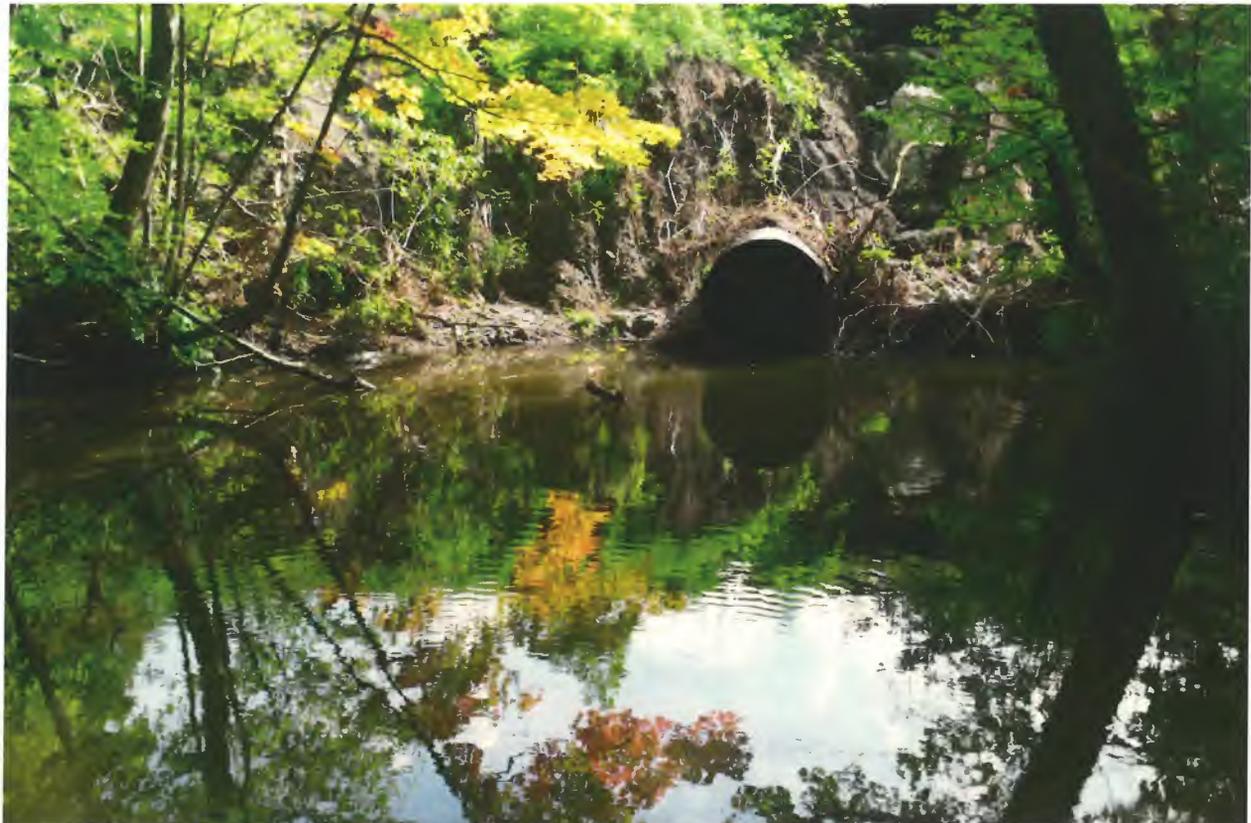
Existing 48" culvert pipe outlet and plunge pool, facing east (upstream)
