Town of Pittsford

Energy Efficiency Measures in Town Owned and Operated Buildings

February 7, 2020

Building Re-Tuning Walk-down Observations for Pittsford Town Hall

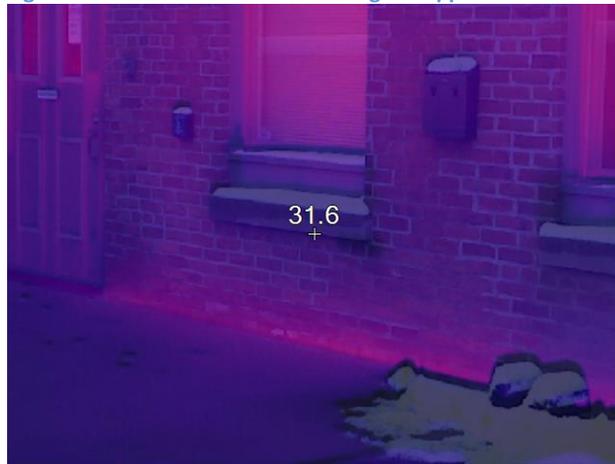
Figure 5 - IR000192.IS2: Thermal image of exterior wall on east side of building. The heat escaping at the bottom of the wall may also indicate a gap.

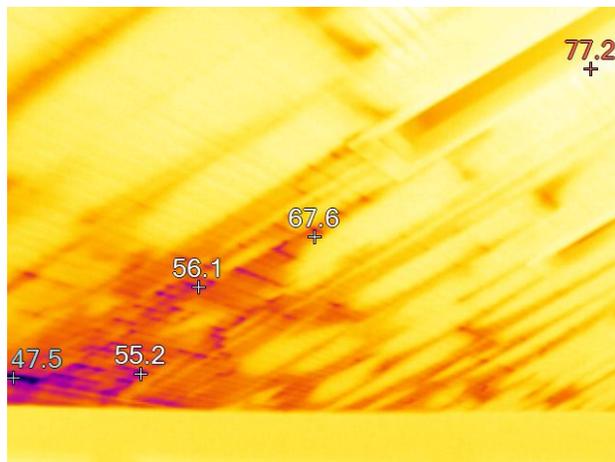
- Hot spot in peak (Figure 4) and heat from ridge vents indicates possible substandard attic insulation
 - Concern also supported by thermal image of 2nd floor ceiling shown in Figure 3.

Figure 6 - IR000137.IS2: Thermal image showing cold area of 2nd floor ceiling. Compromised insulation could cause cold areas.

- Install insulation on exterior walls in ceiling space.
 - Check supply air ducts in ceiling space to make sure conditioned air is not leaking into the space.

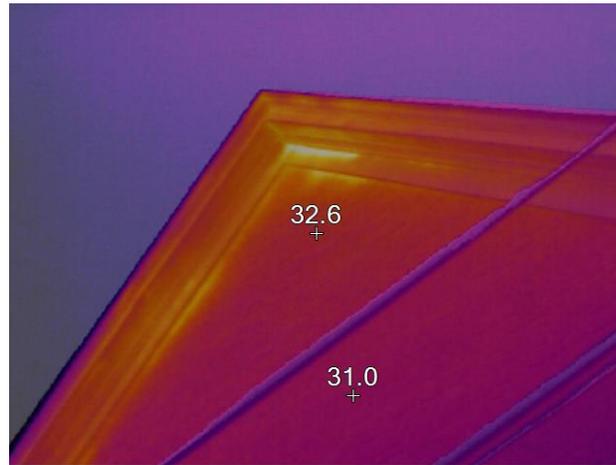
Figure 7 - IR000194.IS2: Thermal image showing heat loss near the peak of the east end of the building that could indicate that heat is escaping into the attic space.

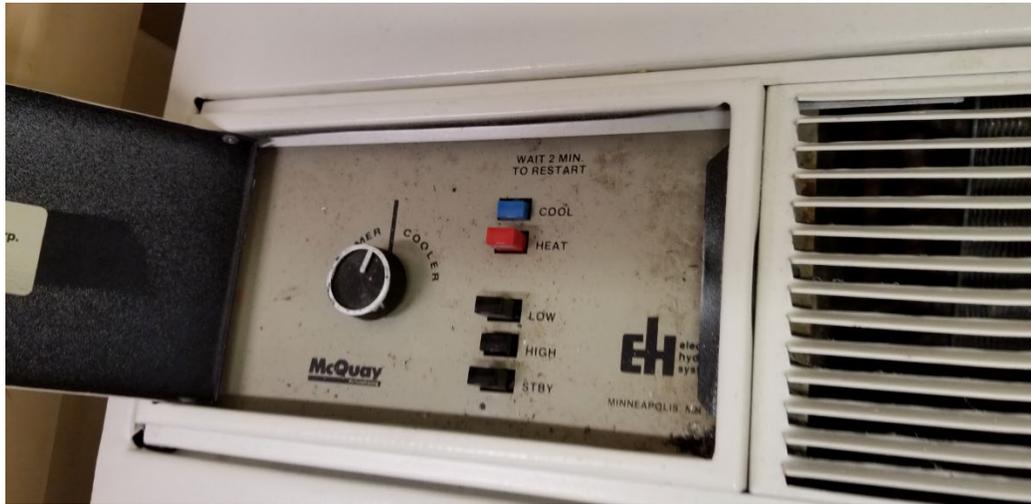
- Restrict control to building manager.
- Occupants and visitors can adjust heat pump consoles; e.g. - One basement console was running in cooling mode while the fresh air system was heating the space.

Figure 8 - Basement heat pump console running in cooling mode directly under an air vent supplying heat to the room.

- Restrict access to controls to responsible occupants or building manager
- Install timers so changes to settings are temporary
- Temperature set-backs are not used for unoccupied times due to the belief that the energy to re-heat the building exceeds the energy saved with night and weekend set-backs. Therefore the building operates in occupied mode all of the time.
 - Have the building manager perform an experiment comparing set-back operation to full time occupied operation. NYSP2I can advise on experiment protocol if requested.
 - Install interval meters and have building manager evaluate daily
- Some computer monitors were left on over the Thanksgiving weekend.
 - Program computers to turn off displays during inactivity.
 - Instruct office staff to turn off displays at end of day.

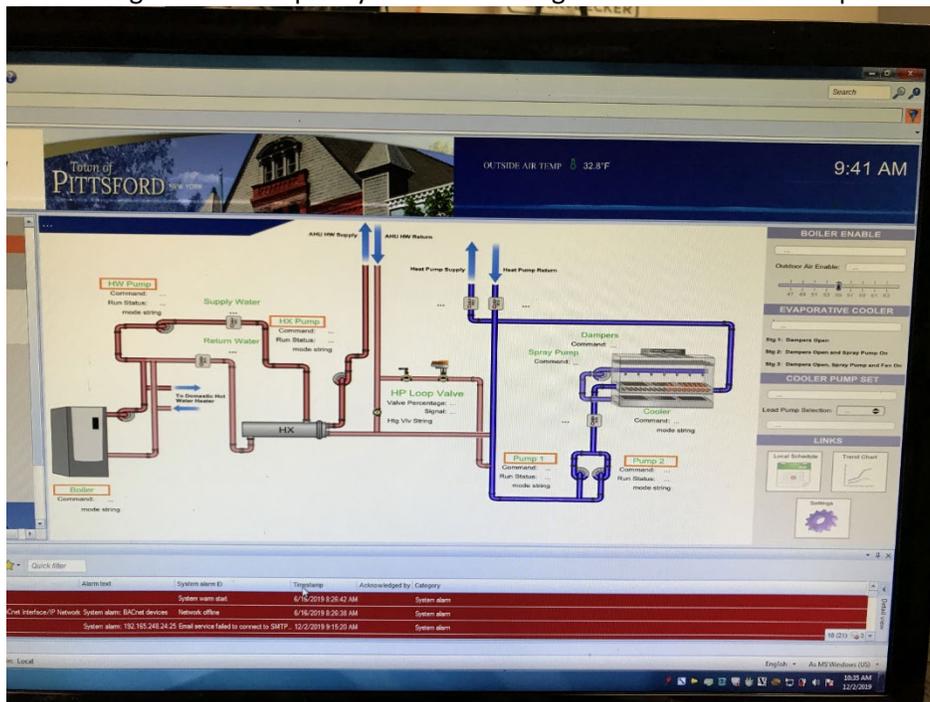
- See note in behavior section
- Heating/cooling is used in front vestibule
 - Consider reducing heating and increasing cooling temperatures in the vestibule
 - Make sure it doesn't adversely affect the clerk's office staff when the entry door is opened.
- Duct attached to HPL-13 leaking due to aged duct sealing tape.
 - Use UL listed metal tape to seal ducts instead of duct tape.
 - Consider an inspection of all ceiling and attic ducts. Are the unheated spaces through which they pass showing signs of air leakage? i.e. – warm in winter and cool in summer. Are there any visible leaks? Are the ducts well insulated?
- Boiler water is run through cooling tower prior to heat pumps. Staff said it is to keep cooling tower from freezing. This is not a common practice and is the same as simultaneous heating and cooling of water loop. Any heat lost through the tower must be replaced by the boiler.

- Winterize the cooling tower in the fall and valve off the water to it. This will save electricity used by the tower pumps and reduce natural gas used by the boiler.
- This ECM is considered medium to high effort because it requires plumbing changes to the heat pump circuit but it is expected to yield high energy savings.
- Space heaters in offices indicate that the heating system is not well balanced.

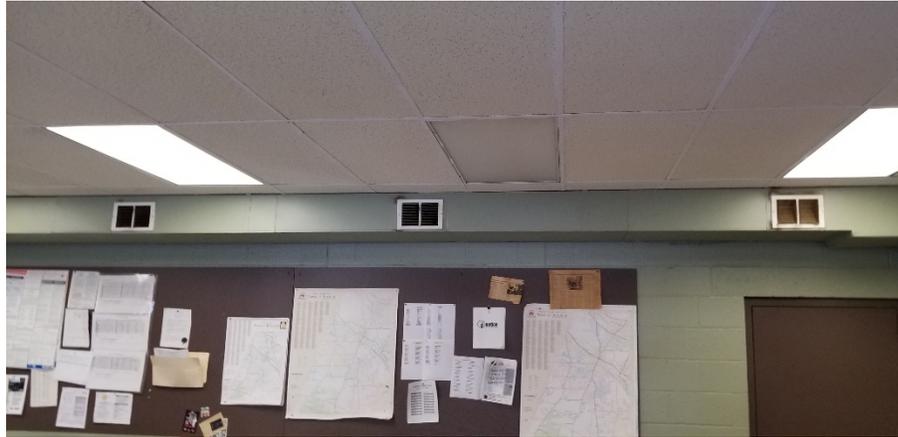
-
- The temperature set-point was 80F. When measured, the temperature in the room was 74F and the heat was not running. There are three possible causes:

- The thermostat may be out of calibration
 - The imbalance of the diffusers may be overheating the thermostat area
 - The thermostat may be located near a heat source

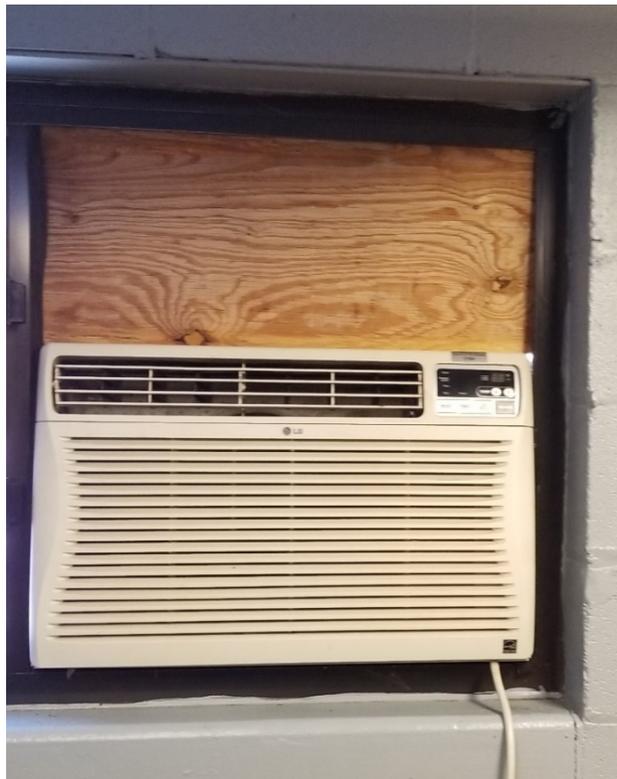
-
- Sign Shop
 - There was a window air conditioner in the sign shop with a loose fitting, uninsulated plywood panel blocking the remainder of the open window. Consider removing the AC unit for the winter and closing the window.

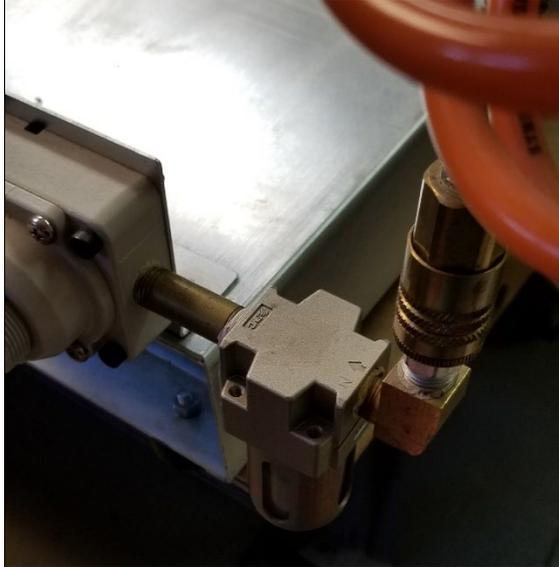
- Baseboard electric heat. Temperature set-point was 74F and the room was not occupied.
- Compressed air leak on the roller machine. An air hose with a quick disconnect fitting was plugged into the machine while the sign shop was unoccupied. Consider fixing the

leak or at least disconnecting the air supply when not being used.

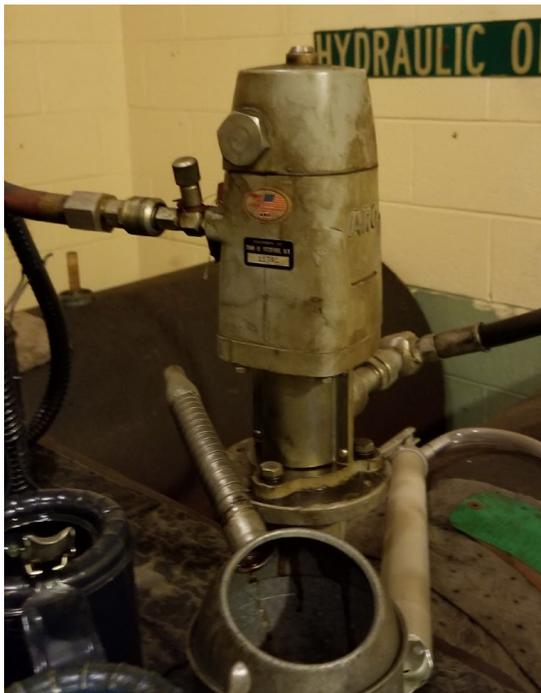
- Mechanics Bay
 - The area has two engine exhaust systems. The occupants stated that they don't use either when running trucks inside the bay. Instead, they open the bay doors.
 - Consider looking into repairs of the exhaust systems.
 - Consider a heat interlock with the doors so that the heat cannot run when a bay door is open.
 - Pneumatic oil pump leaking air.

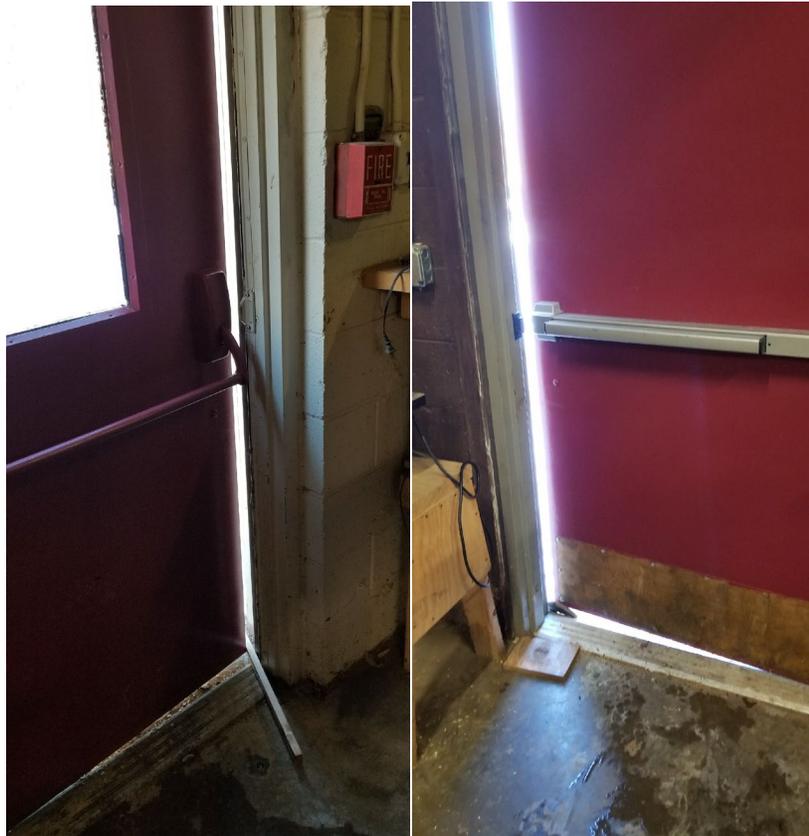
- Occupant complained that the night crew turns the heat up. The occupant stated that he opens the bay doors in the winter to cool down when he arrives. Consider adjusting and locking the thermostats.
- Truck Bays
 - Temperature in most bays was set to 64°F. Some areas were set higher. All connected bays should be set the same to avoid one area running too frequently.
 - Man doors were found propped open to allow access to the building. This is a large heat loss during cold weather. Consider unlocking the doors during the day (this one was already unlocked).

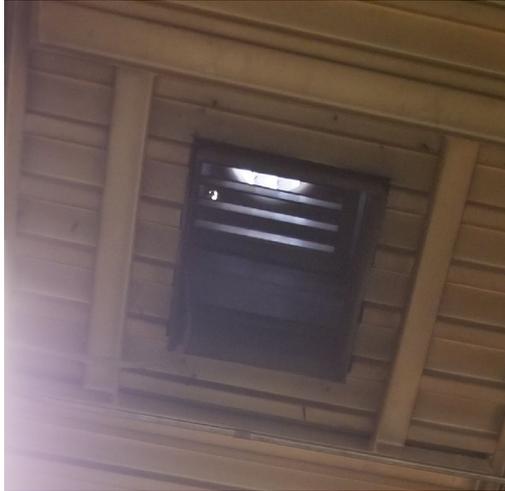
- Roof vent louvers were stuck open.

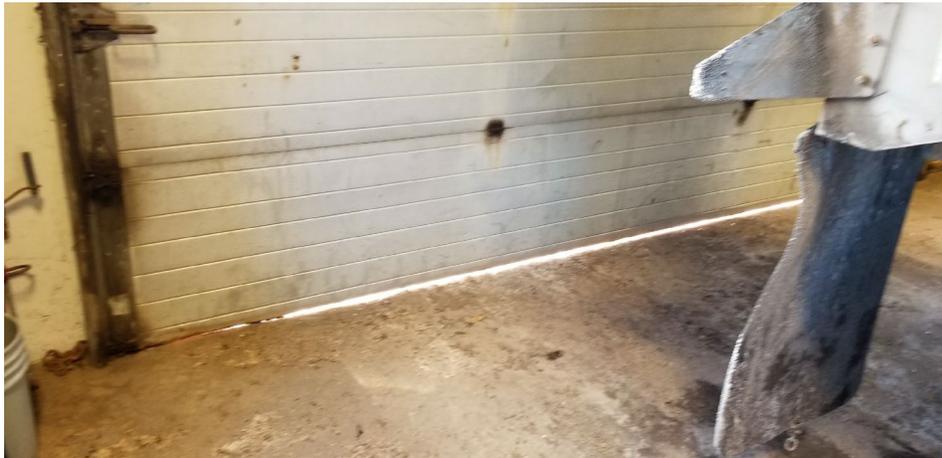
- Most bay doors were new and well sealed. Some of the older doors had gaps.

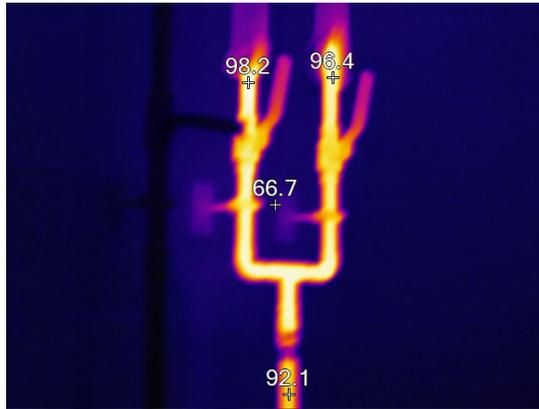
- Large single pane window on east end of building is poorly insulated.
- Water valves for both hot and cold water were both left open during non-use times at many locations. Using cold water elsewhere in the building would allow some hot water to enter the cold water lines consuming natural gas at the water heaters. The following photo shows both valves open and the heat in the cold water line indicates flow from the hot side to the cold side.

Instruct drivers to close at least one of the supply valves when not using the water hoses.

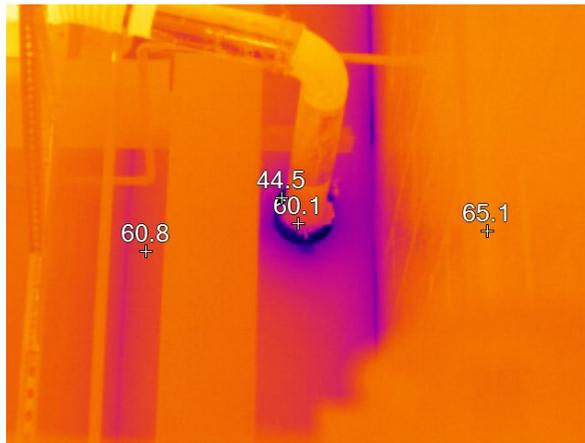
- Some building penetrations were not well sealed such as this radiant heat exhaust opening. All penetrations should be sealed with temperature appropriate sealant.
