Town of Geneva

Energy Efficiency Measures in Town Owned and Operated Buildings

August 10, 2020

Building Re-Tuning Walk-down Observations for Geneva Town Hall

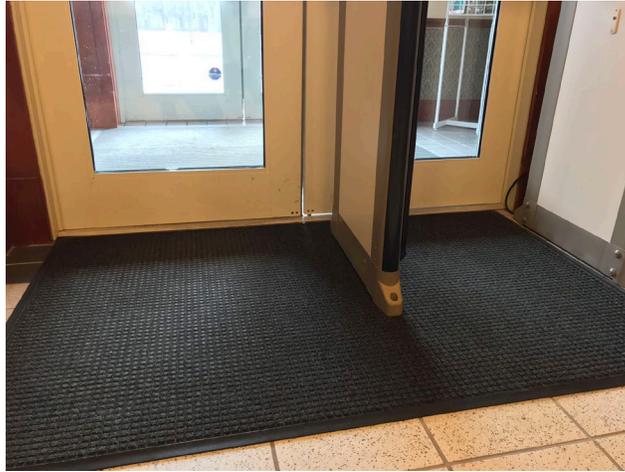
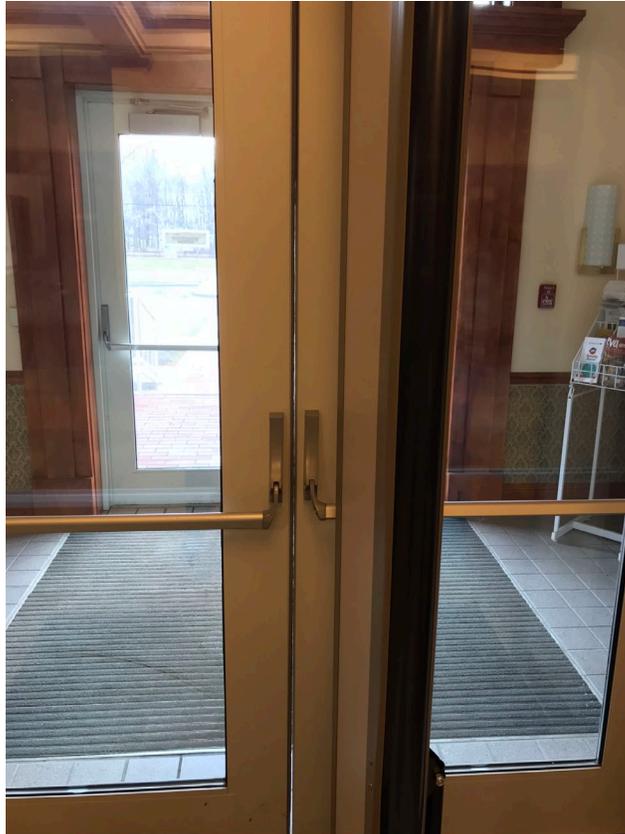
- Fluorescent lighting can be switched to LED for energy savings
- Vestibule
 - Gross floor area 92 sqft
 - Air temperature 60°F
 - Electric wall heater
 - Knob control
 - Low set point according to dial, but accessible to all staff and visitors

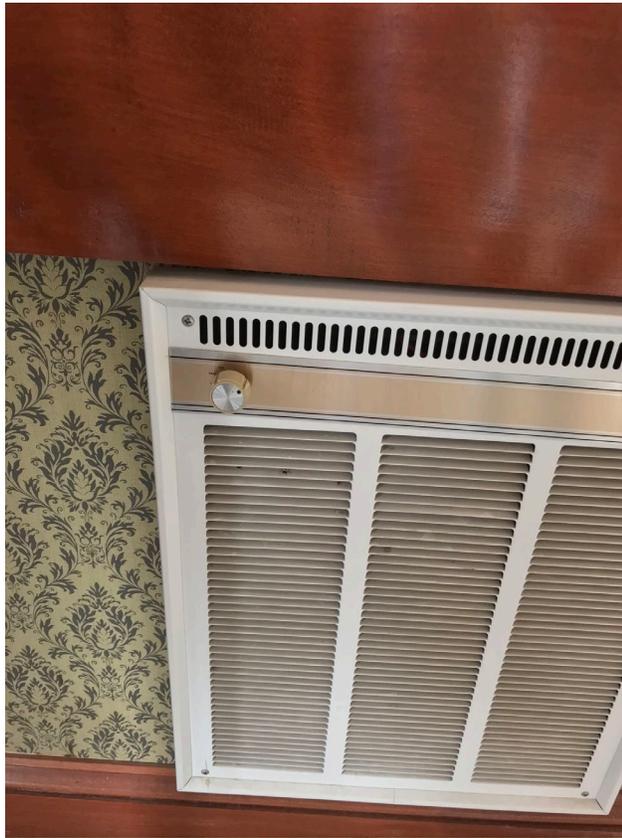
- Gaps, missing/worn weather stripping around exterior doors
- Court Room
 - Gross floor area 1492 sqft
 - Air temperature 73°F
 - Equipment
 - Copier
 - Cool spot high on the south wall shows missing insulation and heat loss into attic/roof access corridor

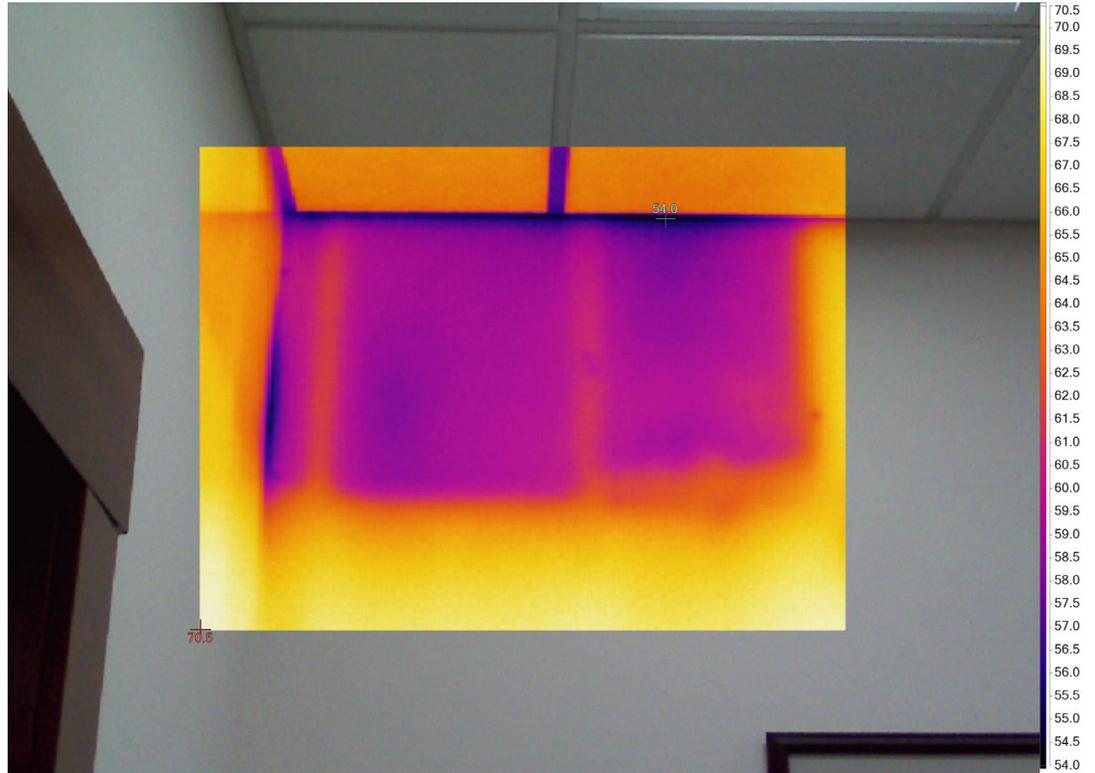
- Reception
 - Gross floor area 121 sqft
 - Air temperature 70°F
 - Weekly hours: Monday – Friday, 7am-4pm
 - Heater under desk because wall feels cold
 - Cold spots high on the wall indicate lack of insulation in portions of the attic space

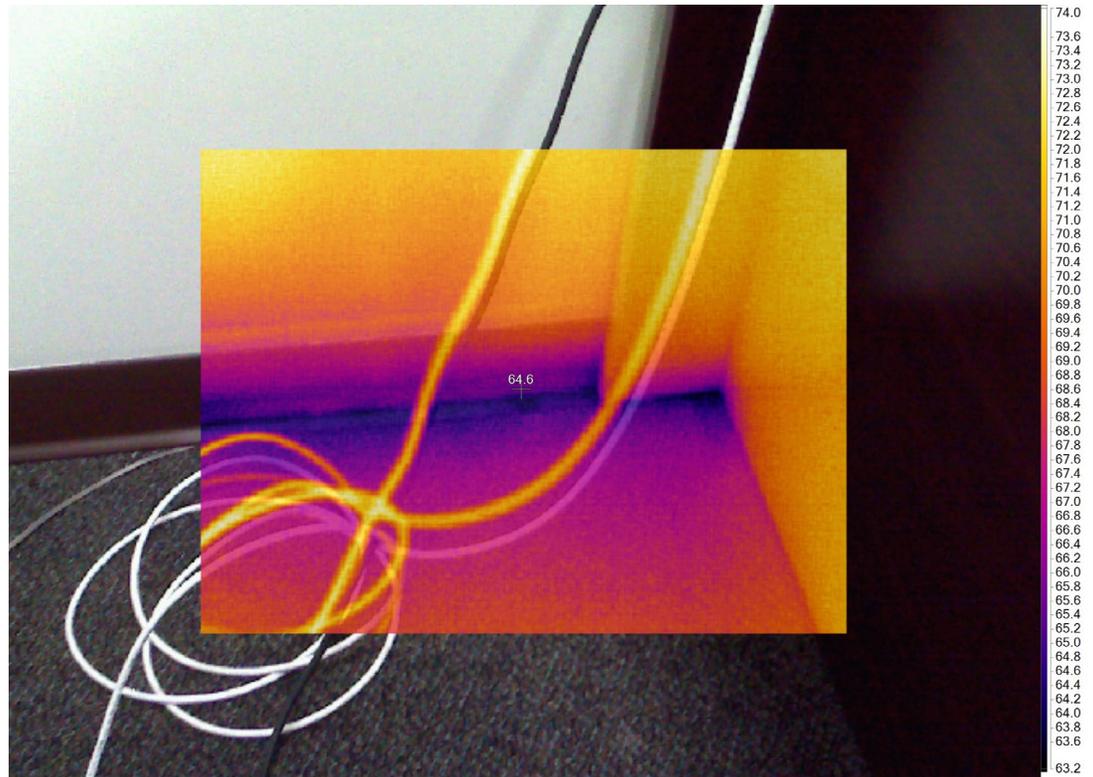
- Cold spots at floor level indicate thermal bridging, though less severe than in the Men's Restroom

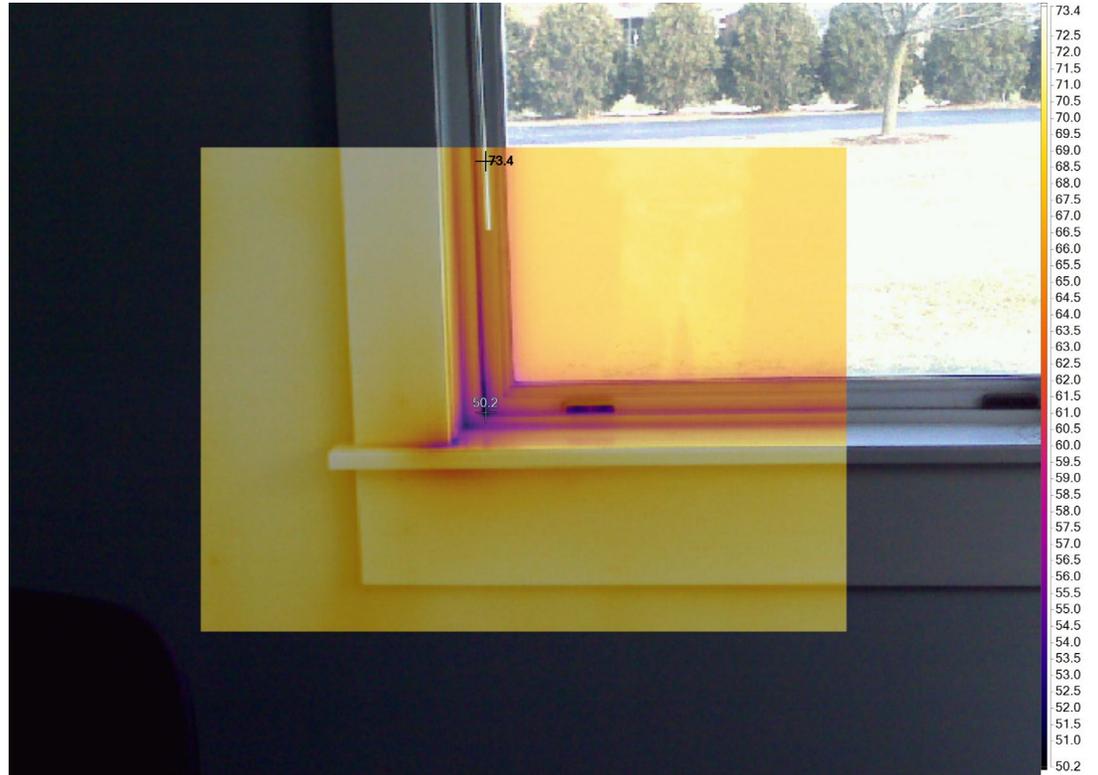
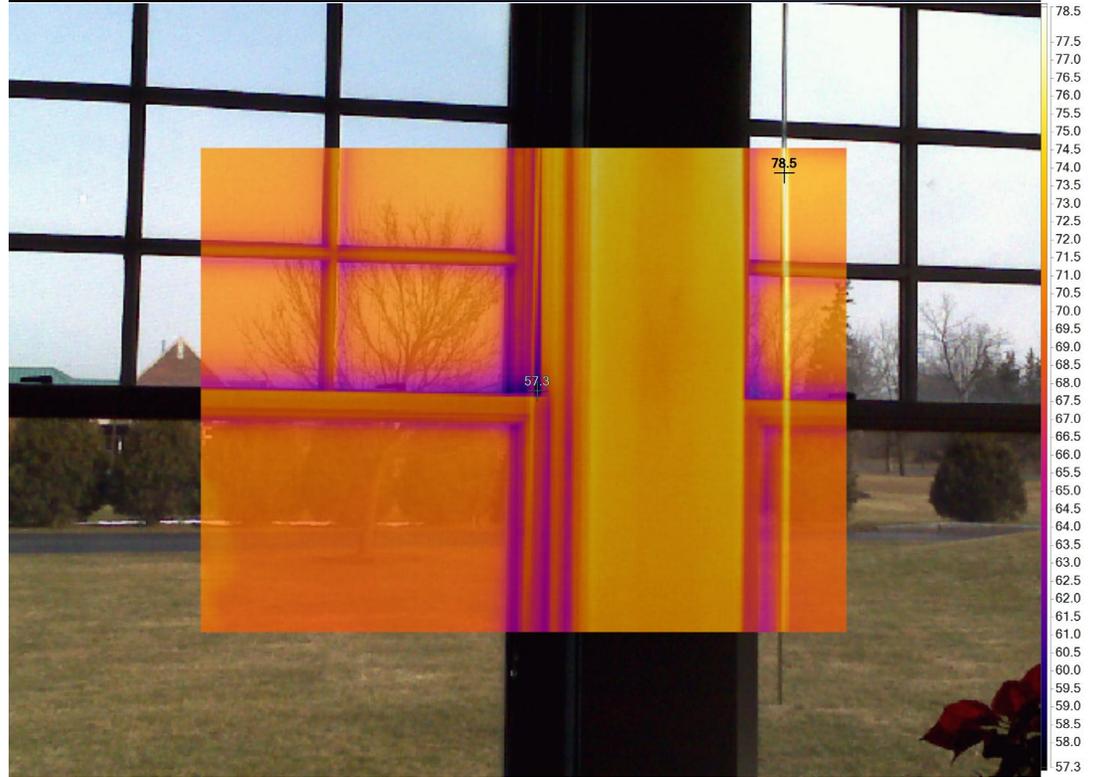
- Town Clerk
 - Gross floor area 203 sqft
 - Air temperature 70°F
- Assessor Office – Interior
 - Gross floor area 131
 - Air temperature 73°F
 - Weekly hours: Monday – Thursday, 9:30am-3pm
 - Both doors open, hallway and breakroom
- Tax Collector
 - Gross floor area 131 sqft
 - Air temperature 75°F
 - Weekly hours: 15 hours/week
- Bookkeeper
 - Gross floor area 151 sqft
 - Air temperature 73°F
 - Gets so hot occupant must open windows daily
 - Desk against the wall blocking return air vent
- Town Supervisor
 - Gross floor area 216 sqft
 - Air temperature 73°F
 - Weekly hours: 1 hour/day, variable
 - Cold spot in corner of window could be indicative of:
 - Thermal bridging from aluminum windows

- Worn weather stripping letting air leak through
- Code Enforcement
 - Gross floor area 252 sqft

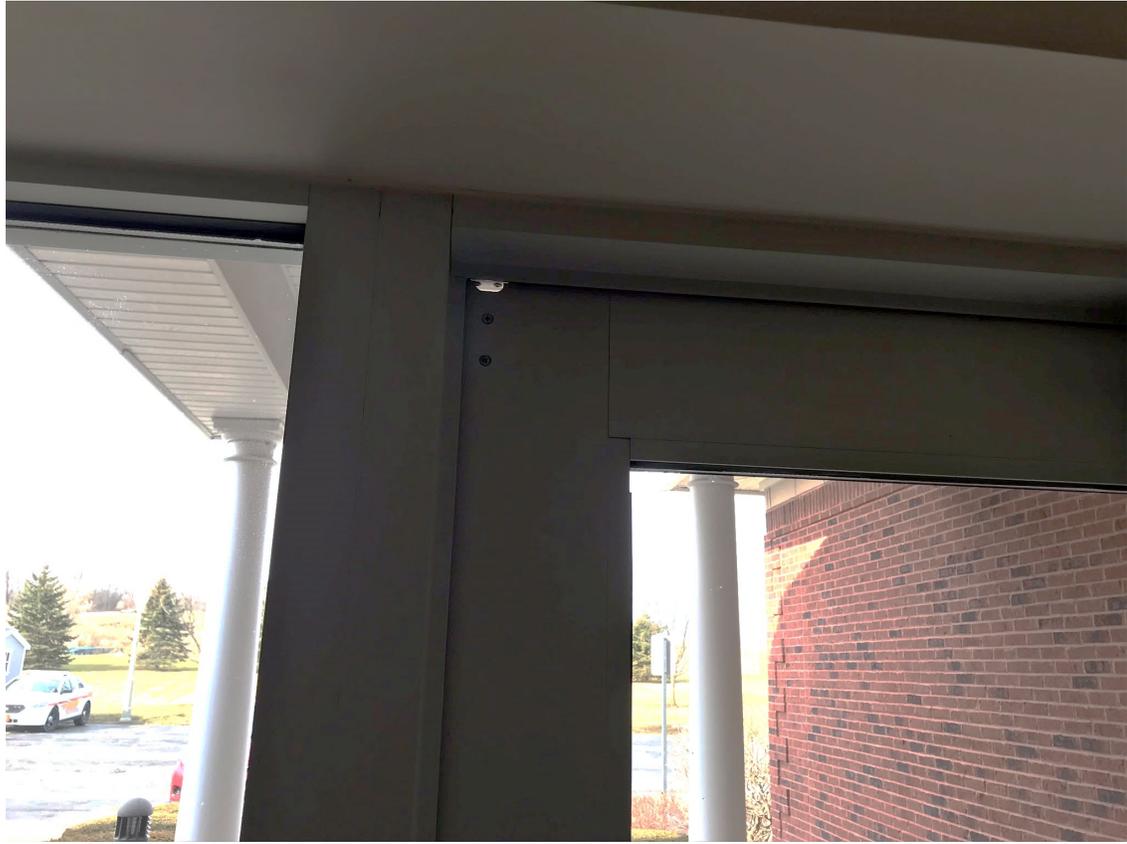
- Air temperature 75°F
 - Weekly hours: Monday – Friday 8am-4pm
- Copier area/room
 - Gross floor area 338 sqft
 - Air temperature 76°F
- Bookkeeper 2
 - Gross floor area 142 sqft
 - Air temperature 77°F
 - Weekly hours: Monday – Friday, 8am-12pm
- Conference Room
 - Gross floor area 168 sqft
 - Air temperature 75°F
- Breakroom
 - Gross floor area 180
 - Air temperature 76°F
- Archives
 - Gross floor area 384
 - Air temperature 74°F
- Rear vestibule
 - Gross floor area 109 sqft
 - Air temperature 67°F
 - Gap on exterior door

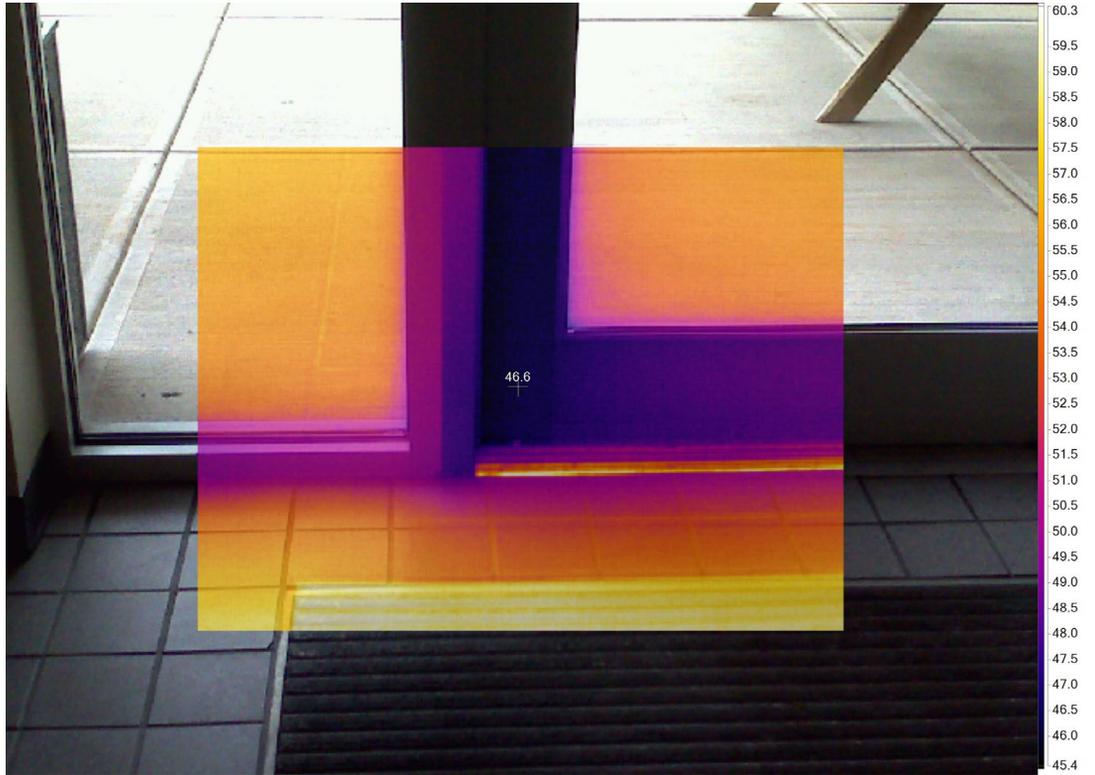
- Aluminum door frames are poorly insulated

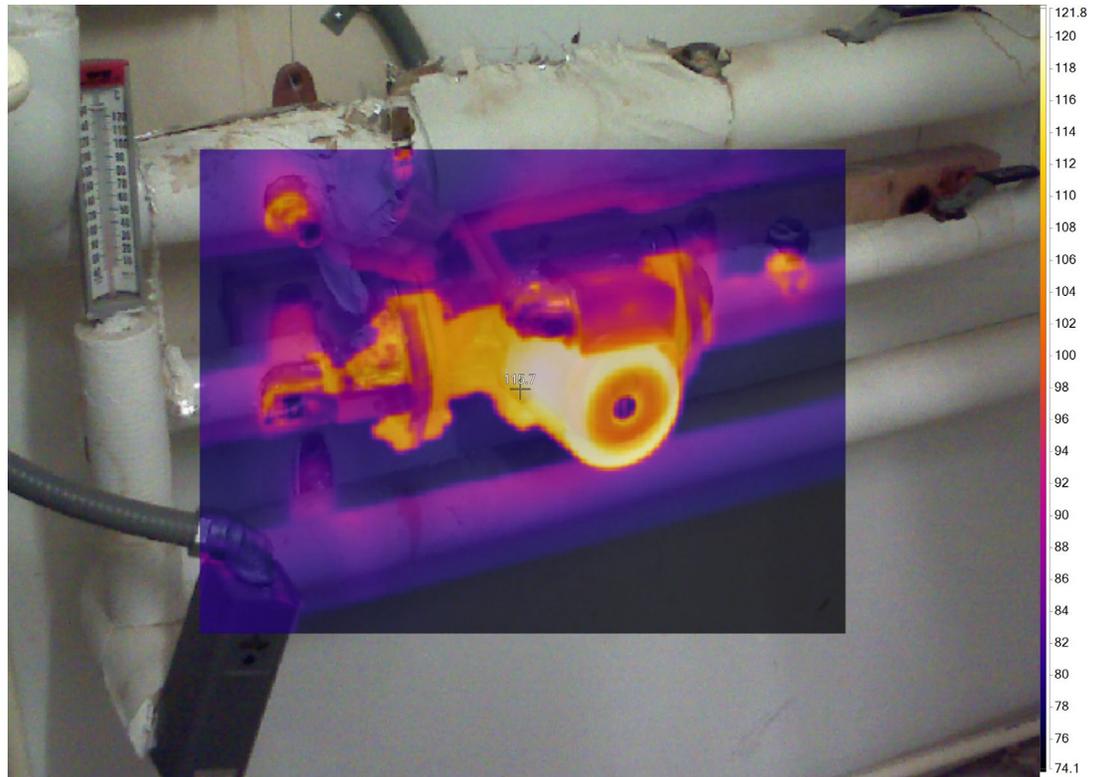
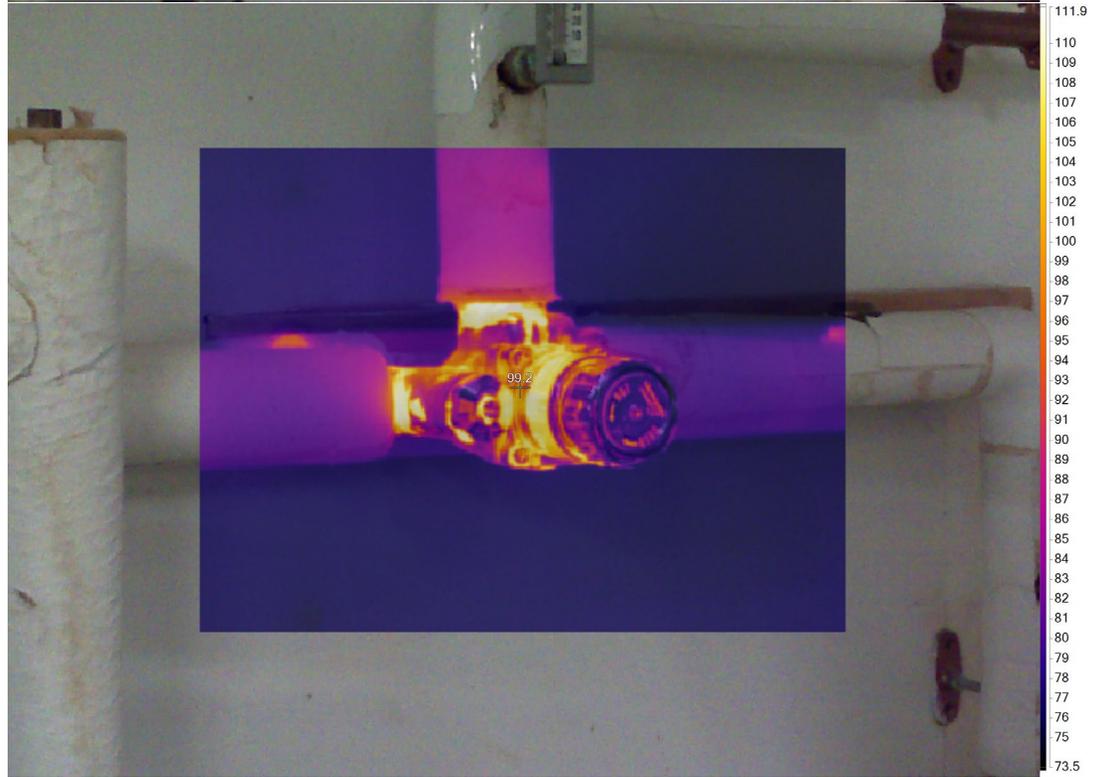
Additionally, NYSP2I discovered that both air handlers as well as the make-up air unit in the attic space were missing air filters. Filters are important for maintaining indoor air quality and filters of the appropriate size and efficiency should be added as soon as possible.

- Sheriff's Office
 - Gross floor area 177 sqft
 - Air temperature 67°F
- Holding Cell
 - Gross floor area 104 sqft
 - Air temperature 71°F
- Justice area
 - Gross floor area 250 sqft
 - Air temperature 72°F
 - Weekly Hours 4-6
- Court Clerk
 - Gross floor area 257 sqft
 - Air temperature 73°F
 - Return air vent partially covered
- Court Restroom
 - Gross floor area 55 sqft
 - Air temperature 69°F
- Court Conference room
 - Gross floor area 196 sqft
 - Air temperature 70°F
- Attic
 - Hot water circulator pump and mixing valve very warm but no warm water in either bathroom
 - Should be investigated further

- Air handlers are missing the filters

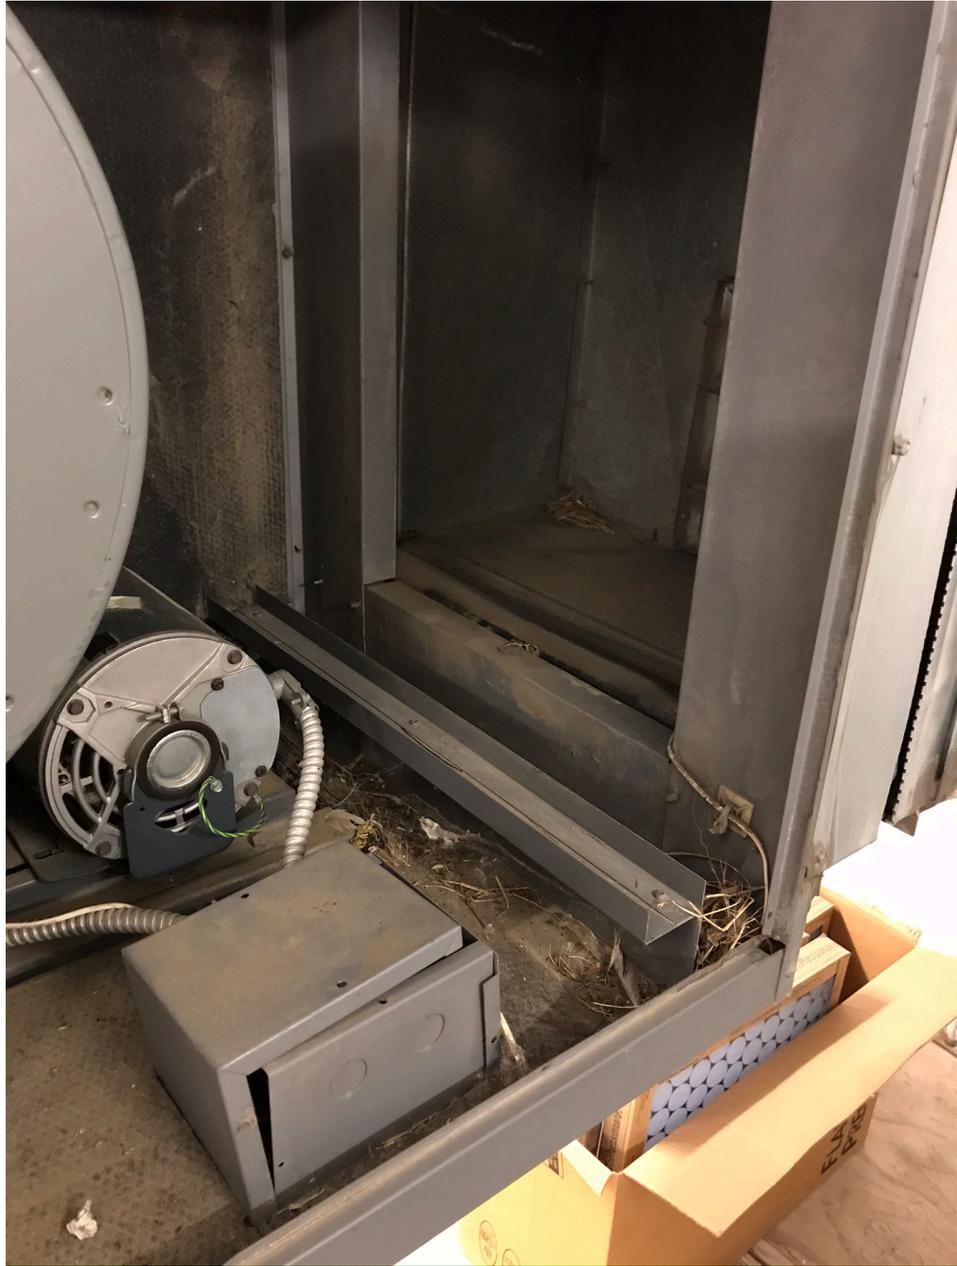
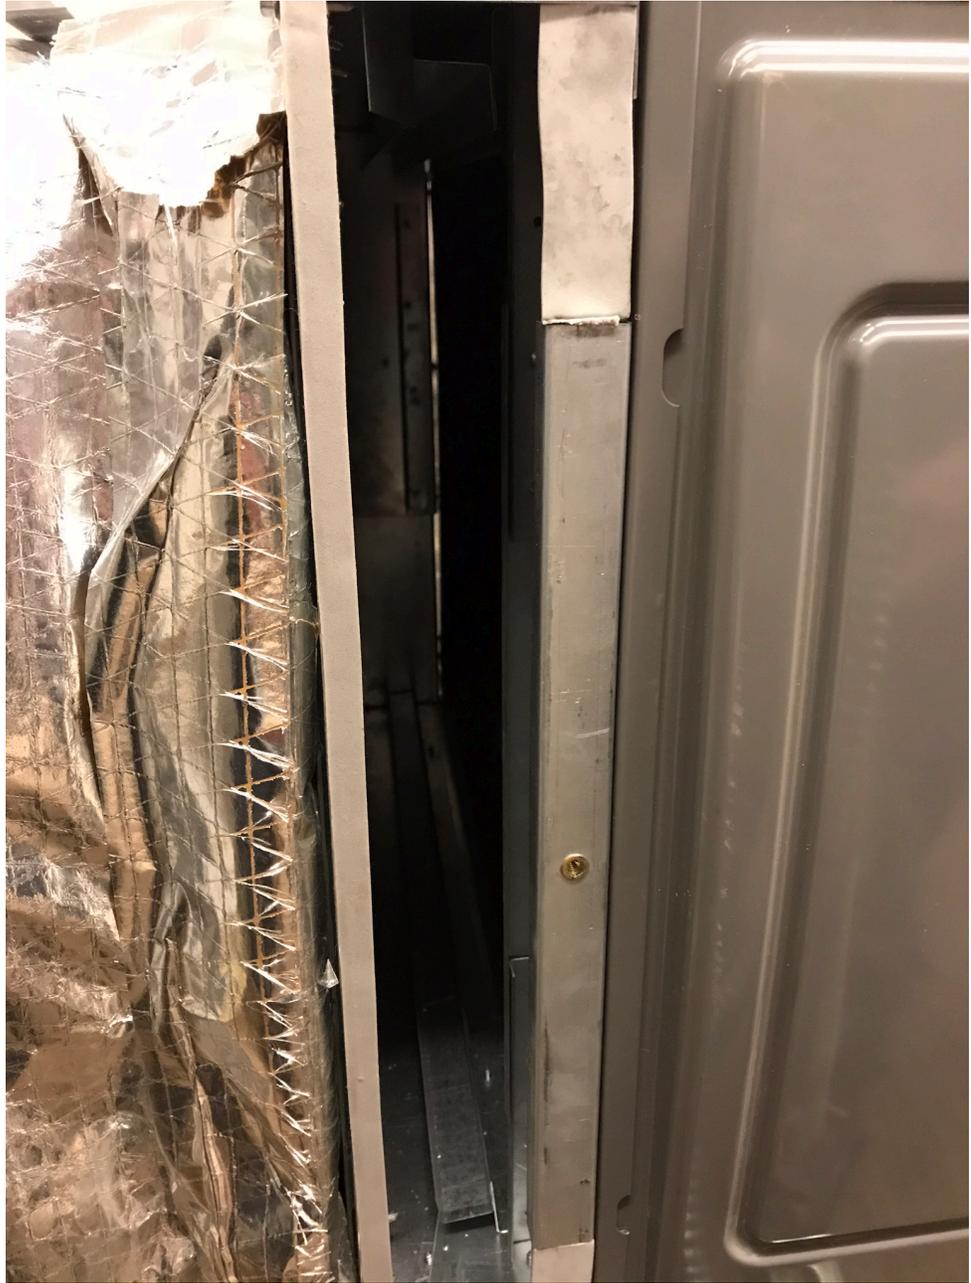
- Some air handlers missing the appropriate screws, or the screws are not fastened. Leads to leakage out of the unit and wasted energy

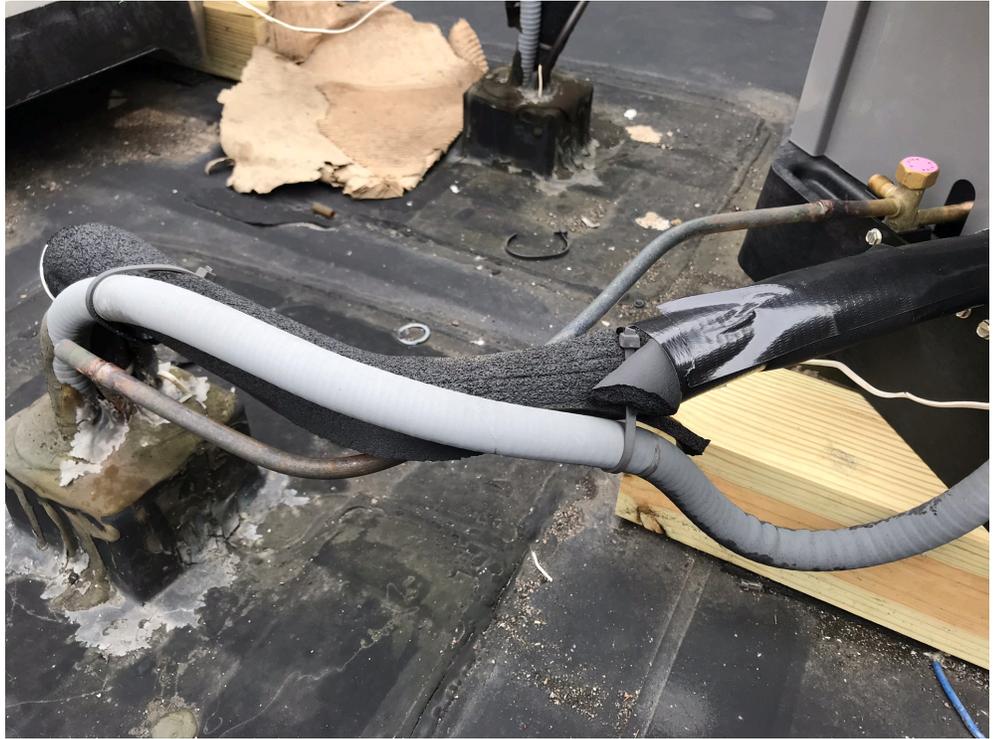
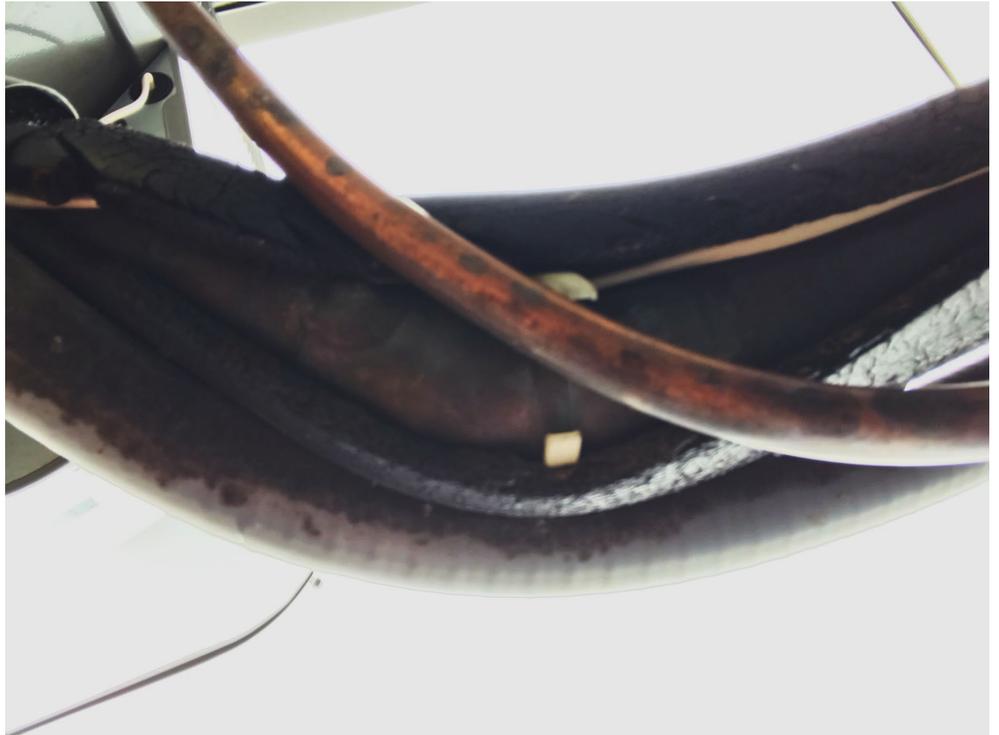
- Roof
 - Debris left on roof from air conditioning upgrades
 - Should be removed, potential puncture hazard to roof membrane
 - Suction lines on condensers has reused insulation
 - Primary issue is the potential for water ingress through roof penetrations
 - Secondary issue is poor insulation reduces the efficiency of the system

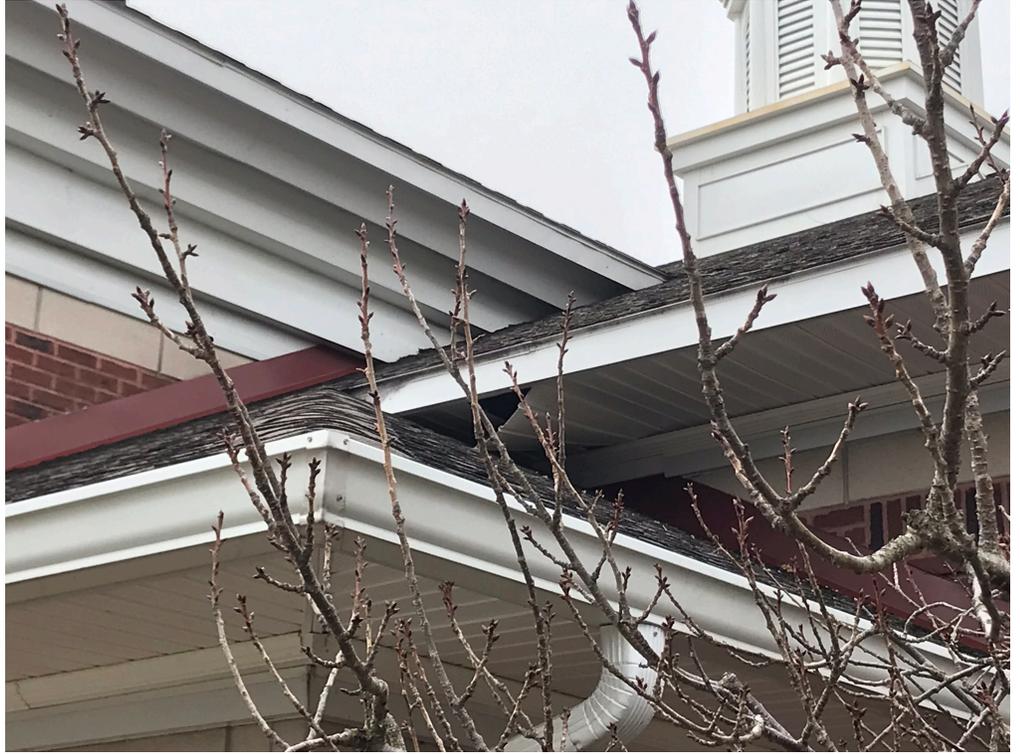
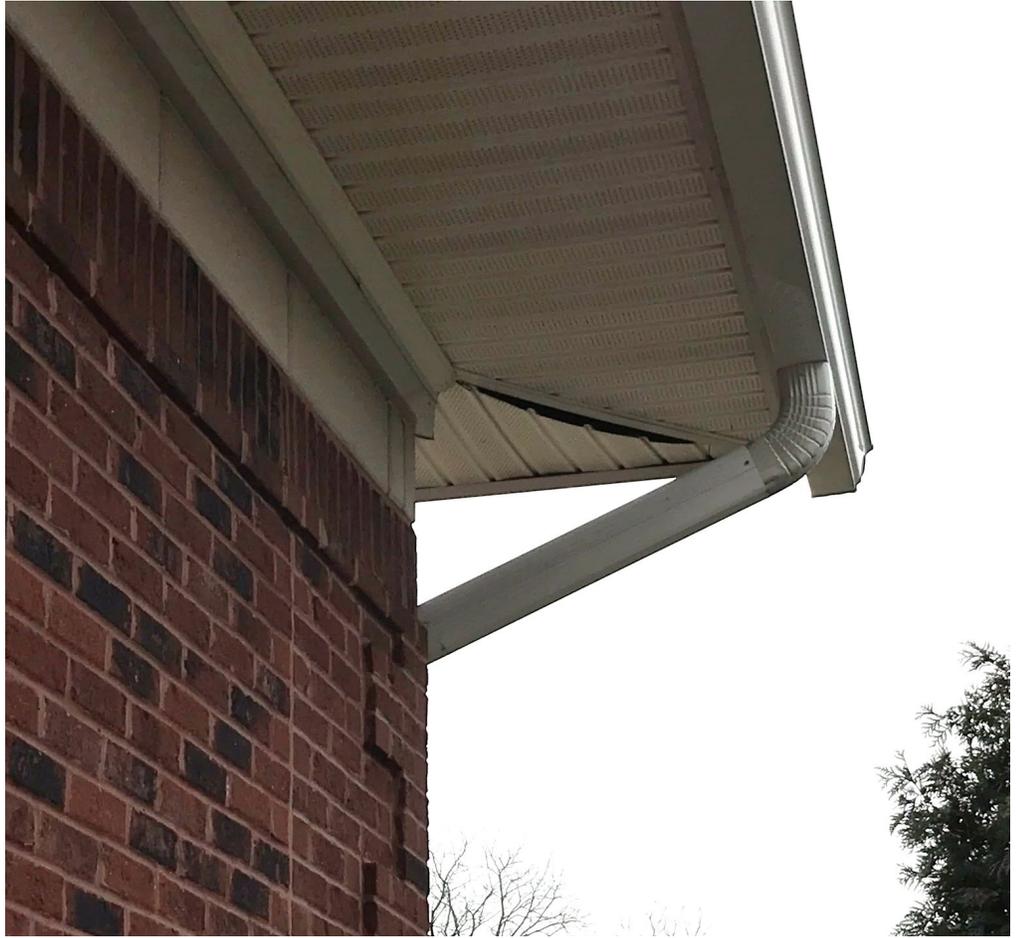
Another area for consideration is the external building envelope. In several locations the soffit has come loose and is hanging lower than it should. This can cause excessive ventilation of the attic space increasing heating and cooling cost as well as allow rodents and insects an easy access point commonly leading to compromised insulation and other types of damage and health hazards. NYSP2I also noted that the breakroom exhaust fan vent damper was stuck open and appears to currently, or recently had a bird(s) living inside of it. This can cause: the vent to operate improperly, air leakage out of the conditioned building space increasing heating costs and poses potential health hazards.

- Unable to check for filter in Roof top unit, but based on the other three units in attic, would not be surprised if it were missing a filter as well.
- Exterior
 - Soffit hanging loose in multiple locations
 - Can allow pest in

- Can cause excessive or over ventilation of attic

- Repairing loose soffits on the Town Hall
- Repairing Town Hall breakroom ventilation
- Replacing worn or missing weatherstripping in exterior doors and windows in all buildings
- Self-closing mechanisms on exterior person doors in Highway Department Buildings
- Upgrading thermostats to programmable type in all Highway Department buildings and using occupancy dependent set-backs

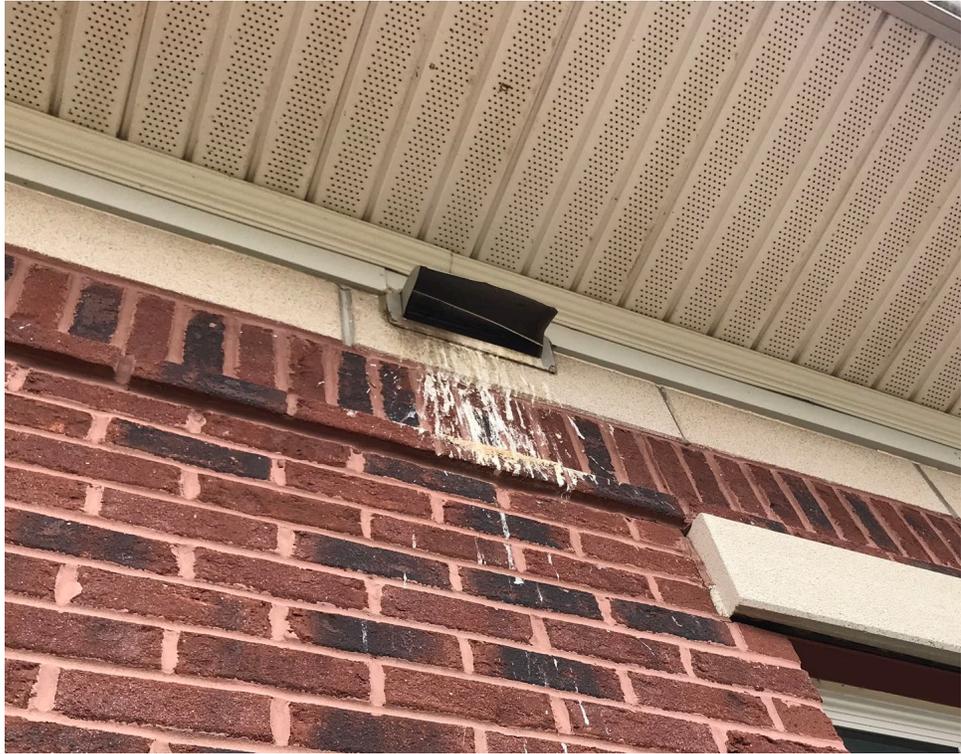
- Exhaust air vent from break room stuck open
 - Evidence of bird nesting activities

- - Pieces of shingle coming off roof/shingle degradation

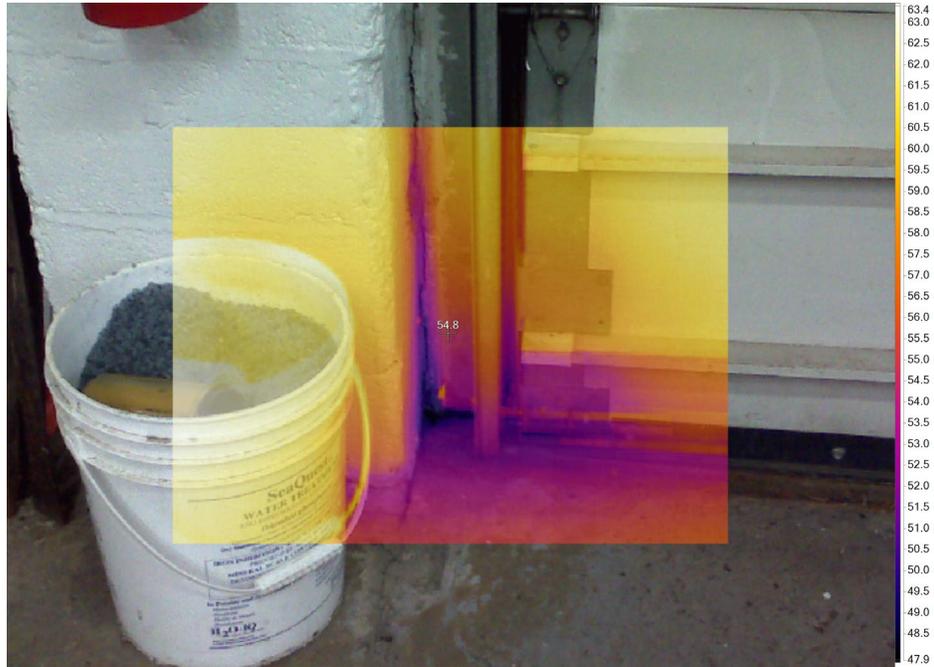
- Highway Department Office Building
 - The entire building has been retrofitted with two inches of exterior foam insulation
 - Original windows were replaced with double pane windows
 - Garage Area
 - Air Temperature 64°F
 - Gross floor area 2750 square feet
 - Estimated weekly operating hours: 10-20
 - Overhead garage doors are insulated
 - Any gaps and cracks around doors should be addressed as they contribute to lost heat

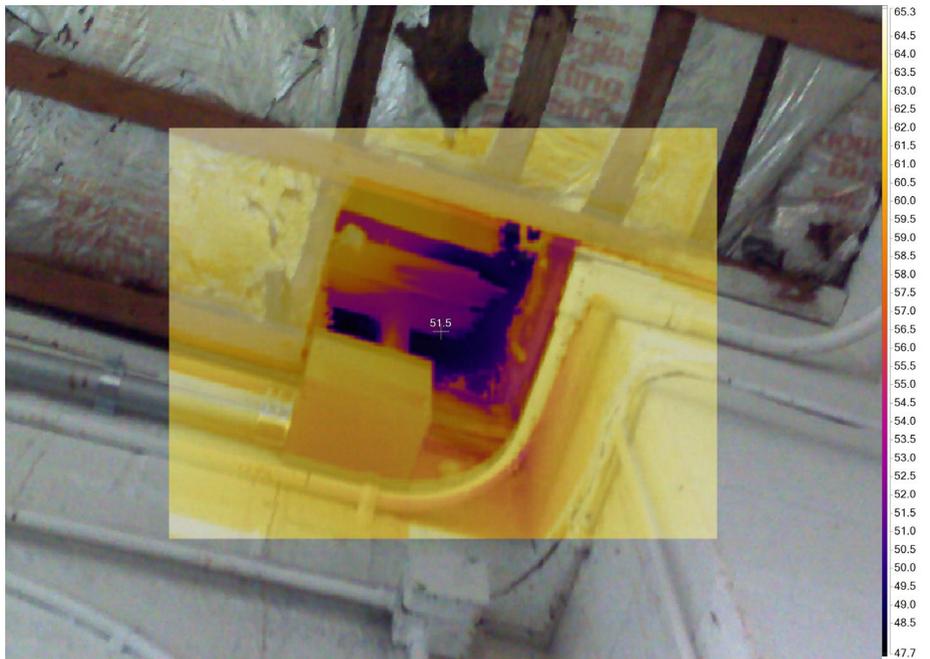
- - Visible ceiling insulation was six inches R-19 fiberglass batts
 - Could consider increasing to reduce heat loss
 - Seal off attic access to keep warm air in conditioned space
