Green Infrastructure Enhancements at the Monroe Community College Downtown Campus

Feasibility Study

Monroe County
50 West Main Street
Rochester, NY 14614

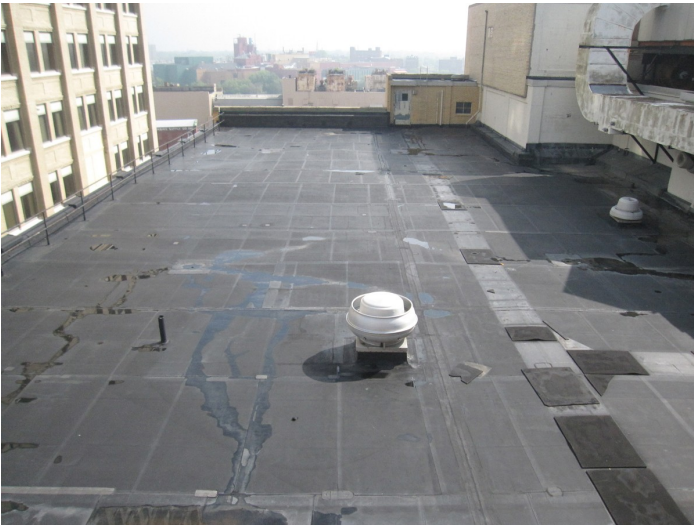
Figure D.1: Building 3—Overall view from above, looking east

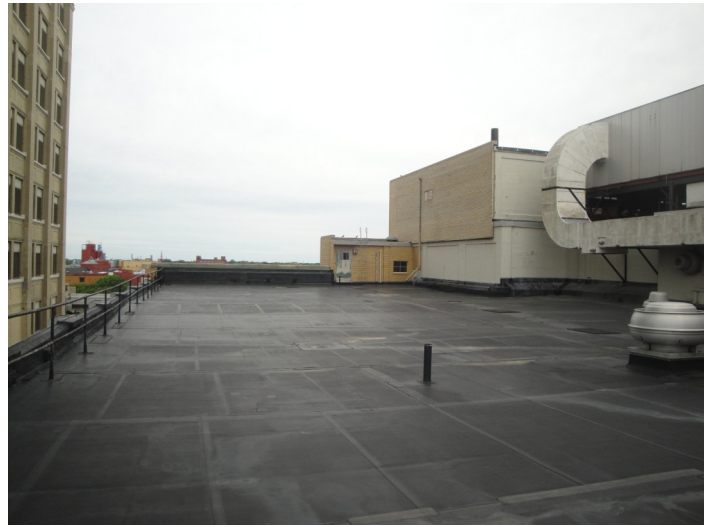
Figure D.2: Building 3—Overall from roof level, looking east

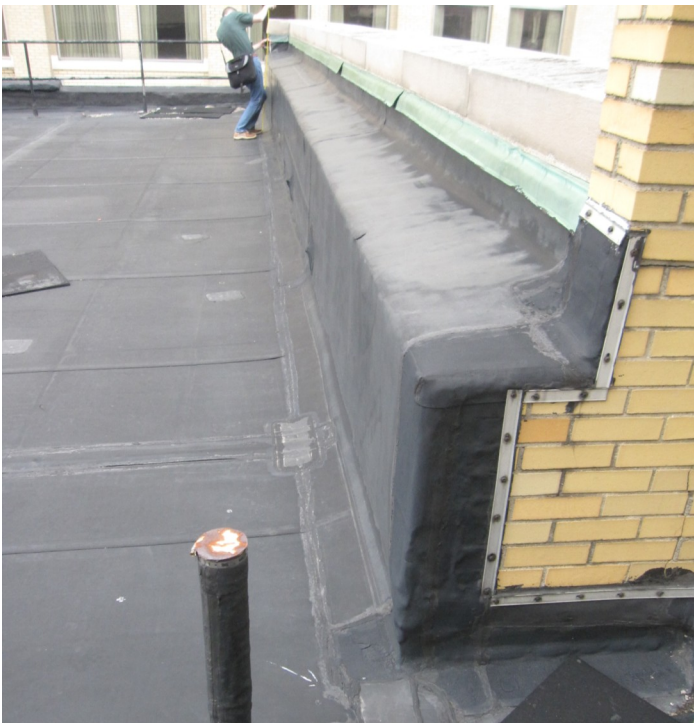
Figure D.3: Building 3—Detail view of existing parapet at east roof edge

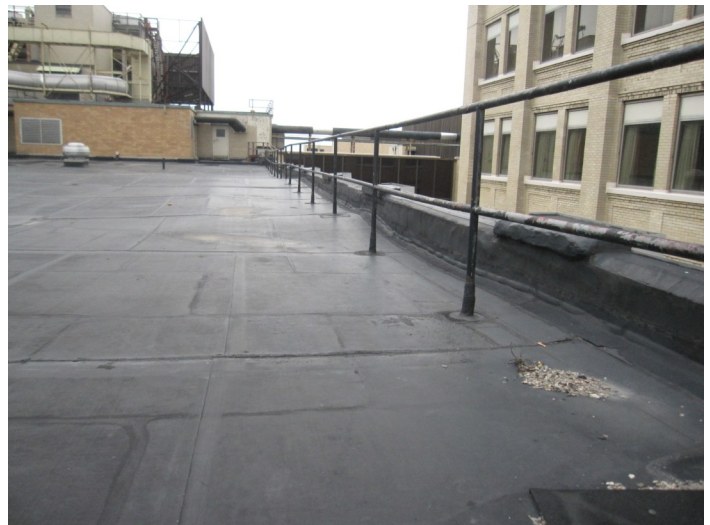
Figure D.4: Building 3—Detail view of existing guardrail at north roof edge

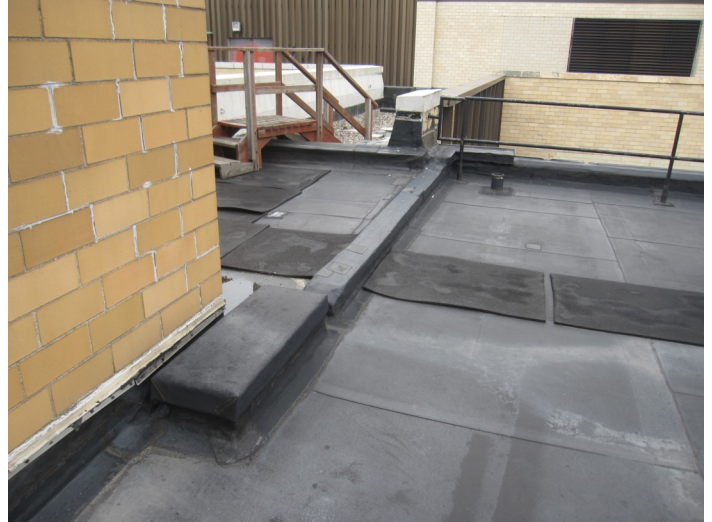
Figure D.6: Building 3—Detail view of curbs at west edge of roof

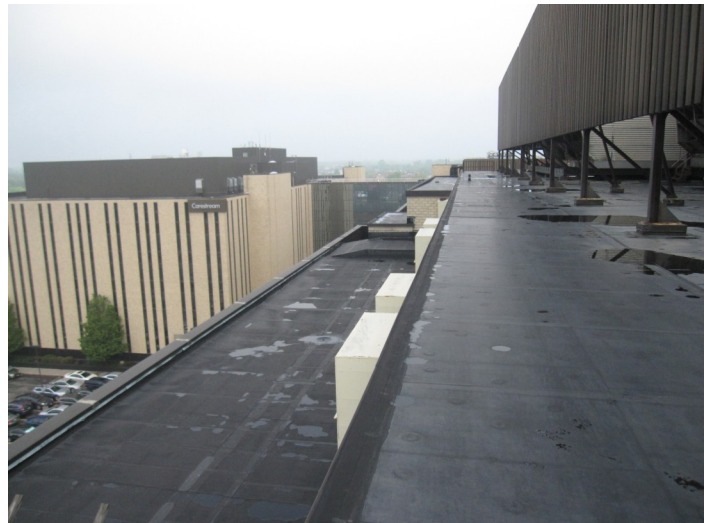
At the exterior edges, there is no parapet and no fall protection. An aluminum equipment screen attached to steel framing is set back from the roof edge, and acts as a visual barrier to the cooling towers on four sides. The screen panels are mounted roughly 7'-0" above the roof surface and extend approximately 20'-0" vertically.

Figure D.11: Building 16—Overall view of roof showing typical roof edge, looking north

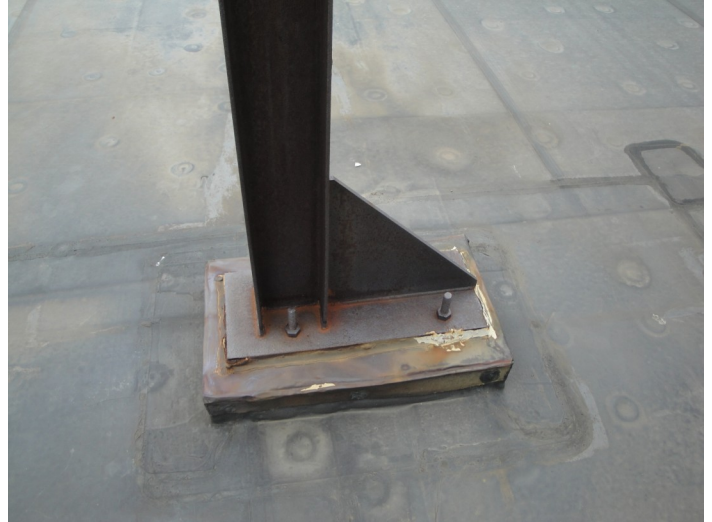
Figure D.13: Building 16—Detail view of equipment screen support

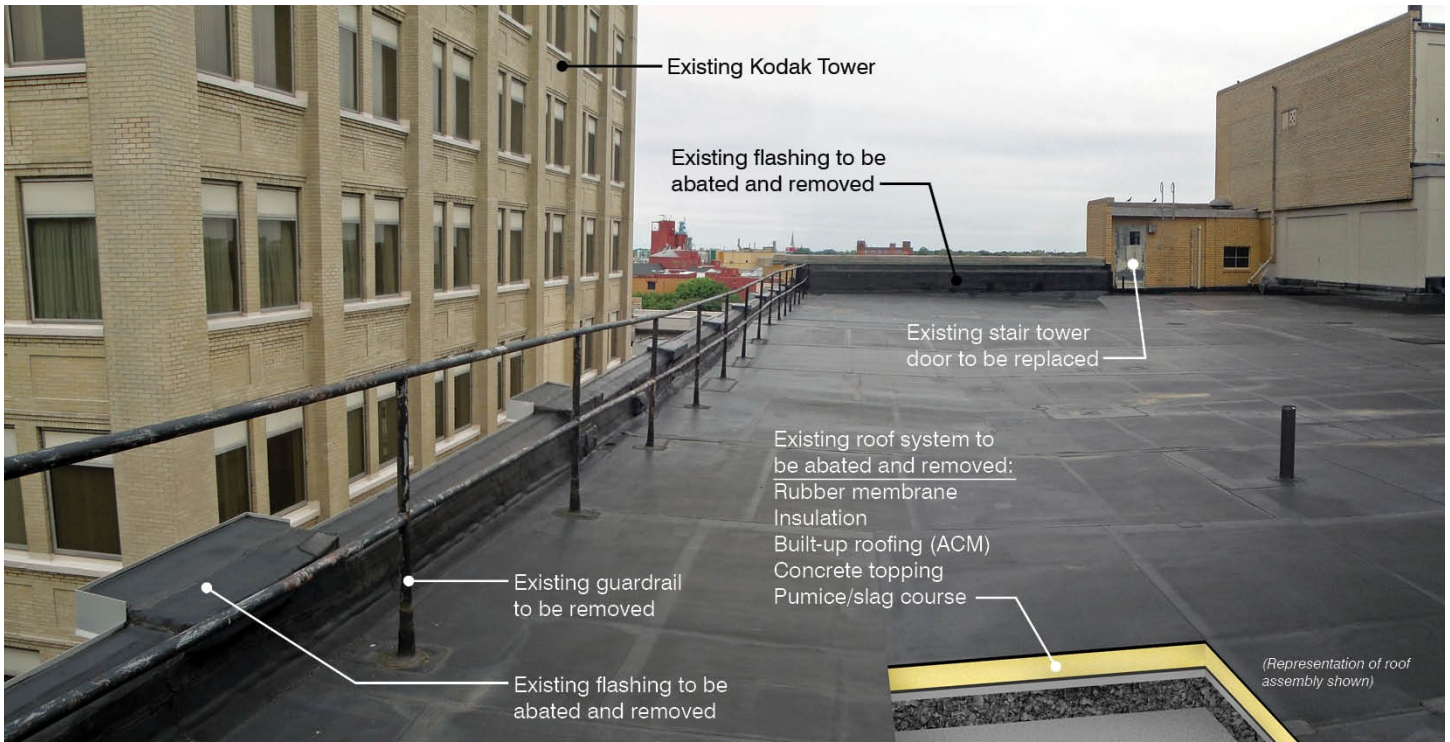
Figure D.17: Building 3. View of existing roof, looking north east. Notes indicate proposed demolition work necessary for installation of vegetated roof system.

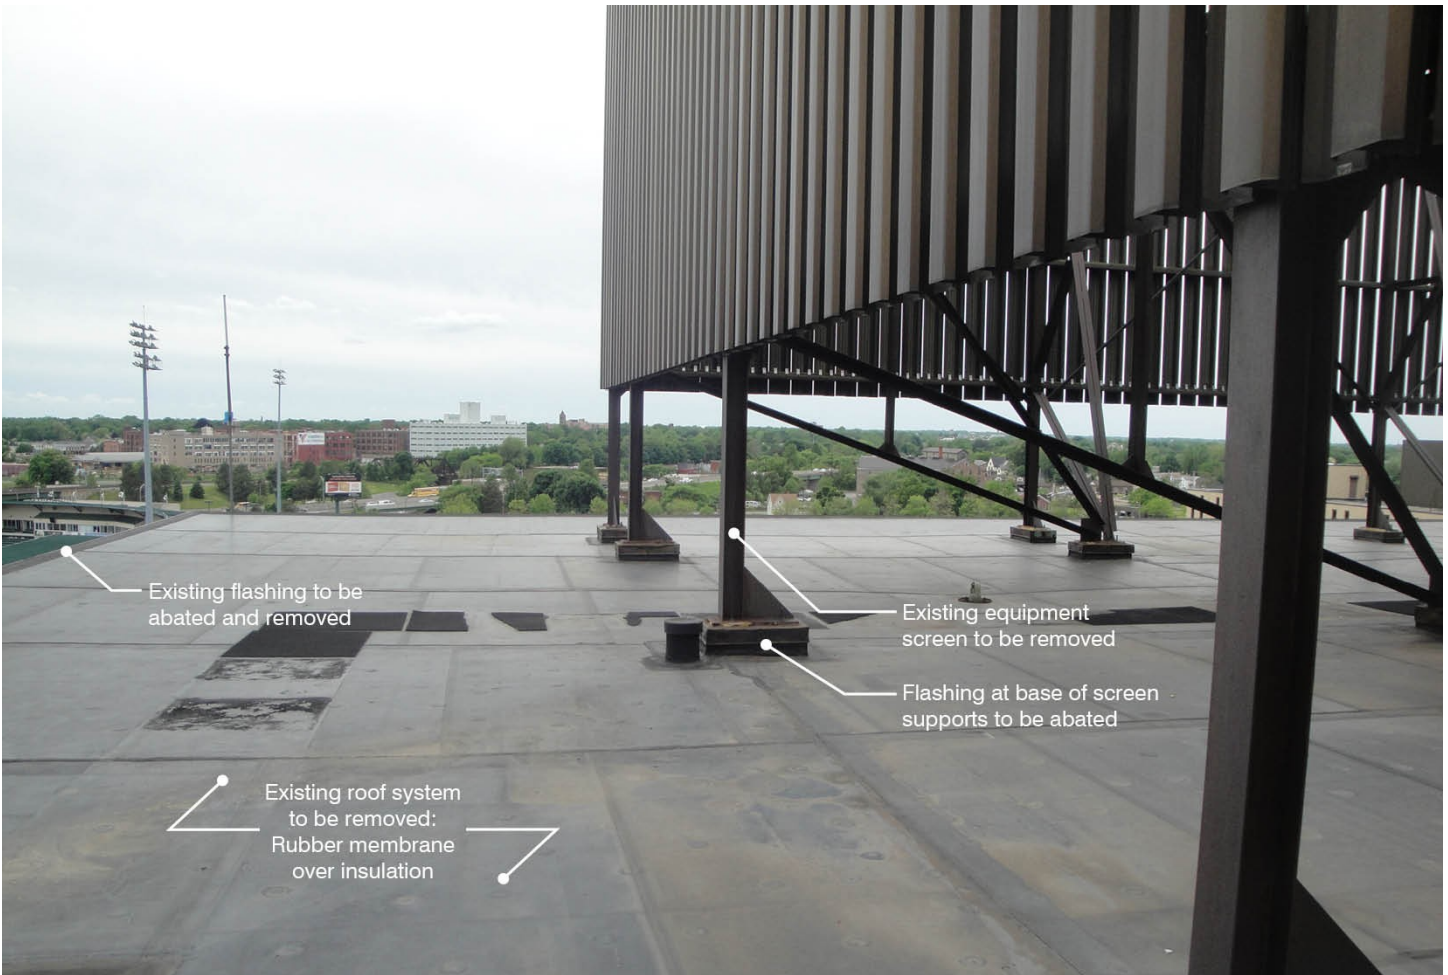
Figure D.19: Building 16. View of existing roof, looking south west. Notes indicate proposed demolition work necessary for installation of vegetated roof system.
