Flood Predictive Model and Mitigation: Asher Dam

Village of Rhinebeck

May 2019

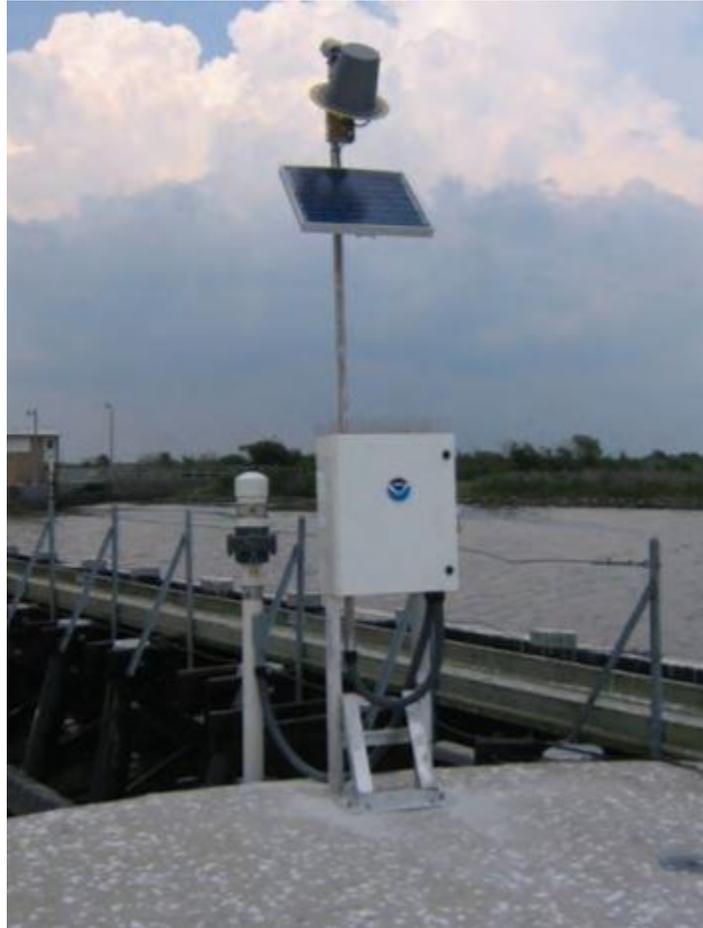
Figure 12. A NOAA telemetry station as depicted in the USGS handbook, (Sauer, 2010).

opening of the dam to reduce the chance of flooding. Figure 12., is a NOAA telemetry station representing the type of stream gage station that would be recommended.

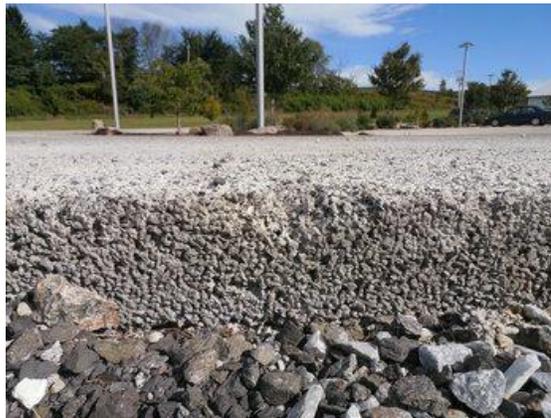
Figure 14. Porous concrete parking lot, located at the Roeliff Jansen Community Library in Copake. (NYSDEC, 2018a).

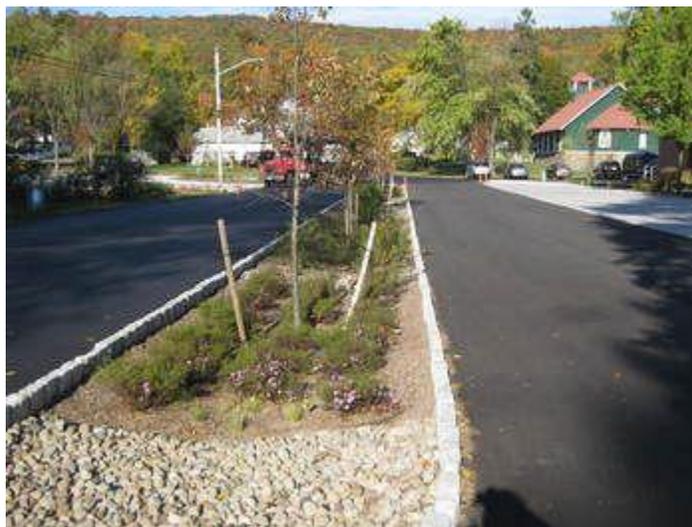
Figure 15. A Vegetated swale in the median of a roadway in the Village of Greenwood Lake in Orange County. (NYSDEC, 2018a)

Bioretention and filtration methods essential create surface space for water to safely accumulate during heavy precipitation events, throughout the municipality. These areas also offer a chance for aesthetic improvements throughout the municipality. Retention areas can be implemented at bus stops and parks, as well as through roadways. Strategic planting of certain species of trees, and flowering plants and bushes can help to increase rain absorption, water percolation, and add aesthetic value to the community. Figure 15., is an example of such a bioretention center, in the form of a vegetated swale. Illustrated by this figure is the conjunctive use of trees, shrubs and flowering plants to create a bioretention/filtration area along the road median.

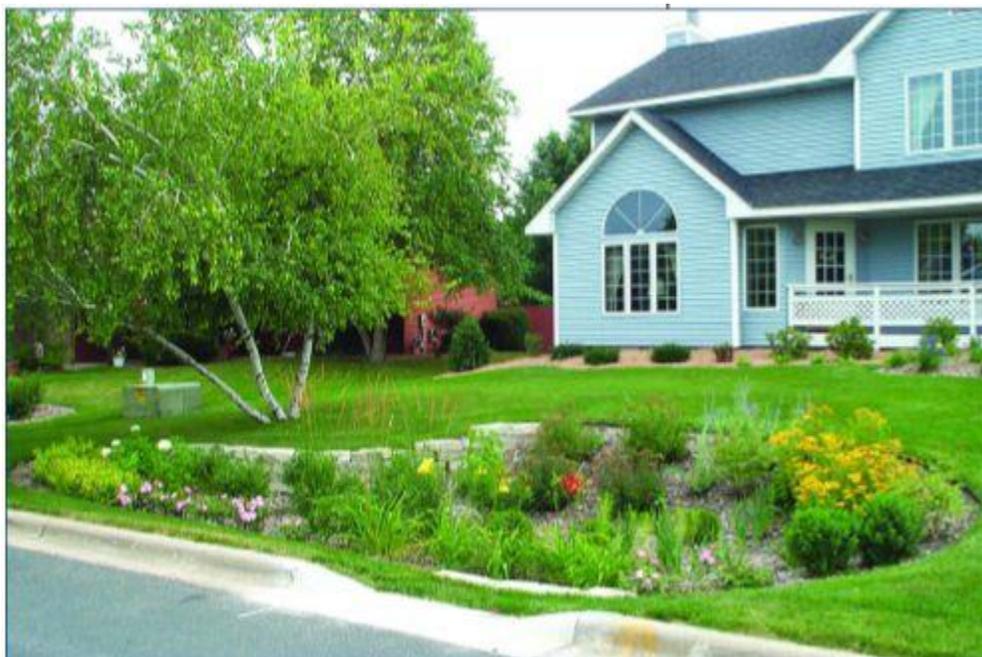
Figure 16. A rain garden strategically placed at the end of a yard, in order to capture street and lawn runoff.

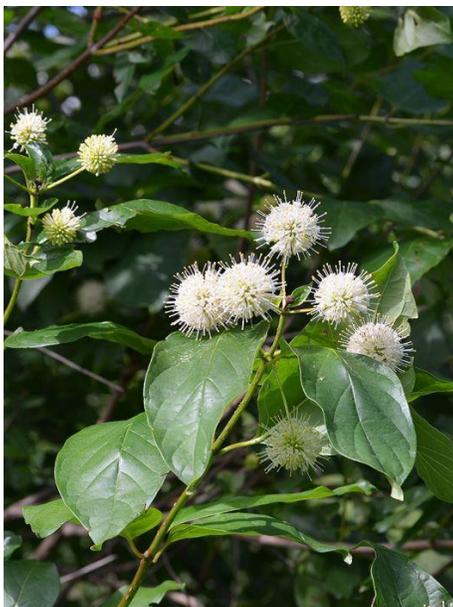
- 1) *Cephalanthus occidentalis*, button bush has a moderate growth rate, which is important to consider for initial implementation of this shrub. They also have a moderate moisture use meaning they are able to absorb copious amounts of water. Their adaptability to fine soils is ideal for the type of soil found in the village of Rhinebeck. It is also used for erosion control along shorelines and forms dense stands that stabilize the plant, this is done with their roots that reach 14 inches long. (USDA, NRCS, The PLANTS database, 2019). An additional that is relevant to one of the most important elements of riparian vegetation is that this species is flood tolerant. They are able to continue to flourish even through flooding. These multitudes of characteristics make button bush an appropriate candidate for riparian vegetation in the watershed (Wennerberg, 2004).

Figure 17. *Cephalanthus occidentalis* (Prairie Moon Nursery, (N.A.))

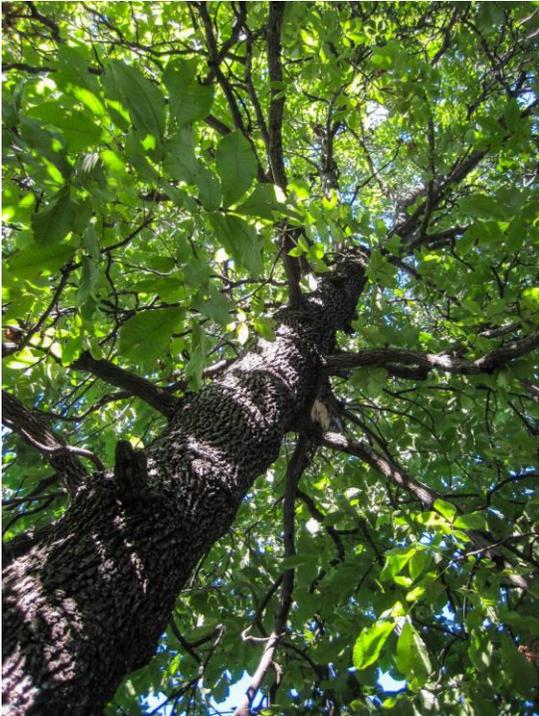
2) *Carya ovata*, Shagbark Hickory, is native to North America and has numerous riparian functions (USDA NRCS The PLANTS database, 2019). Although they have a slow growth rate, they are able to grow and flourish in the fine clay soils located in the Village of Rhinebeck. The species has medium moisture use and flood tolerance is one of their main features along with their incredibly long roots that can reach up to 48 inches This is a useful quality of this species as they are able to control erosion in an effective manner (USDA NRCS The PLANTS database, 2019).

Figure 18. *Carya ovata* (Chert Glades Chapter. (n.d.))

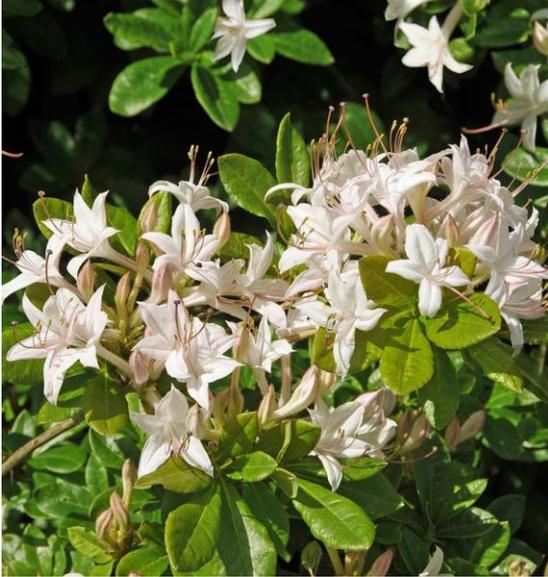
3) *Rhododendron viscosum*, swamp azalea, are tolerant of moist to wet soils, including the clay and silt found in Rhinebeck and tolerates periodic flooding. This shrub has a shallow root system of 14 inches that has a high retention of moisture (Missouri Botanical Garden, 2019). It is native to North America and has a slow growth rate, although, they are able to tolerate consistent flooding which is a crucial characteristic of riparian vegetation. Their high moisture and root system make them an important shrub to consider implementing in flood areas (USDA NRCS The PLANTS database, 2019).

Figure 19. *Rhododendron viscosum* (White Flower Farm. (n.d.))

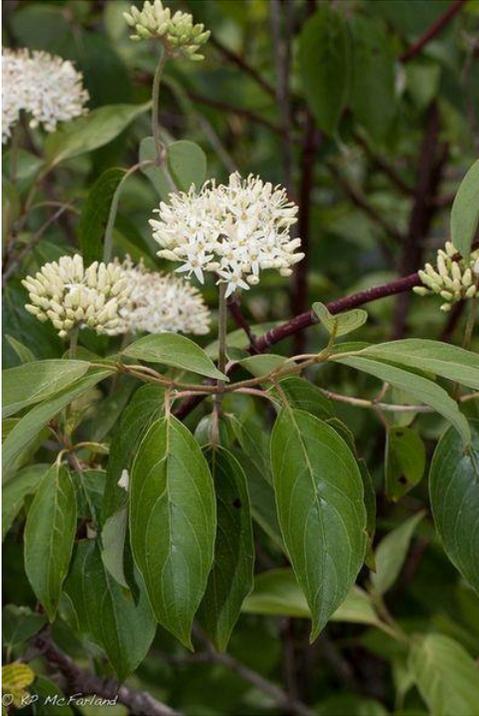
4) *Cornus amomum* is usually referred to as silky dogwood and is native to North America. They are a good shrub for moist and wet areas as they have a high moisture content and function well along streams/ponds for erosion control due to their roots that can reach 16 inches long (Missouri Botanical Garden, 2019). They are used for streambank protection as they are flood tolerant (USDA NRCS Northeast Plant Materials Program, 2002). It is able to adapt to fine soils, similar to those in Rhinebeck. Their moderate growth rate will allow them to be used in an appropriate amount of time in this area (USDA, NRCS, The PLANTS database, 2019).

Figure 20. *Cornus amomum* (NC State University. (n.d.).)

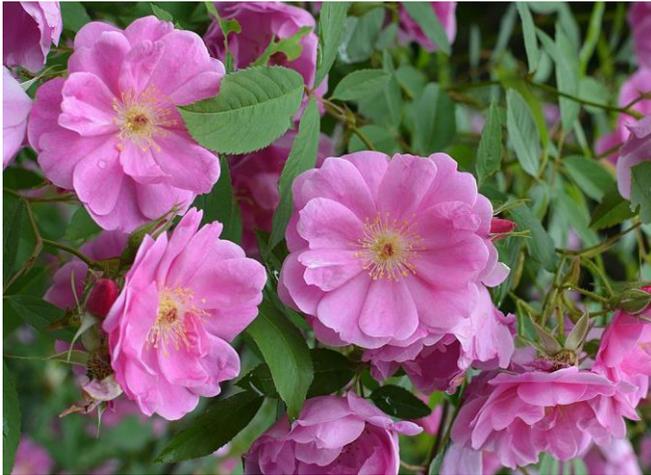
5) *Rose paulustris*, commonly known as swamp rose, is another important shrub to consider in riparian vegetation. They flourish in fine soils like those in the Village of Rhinebeck with a moderate growth rate. They tolerate some flooding but their roots of 18 inches allow them to control erosion as well as absorb a moderate amount of floodwater (USDA, NRCS, The PLANTS database, 2019).

Figure 21. *Rose paulustris* (Barrie Collins. (n.d.).)

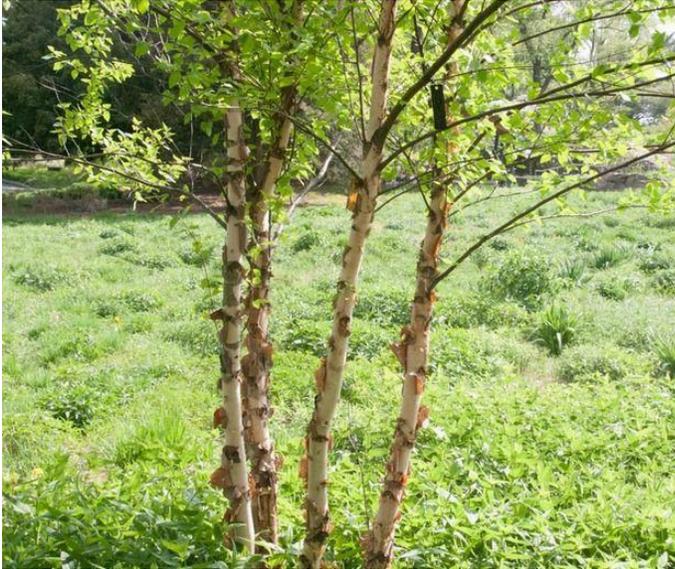
1) *Betula nigra*, commonly known as river birch, grows rapidly in clay soils and is resistant to flooding. (USDA NRCS The PLANTS database, 2019) River birch has a high moisture use. (USDA NRCS The PLANTS database, 2019)

Figure 23. *Betula nigra* (Gardenia. (n.d.).)

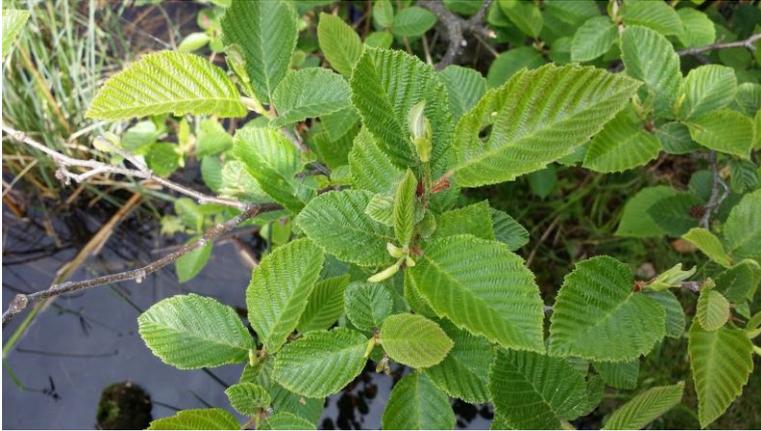
2) *Alnus Serrulata*, the Hazel Alder/Speckled Alder is tolerant to various types of soils including clay and can tolerant seasonal flooding, while maintaining a rapid growth rate. (USDA NRCS The PLANTS database, 2019) *Quercus bicolor*, known by its common name, the white swamp oak, has a minimum root length of 40 inches which would aid in preventing erosion. Also, this species rapidly grows and is tolerant to flooding which is ideal.

Figure 24. *Alnus serrulata* (Cold Stream Farm. (n.d.).

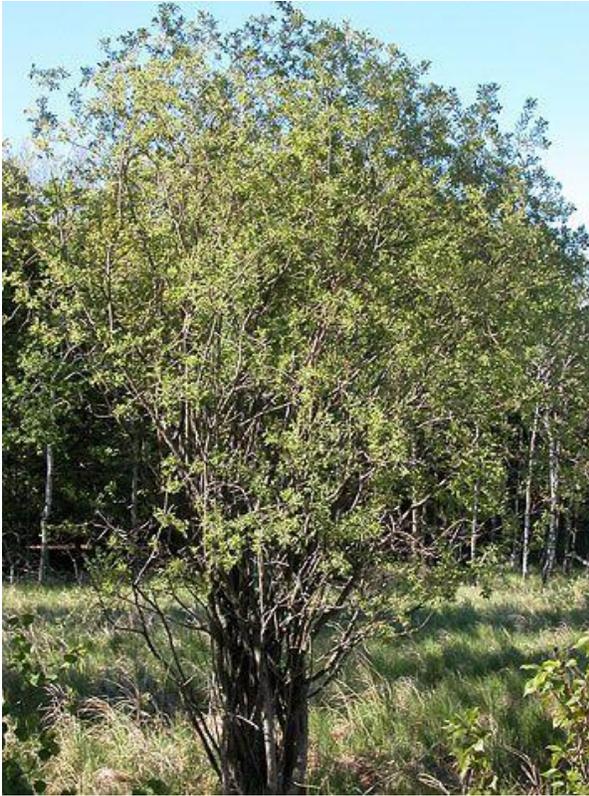
3) *Salix bebbiana*, Bebb willow, is tolerant to flooding and has a high moisture use. Additionally, the species grows rapidly and is adaptable to fine soils which are found in the village of Rhinebeck (USDA NRCS The PLANTS database, 2019).

Figure 25. *Salix bebbiana* (University of Wisconsin Green Bay. (n.d.).)

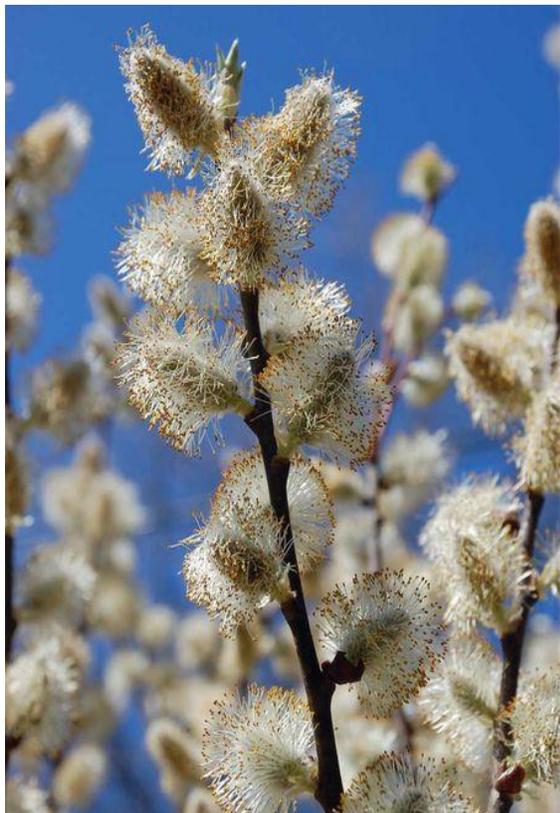
4) *Salix discolor*, may be better known as pussywillow, is another species that is recommended for the area. Like the other species mentioned, *Salix discolor* grows rapidly and is adaptable to the fine soils found near the Landsman kill. The deep roots of the species prevents soil erosion and the species has high moisture use (USDA NRCS The PLANTS database, 2019).

Figure 26. *Salix discolor* (Long Island Natives. (n.d.).)
