Saw Kill Watershed and Flood Mitigation Assessment - Final Report

NEIWPCC and NYSDEC Hudson River Estuary Program

MARCH 2018

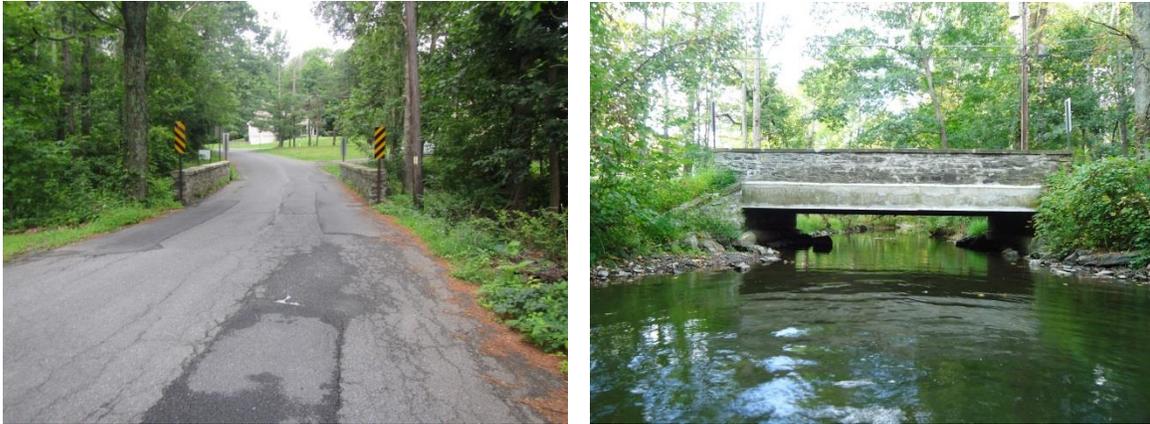
Figure 1. Photographs of the downstream Aspinwall Road Bridge. The relatively narrow bridge opening and limited vertical clearance constrict streamflow during high flow conditions.

Under current conditions, the River Road and Aspinwall Road (downstream crossing, near West Bard Avenue) bridges are clearly undersized, overtopping during floods as small as the 50-year flood and the 10-year flood, respectively. The overtopping of these bridges results partially from the nature of the bridges' design. Many of the bridges on the Saw Kill are characterized by approaches that slope down toward the river, with the bridge built at the low point. In addition, they tend to constrict the channel into a cross section that is narrower than reaches upstream or downstream, causing backwater behind the bridge under high flow conditions as well as increased flow velocities within the bridge opening itself, as demonstrated in the photographs of the downstream Aspinwall Road Bridge in *Figure 1*. The

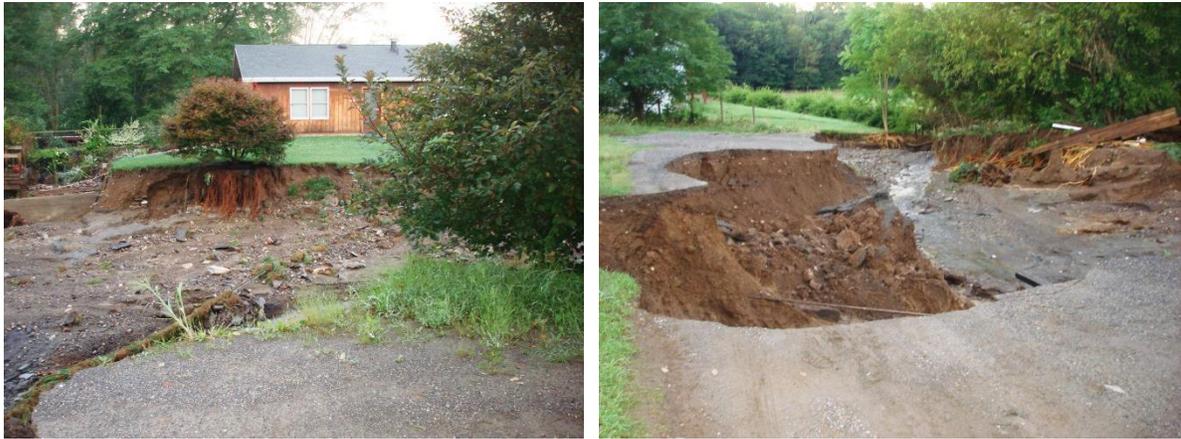
Figure 2. Photographs of erosion caused by the overtopping of the left abutment at the Mill Road dam during Tropical Storm Irene in 2011

including the Mill Road Bridge and a section of Mill Road approximately 700 feet south of the bridge, which overtops during large floods. The flood inundation maps in *Appendix B* indicate that one or more structures may be inundated during a 100-year flood and driveways, docks, and other site elements may be impacted. During Tropical Storm Irene, floodwaters overtopped the dam abutments, circumventing the dam training walls, and caused severe erosion on private property adjacent to and downstream of the dam, as shown in *Figure 2*. However, by retaining water, the dam may also provide some flood mitigation benefit to areas downstream, including the Town of Red Hook well intake.

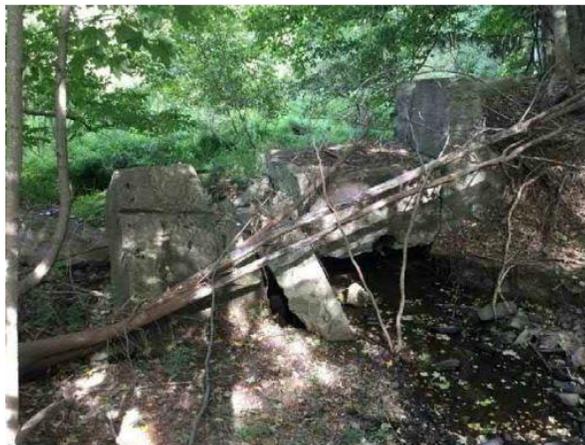
Figure 3. Photograph of relic dam at Battenfeld Road

Removal of the relic dam at Battenfeld Road is recommended as a relatively low-cost option to reduce localized flooding during large storms.

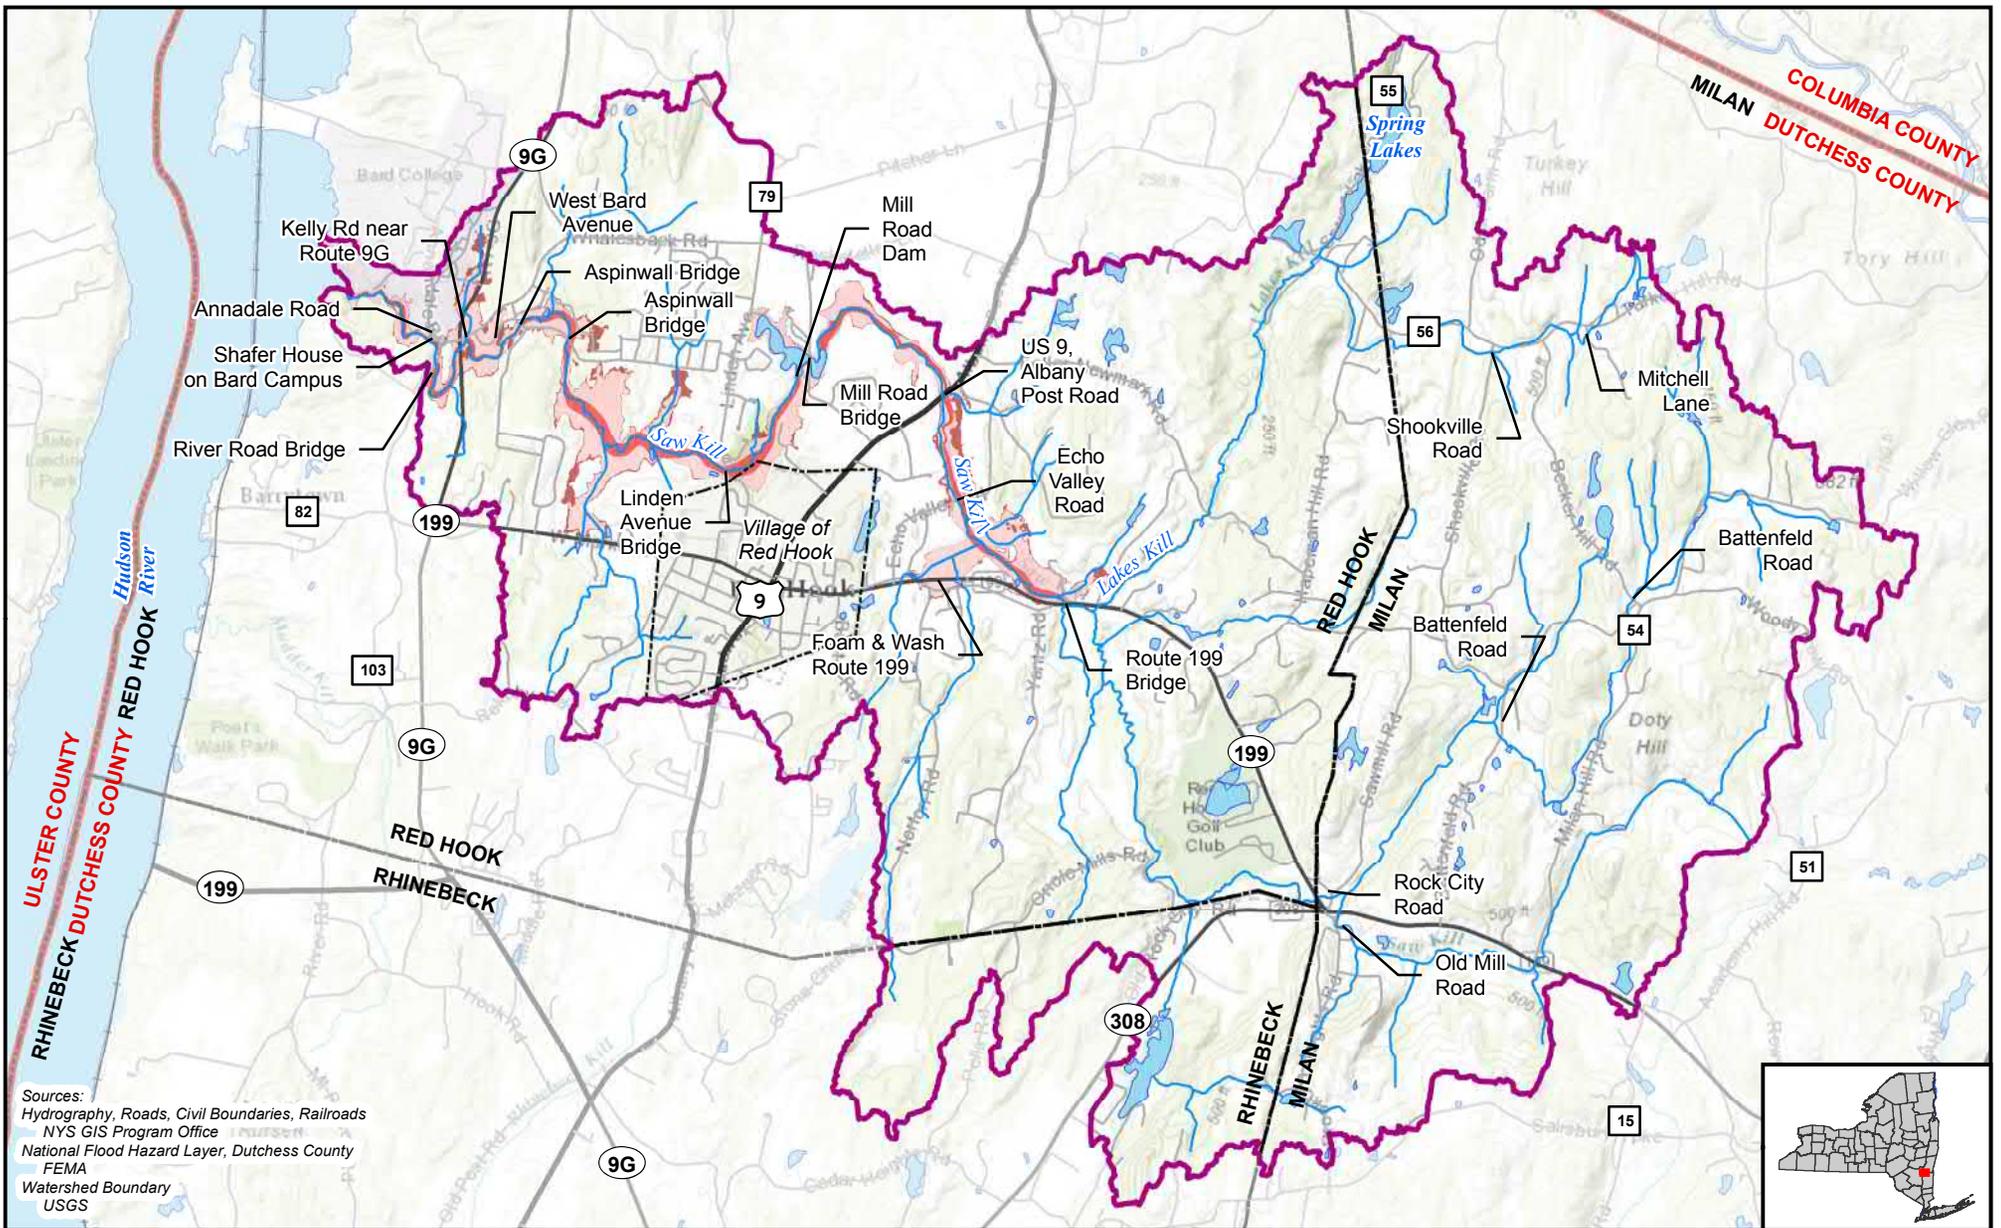
Figure 2: Areas Susceptible to Flooding and Flood Hazard Zones
 Saw Kill Watershed

Appendix A, Figure 2 depicts identified areas susceptible to flooding as well as the areas along the Saw Kill that are located within FEMA regulatory flood zones. It should be noted that the FEMA analysis used to generate flood hazard mapping focused on only a portion of the main stem, and that flood hazard mapping has not been completed for the entire watershed. Furthermore, the hydrologic and hydraulic analysis that serves as the basis for the flood hazard mapping was completed in 1983.

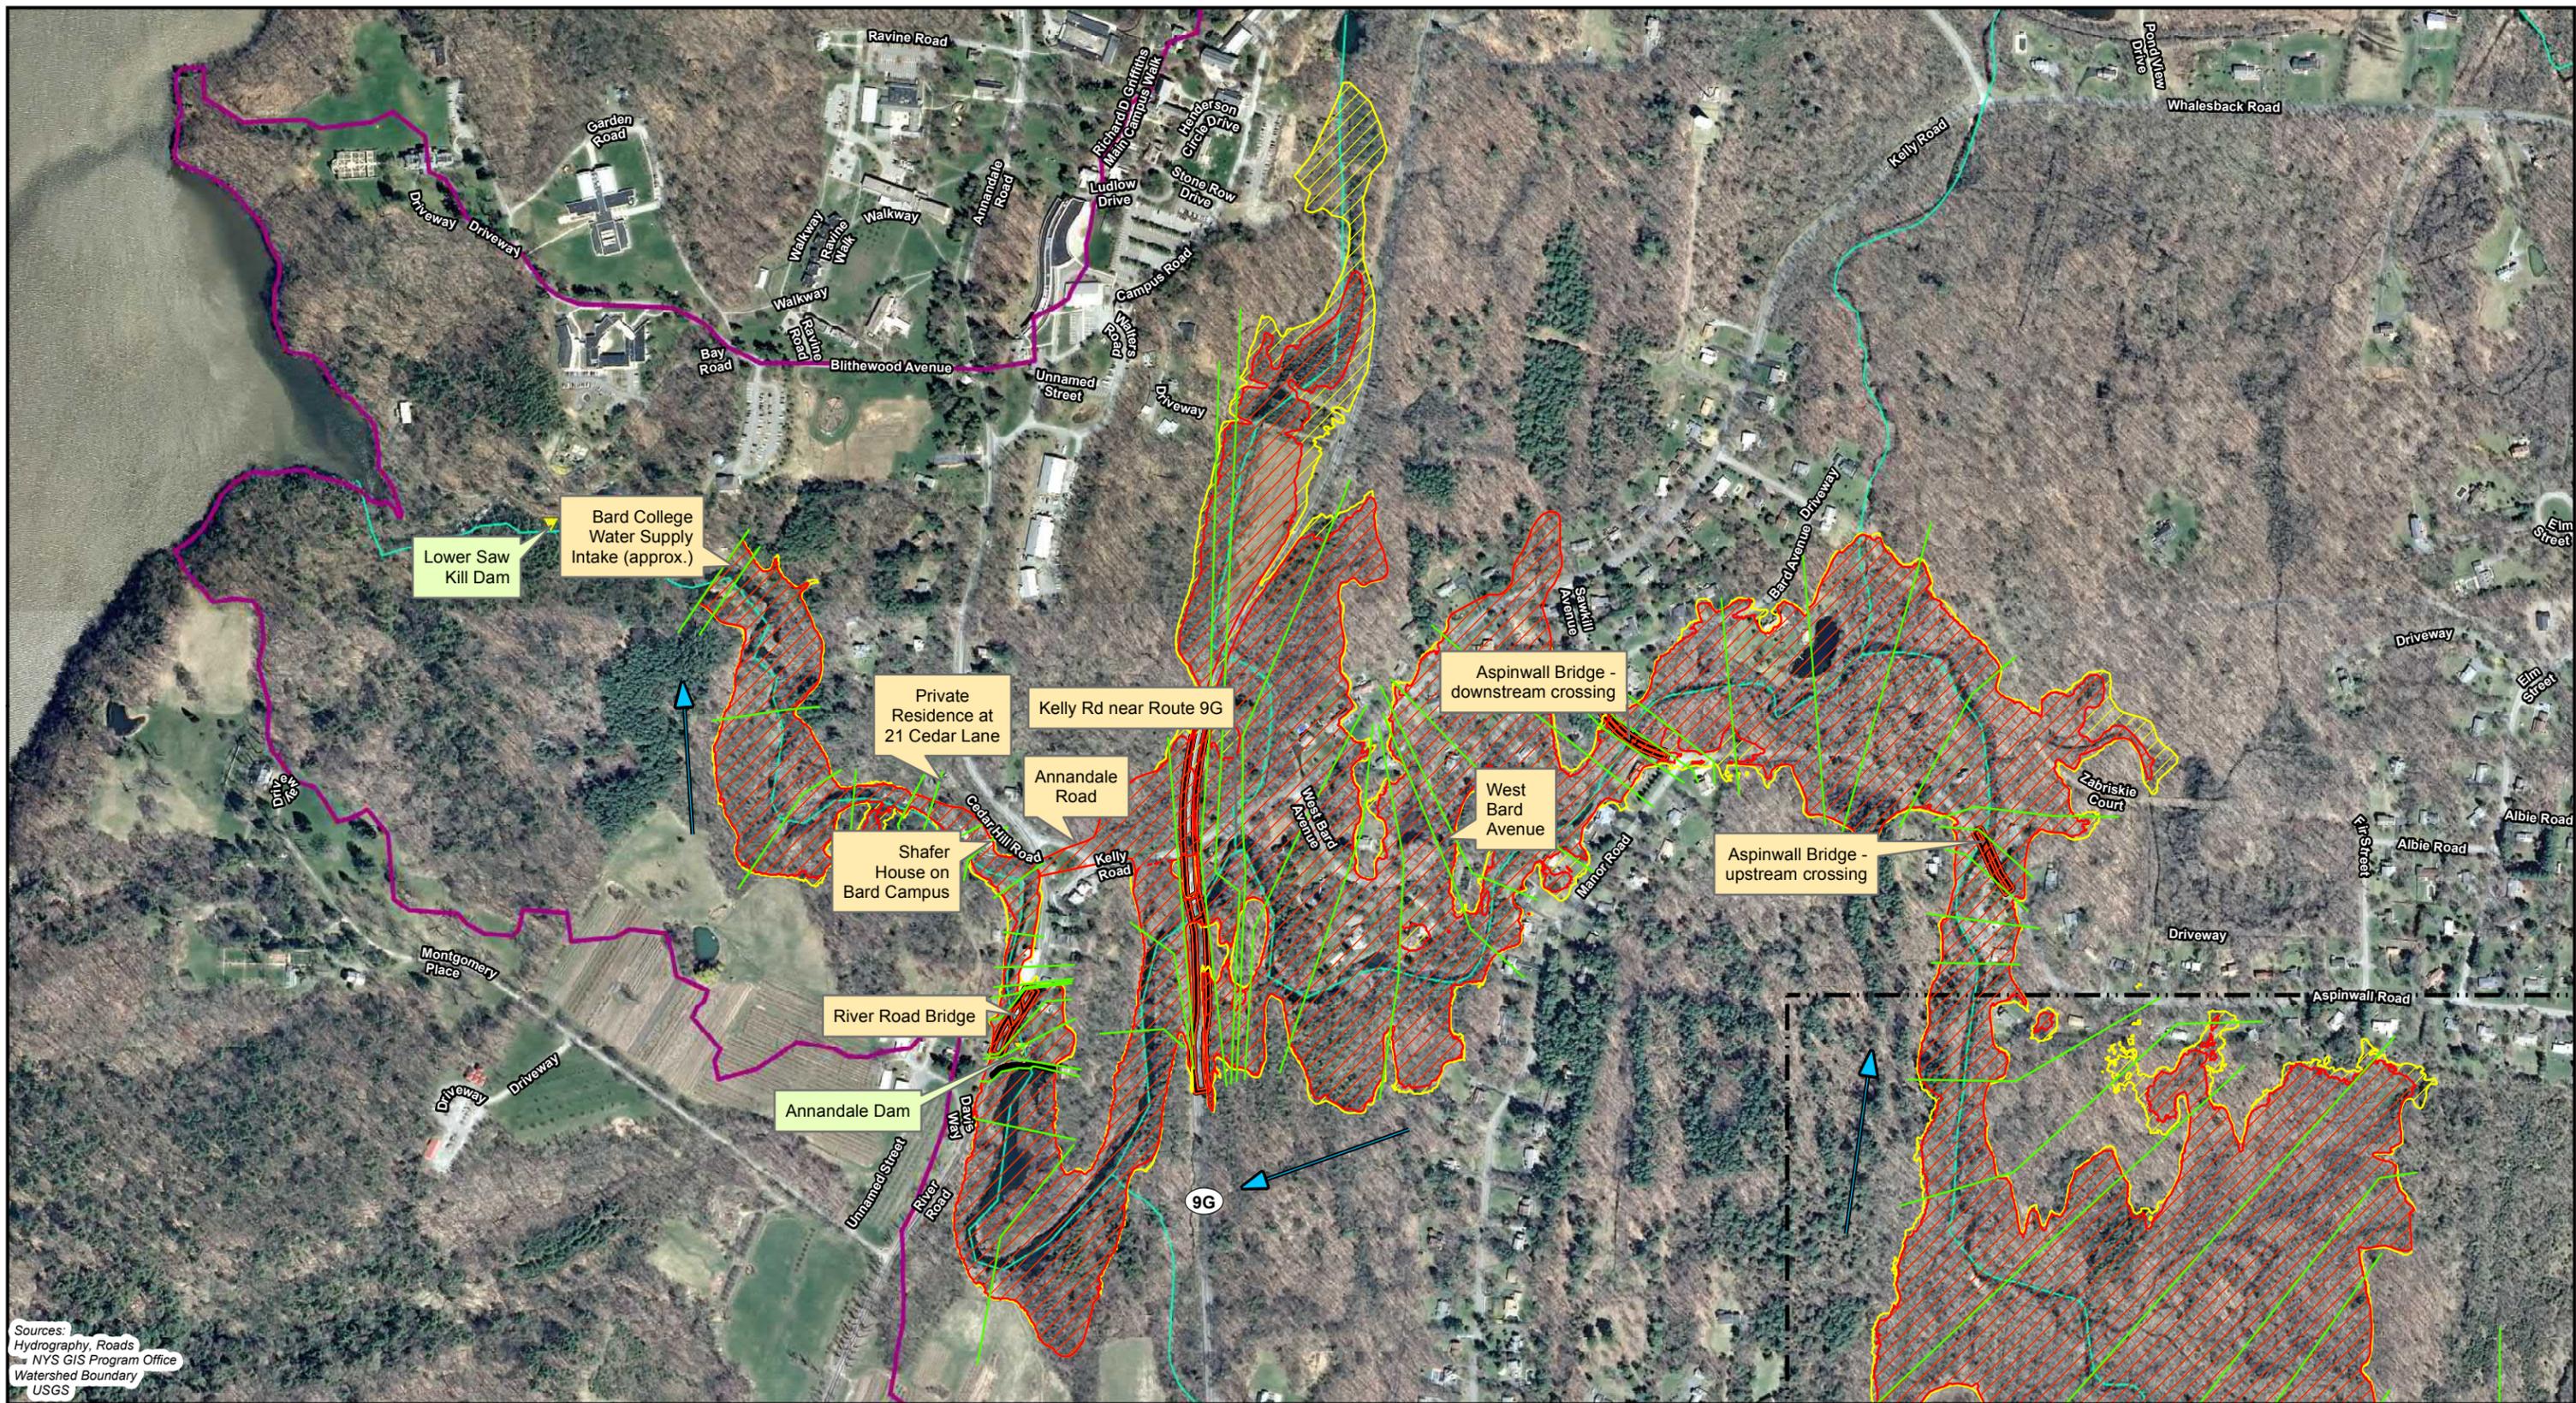
Figure 1-1: Inundation Map
 Saw Kill Watershed

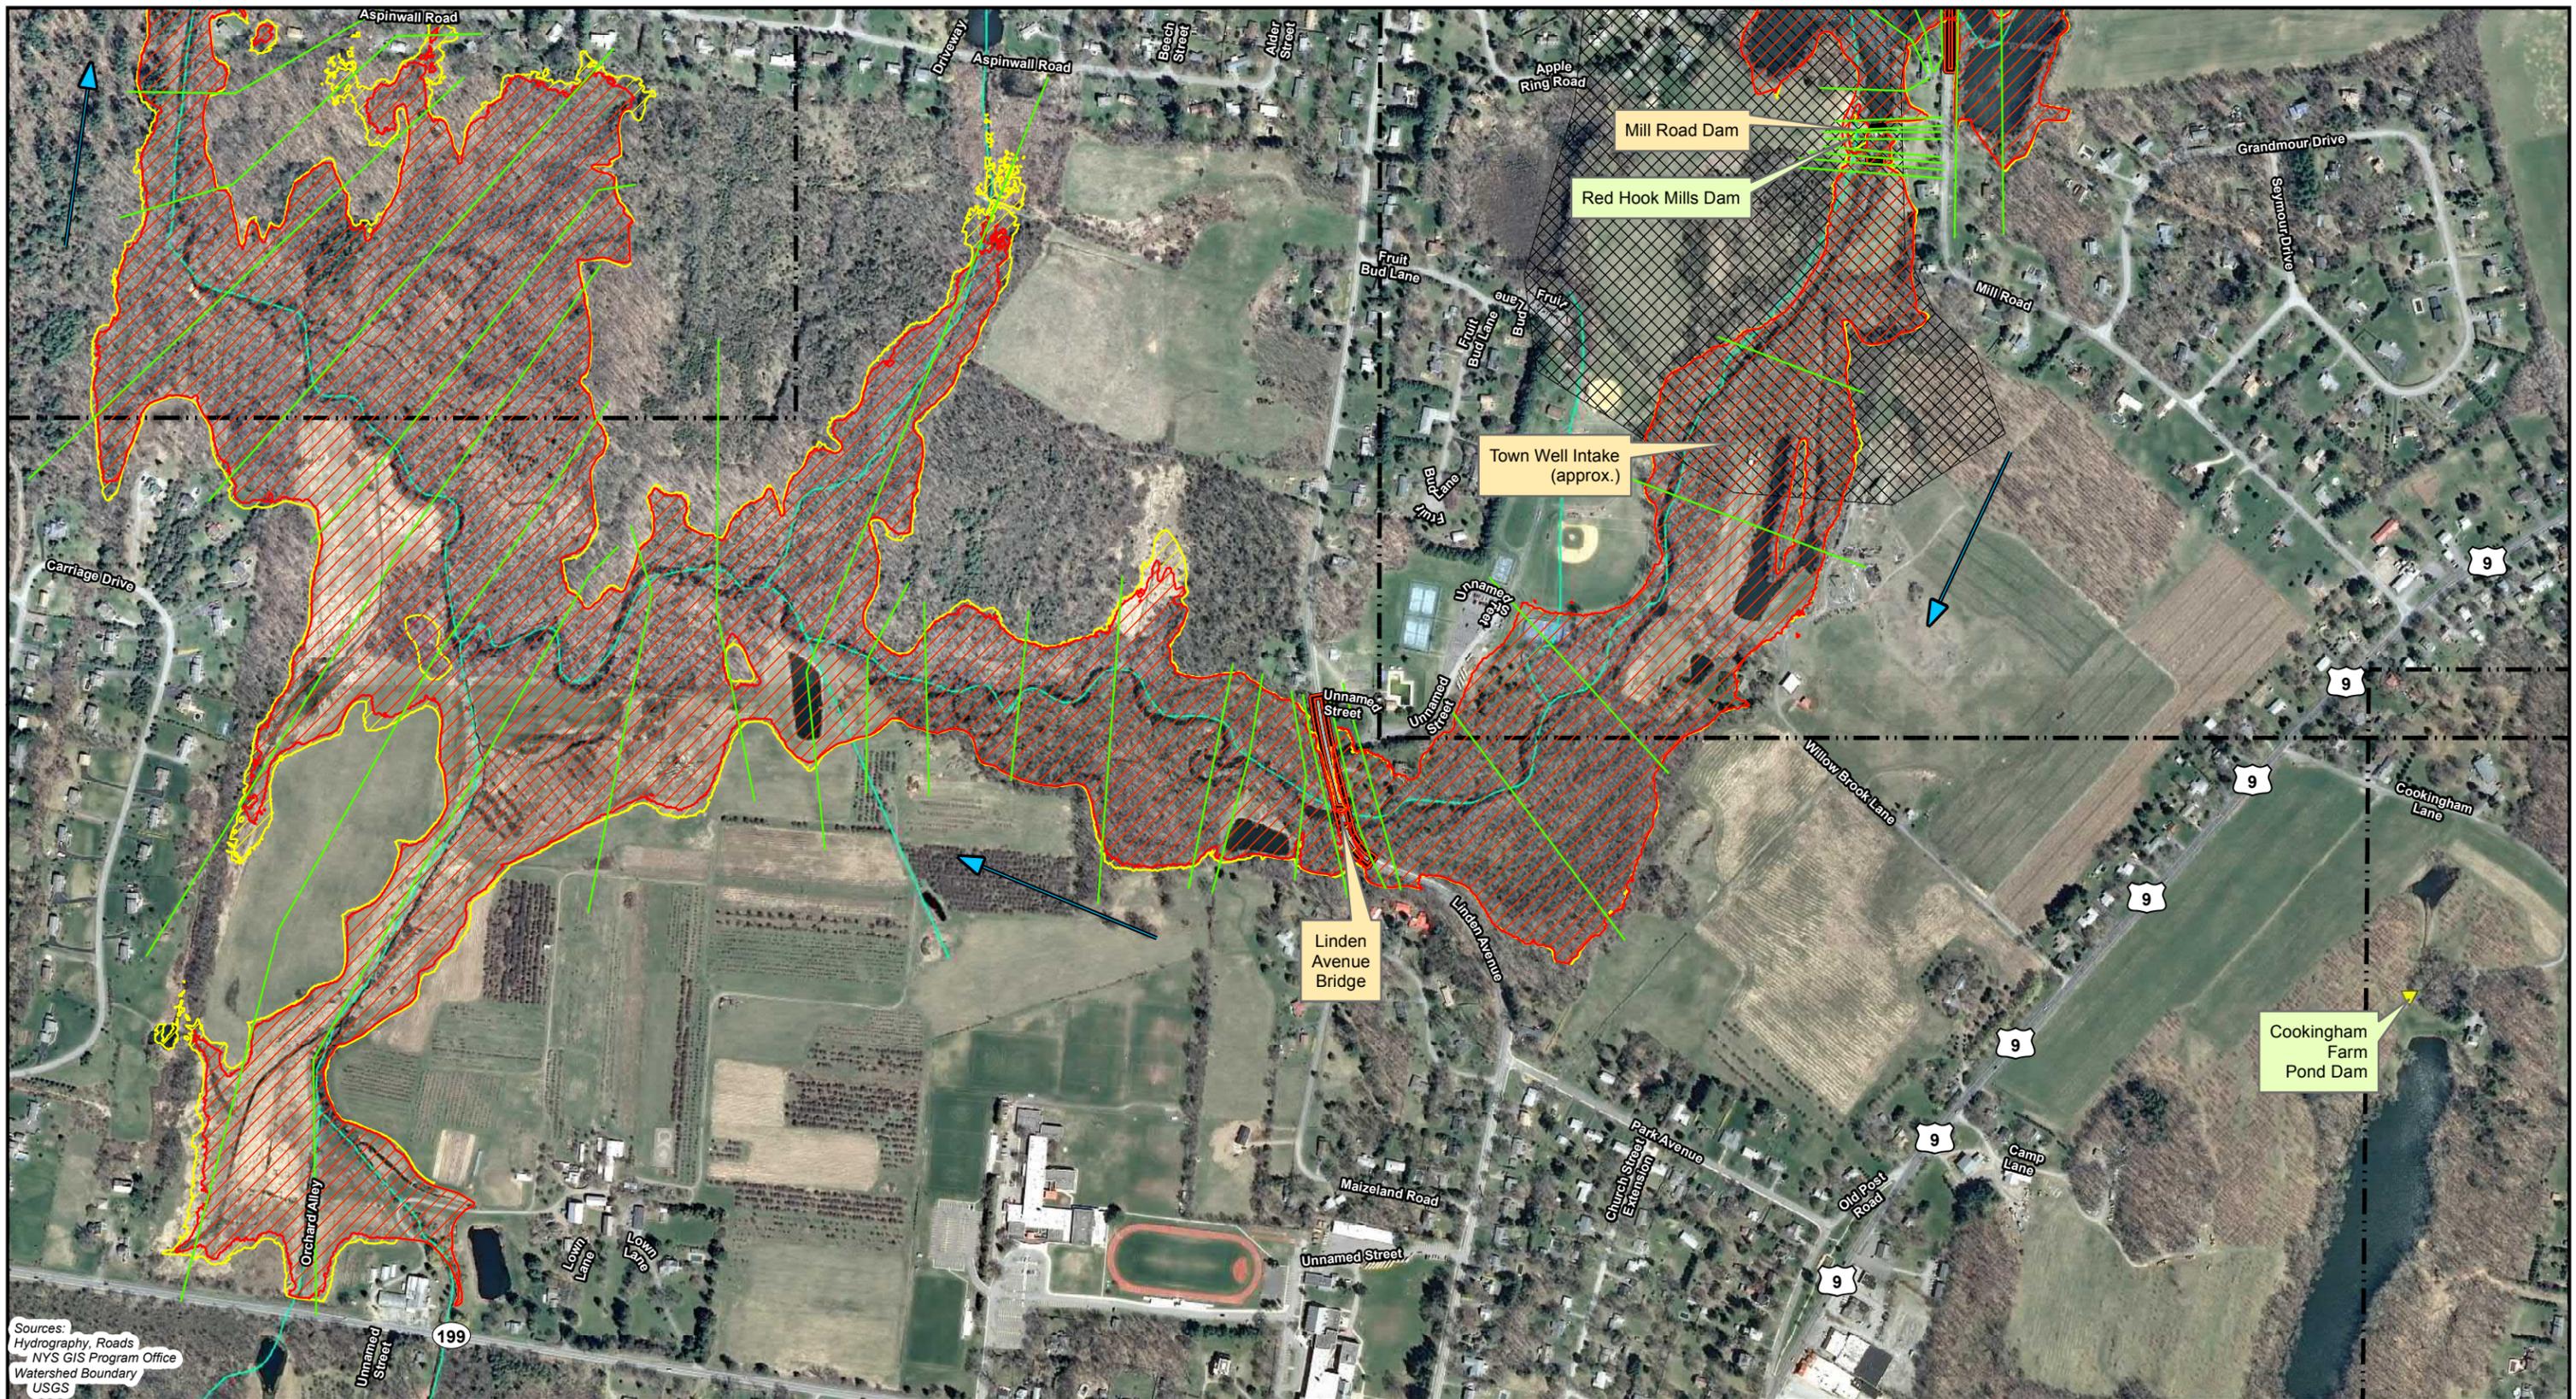
Figure 1-2: Inundation Map
Saw Kill Watershed

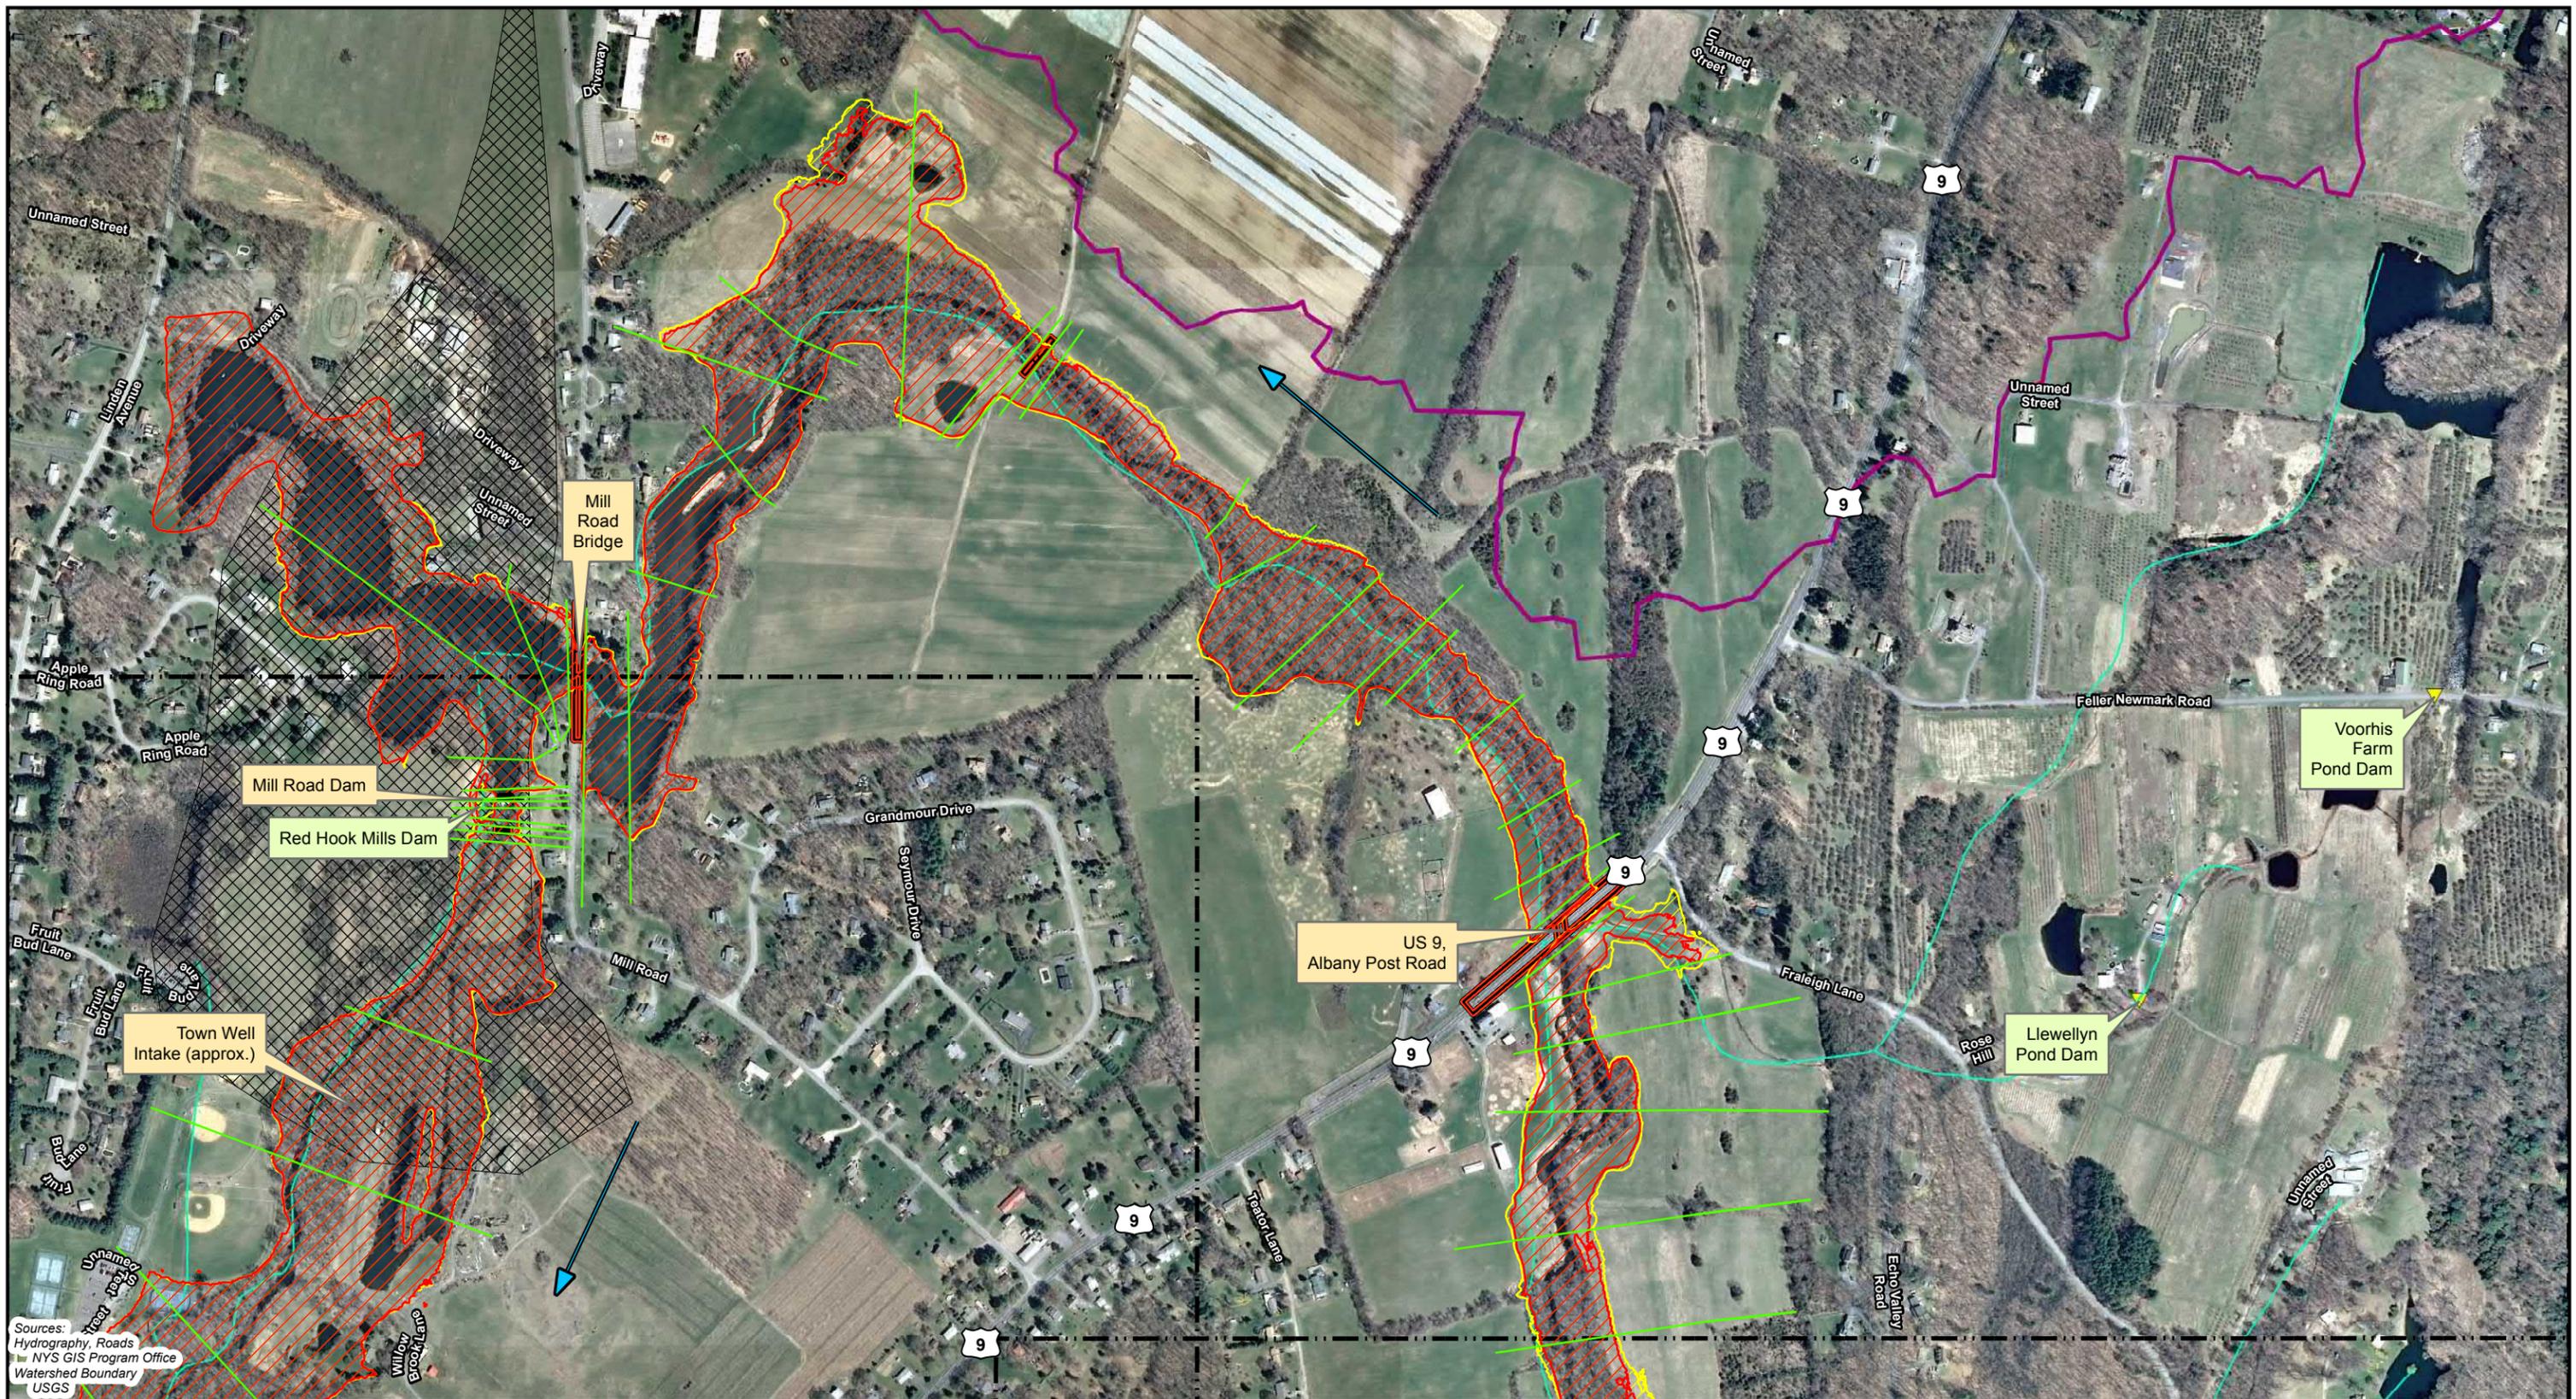
Figure 1-3: Inundation Map

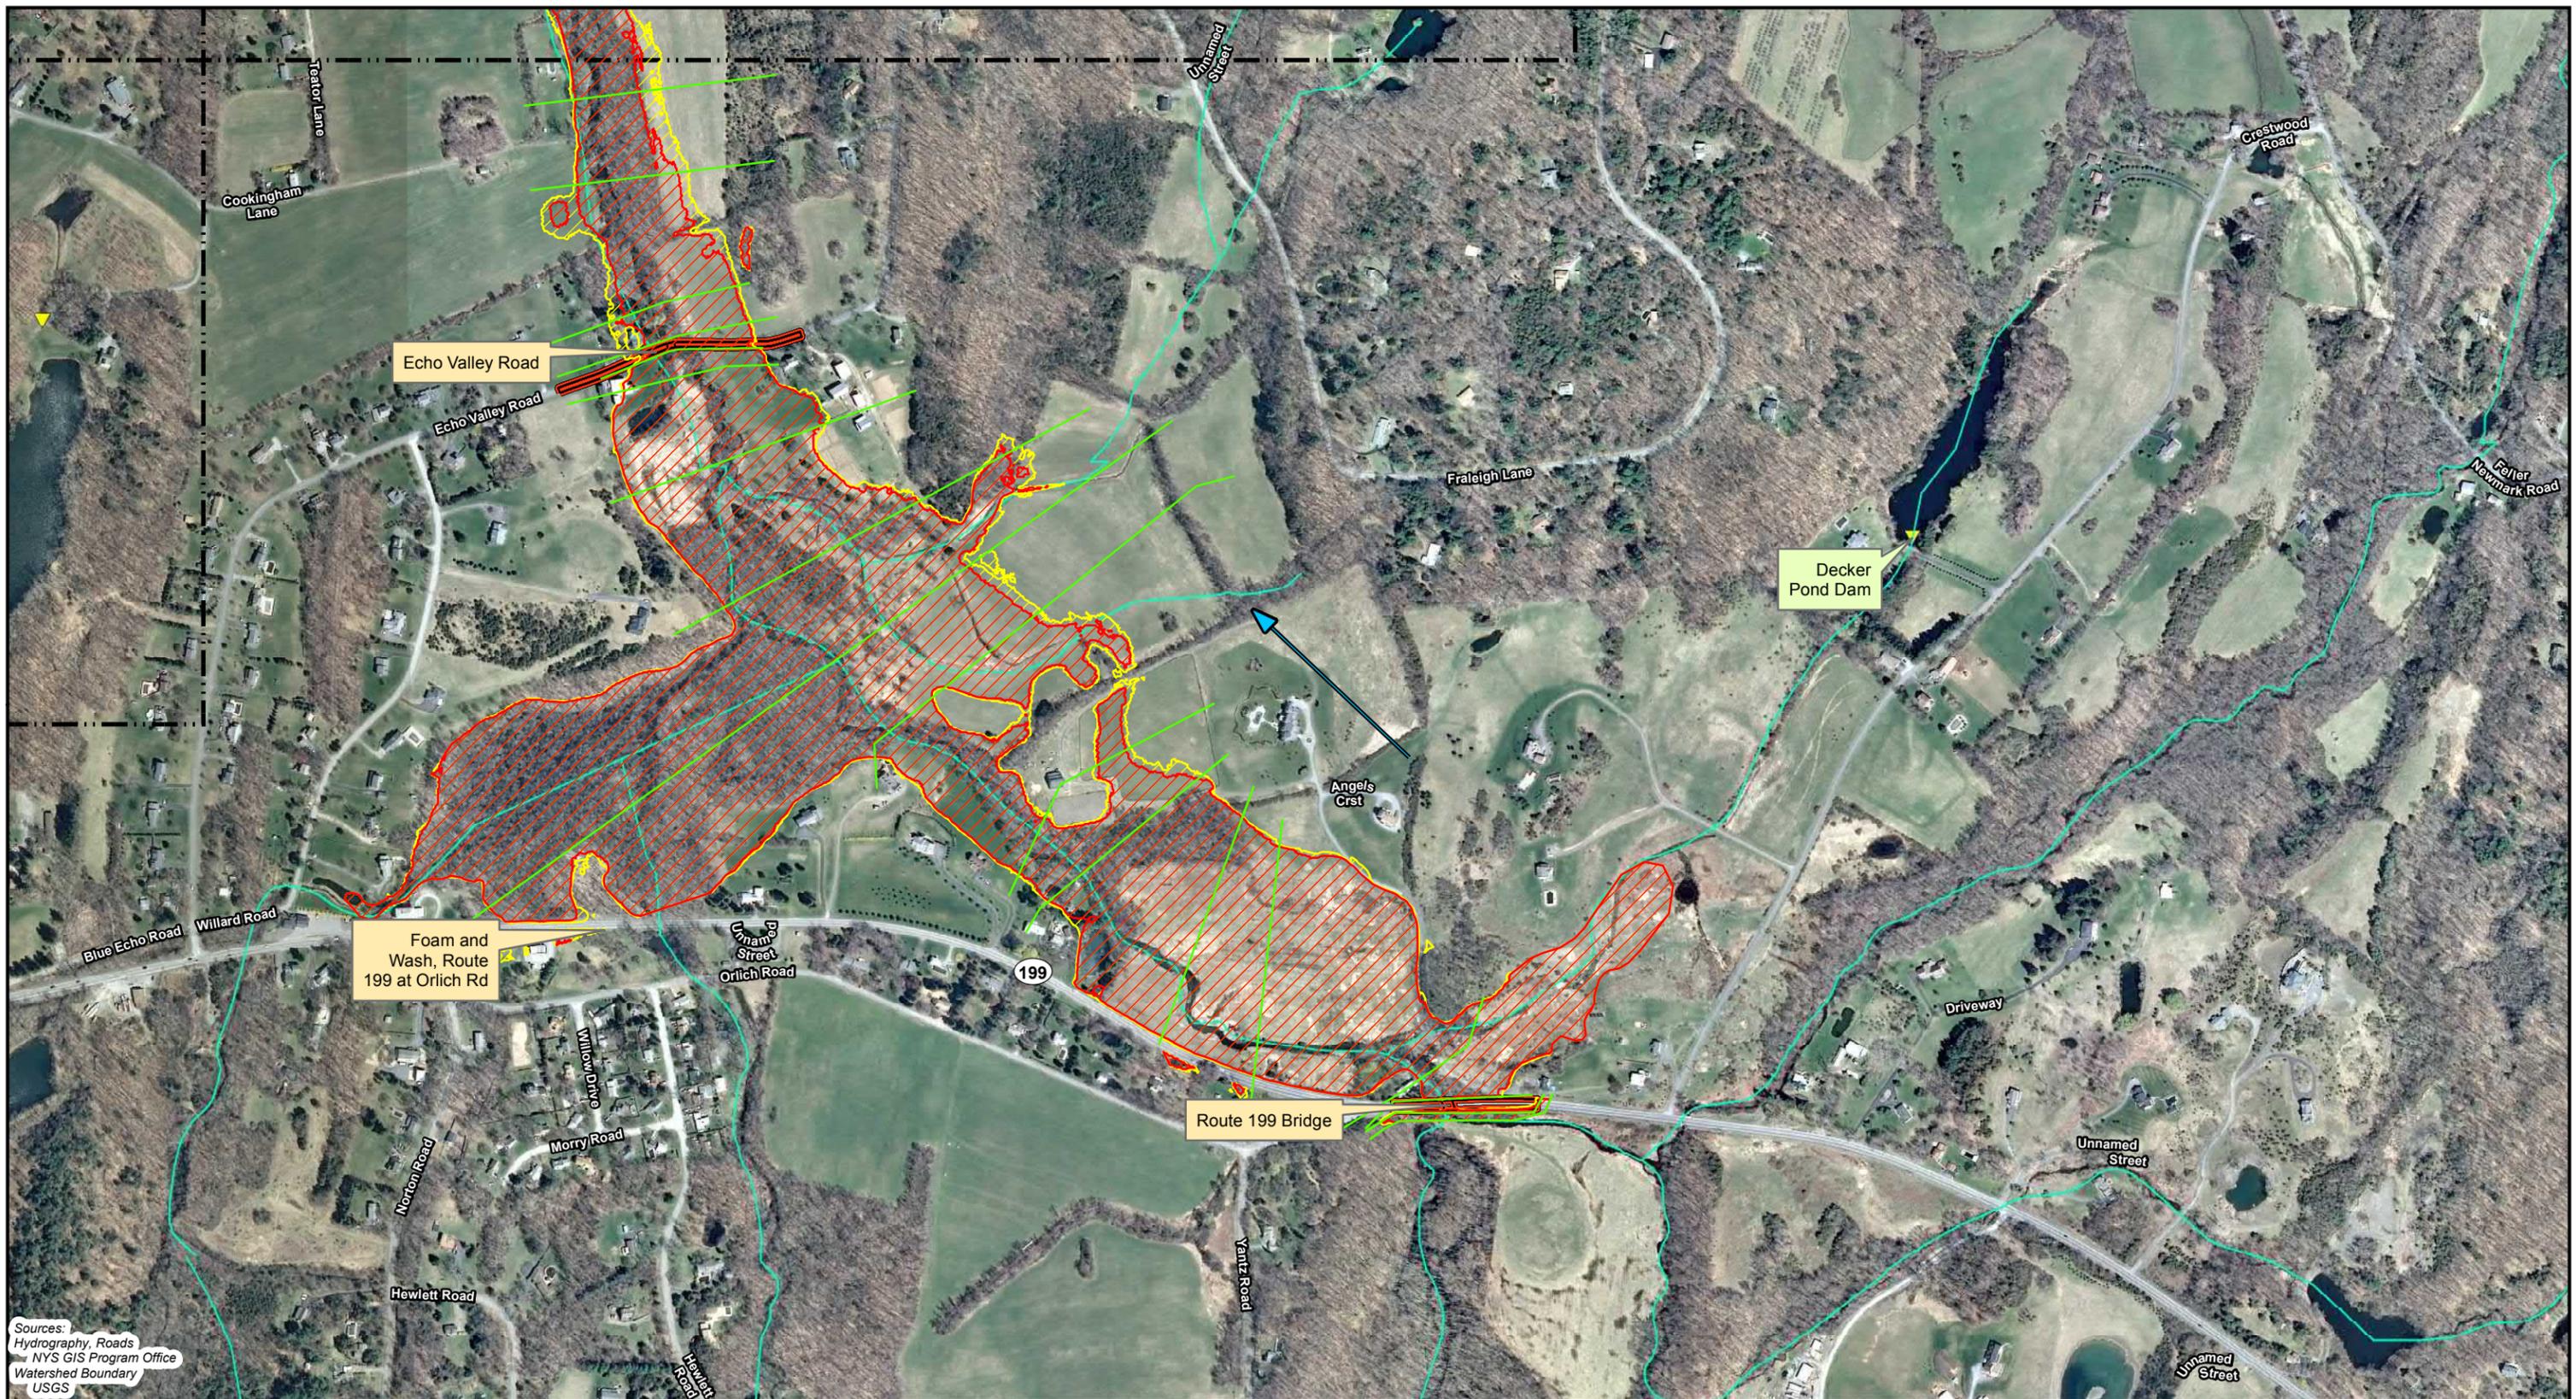
Figure 1-4: Inundation Map

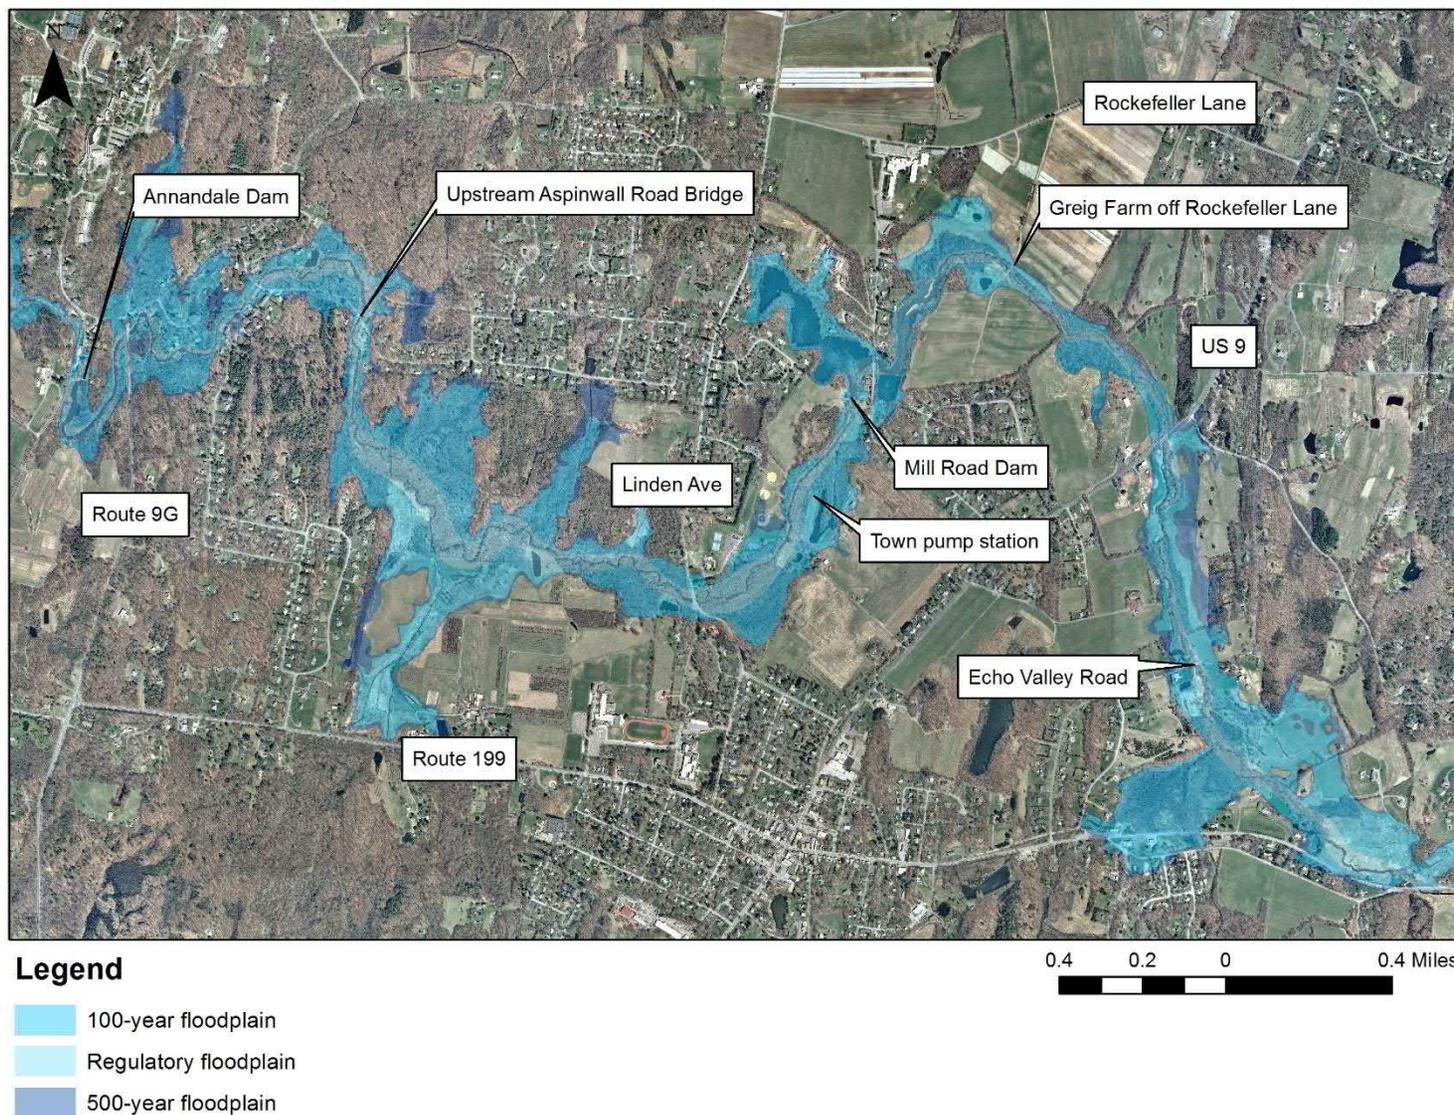
Figure 1. FEMA floodplain from Annandale Dam upstream to NY State Highway 199. Flow direction is from east to west. Data sources: Natural Flood Hazard Layer, Dutchess County, FEMA; Digital orthoimagery, Town of Red Hook, NYS Digital Orthoimagery Program.

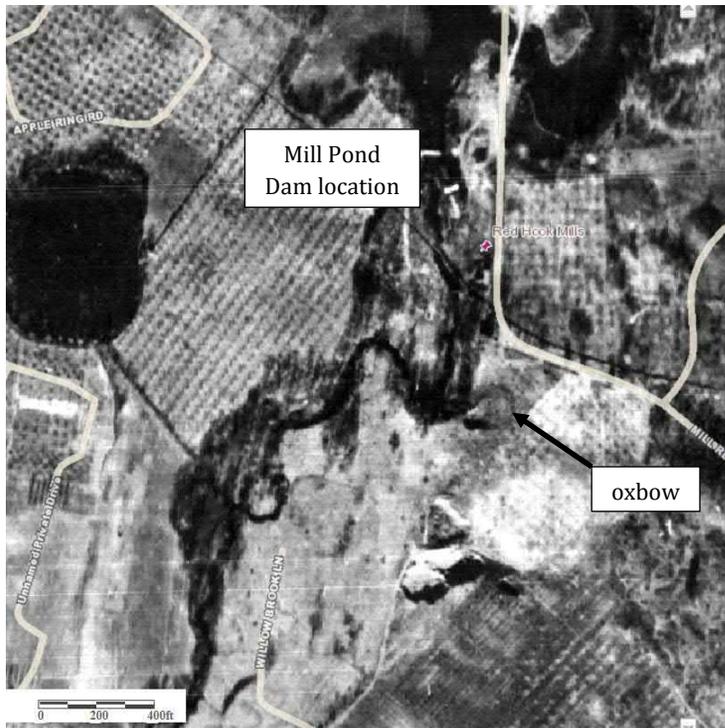
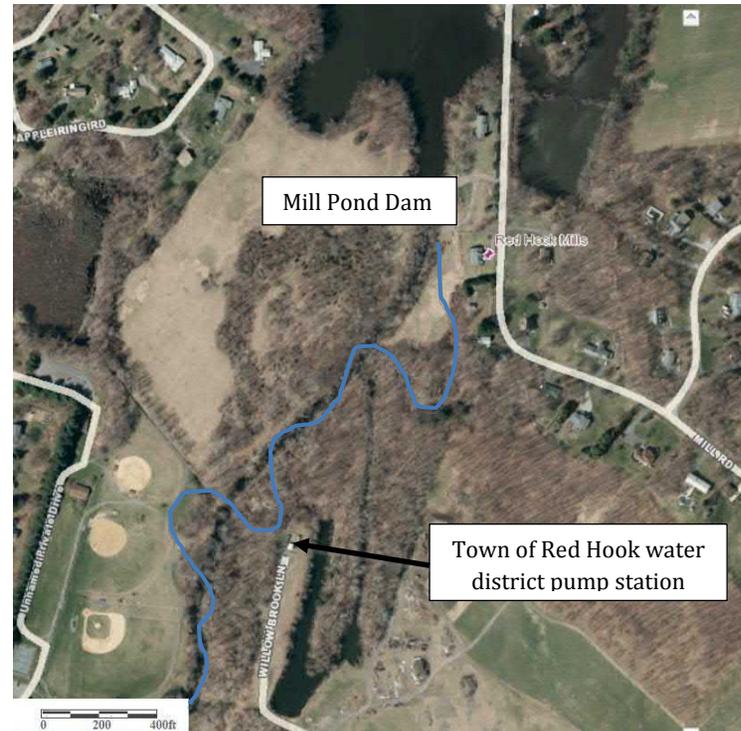
Figure 2. Aerial photographs of the Saw Kill immediately below Mill Pond Dam showing how this reach was channelized. The photograph on the left is from 1936, and the photo on the right is from 2014. A trace of the 1936 channel is shown overlain onto the 2014 image. Data source: <http://geoaccess.co.dutchess.ny.us/aerialaccess/>. Accessed September 24, 2017.

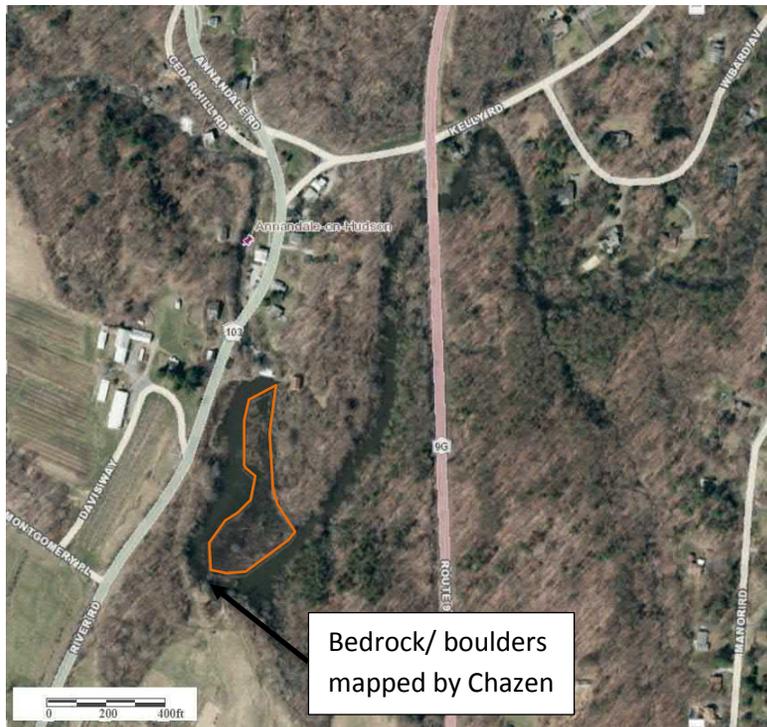
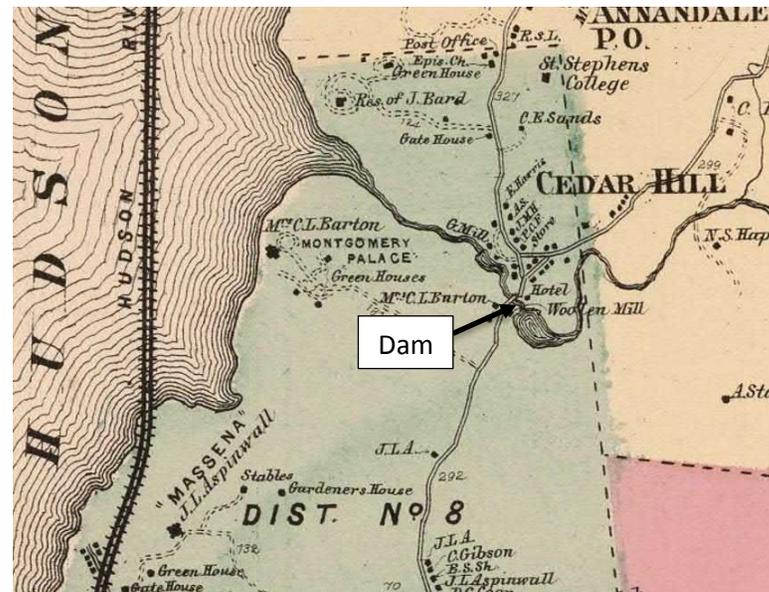
Figure 3. On left, 2014 aerial photograph with colonized impounded sediment outlined in orange (<http://geoaccess.co.dutchess.ny.us/aerialaccess/>, accessed September 24, 2017). On right, 1867 map showing mill (labelled “Woolen Mill”) and open water impoundment behind the dam (Beers, Frederick W., 1867. Town of Red Hook, Dutchess County, NY, 1:31,680. Accessed on September 24, 2017 via the David Rumsey Historical Map Collection, <https://www.davidrumsey.com>).
