Saw Kill Watershed and Flood Mitigation Assessment - Final Report

NEIWPCC and NYSDEC Hudson River Estuary Program

MARCH 2018

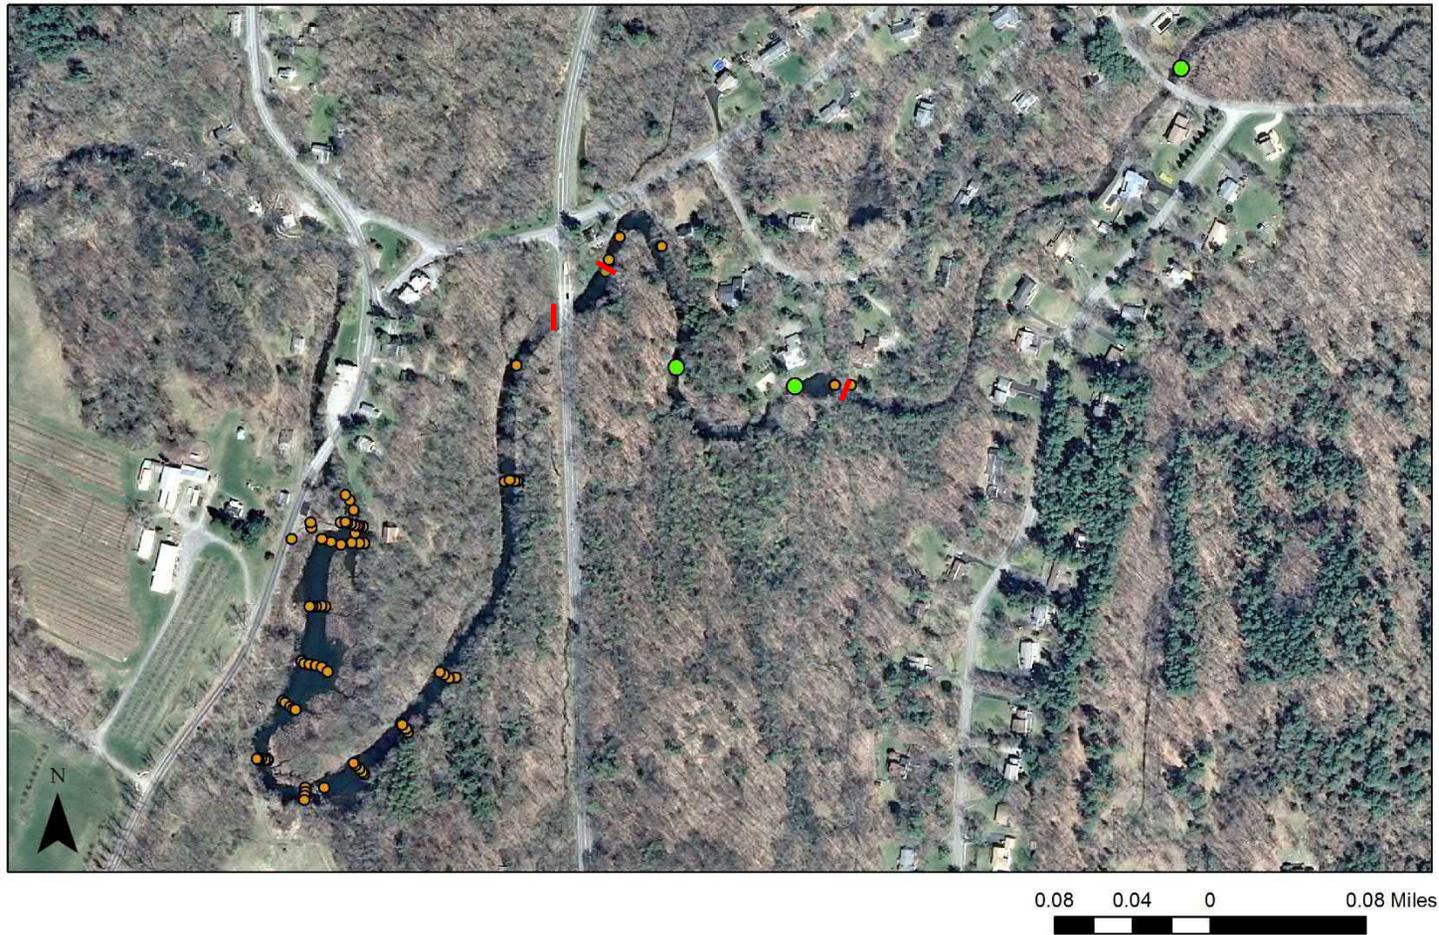
Figure 5. Map of bathymetric and depth of refusal survey data collected at Annandale Dam (orange points) and other inspection points (green). Locations of observed bedrock seams are shown as red lines. The furthest upstream bedrock seam shown on the map corresponds with the upstream extent of the impounded water surface during low-flow conditions.

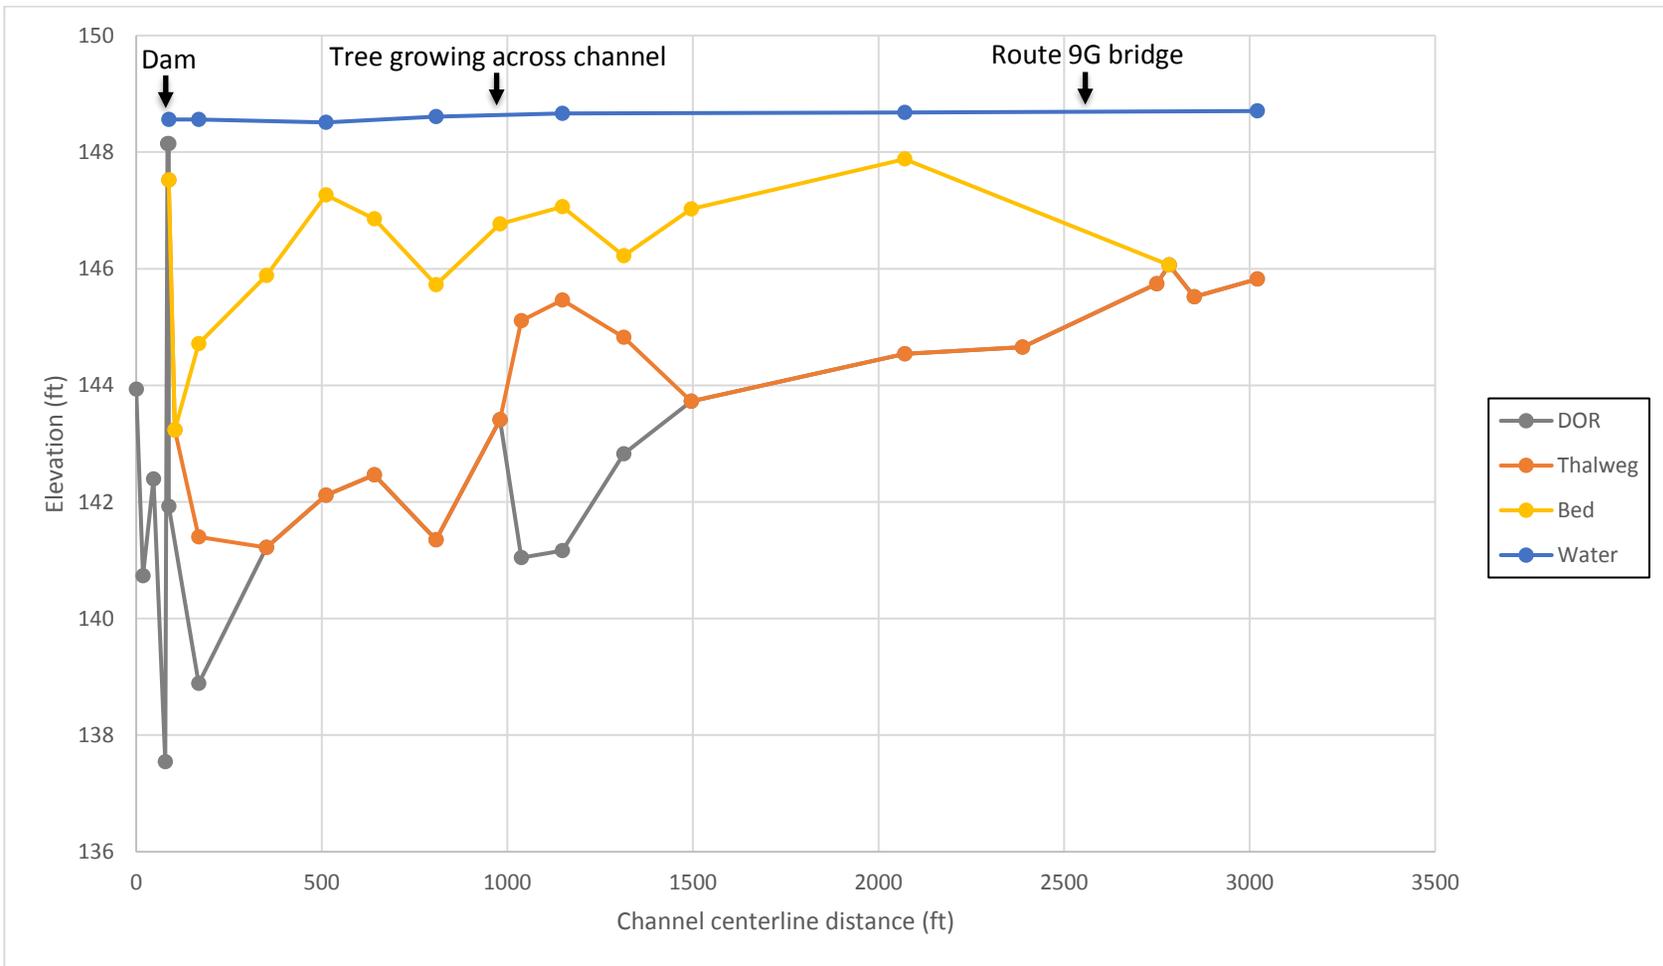
Figure 6. Longitudinal profile through the impoundment showing depth of refusal (DOR), the bed surface along the thalweg of the channel through the impoundment (thalweg), the bed surface along the right side (inside of meander bend) of the channel through the impoundment (bed), and the water surface (water). Elevation is relative to the NAD 83 datum.

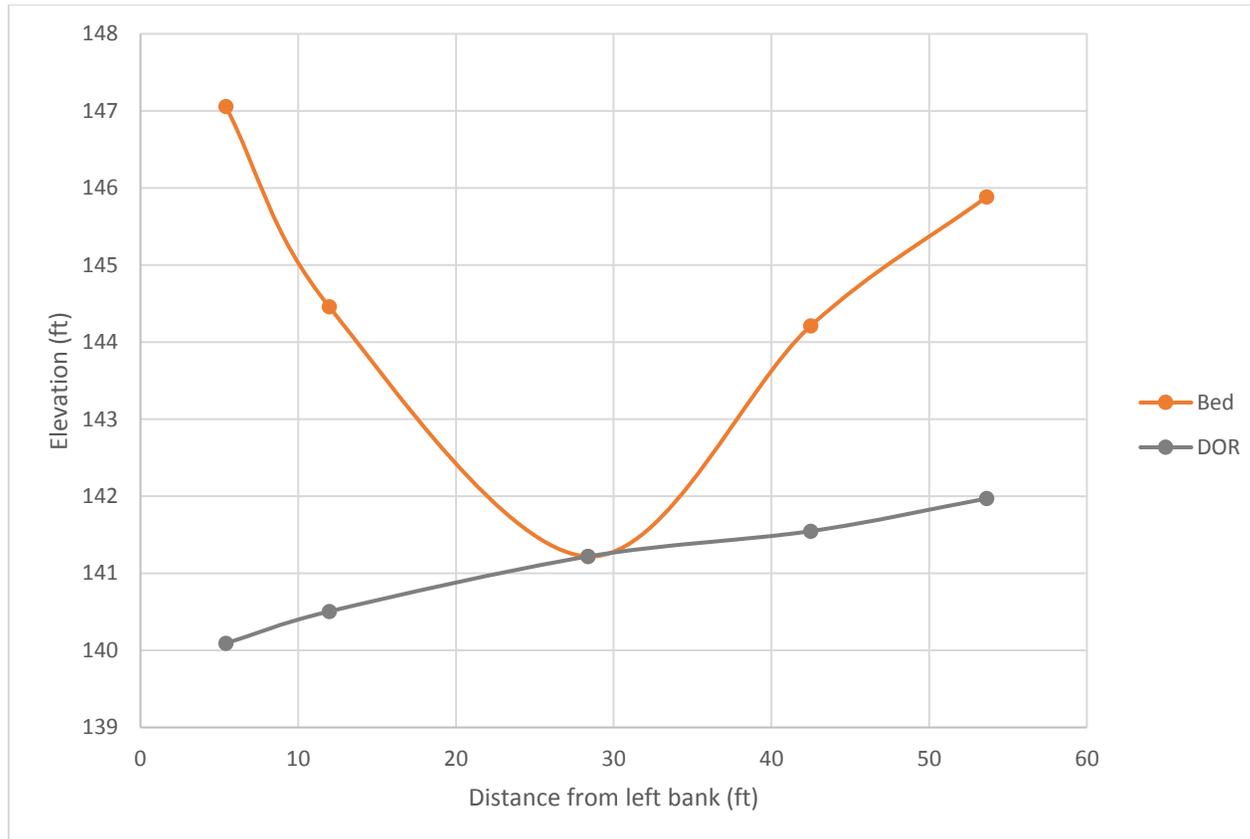
Figure 7. Cross section through the impoundment taken approximately 265 feet upstream of the dam showing depth of refusal (DOR) and the bed surface (bed). Elevation is relative to the NAD 83 datum.

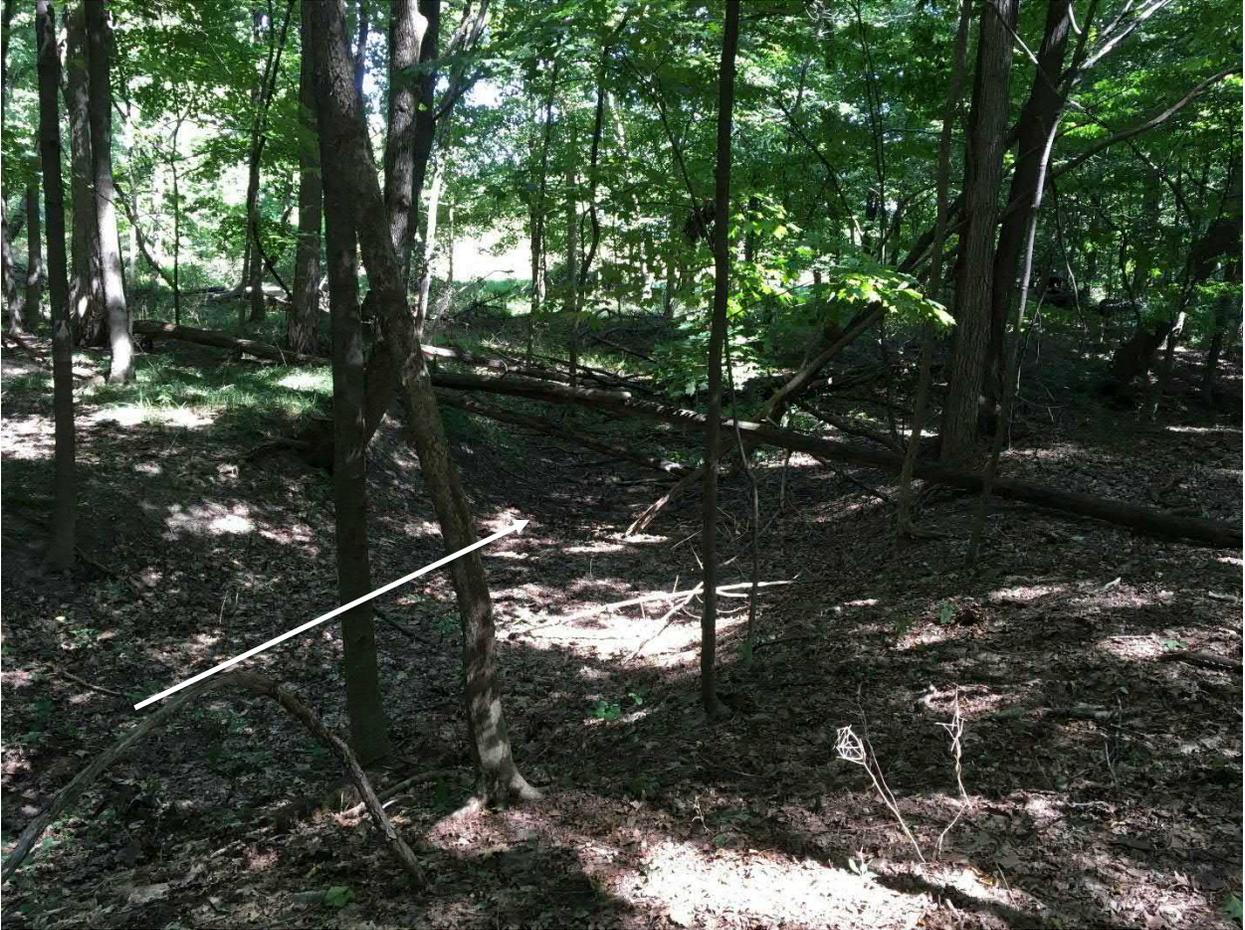
Figure 8. Relic channel on left bank floodplain downstream of Mill Road Dam. The arrow indicates flow direction along the approximate location of the preserved thalweg.

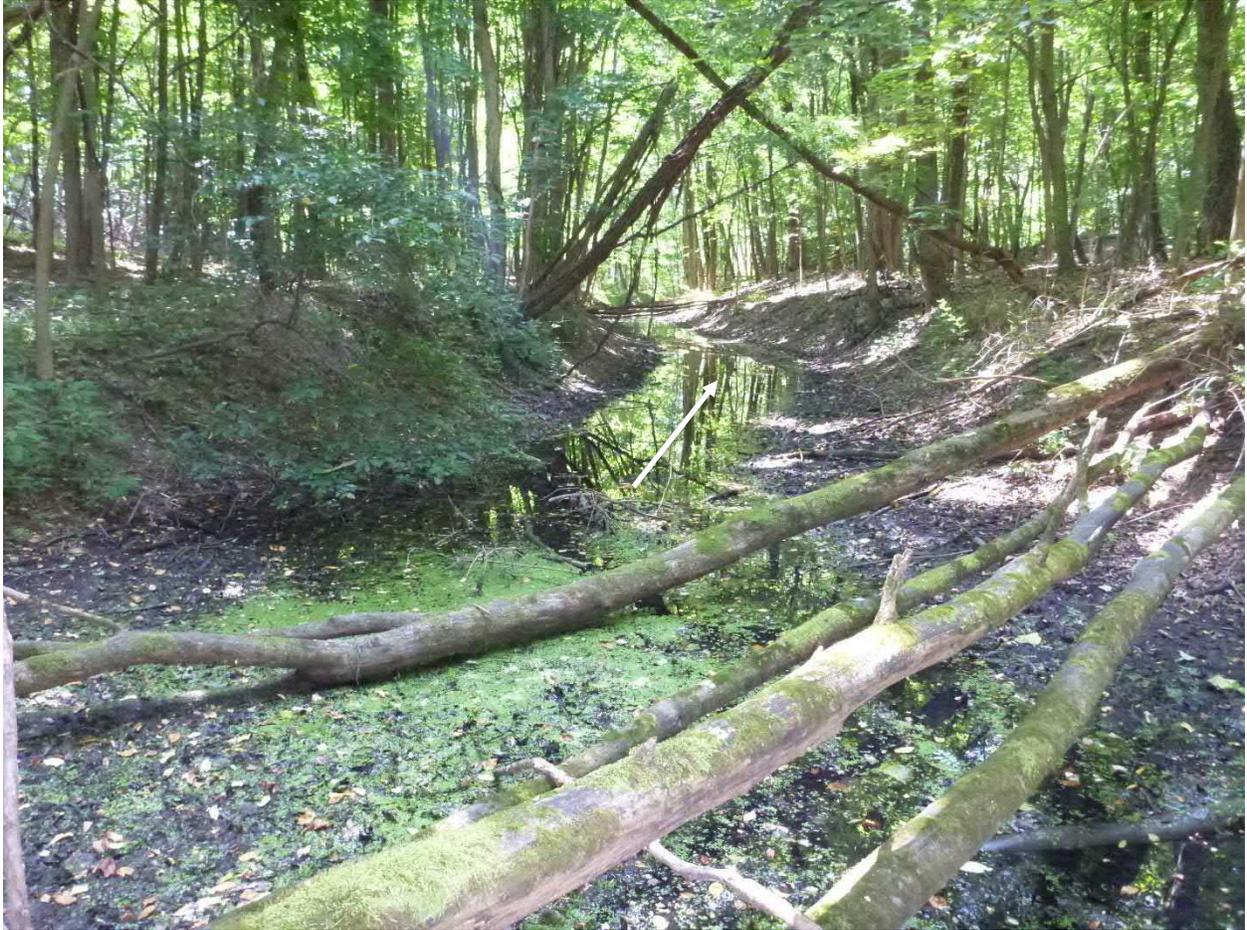
Figure 9. High-flow channel feeding pond adjacent to Town wellfield. The arrow indicates flow direction into the high-flow channel from the main channel.

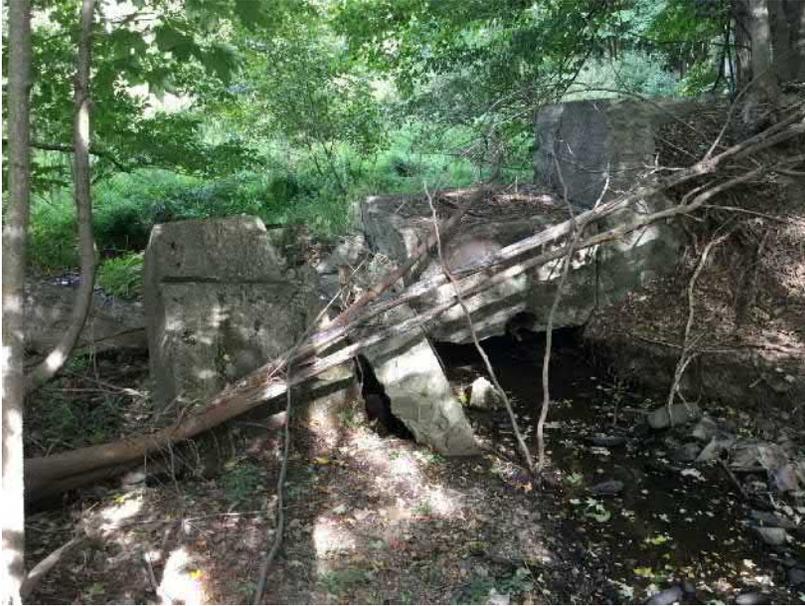
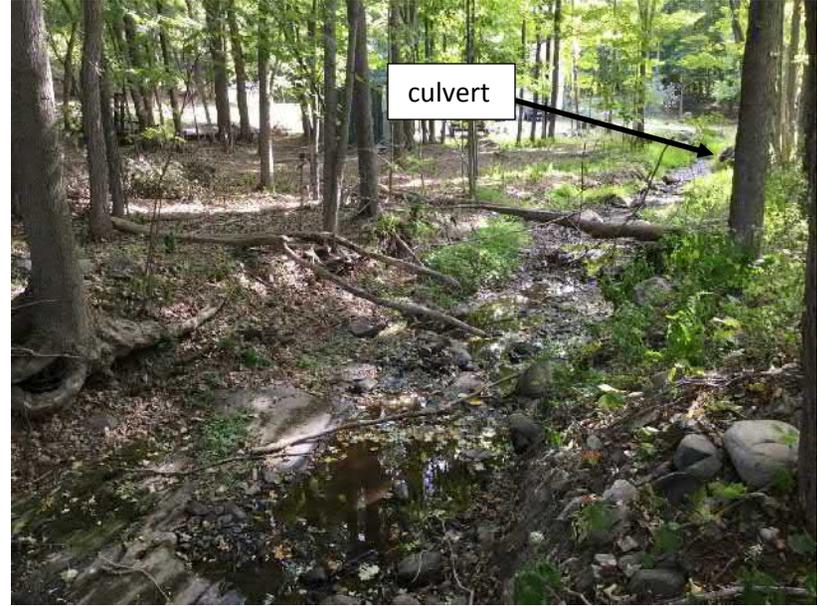
Figure 10. On left, the relic dam along Battenfeld Road. On right, the channel looking downstream toward an undersized culvert beneath a private driveway.

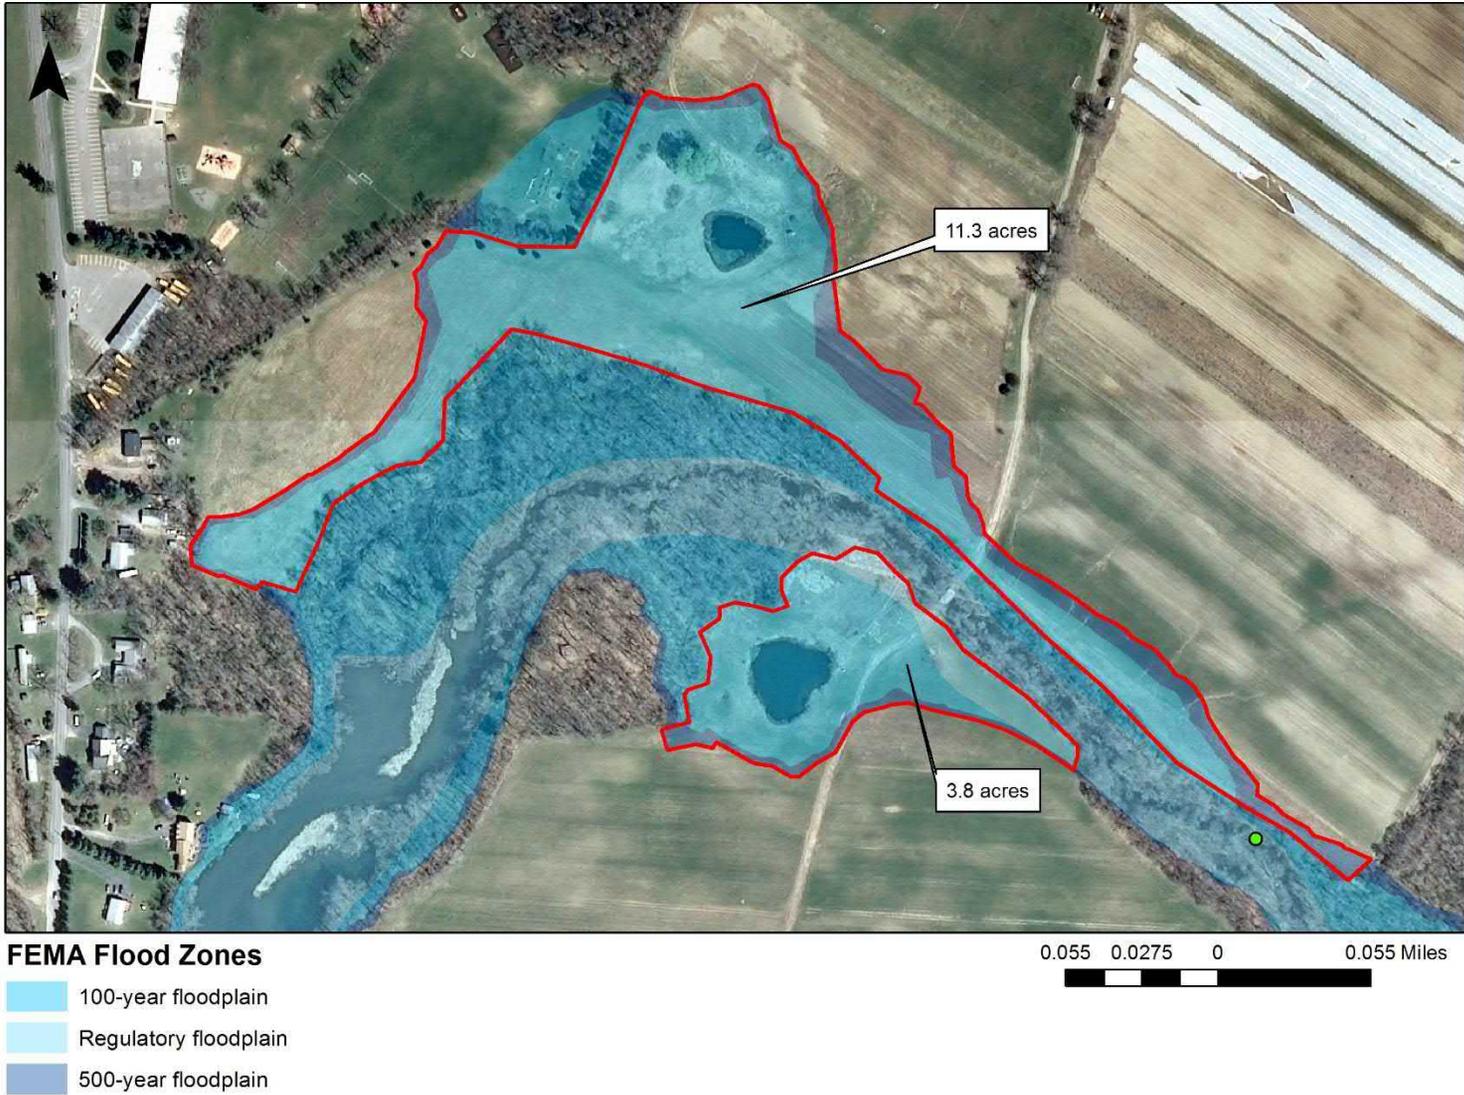
Figure 11. Potential areas of riparian buffer expansion at Greig Farm off of Rockefeller Lane. Flow direction is from east to west.

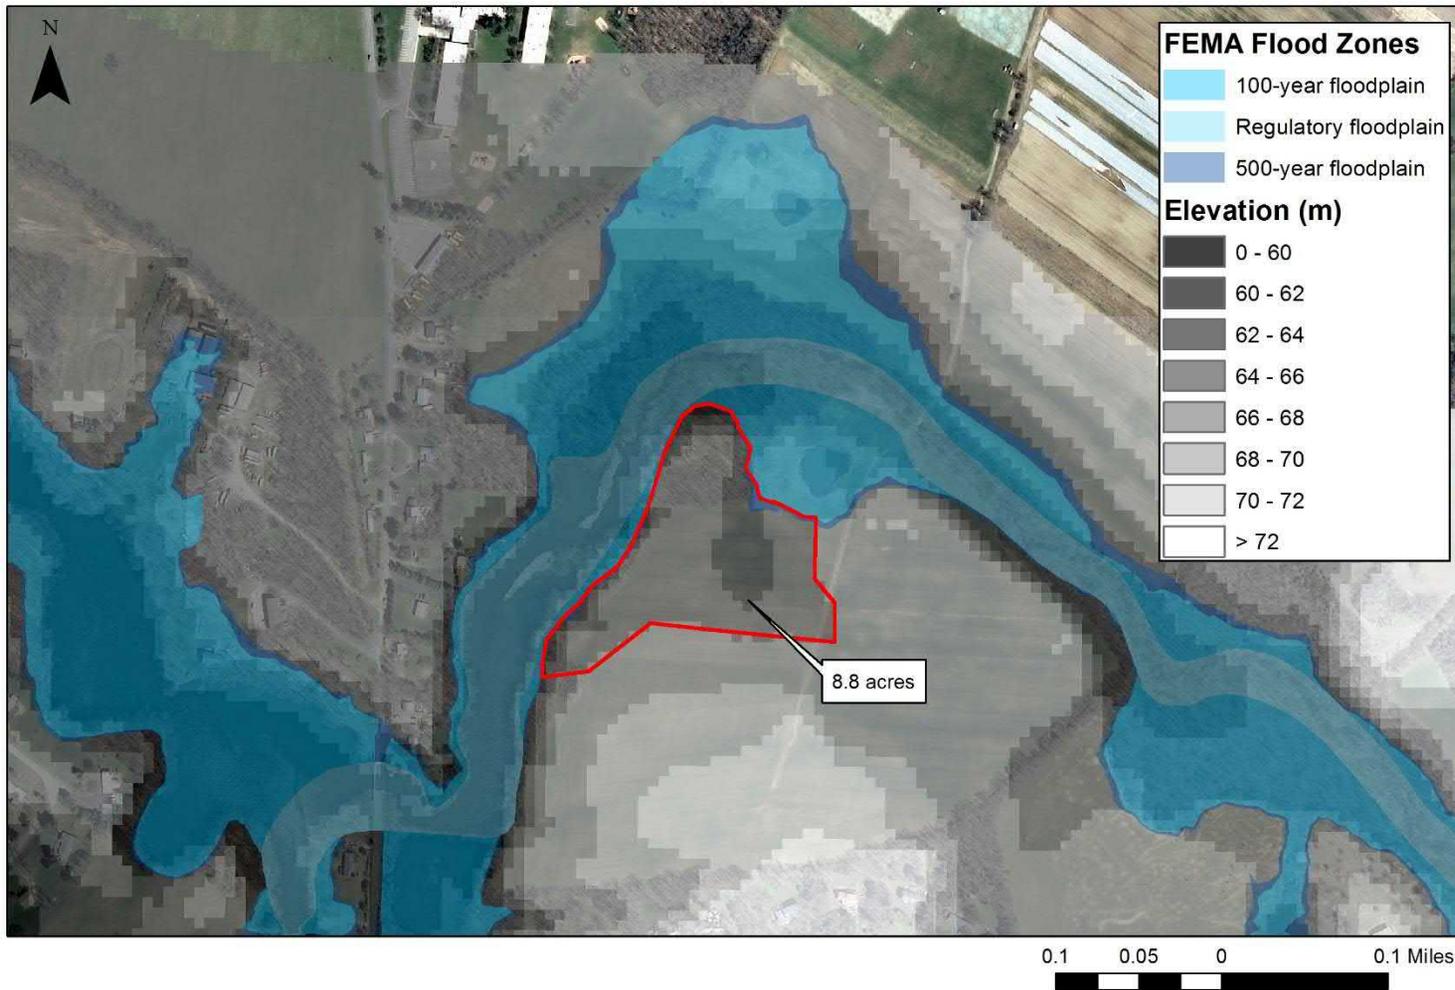
Figure 12. Potential flood storage area at Greig Farm off of Rockefeller Lane. Flow direction is from east to west.

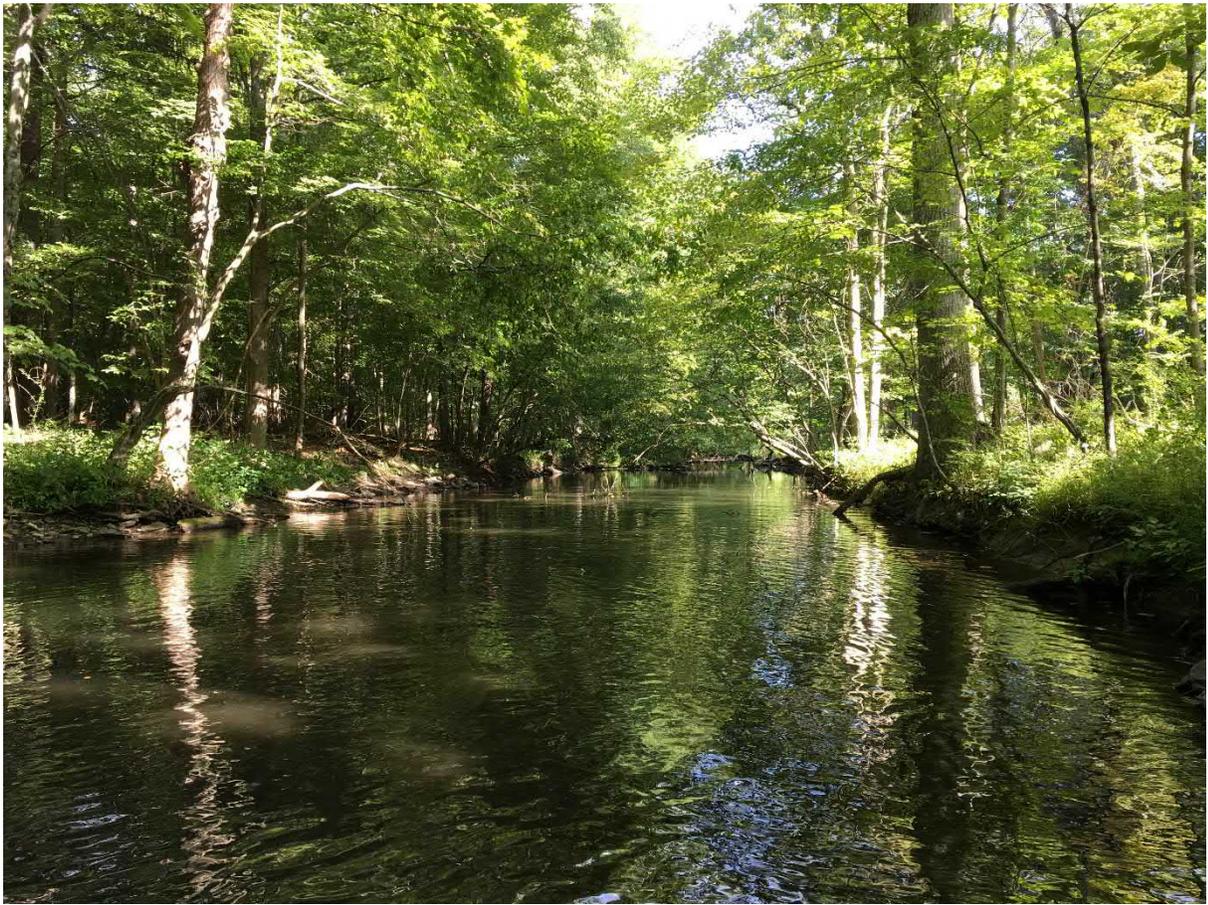
Cross section XS1 looking downstream

Representative cross-section sketch		
Bankfull width XS1 = 33 ft	Floodplain width =	Water depth (at survey) XS1 = 2 ft
Bankfull width XS2 = 29 ft	Channel Class =	Water depth XS2 = 2.5 ft
Bankfull depth XS1 = 3 ft		Water width (at survey) =
Bankfull depth XS2 = 4 ft

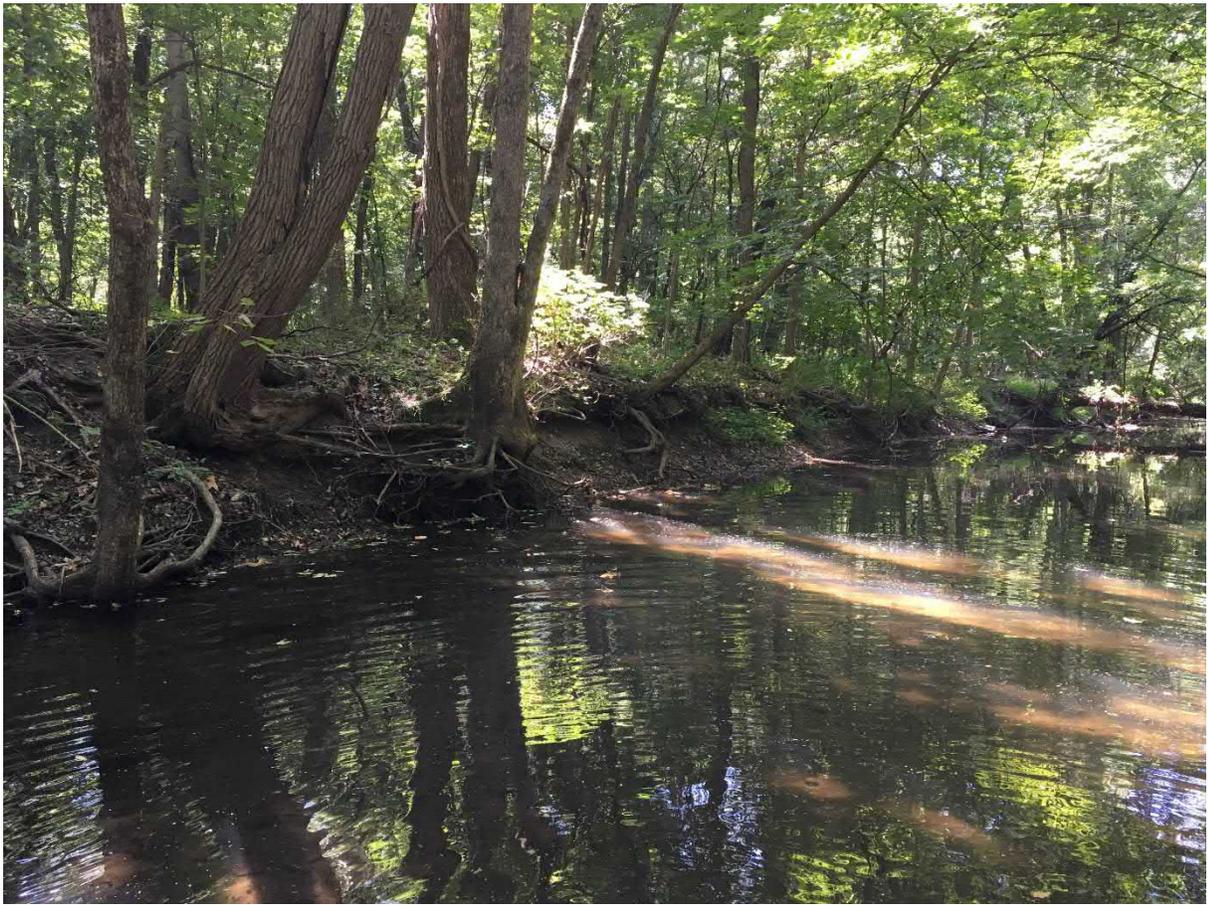
Cross section XS3 looking downstream

Bankfull width XS3 = 48 ft	Floodplain width =	Water depth (at survey) XS3 = 1 ft
Bankfull width Riffle = 34 ft	Channel Class =	Water depth (at survey) Riffle = 0.5 ft
Bankfull depth XS3 = 5 ft		Water width (at survey) =
Bankfull depth Riffle = 3 ft

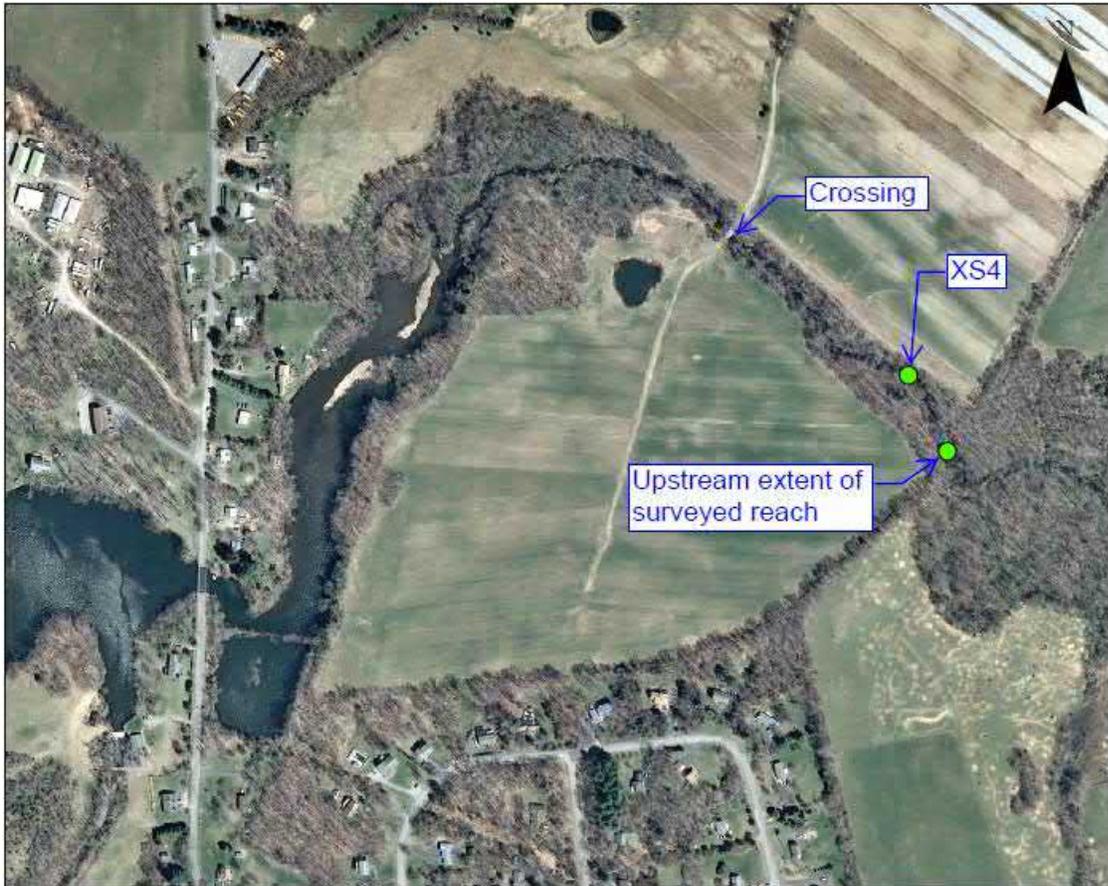
Representative cross-section (XS4)		
Bankfull width = 35 ft	Floodplain width =	Water depth (at survey) = 1 ft
Bankfull depth = 3.5 ft	Channel Class =	Water width (at survey) =

Cross section XS4 looking downstream

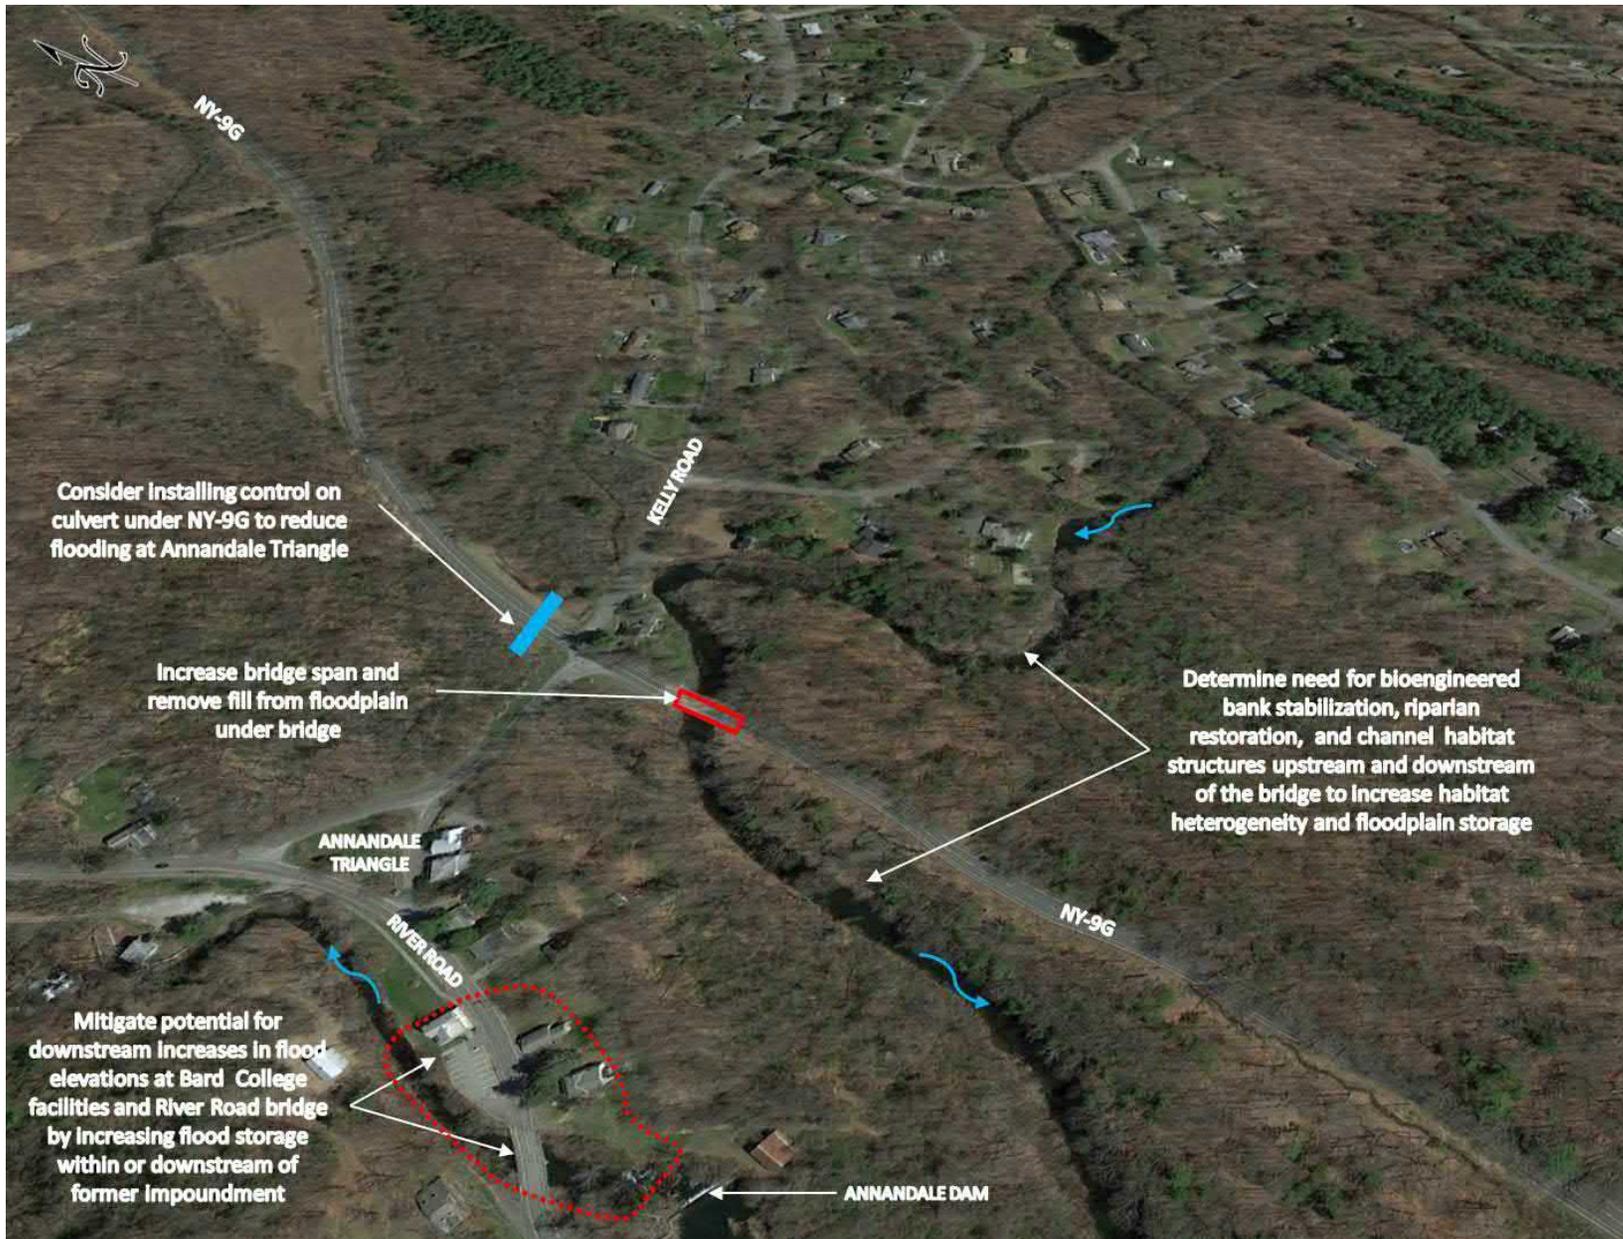
Recommendation #2 – NY-9G Bridge

Replace and Upgrade Bridge

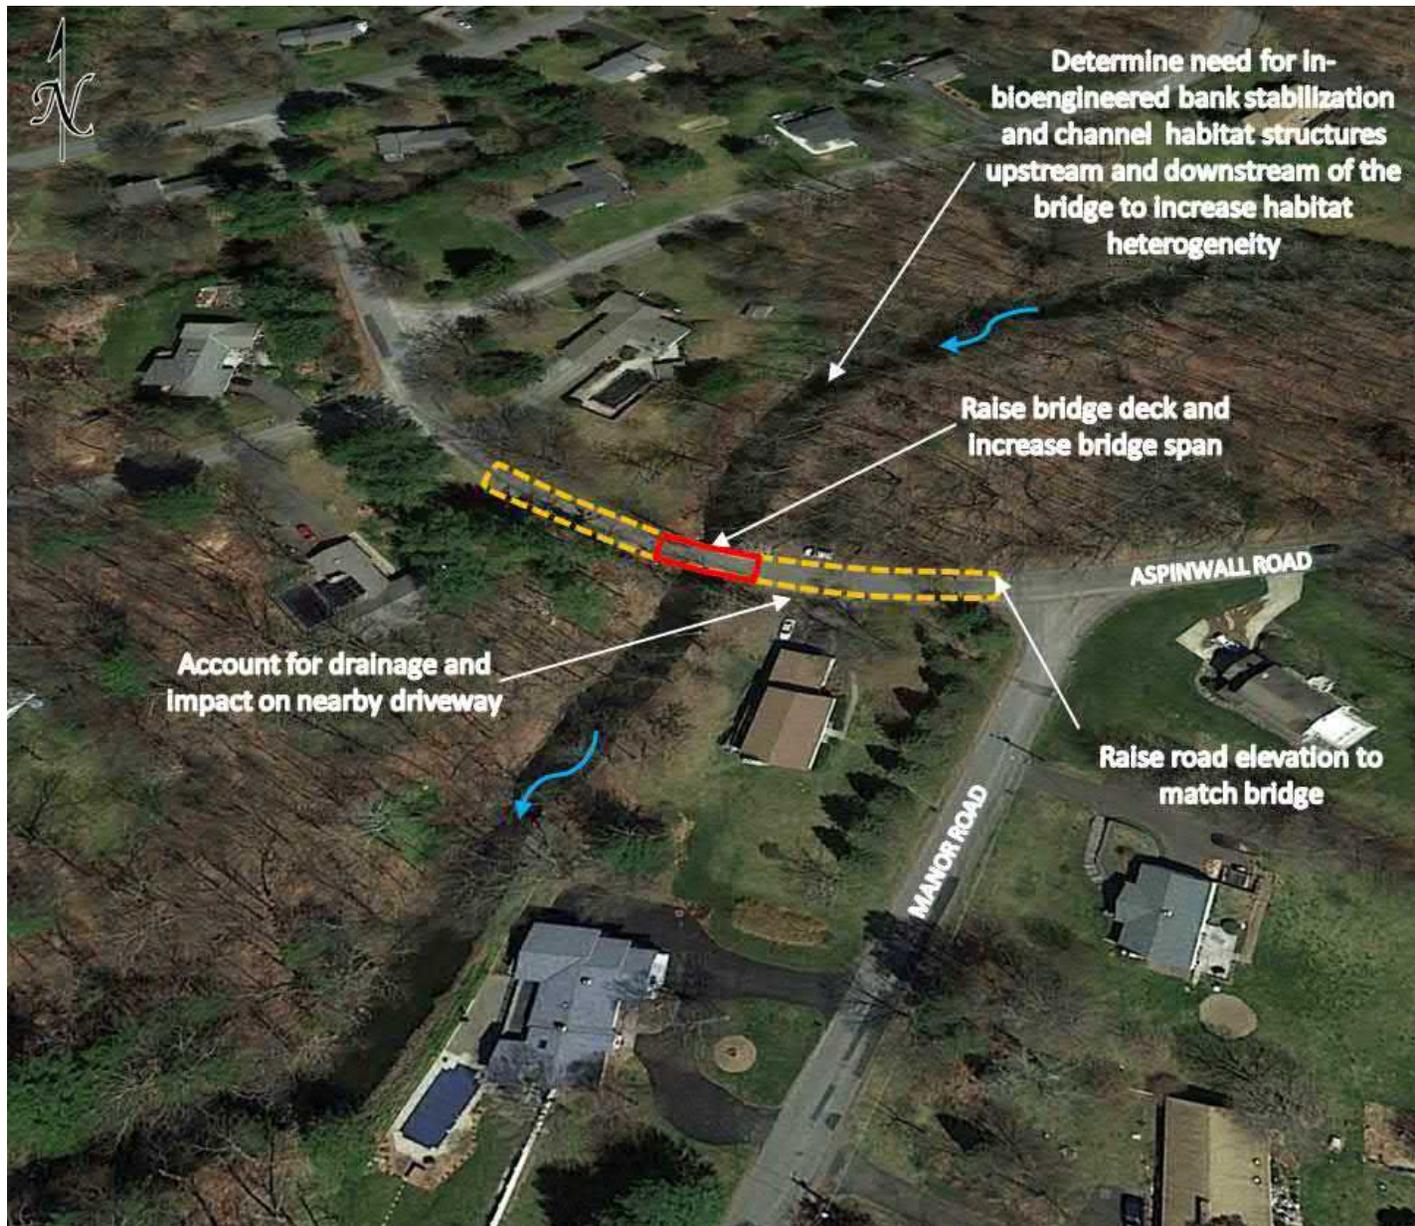
Recommendation #3 – Aspinwall Road Bridge
Replace and Upgrade Bridge and Elevate Road Approaches
Aspinwall Road (downstream crossing), Red Hook, New York

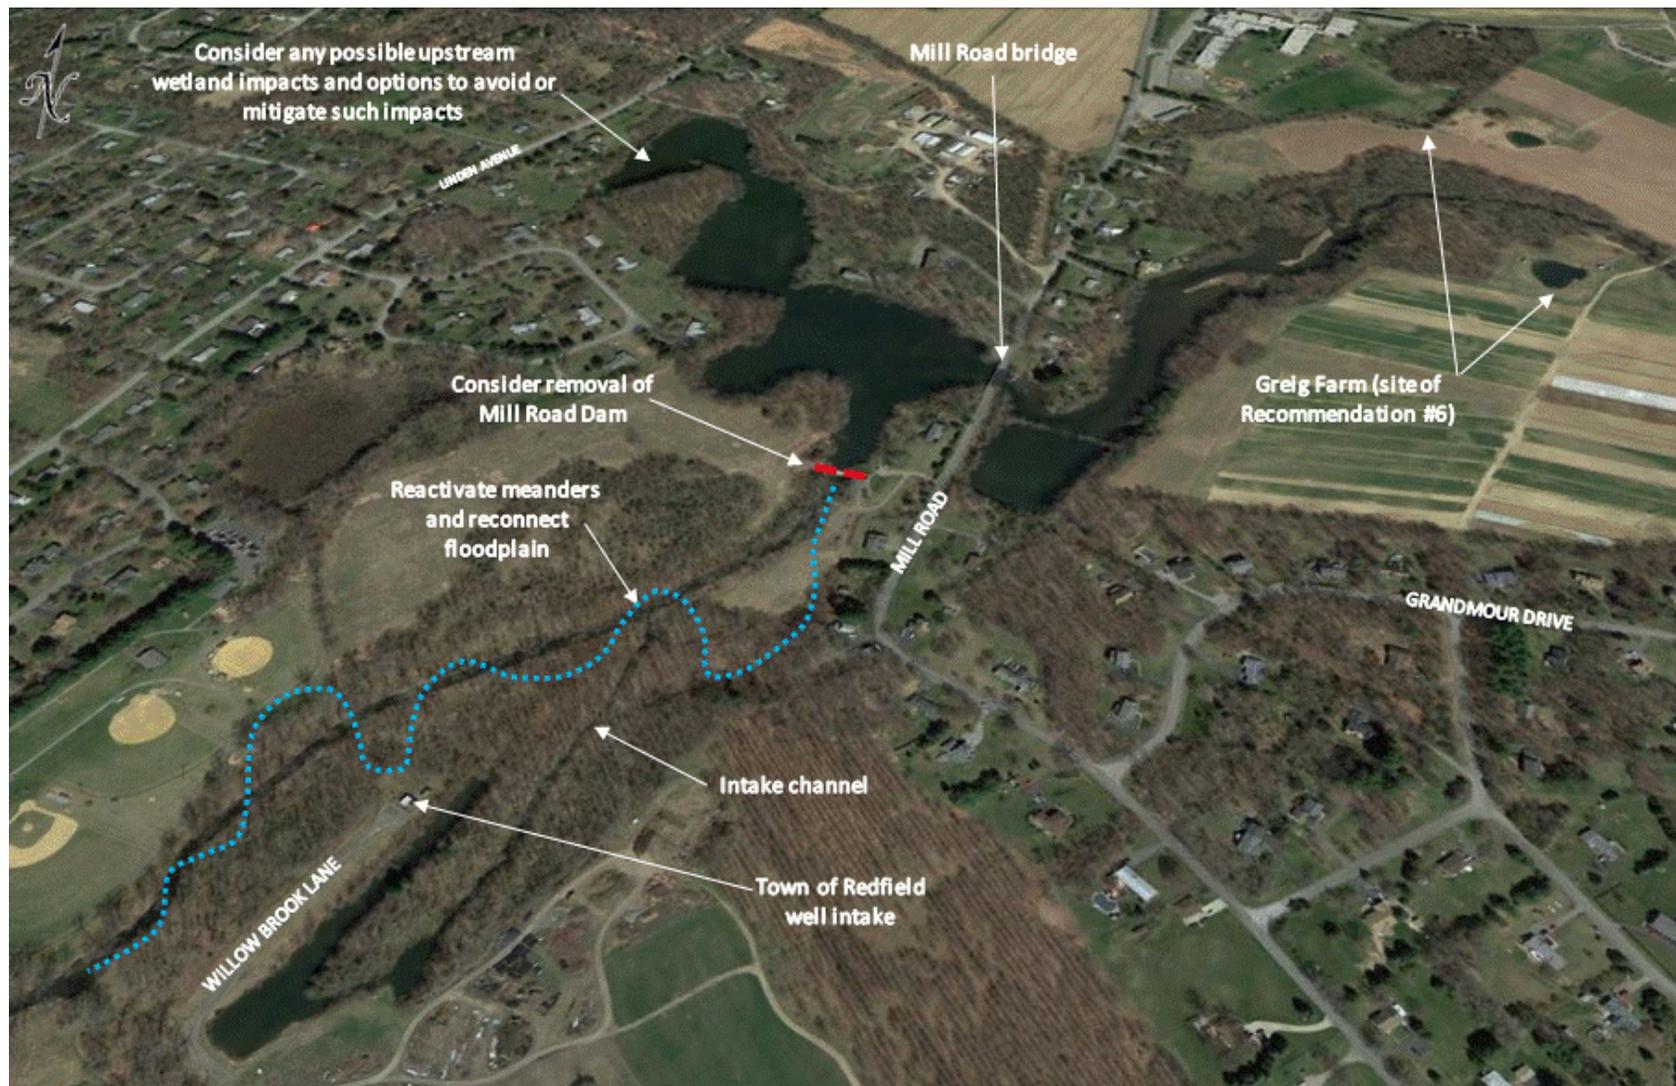
Recommendations #4 and #5– Mill Road Dam
Remove Dam and Reactivate Stream Meanders Downstream of Dam
Mill Road, Red Hook, New York

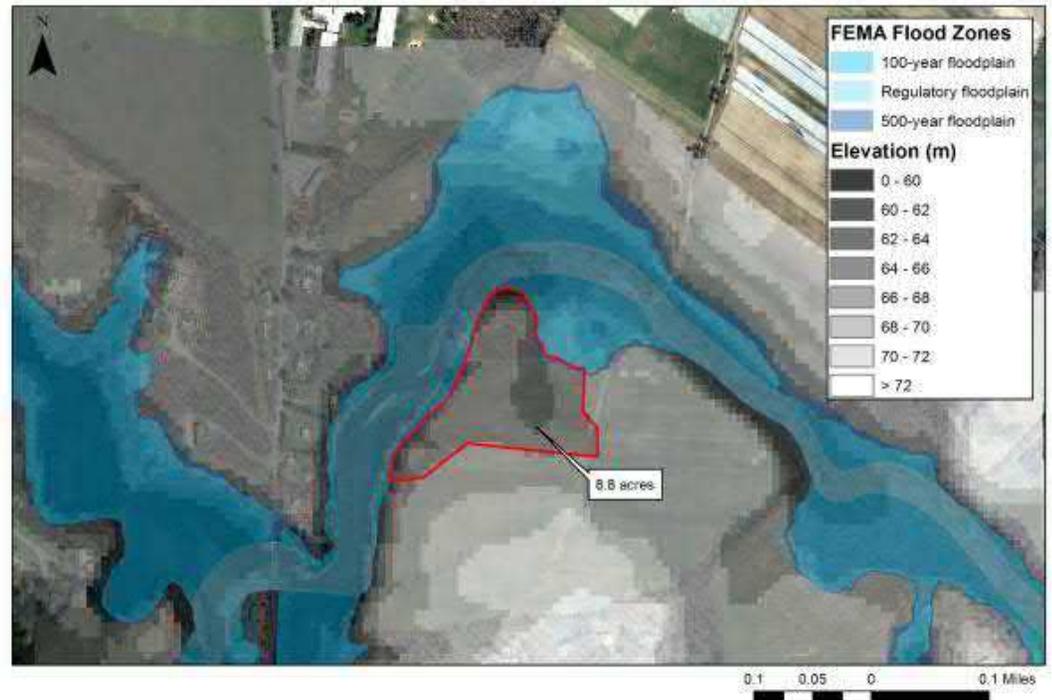
Expand Riparian Buffer and Increase Flood Storage

Greig Farm, Red Hook, New York

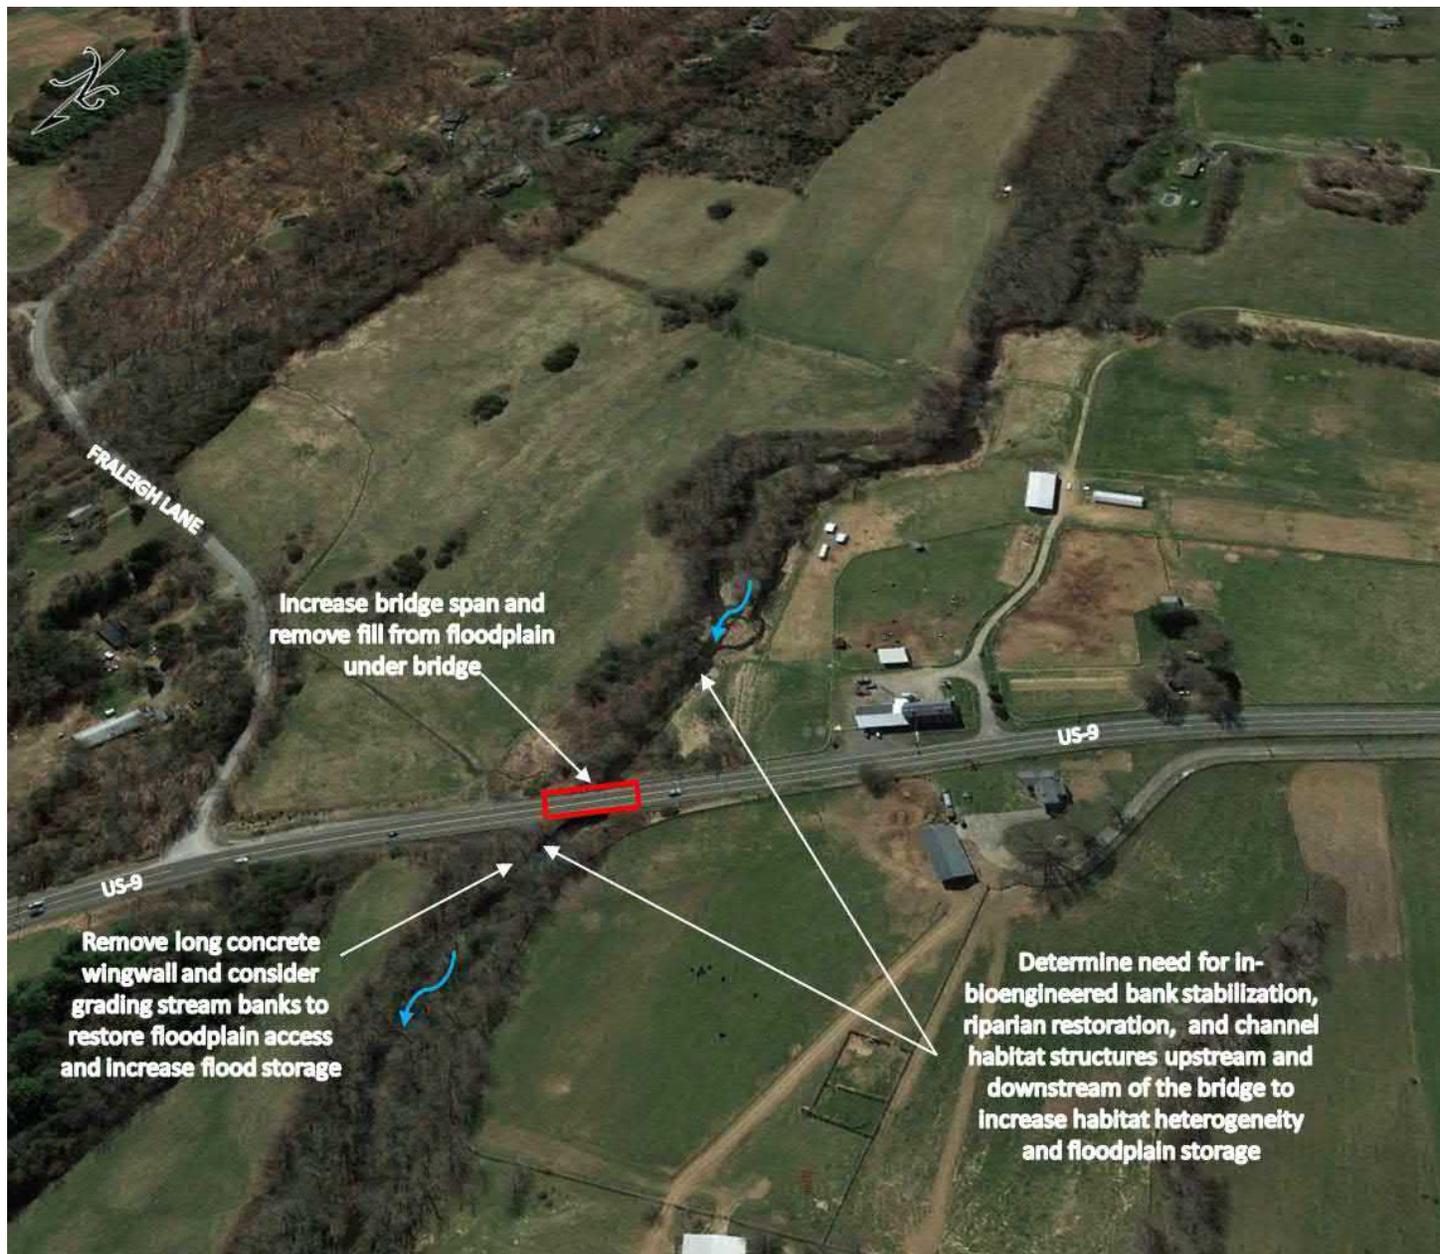
Recommendation #7 – US-9 Bridge
Replace and Upgrade Bridge
US-9, Red Hook, New York
