Saw Kill Watershed and Flood Mitigation Assessment - Final Report

NEIWPCC and NYSDEC Hudson River Estuary Program

MARCH 2018

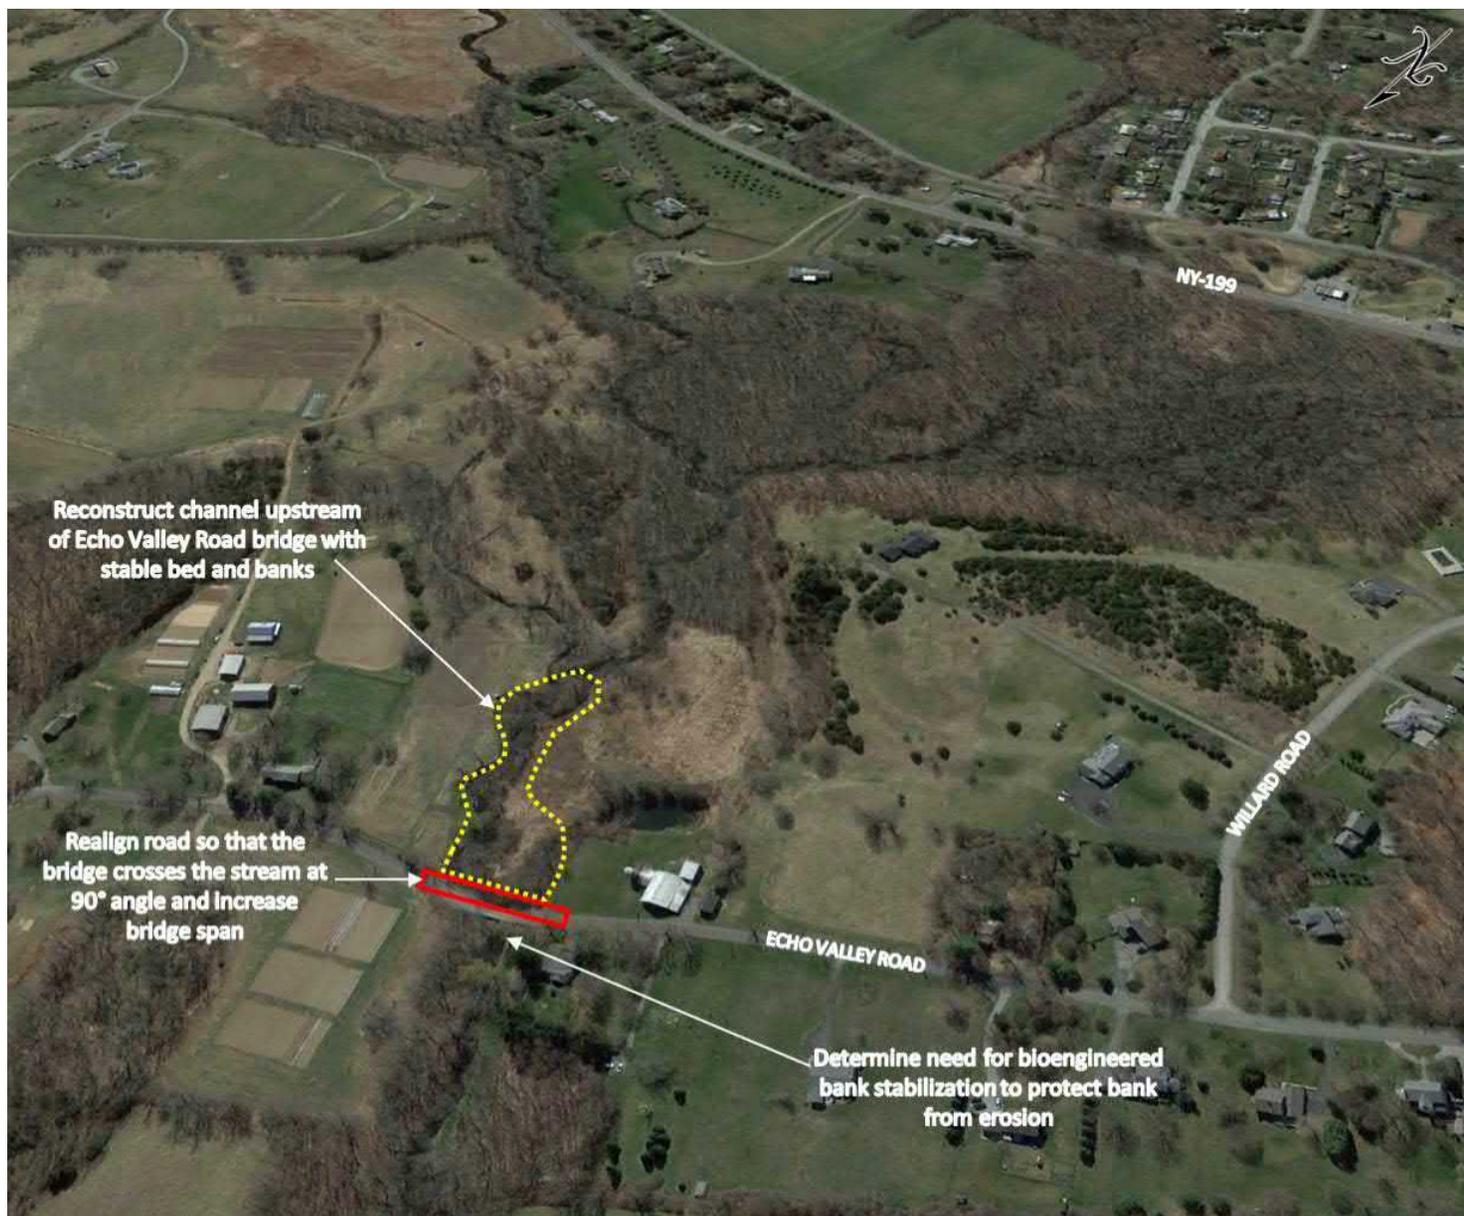
Recommendations #8 and #9 – Echo Valley Road Bridge
Replace and Realign Bridge and Reconstruct Stable Upstream Channel Bed and Banks
Echo Valley Road, Red Hook, New York

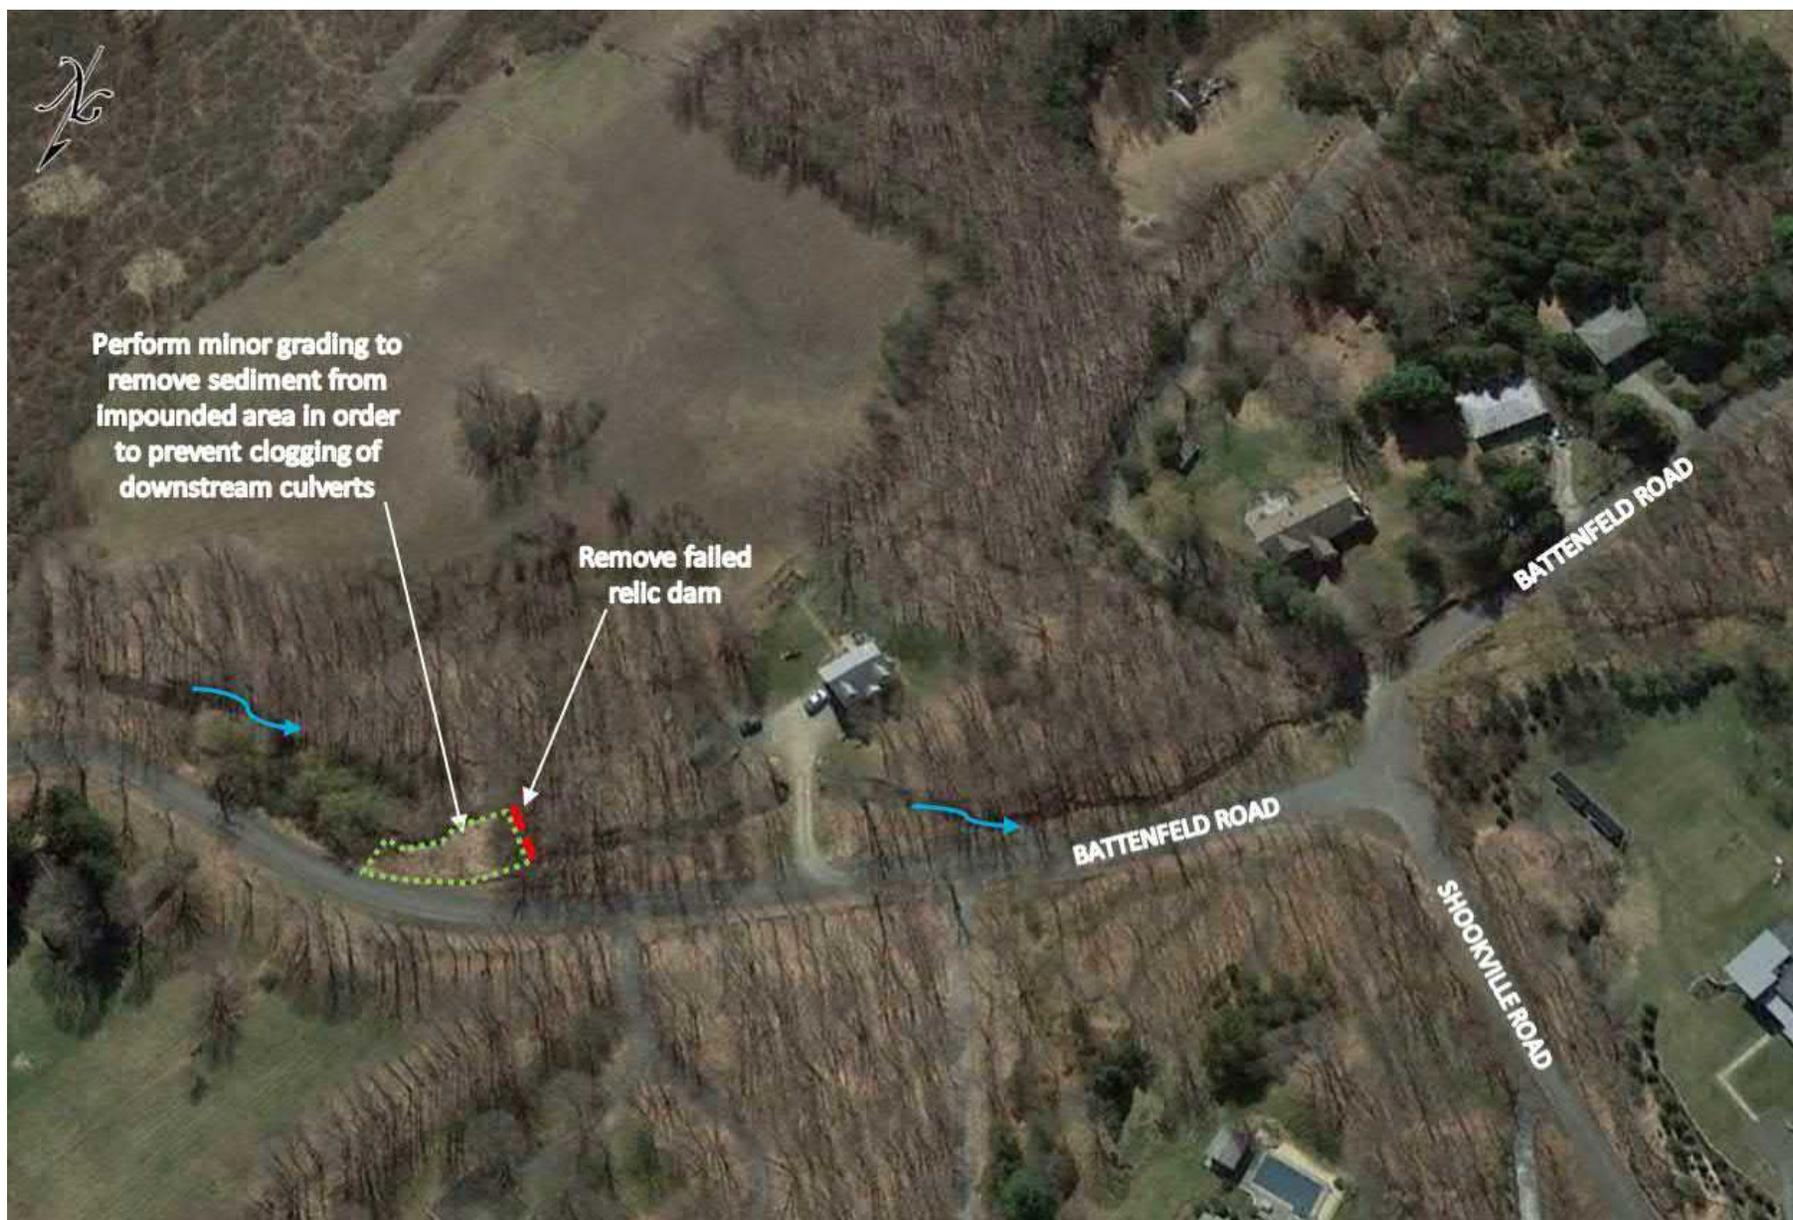
Recommendation #10 – Battenfeld Road
Remove Failed Dam
Battenfeld Road, Milan, New York
