ULSTER COUNTY

Road-Stream Crossing Management Plan

Ulster County Department of Environment

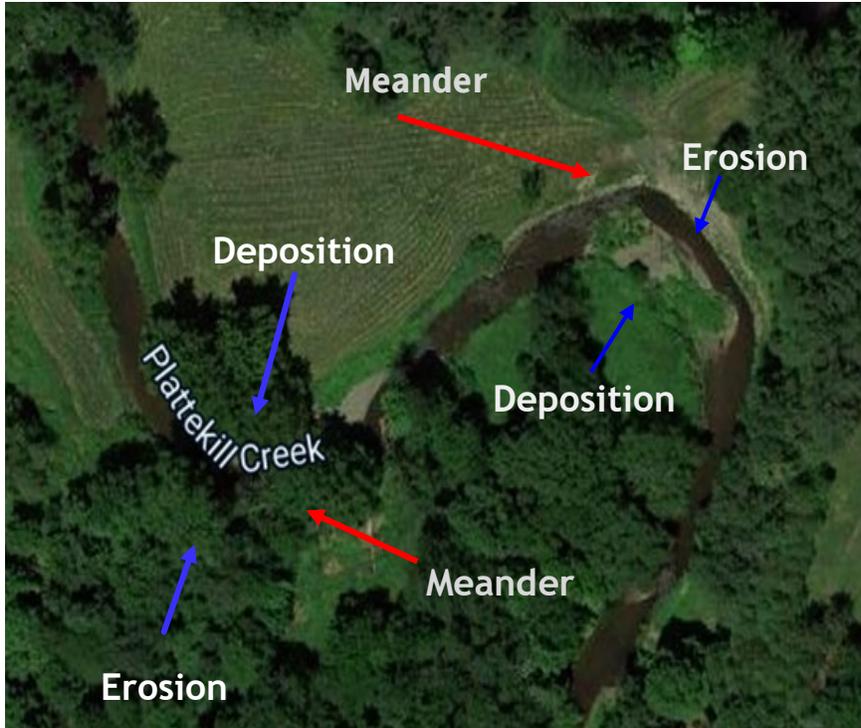
A bird's eye view of two meanders within the Plattekill Creek. Deposition will occur on the inner part of the curve while erosion will occur on the outer part of the curve. Source: Ulster County Department of Environment.

The processes of erosion and deposition serve to lengthen a channel through a curving process known as “meandering”. Meanders are essentially curves. While water flows around a curve, the outer edge of the water is flowing faster than the inner edge. The increased velocity of the water causes bank erosion on the outer section of the curve (cutbank) and removes material. The decreased velocity of the water on the inner part of the curve encourages sediment to drop out of the slower moving water resulting in the deposition of material, usually of the smaller sort (i.e. sand and gravel) along this bank (point bar). Curves slow down the water and absorb energy, which helps reduce the potential for erosion.

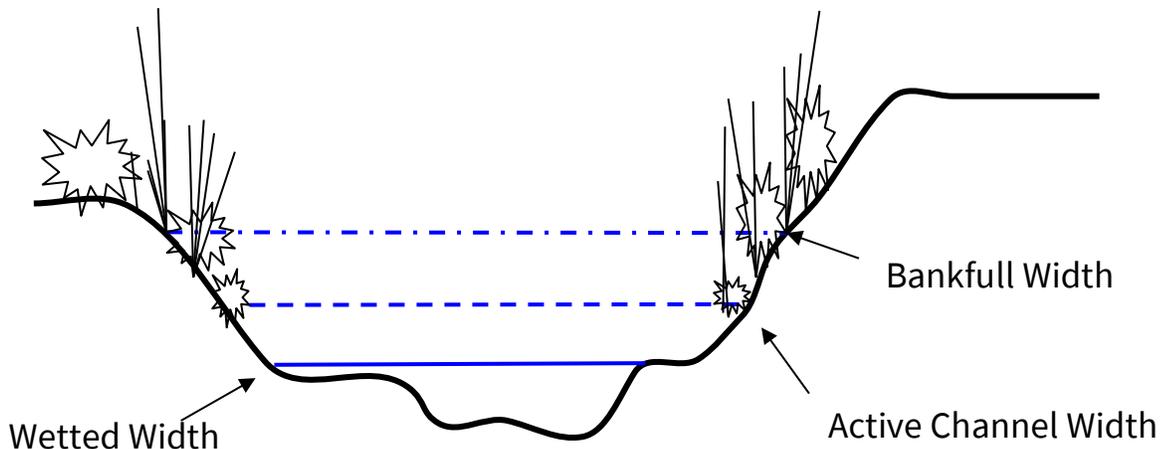
Active channel width is larger than wetted width and smaller than bankfull width. Source: Ulster County Department of Environment.

Active channel width is a measurement that can be examined when comparing the stream dimensions to the structure dimensions. Active channel width is defined as the width of the stream channel that is most frequently affected by higher flows. It is greater than the wetted width of the channel but smaller than the bankfull width. Indicators of active channel width may be a break in slope of the stream banks, sudden sediment size change in the stream banks, a wrack line, or change in vegetation from herbaceous to woody. There are several other indicators of active channel width.

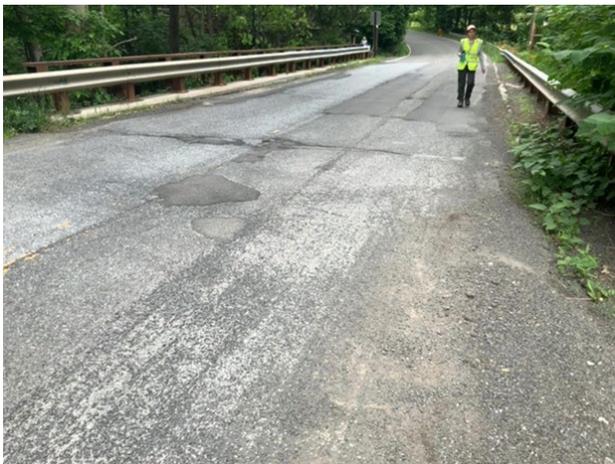
An example of road. Source: Ulster County Department of Environment.

- Asphalt pavement: Rutting, potholes, and general disintegration.
- Concrete pavement: Craving, delamination, and spalling.
- Gravel surfaces: Rutting, potholes, and loss of the center crown of the road.
- Wood bridge decks: Rot, splintering, warping, and material loss will occur in the deterioration process.

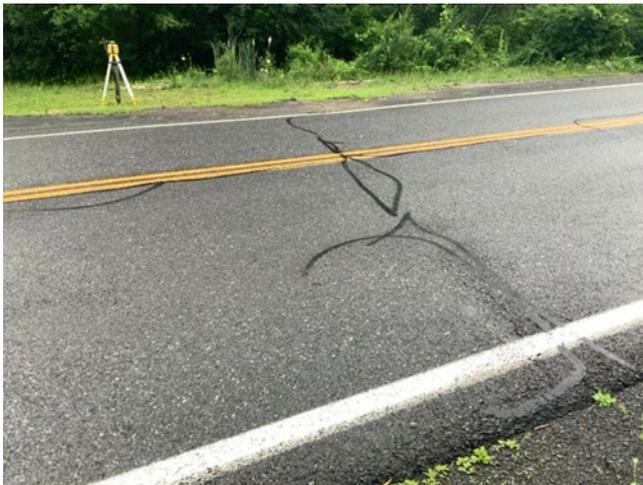
A straightedge laid across the structure longitudinally over the pavement approach is useful for observing settlement (NYSDOT, 2006).

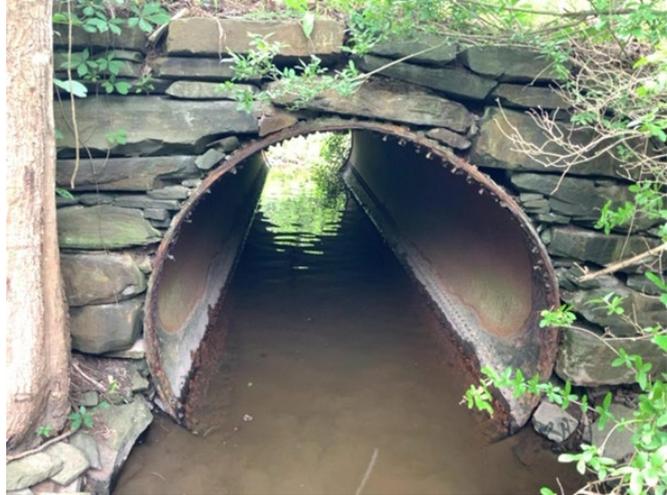
For plastic, metal, or concrete pipes (round, elliptical, arch), observable deterioration is on the inside of the pipe. According to NYSDOT (2006), they include:

- Irregularities or deformities in the shape
- Section loss, corrosion, and abrasion

- Failing span barrels would have significant to extreme distortion, severe isolated corrosion or pitting, widespread moderate section loss, significant cracking along seams, and soil infiltration into structure

An example of a span barrel on Atwood Road.
Source: Ulster County Department of Environment.

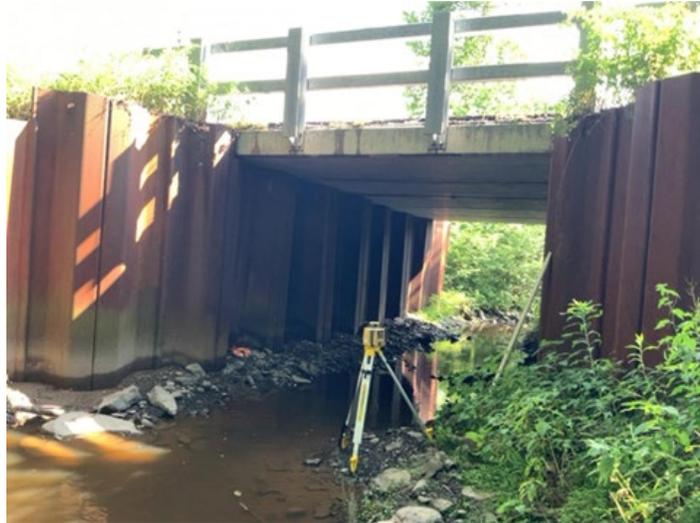
An example of abutments. Source: Ulster County Department of Environment.

Bridges and box culverts will have abutments. According to NYSDOT (2006), general signs of deterioration are:

- Vertical and/or horizontal misalignment
- Differential movement or settlement at joints between sections
- Joint separation
- Leakage
- Cracks, spalls, and delamination
- In severe cases, abutments would have deterioration, differential movement or settlement so severe failure has occurred or is imminent.

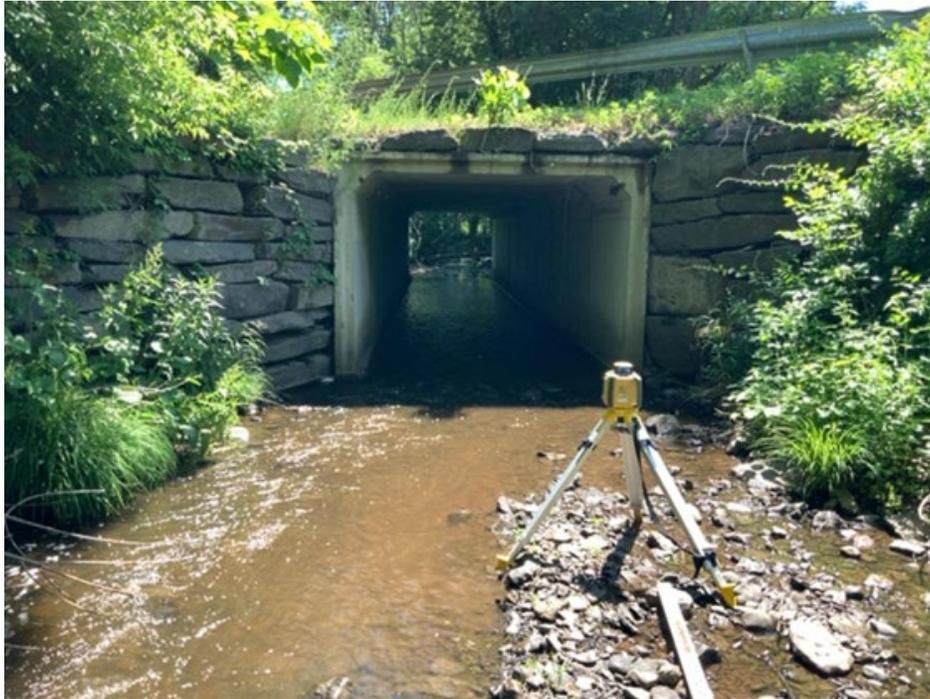
An example of headwalls and wingwalls on Hurley Mountain Road.
Source: Ulster County Department of Environment.

If applicable, it's important that the headwall and wingwalls have the ability to retain the embankment material and support the guardrail. According to NYSDOT (2006), deterioration of structure includes:

- Movement of the headwall/wingwall from its original location, along with associated effects on the embankment and/or guide rail can happen.
- Cracks, spalls, and delamination
- A failing headwall or wingwall would be severely deteriorated and movement is so severe that either the headwall or wingwall no longer supports the embankment or guide rail.

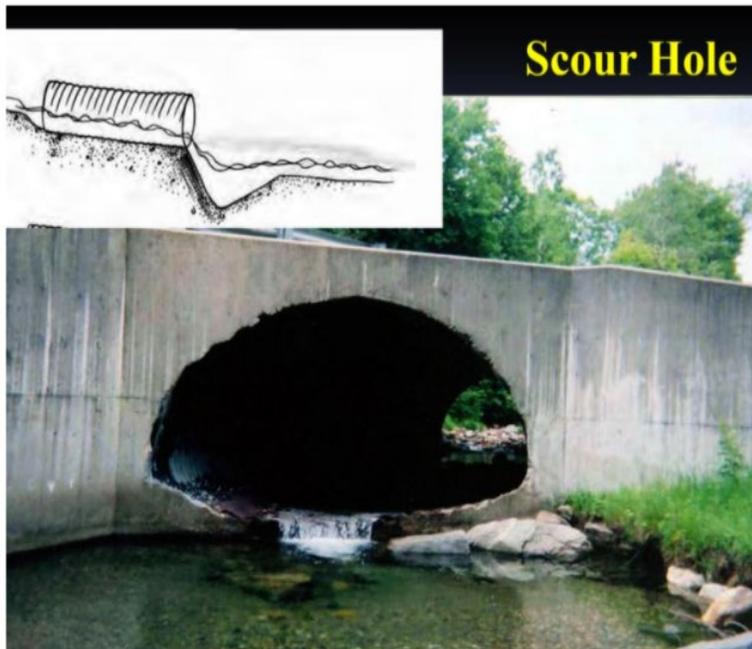
Scour hole downstream of an undersized culvert. Photo source: UMASS River and Stream Continuity Program.

banks. Degradation is most visible in actively eroding banks or headcuts and is common at the downstream end of undersized culverts. A headcut is a small waterfall, often resulting from the deepening of a channel caused by dredging, excavation, or increased stream erosive power downstream of a natural or human caused constriction.

Sometimes degradation is confined to one spot right below an undersized culvert as the culvert serves as grade control. This is called a “scour

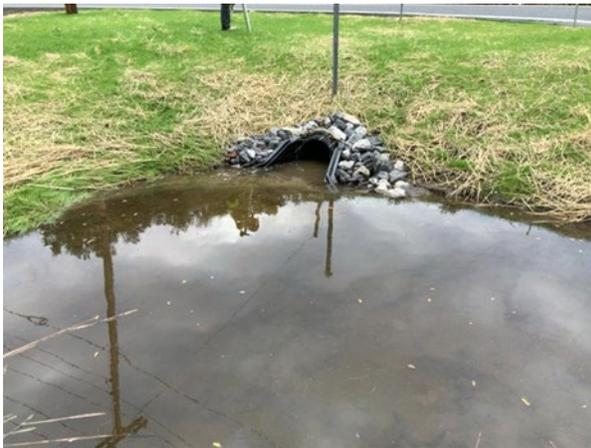
An example of an undersized crossing on Sawkill Road. Source: Ulster County Department of Environment.

A crossing that constricts the natural stream channel is considered undersized. The active channel width of the stream is larger than the width of the culvert and acts a funnel, creating faster flows. The increased velocity causes erosion at both the inlet and outlet. Undersized crossings are often accompanied by outlet drops and/or scour pools.

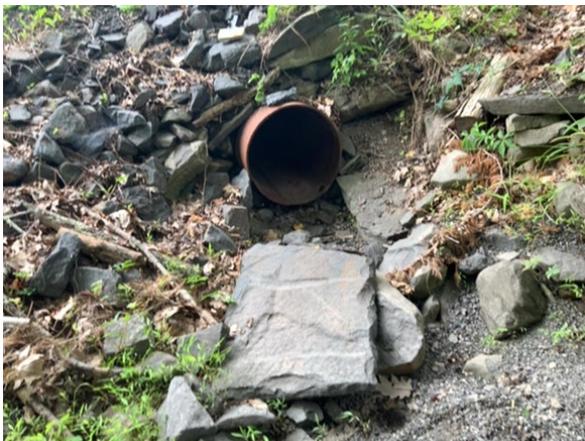
Outlet Drops or perched culverts occur when crossings are incorrectly installed/ designed and have large drops at the outlet. This situation can also be caused by erosion/scouring of the downstream stream bed.

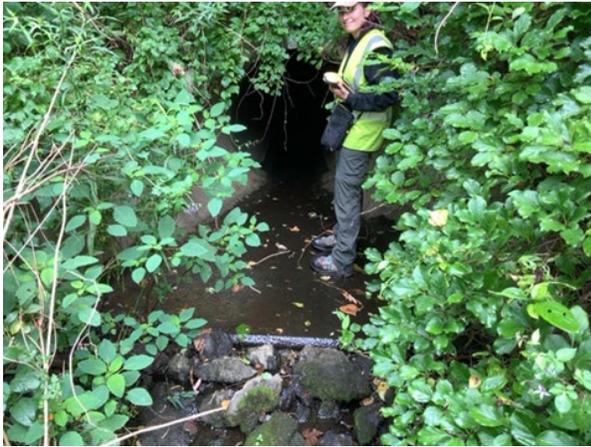
An example of a shallow crossing Source: Ulster County Department of Environment.

Shallow crossings can create multiple risks for both flooding and aquatic life. They are usually either undersized or improperly aligned. This leads to high flows and erosion that causes low levels of flow inside the culverts. Shallow depths can become a barrier to fish passage and even become impassable or dry for extensive periods of time. They also may not have a substrate that matches the stream bed.

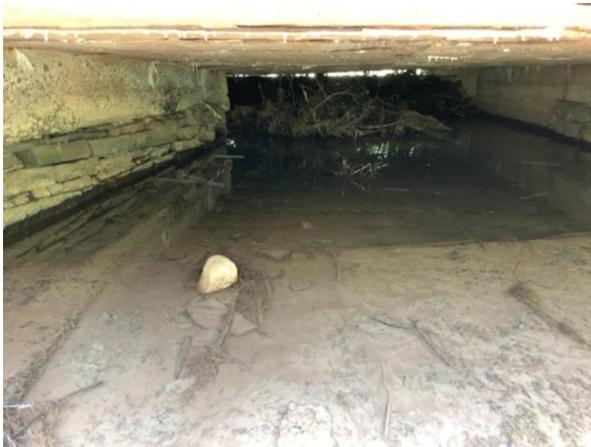
An example of a clogged crossing. Source: Ulster County Department of Environment.

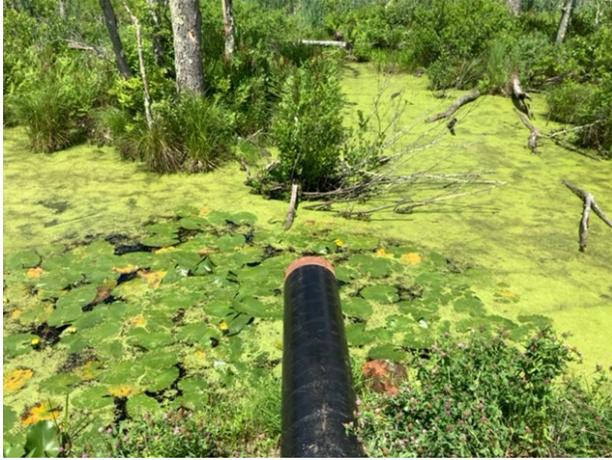
An example of ponding. Source: Ulster County Department of Environment.

Ponding is the backup of water upstream of a crossing. Typically, this happens because a crossing is undersized and can continue throughout the year due to an issue like clogging or may occur seasonally due to an issue like highwaters/flooding. Ponding can create multiple problems. It may drive stream bank and road erosion and creation of wetland ecosystems. Ponding can also be harmful to aquatic life by creating stagnant water, which leads to increased temperatures and lower oxygen levels.

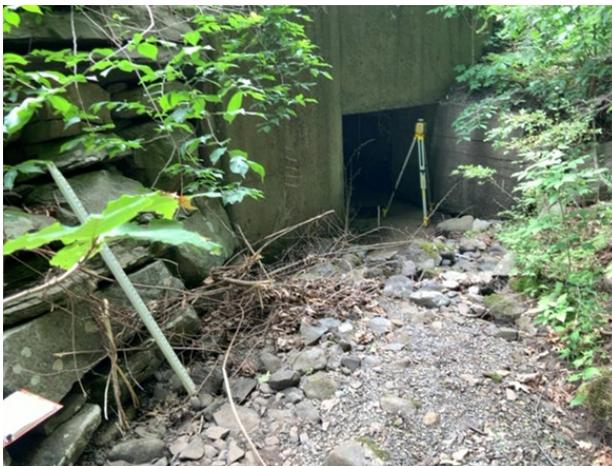
An example of a misaligned crossing on Atwood Road. Source: Ulster County Department of Environment.

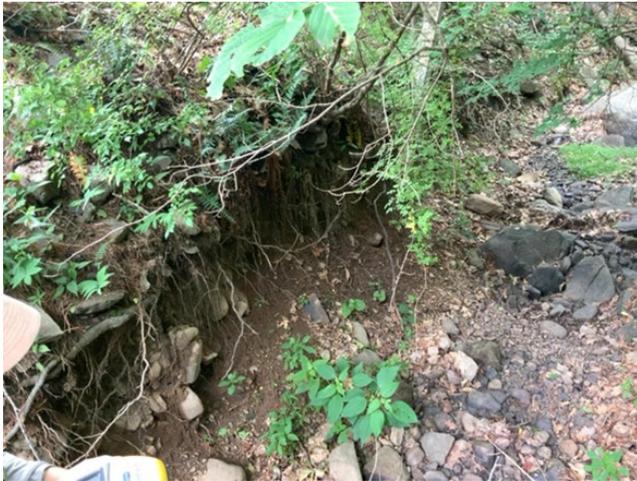
An example of erosion caused by a crossing on Atwood Road. Source: Ulster County Department of Environment.

Scour and erosion are consequences of all crossing insufficiencies besides shallow crossings. It is a direct consequence of high flow and ponding. Erosion of stream banks will occur both upstream and downstream of the crossing. Scour pools will occur at the downstream of perched crossings. This can lead to the undercutting of the crossing and possibly the road. Aquatic organisms are also affected as the natural substrate is eroded. This deteriorates passage and natural habitat.

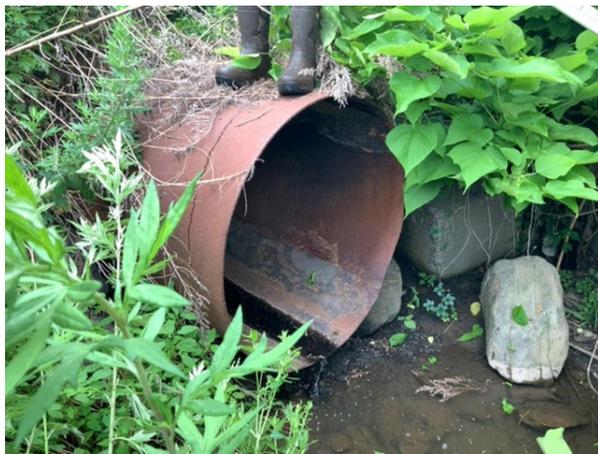
An example of a crossing that lacks natural substrate on Atwood Road. Source: Ulster County Department of Environment.

Incorporation of natural substrate in a crossing that matches the stream is critical for aquatic organisms. By using the rocks as an anchor or a mechanism for movement by taking advantage of slower water around rocks and other substrate, aquatic organisms can safely maneuver through their environment. It is recommended that this idea is implemented within a crossing to maintain natural conditions. Once natural conditions are maintained, stream continuity remains uninterrupted and scour is avoided. It is recommended that metal, or smooth and unnatural materials, be avoided when constructing a culvert as these materials tend to increase water velocity.

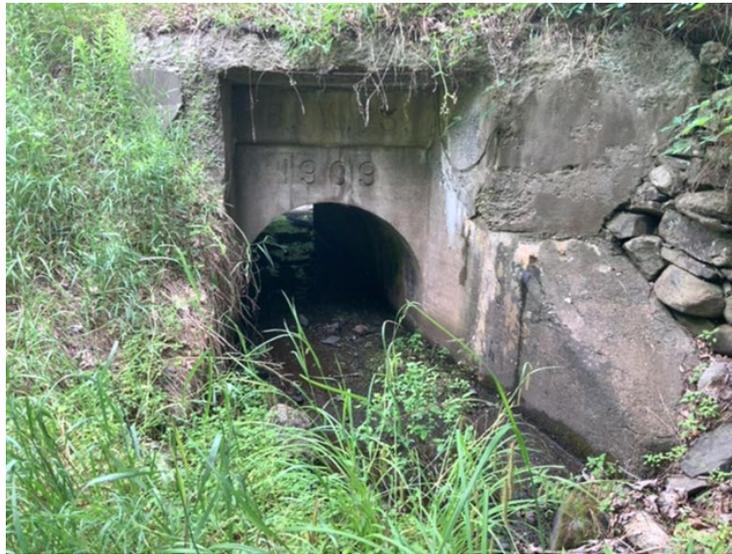
An example of a crossing that is aging on Atwood Road.
Source: Ulster County Department of Environment.

It is recommended to replace crossings that are antiquated in terms of current crossing standards. Older crossings may have extensive scour and erosion. They may be failing or close to failing due to movement and/or breakage of individual components. These inefficiencies can pose a flood risk. Keeping maintenance records updated allows for tracking and planning for proper maintenance over time, which can serve to protect a crossing against deterioration and prolong its life.

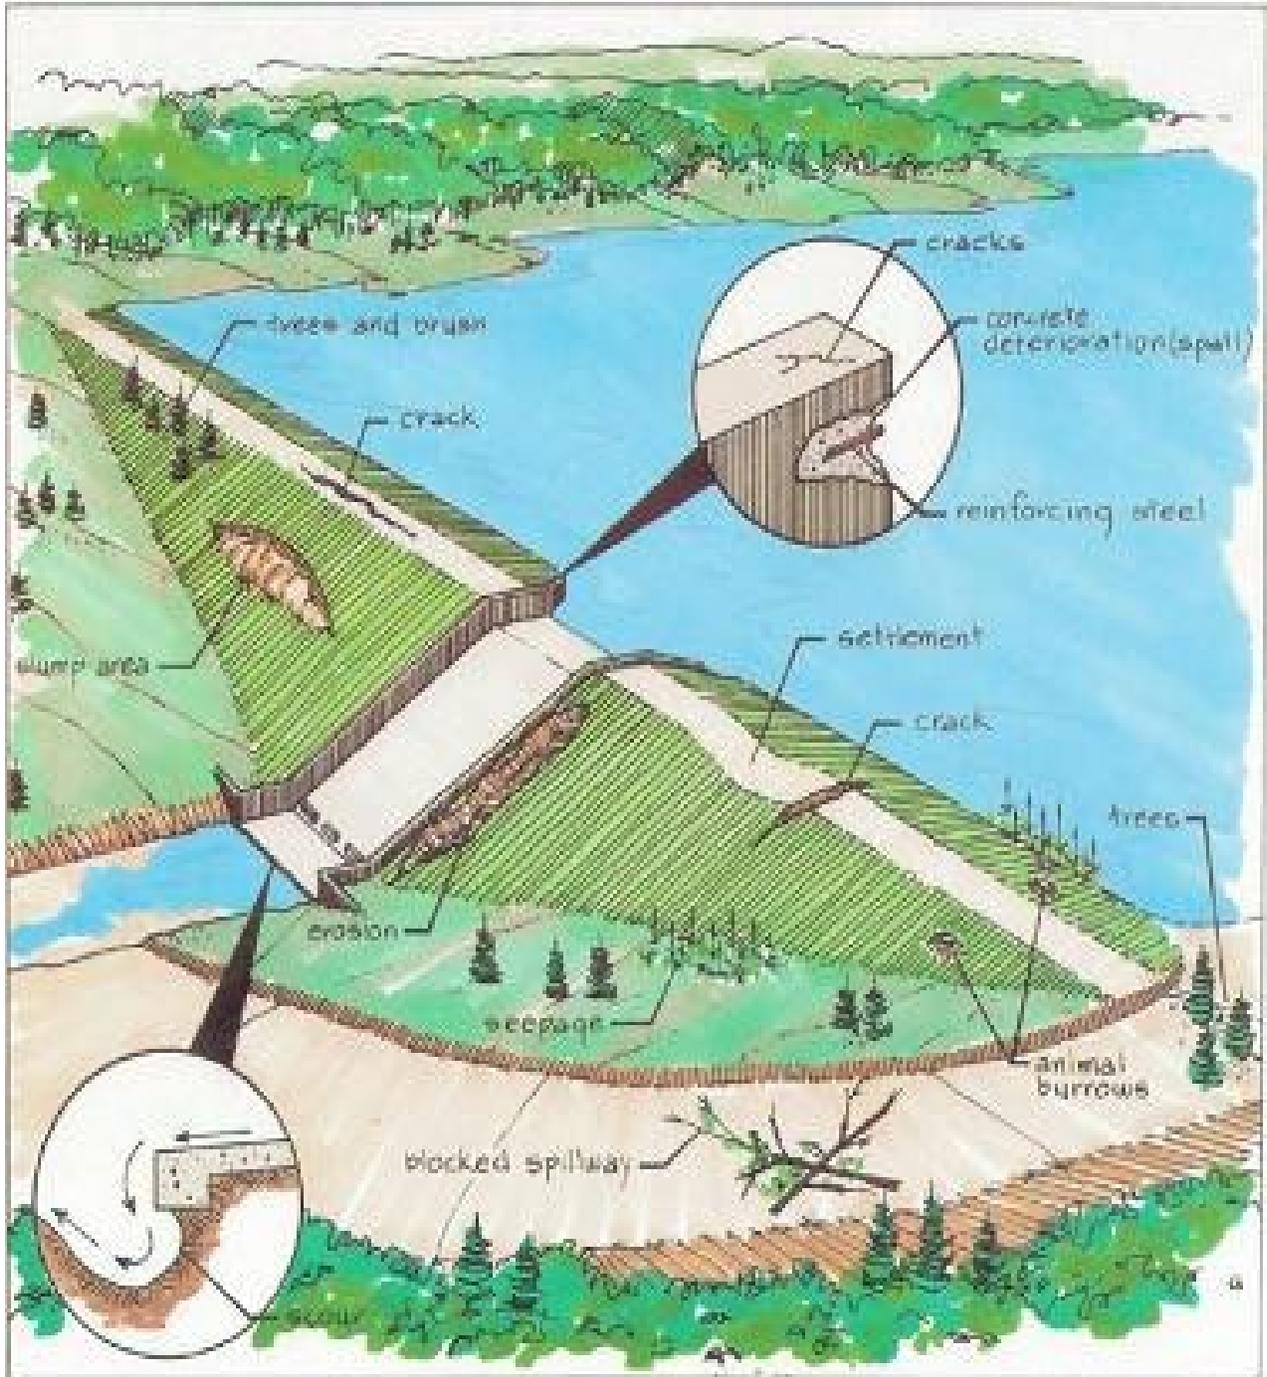
Signs of deterioration in dams. Source: British Columbia Dam Safety Guidelines.

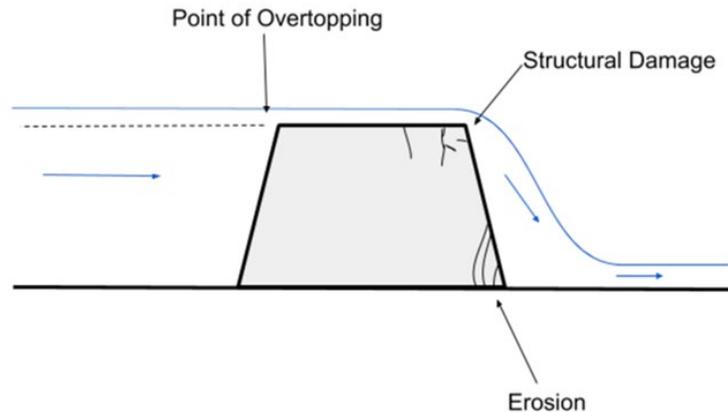
Overtopping can cause structural damage and erosion. Source: Ulster County Department of Environment.

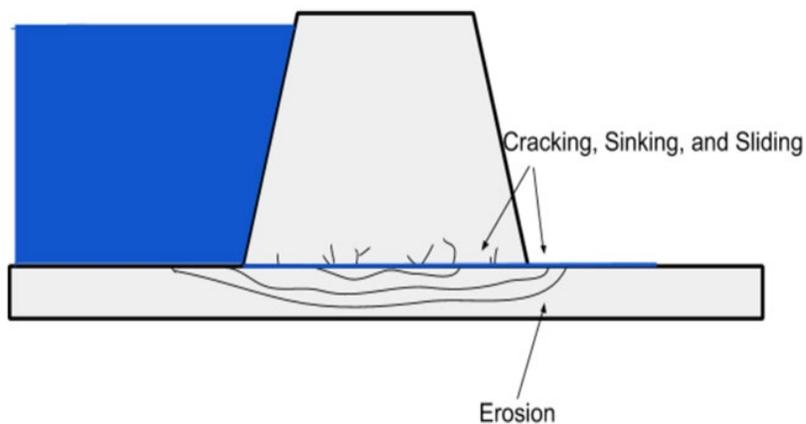
Foundation defects can cause erosion, cracking, sinking, and sliding. Source: Ulster County Department of Environment.

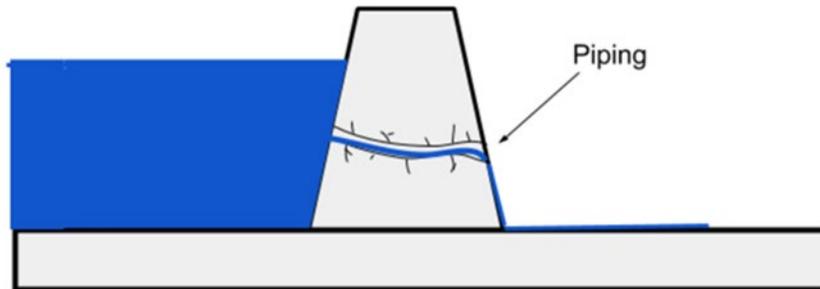
Piping can allow water to seep through the dam and may possibly cause failure. Source: Ulster County Department of Environment.

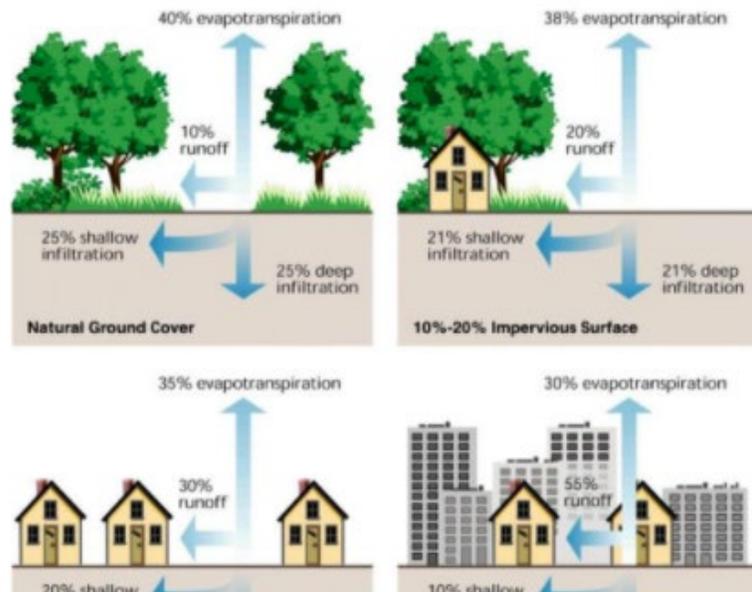
Changes in proportion of rainfall that becomes runoff in different IC scenarios. Source: HVA and LHCCD. See appendix F for more details.

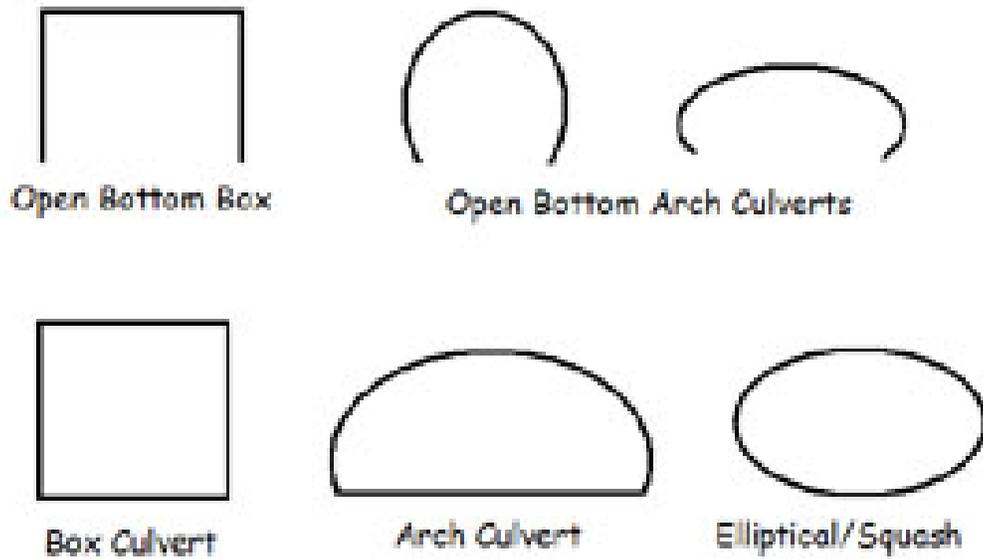
Different types of crossings. Source: NYSDEC

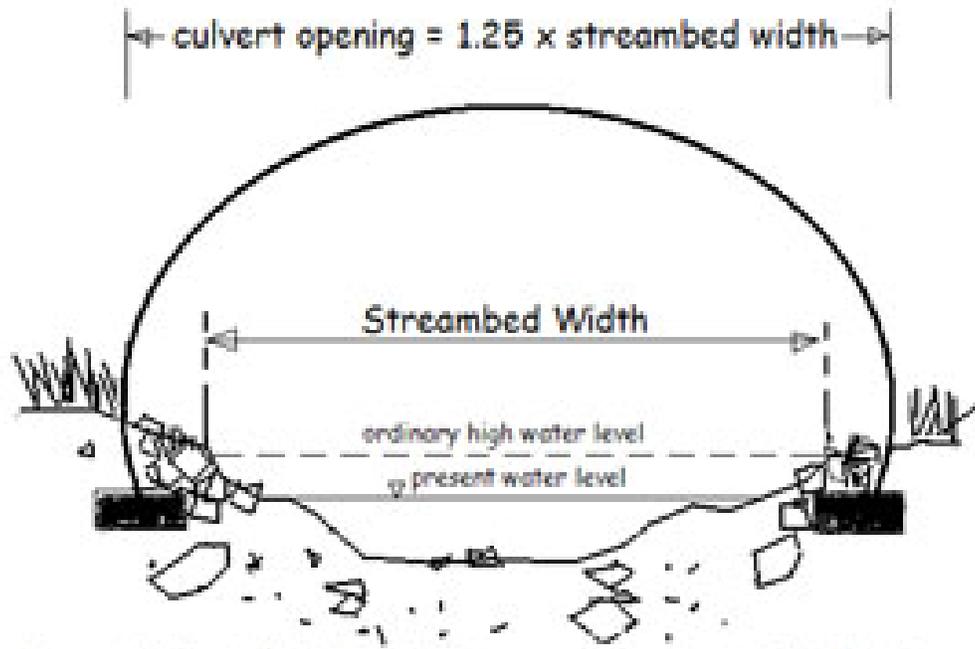
Correctly installed open-bottom arch culvert with footings

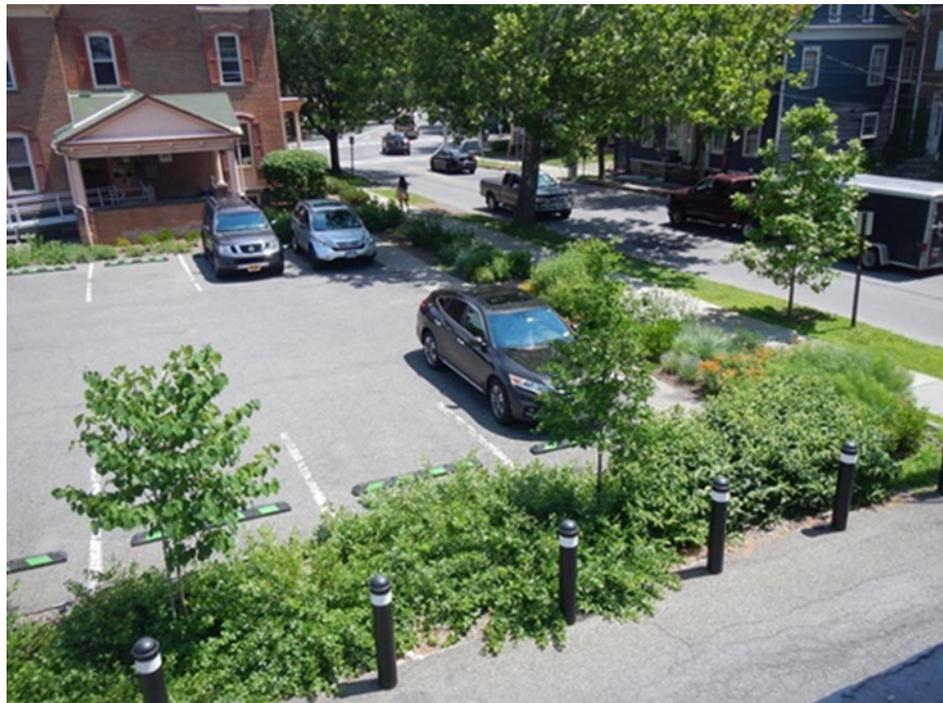
An example of a bioretention area at the Ulster County Department of Environment. Source: Ulster County Department of Environment

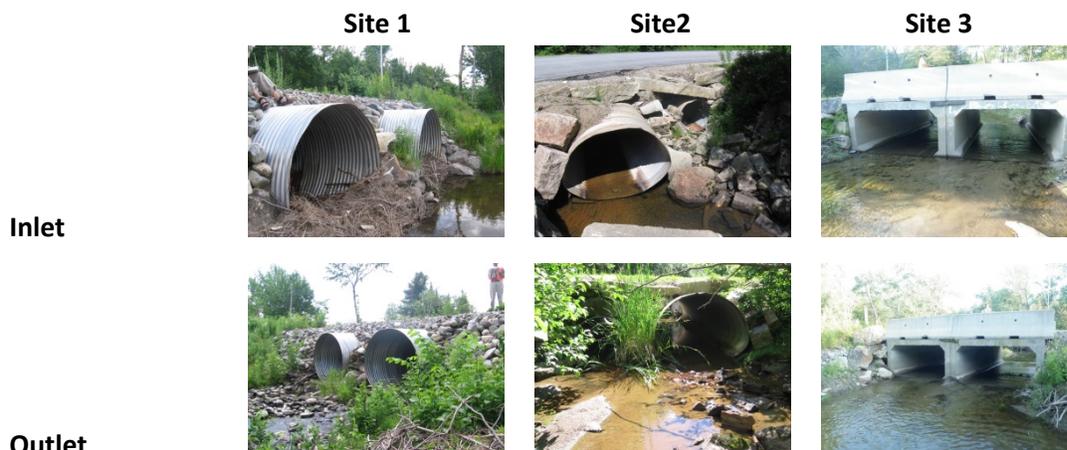
Upstream

The following are some examples of useful photos:

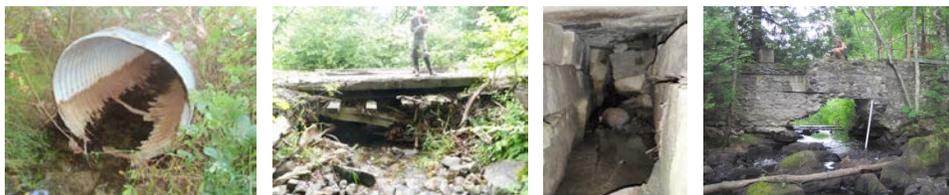
Poor: This value is intended for structures where the material appears to be failing, such as metal culverts with rot (not just surface rust), or concrete, stone or wooden structures that are already collapsing, or in danger of immediate failure (see images below as examples).

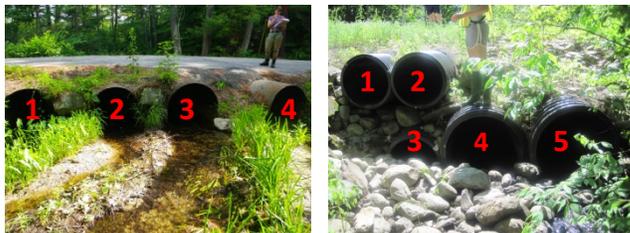
When there are multiple culverts and/or bridge cells, number them from left to right, while looking downstream toward the culvert inlet. The left-most structure is Structure 1, and structure numbers increase to the right. See examples below.

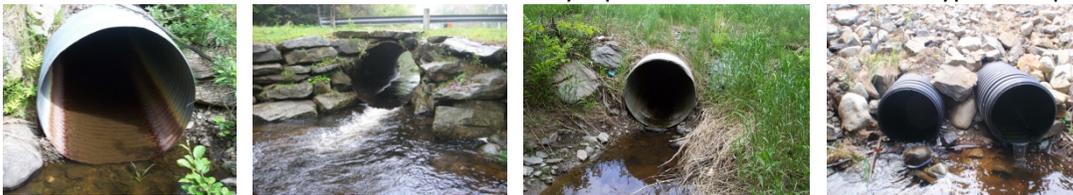
1 - Round Culvert: This is a circular pipe. It may or may not have substrate inside, even though the diagram on the field form shows a layer of substrate. It may be compressed slightly in one dimension, and should be considered round unless it is truly squashed so that it reflects a type 2 shape below.

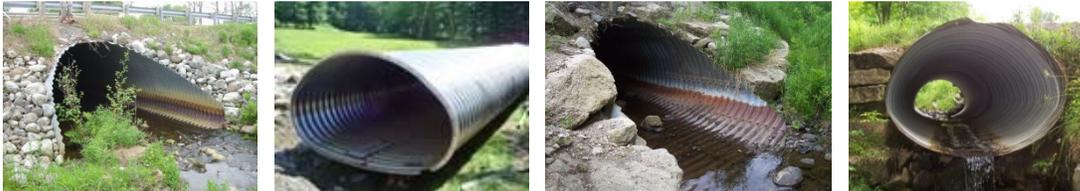
2 - Pipe Arch/Elliptical Culvert: This is essentially a squashed round culvert, where the lower portion is flatter, and the upper portion is a semicircular arch, or as on the right below, more of a pure ellipse. It may or may not have substrate inside (the diagram on the field form shows a layer of substrate).

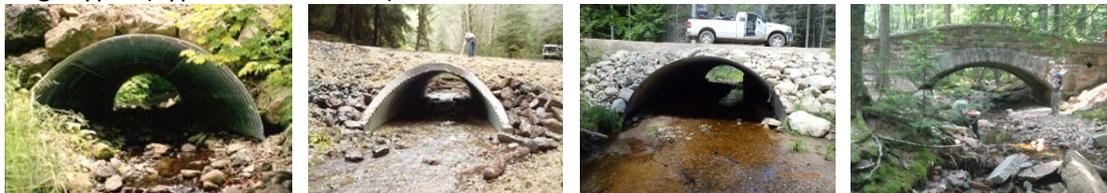
3 - Open Bottom Arch Bridge/Culvert: This structure will often look like a round culvert on the top half, but it will not have a bottom. There will be some sort of footings to stabilize it, either buried metal or concrete footings, or concrete footings that rise some height above the channel bottom. There will be natural substrate throughout the structure. To distinguish between an embedded Pipe Arch Culvert and an Open Bottom Arch, note that the sides of the Pipe Arch curve inward in their lower section, while the sides of the Open Bottom Arch will run straight downward into the streambed substrate or to a vertical footing. Beware of confusion between an Open Bottom Arch and an embedded Round Culvert; Open Bottom Arches tend to be larger than most Round Culverts. This shape could also be selected for certain bridges that have a similar arched shape and are not well represented by other bridge types (Types 5, 6, 7, below).

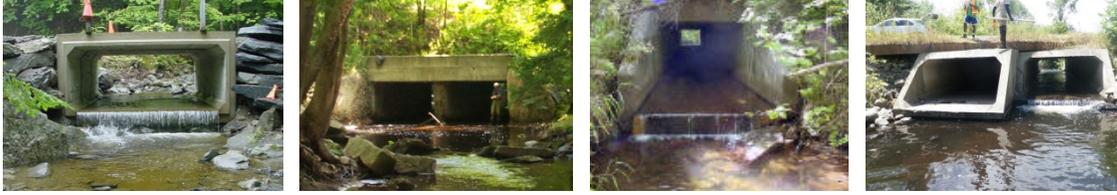
4 - Box Culvert: These structures are usually made of concrete or stone, but sometimes of corrugated metal with a slightly arched top. Typically, they have a top, two sides, and a bottom.

A box culvert without a bottom, called a bottomless box culvert, should be classified as a *Box/Bridge with Abutments* (#6, below). If you cannot tell if the structure has a bottom, classify it as a *Box/Bridge*

with Abutments (#6). The images below show *Box Culverts* (#4).

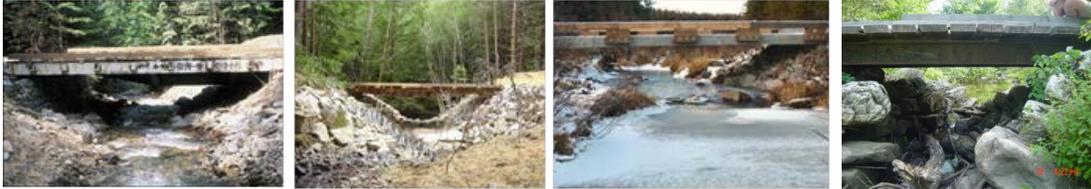
5 - *Bridge with Side Slopes*: This is a bridge with angled banks up to the bottom of the road deck. This type will have no obvious abutments, though they may be buried in the road fill.

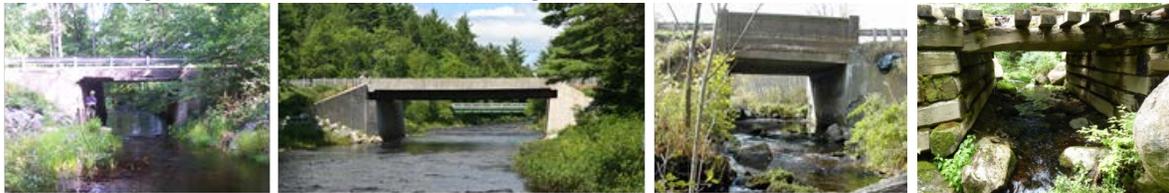
6 - *Box/Bridge with Abutments*: This is a bridge or bottomless box culvert with vertical sides.

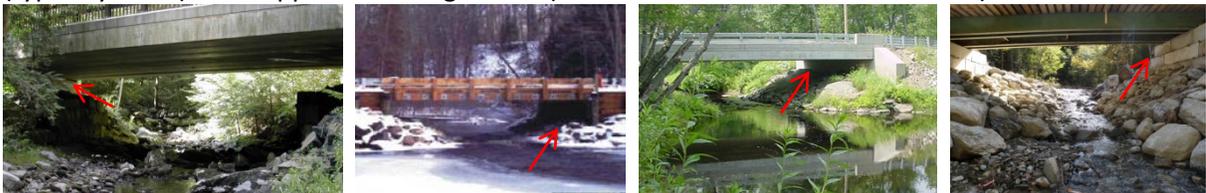
7 - *Bridge with Side Slopes and Abutments*: This is a bridge with sloping banks and vertical abutments (typically short) that support the bridge deck. (Arrows below show the abutments.)

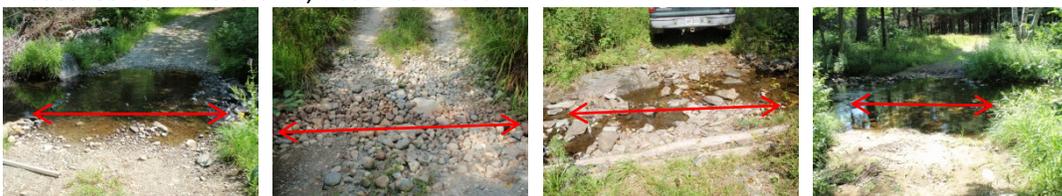
Ford: A ford is a shallow, open stream crossing that may have a minimal structure to stabilize where vehicles drive across the stream bottom. The arrows below indicate the length of a ford, to be measured as Dimension L , described below.

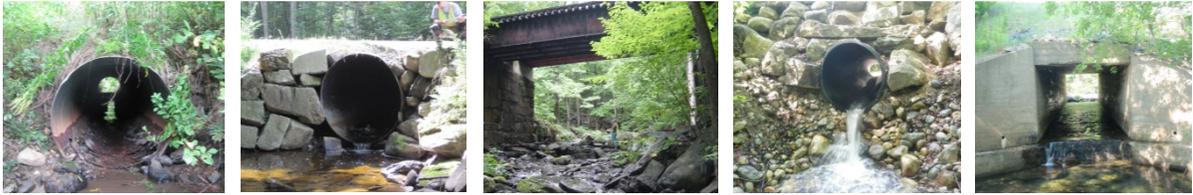
None: This situation represents the majority of crossing structures. You may observe rocks that have fallen from the embankment or that are natural to the stream. Most cascades do not constitute armoring unless specifically put in place to minimize outlet scour.

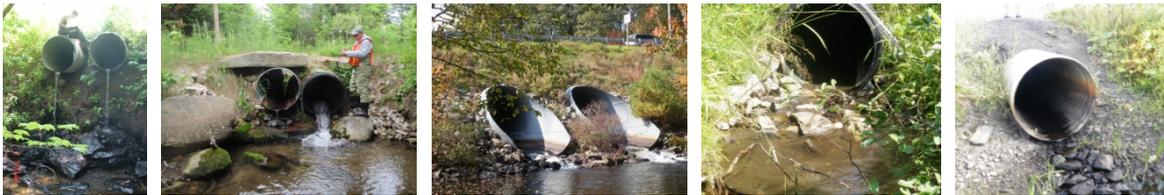
Not Extensive: There is a layer of material covering an area *less than 50% of the stream width* placed purposefully below the outlet specifically to minimize the effects of scour.

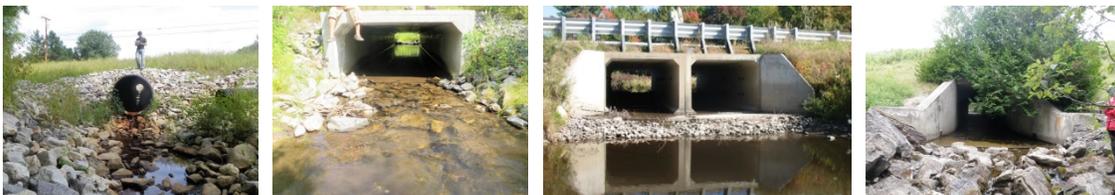
Extensive: Select this option only if you observe an extensive layer of material covering an area more than 50% of the stream width, which was put in place specifically to minimize scour at the outlet.

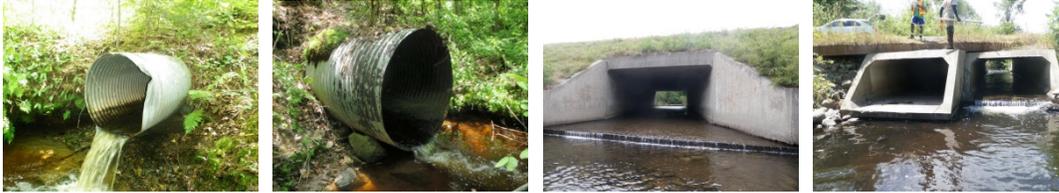
Free Fall: The outlet of the structure is above the stream bottom such that **water drops vertically** when flowing out of the structure.

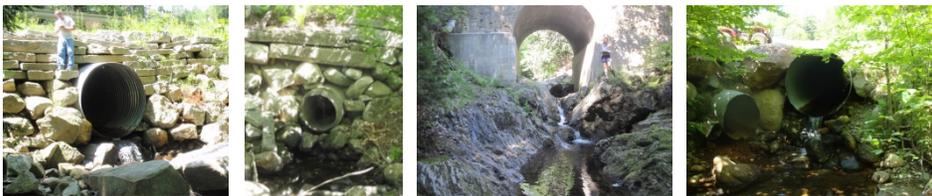
Cascade: The outlet of the structure is raised above the stream bottom at the outlet such that **water flows very steeply downward across rock or other hard material** when flowing from the structure. Think of this as series of small waterfalls at the outlet.

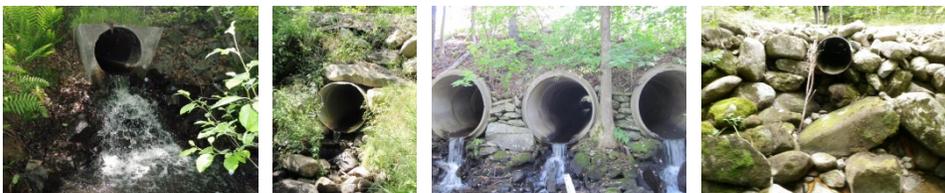
Free Fall Onto Cascade: The outlet of the structure is raised above the stream bottom at the outlet such that **water drops vertically onto a steep area of rock or other hard material, then flows very steeply downward** until it reaches the stream.

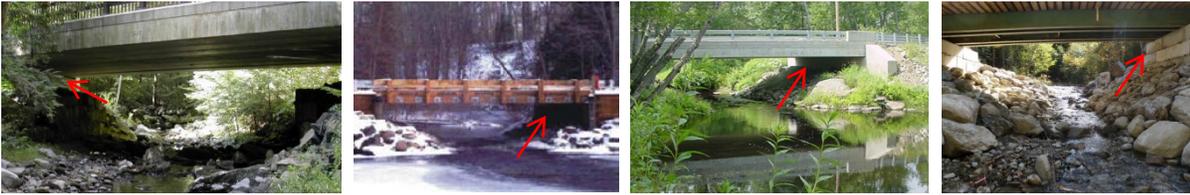
Abutment Height, Dimension E: This measurement is taken only when surveying a *Bridge with Side Slopes and Abutments* (#7 structure). To the nearest foot, measure the height of the vertical abutments from the top of the side slopes up to the bottom of the bridge deck structure.

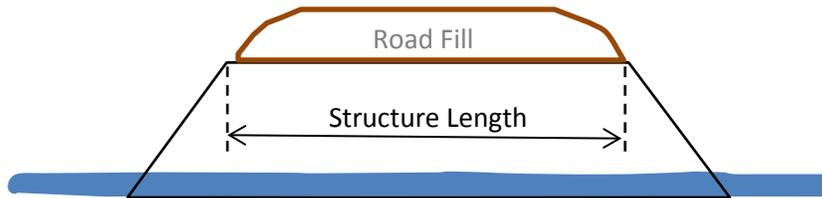
Structure Length, Dimension L: To the nearest foot, measure the length of the structure at its top.

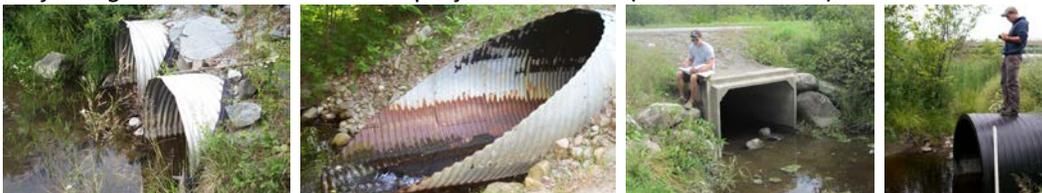
Projecting: The inlet of the culvert projects out from (is not flush with) the road embankment.

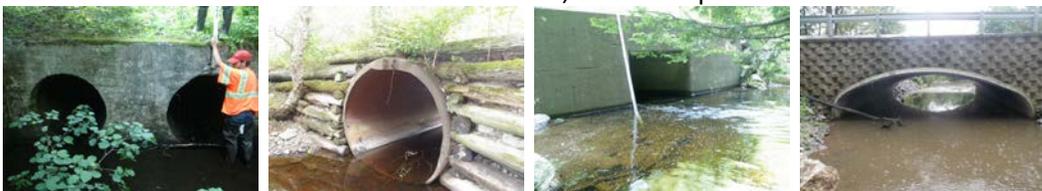
Headwall: The inlet is set flush in a vertical wall, often composed of concrete or stone.

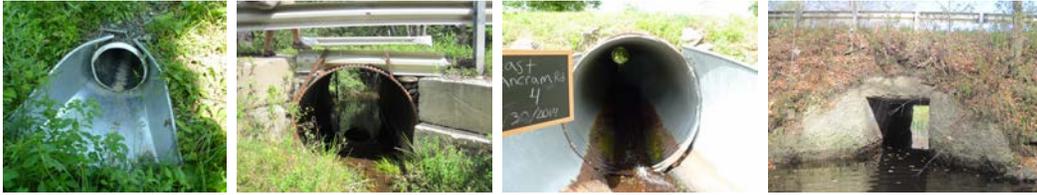
Wingwalls: The inlet is set within angled walls meant to funnel water flow. These walls can be composed of the same material as the culvert, or different material. It is relatively rare to see wingwalls without a headwall.

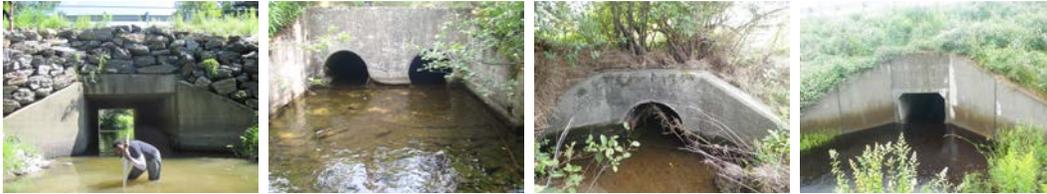
Headwall & Wingwalls: The inlet is set flush in a vertical wall, and has angled walls to funnel flow.

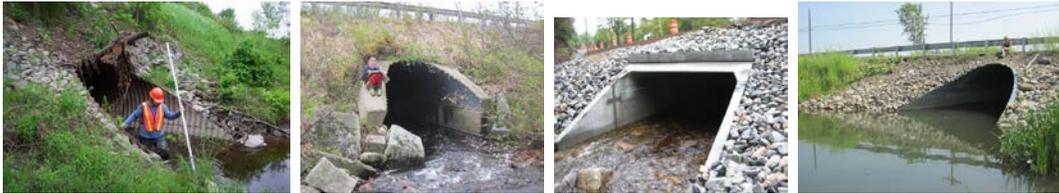
Mitered to Slope: The inlet is angled to fit **flush with the slope of the road embankment**. Note that many mitered culverts project out from the embankment, and should be recorded as *Projecting*.

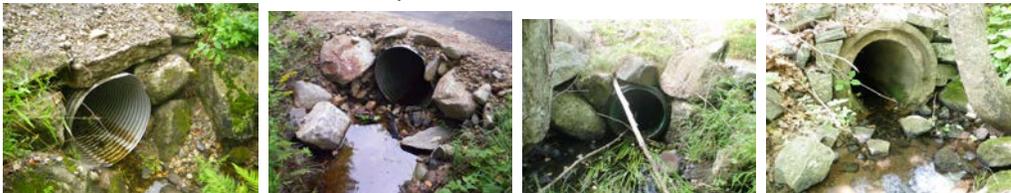
None: The inlet does not have any of the above features or characteristics.

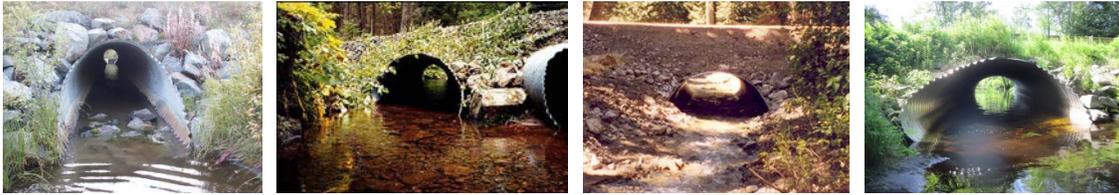
At Stream Grade: The inlet of the structure is at approximately the same elevation as the stream bottom upstream of the structure.

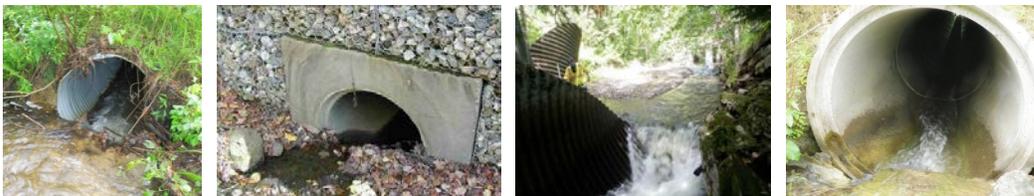
Inlet Drop: Water in the stream has a near-vertical drop from the stream channel down into the inlet of the structure. This usually occurs because sediment has accumulated above the inlet. The drop should be very obvious and not typical of natural drops in that stream. If there is a debris blockage or dam at the inlet, use **Physical Barriers** to record those features, and mark *At Stream Grade* here.

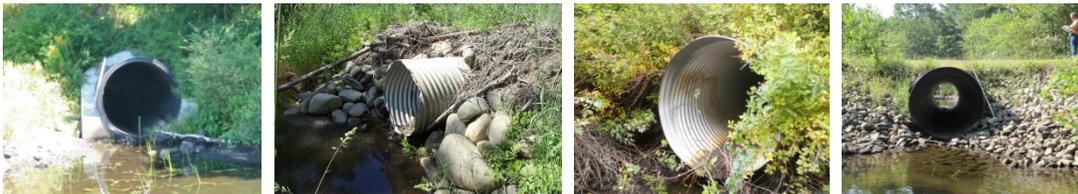
Perched: The inlet of the structure is set too high for the stream, and little water passes through the structure during normal low summer flows, though the stream has water upstream and downstream of the crossing. The structure inlet is above the surface of water in the stream. Water can enter the structure only at higher flows. This is a relatively rare condition, found mostly on very small streams. At such sites, there is generally water backed up above the inlet. In some cases water may be “piping” underneath the structure.

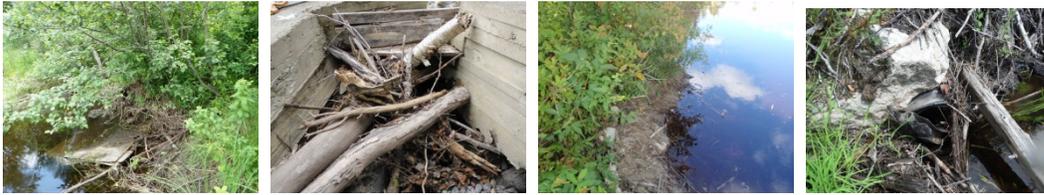
Clogged/Collapsed/Submerged: The structure inlet is either full of debris, collapsed, or completely underwater (not usually all three), making inlet measurements impossible. This may be found in places where beavers or debris have plugged a structure inlet so completely that water has backed up and covered the inlet, or where a crossing has collapsed to the point that it cannot be measured at its inlet.

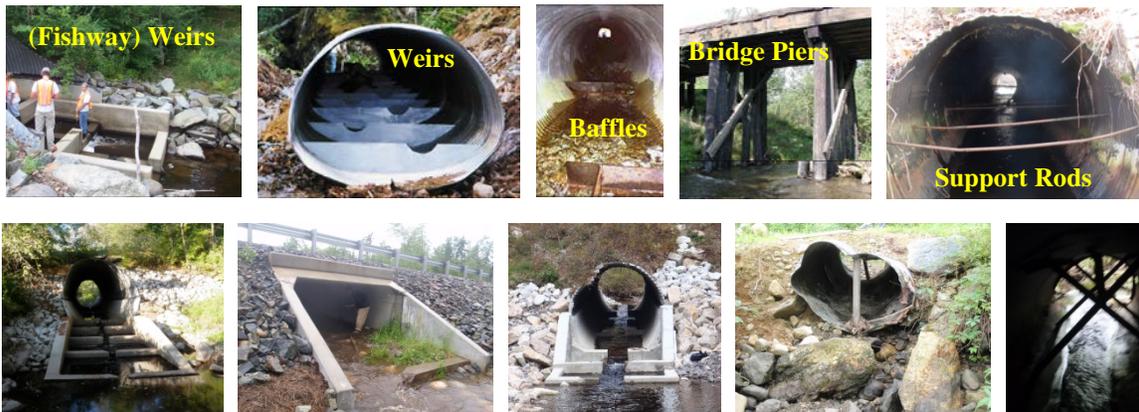
Supports: Some type of structural supports, such as bridge piers, vertical or horizontal beams, or rods apparently meant to support the structure, are observed inside the crossing structure.

Other: Structure(s) other than the categories above are present inside the crossing structure. Provide a very brief description of those structures here, or more fully describe them under **Structure Comments**. **Do not** include here items such as bedrock, material blockages, structural deformation, or inlet fencing to exclude beavers, which will be recorded below as **Physical Barriers**.
