ULSTER COUNTY

Road-Stream Crossing Management Plan

Ulster County Department of Environment

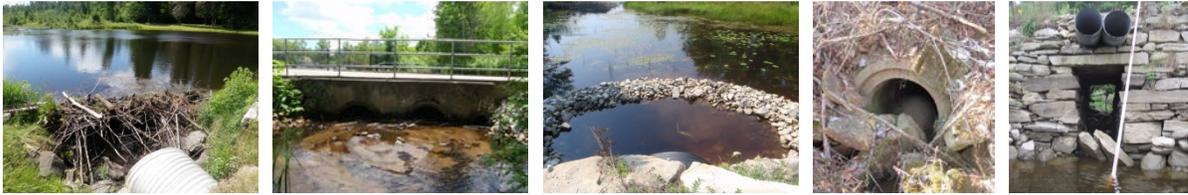
Debris/Sediment/Rock: Woody debris or synthetic material, rock, or sediment blocks the flow of water into or through the structure. This can consist of wood or other vegetation, trash, sand, gravel, or rock. Do not check this option if you observe only very small amounts of debris that are likely to be washed away during the next rain event. Also, do not confuse sediment inside a structure that constitutes an appropriate stream bed with an accumulation that limits flow or passage of organisms.

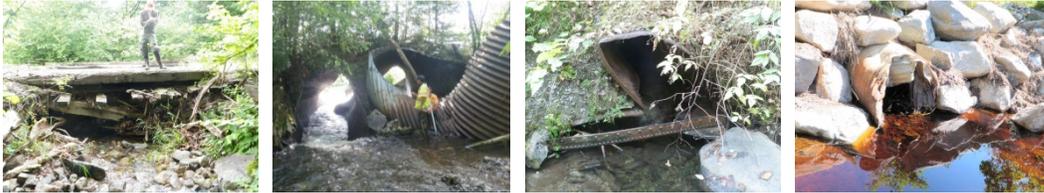
Deformation: The structure is deformed in such a way that it significantly limits flow or inhibits the passage of aquatic organisms. This does not include minor dents and slightly misshapen structures.

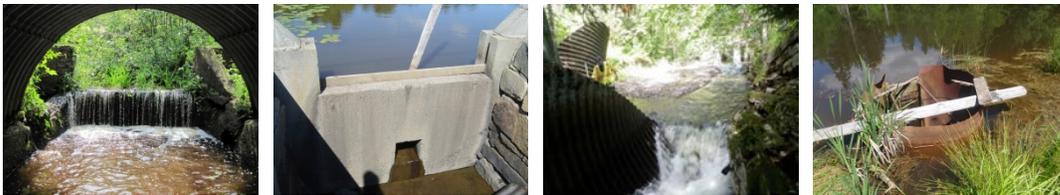
Free Fall: In addition to its **Outlet Grade**, which may include a *Free Fall*, the structure has one or more **additional** vertical drops associated with it. These may include a dam at the inlet, a vertical drop over bedrock inside the structure, or some other feature likely to inhibit passage of aquatic organisms. Note that a *Free Fall* inside a structure is often more limiting than similar size drops found in an undisturbed natural reach of the same stream which occur where there may be multiple paths for organisms to follow. A *Free Fall* can exist because of a debris blockage, so both physical barriers would be recorded.

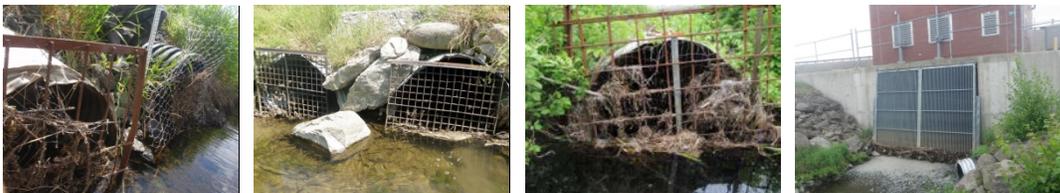
Fencing: The structure has some sort of fencing, often at the inlet to deter beavers. Depending on the mesh size of that fencing, it may directly block the movement of aquatic and terrestrial organisms, and it may become clogged with debris. If also blocked with debris, be sure to check *Debris/Sediment/Rock* as a **Physical Barrier** type as well.

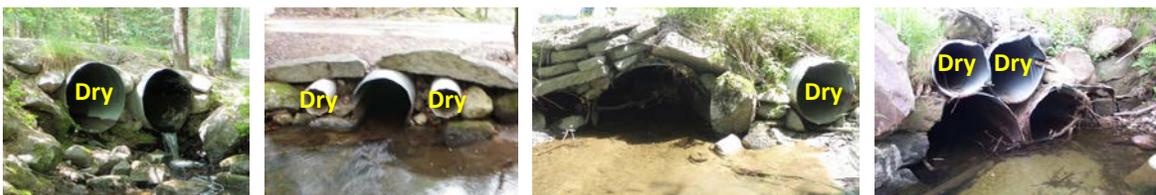
Dry: There is no water in this structure, though water is flowing in the stream. Note that if you recorded *No Flow* for crossing Flow Condition, you should not select *Dry* here, as we expect a dry structure at a dry crossing; it is not in itself a physical barrier. This barrier type helps to identify passage problems associated with overflow or secondary crossing structures.

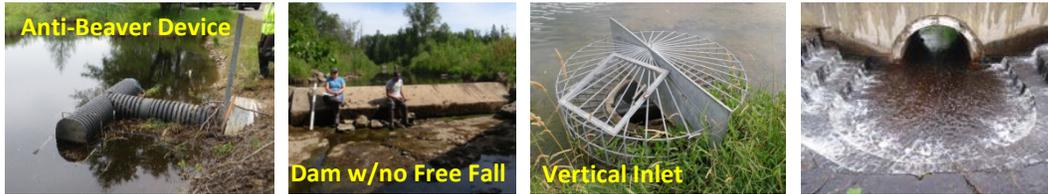
Other: There may be different situations that do not fit clearly into one of the above categories, but may still represent significant physical barriers to aquatic organism passage. Use this option to capture such situations, and add information in Structure Comments. Below are examples of some unusual physical barriers which may not fit under Physical Barrier categories listed above.

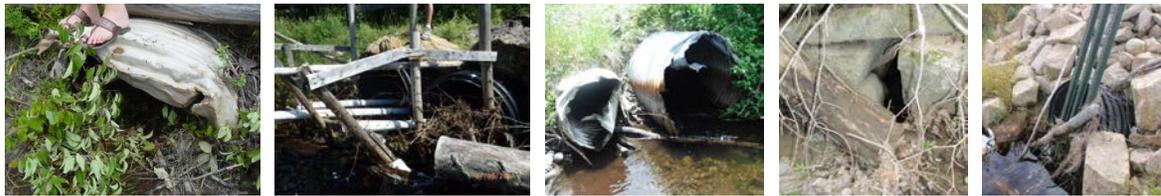
These are examples of structures with a combination of physical barriers. Multiple relevant barrier types should be selected.

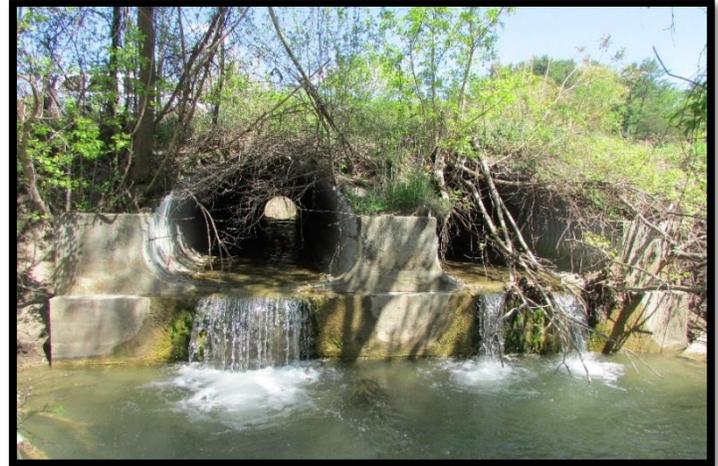
Culverts such as this these can constrict the natural flow of the stream, have a perched outlet that only strong swimmers can jump and contain no natural streambed. Many culverts and dams fragment
