Map of Otsego County Parks, Forests, and Recreation Areas

Town of New Lisbon Comprehensive Plan Recommendations Relating
to Natural Resources and Cultural, Historic and Recreational
Resources

Town of New Lisbon - Base Map

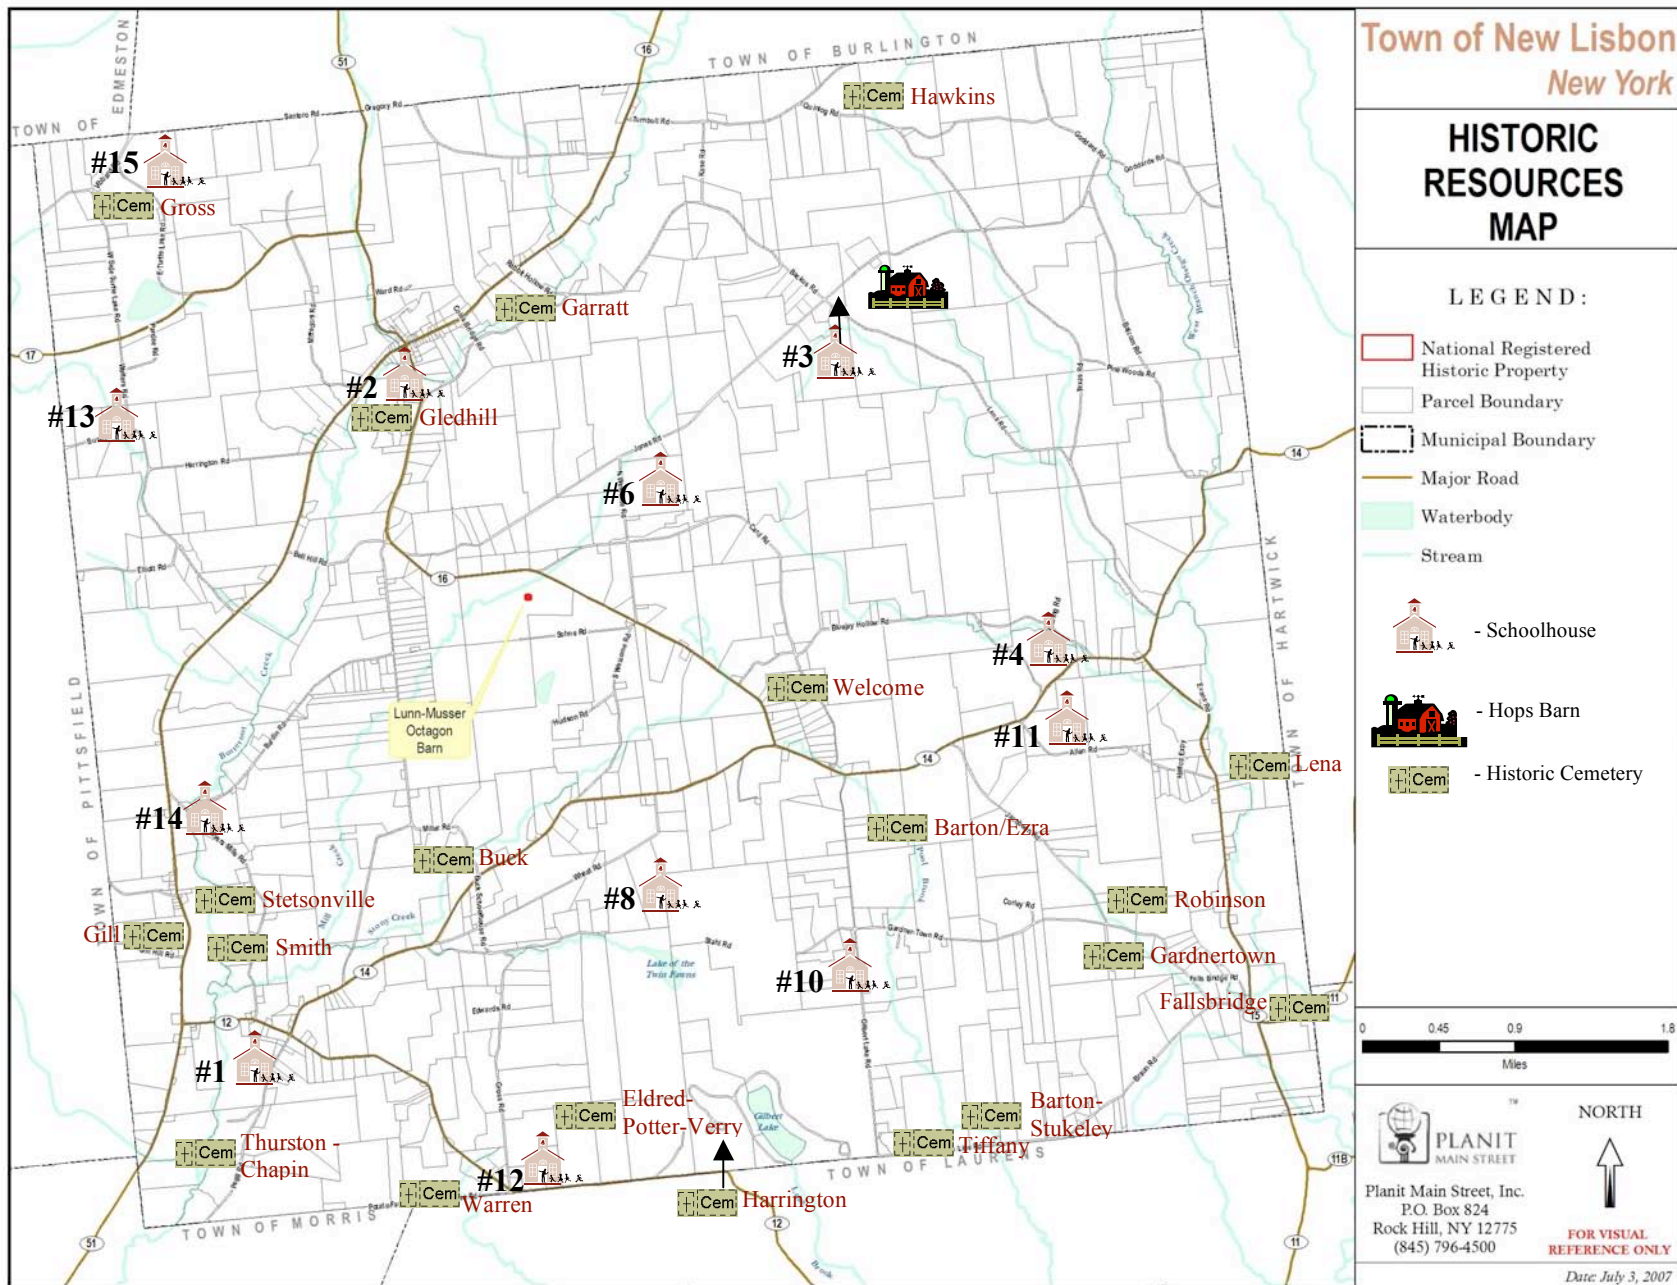
Appendix 7-3

Historic Resources Map
