Ausable River Watershed Management Plan

June 2016

This report was prepared by the Ausable River Association with funding provided by the New York State Department of State under Title 11 of the Environmental Protection Fund.

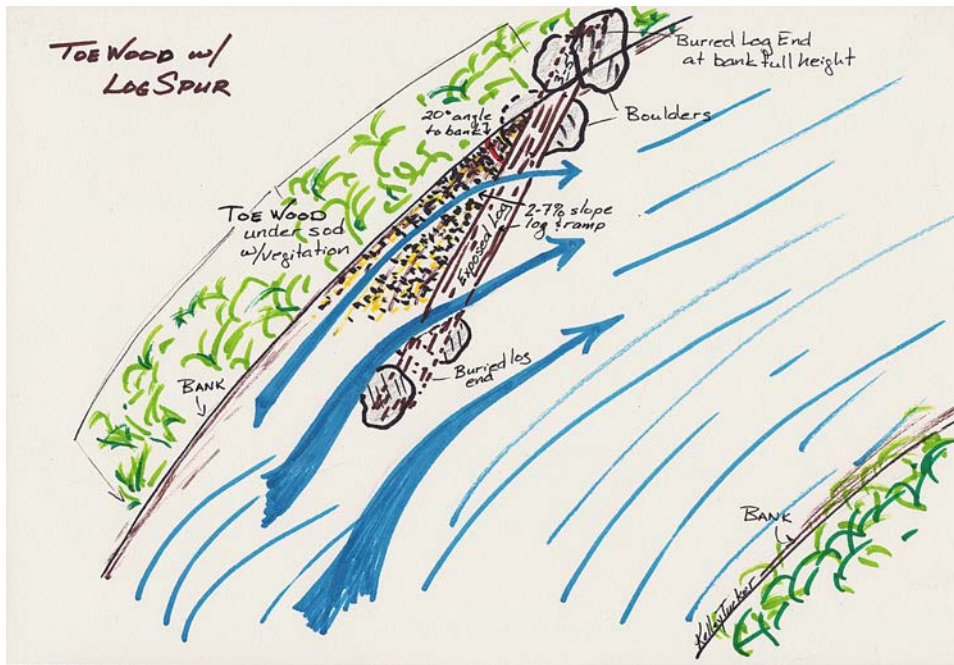
Figure 3. Log vane as part of toe wood, plan view. Boulders secure the log at the bankfull elevation. The log is angled 20-30 degrees from the upstream bank, gravel infill along the upstream face. (K.Tucker for AsRA)

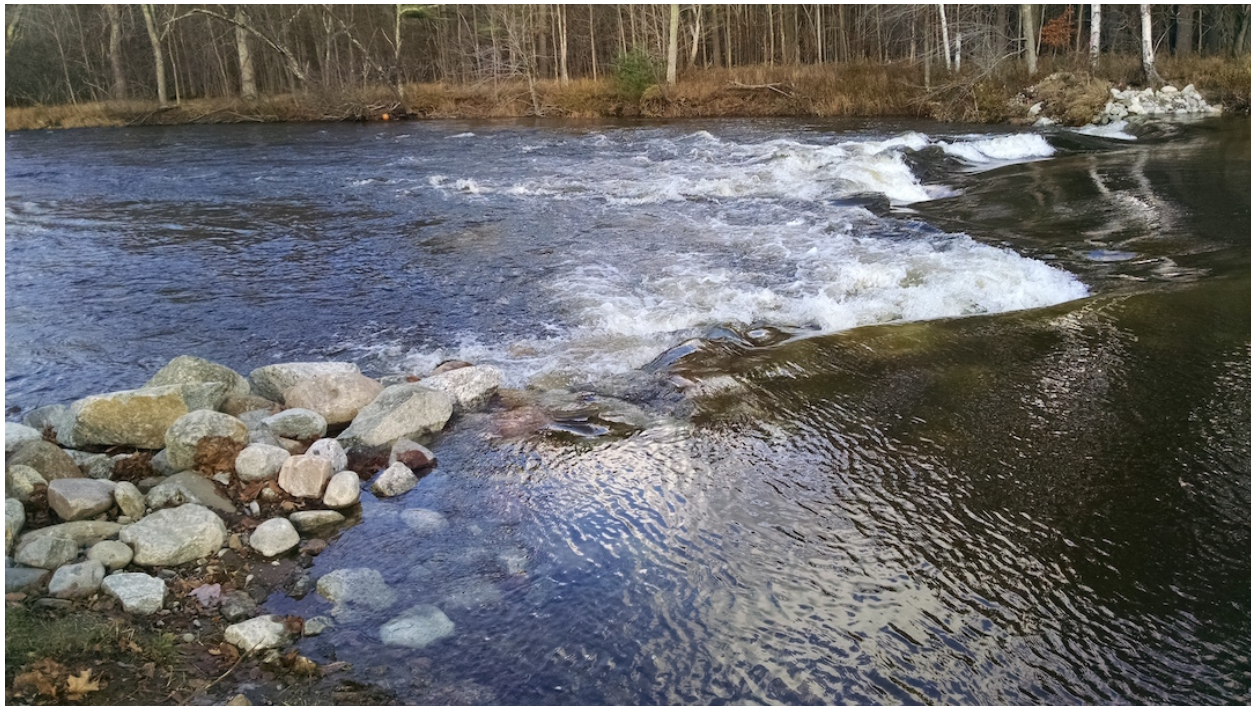
Figure 6. A W-weir installed in the Town of Keene on the East Branch of the Ausable River in 2015 replaced an old wooden recreational dam. Upstream (right) the weir protects a swimming hole. Downstream roughness creates fish habitat for native trout. Photo taken immediately after bankfull event.
