Town of Dover

Road-Stream Crossing Management Plan

Produced by
The Housatonic Valley Association
2019

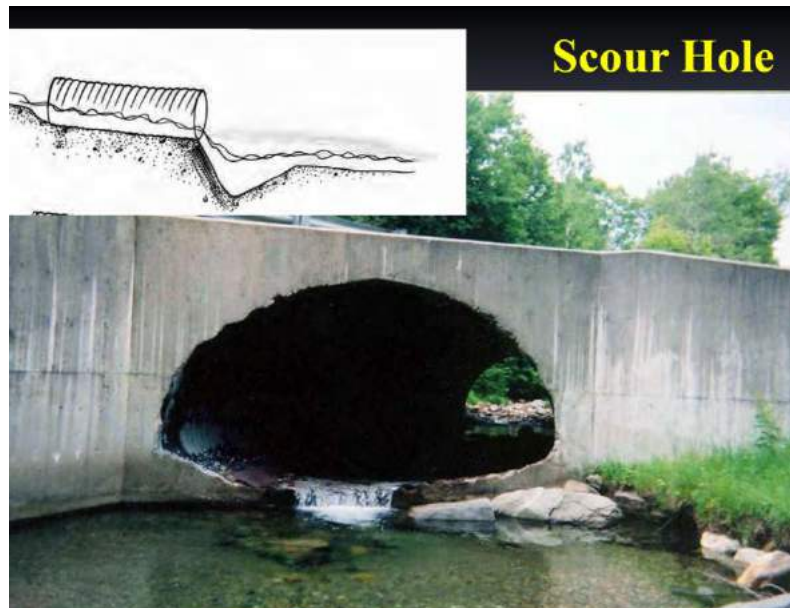
Scour hole downstream of an undersized culvert. Photo/diagram credit: UMASS River and Stream Continuity Program

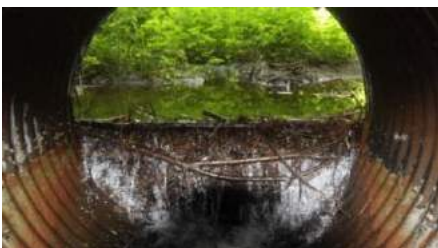
Clogged Crossings

Undersized crossings are more likely to clog with debris. Beaver activity can exacerbate this problem. If not maintained, a clogged crossing will become impassable to fish for as long as the clog is present. Clogged inlets can also cause upstream ponding and/or flooding, and the formation of inlet drops.

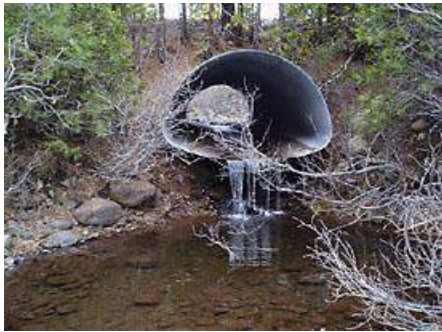
Scour and Erosion

Scour and erosion goes hand-and-hand with high flow and ponding, and is a consequence of all crossing insufficiencies besides shallow crossings. Scour pools often form at the downstream end of perched crossings, leading to the undercutting of the crossings, or in a worse case, the road. Eroded stream banks occur both upstream and downstream of the crossing. Lastly, scouring of natural substrate within the crossing degrades passage and natural habitat for aquatic and terrestrial life.

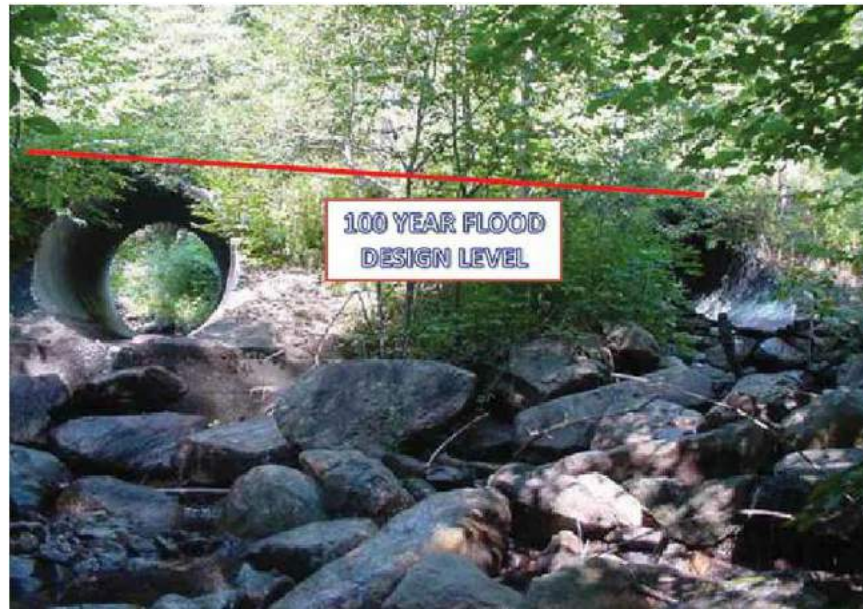
Double-barrel hydraulically designed culvert on Jenny Coolidge Brook, Green Mountain National Forest, VT

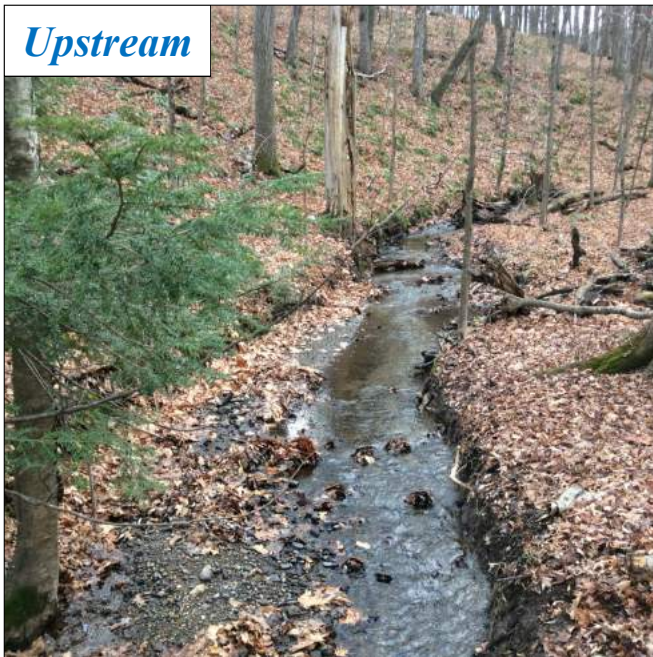
Upstream

Crossing Type: Culvert
Number of structures/cells: 1
Condition: Fair
Crossing Span: Severe Constriction
Alignment: Flow-Aligned

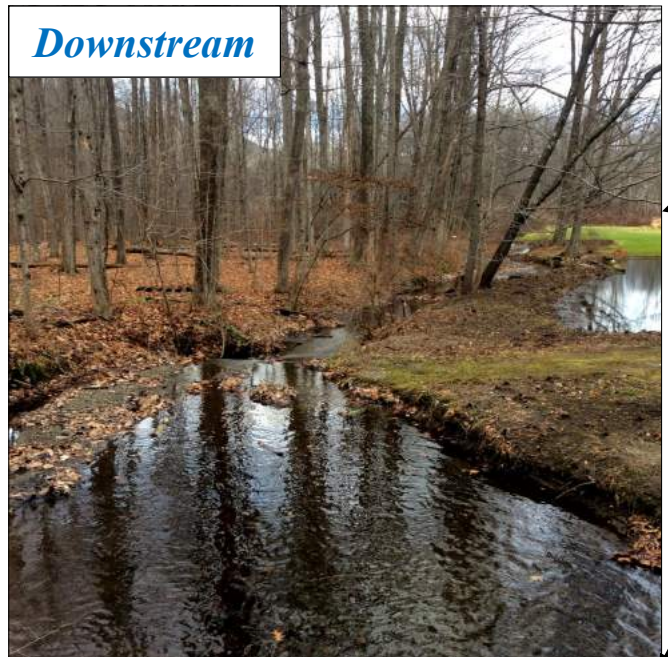
Downstream

Scour Pool: Large
Bankfull Width (feet): No data
Bankfull Width Confidence: No data

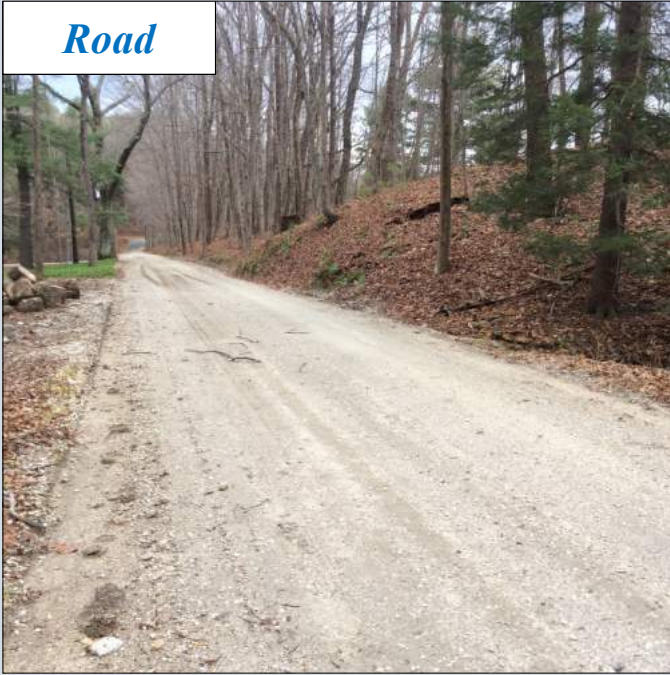
Road Type: Unpaved, 2-Lane Road
 Road Fill Height (feet): 1.6

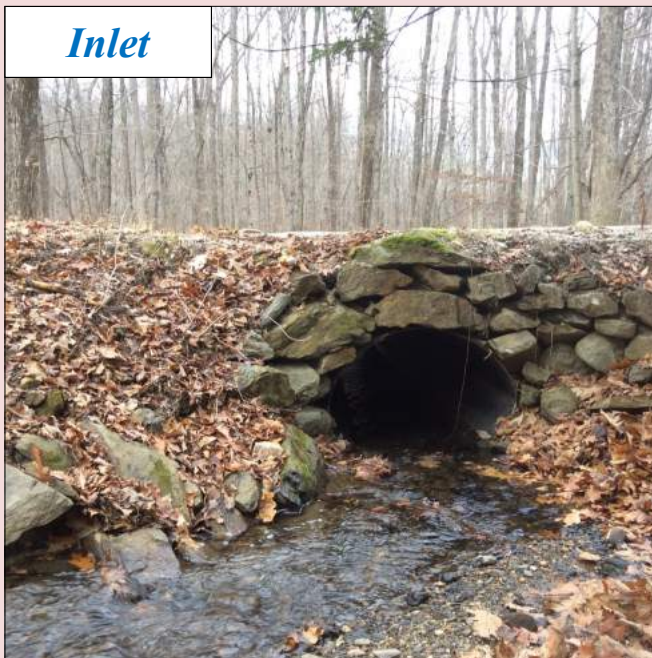
Inlet Shape: Round Culvert Embedded or with Persistent Water
 Inlet Type: No data
 Inlet Grade: No data

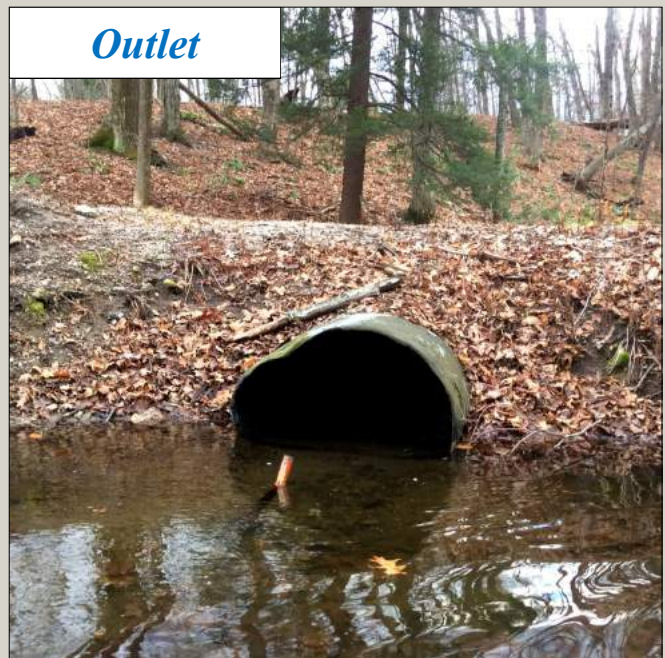
Outlet Shape: Elliptical Culvert Embedded or with Persistent Water
 Outlet Grade: No drop
 Drop to Stream Surface/Bottom: 0/0.5

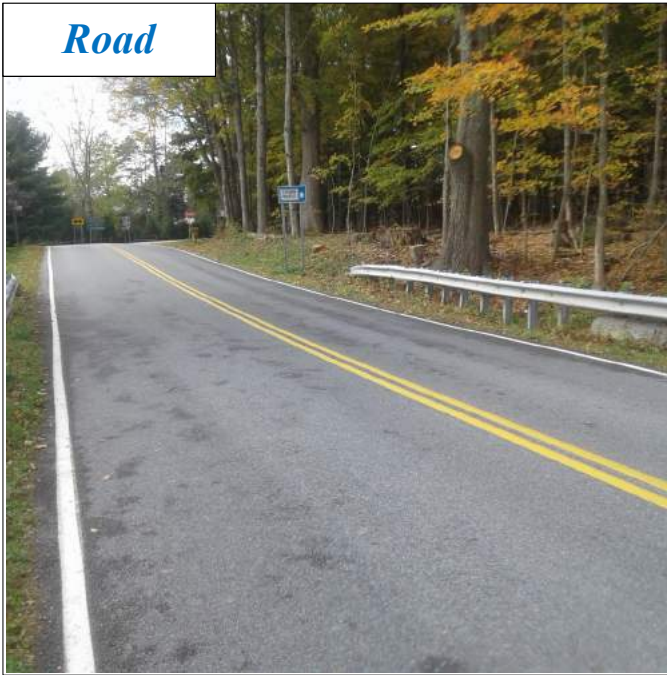
Road

Physical Barrier(s)/Severity: Debris/Sediment/
Rock (Minor)
Slope: No data
Structure Comments: No data

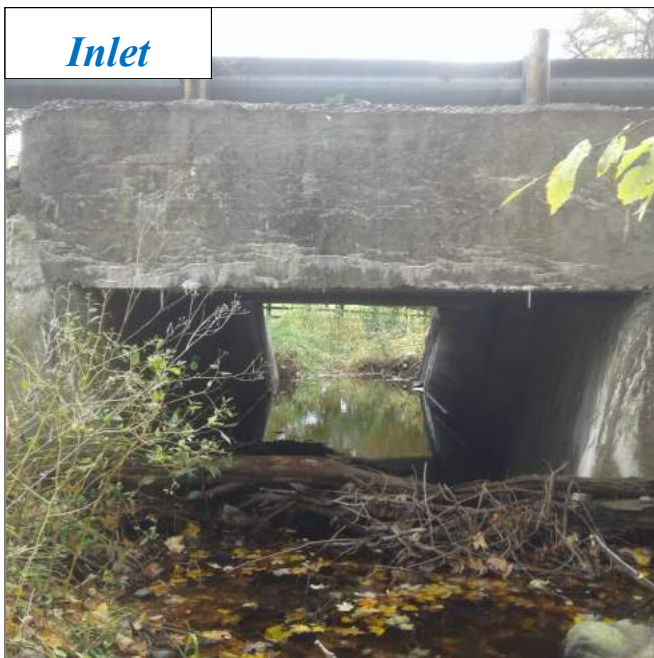
Inlet Shape/Type: Box/Bridge with Abutments
Inlet Drop/Grade: At Stream Grade
Dimensions:
Width: 9.9, Height: 5.1
Substrate/Water Width: 7.2
Water Depth: 0.8
Abutment Height: No data

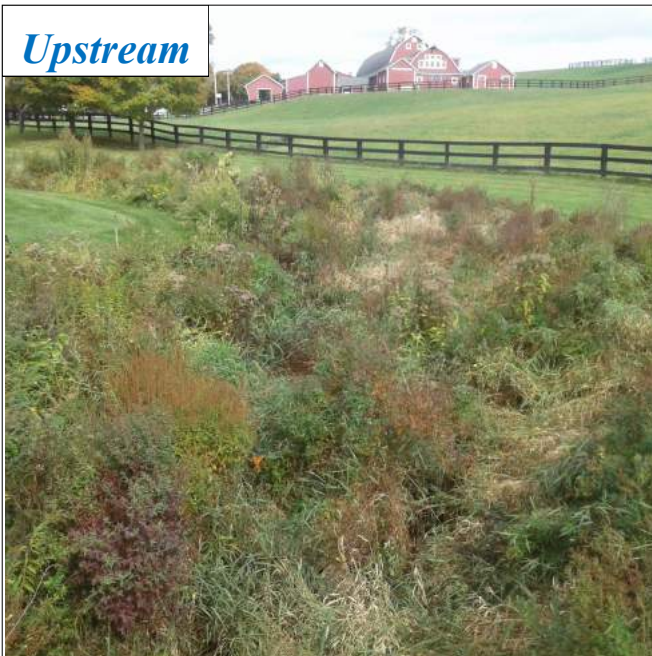
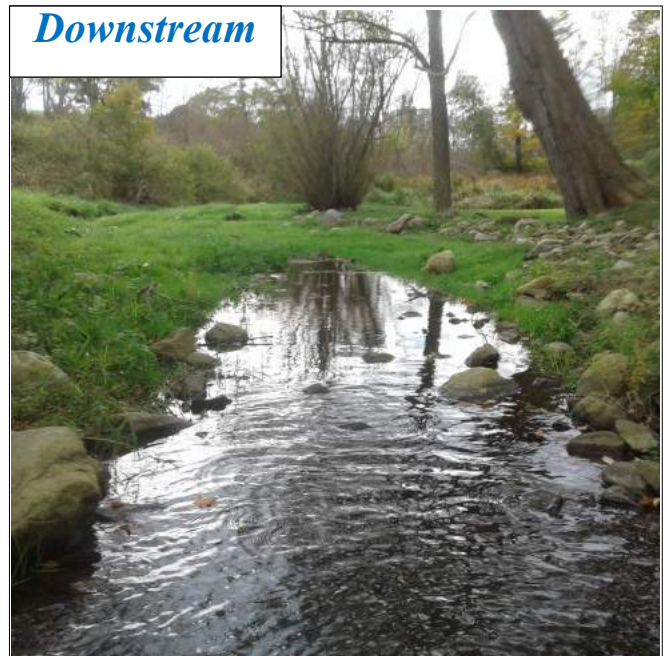
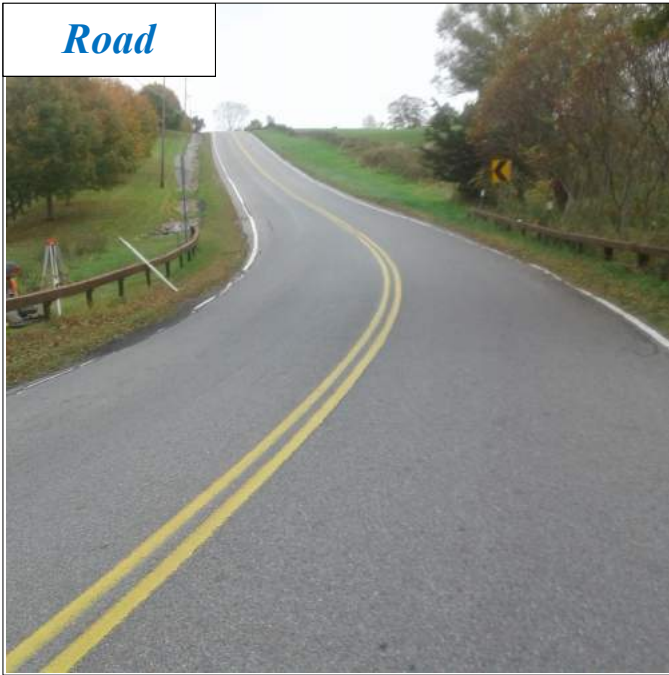
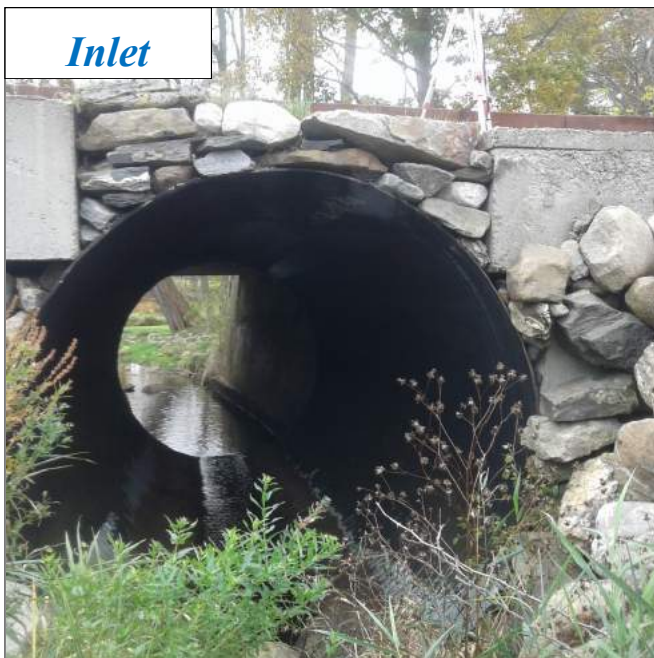
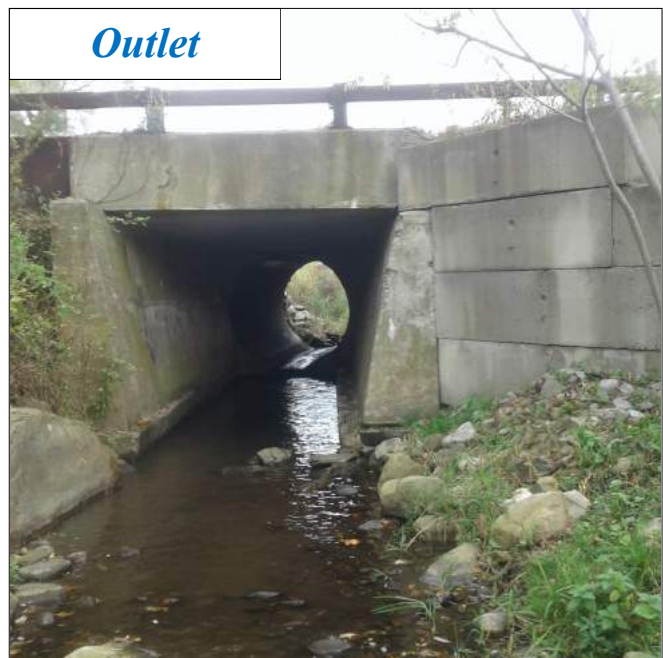
Crossing Comments: Starts as round culvert and changes to bridge half way with free fall.

Physical Barrier(s)/Severity: Free Fall (Moderate)
Slope: 6.7%
Structure Comments: No data

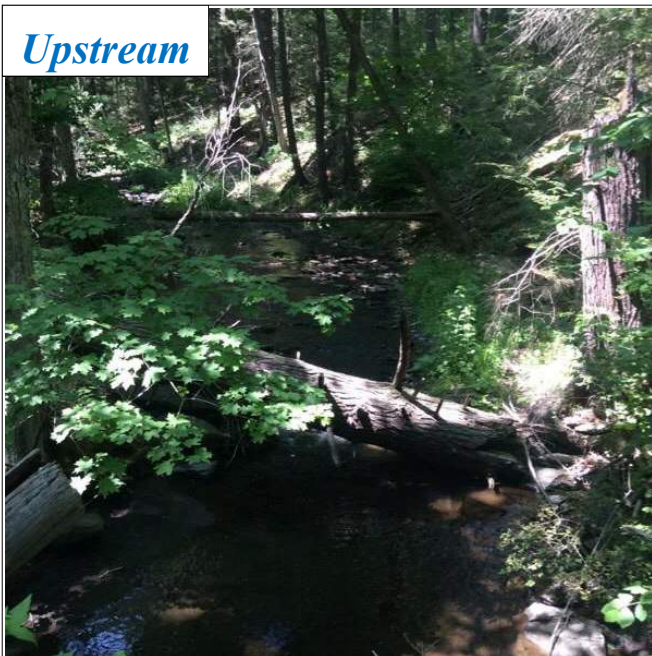
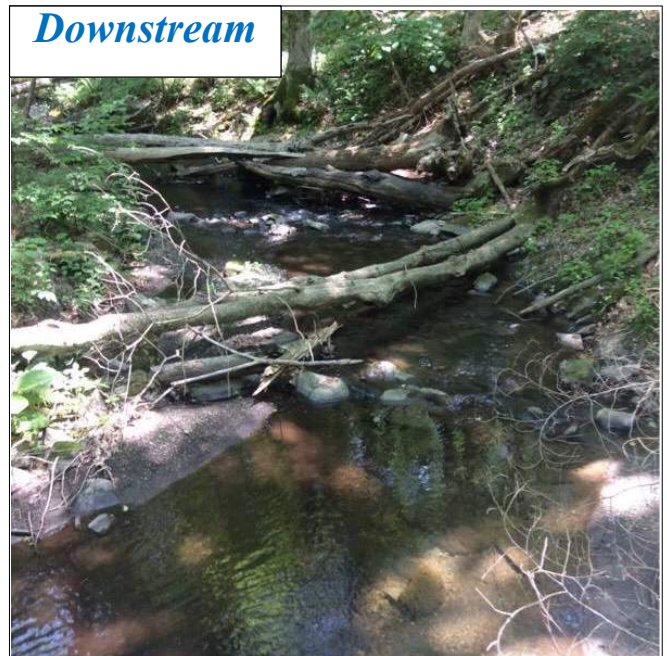
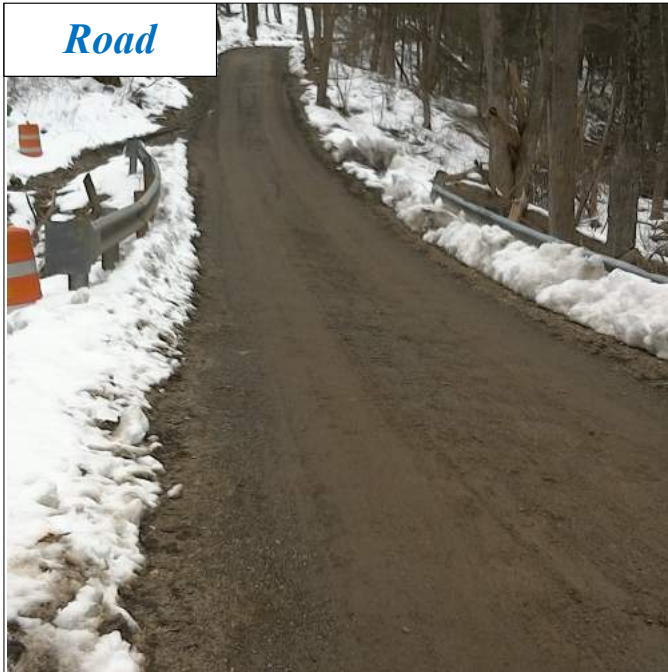
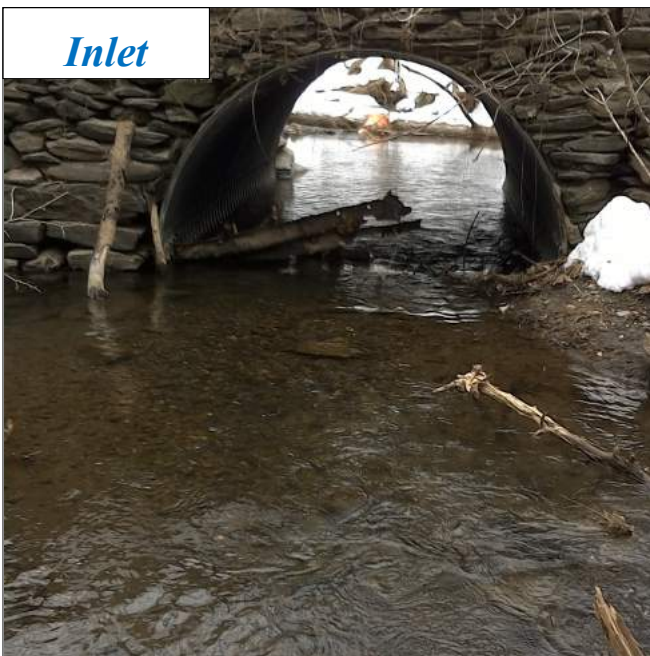
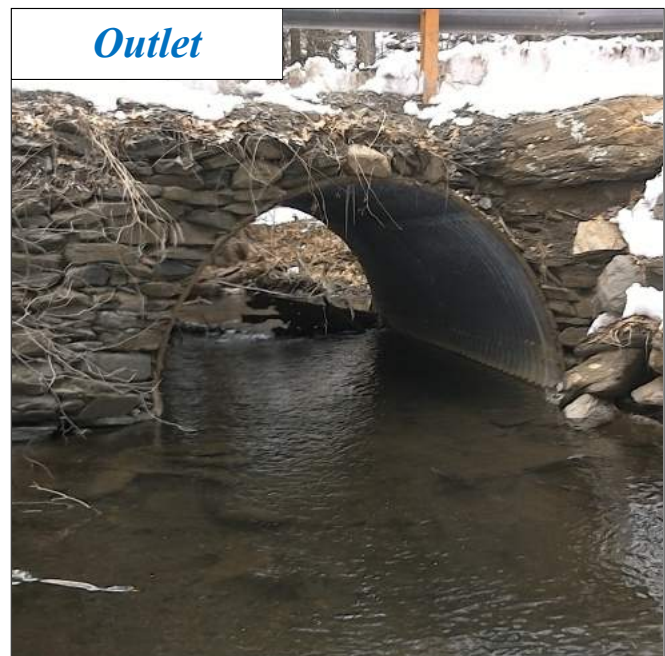
Condition: Poor

Crossing Comments: Culvert is rotting

Physical Barrier(s)/Severity: Debris/Sediment/
Rock (Minor)
Slope: 4.3%
Structure Comments: No data

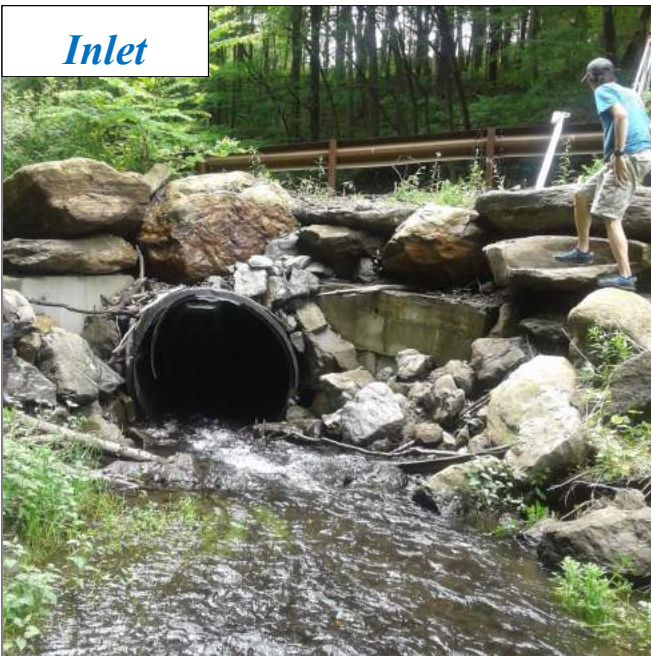
Inlet

Material: Plastic
Length (feet): 64.7
Internal Features/Structures: None
Dry Passage/Height: No

Physical Barrier(s)/Severity: None
Slope: 1.2%
Structure Comments: No data

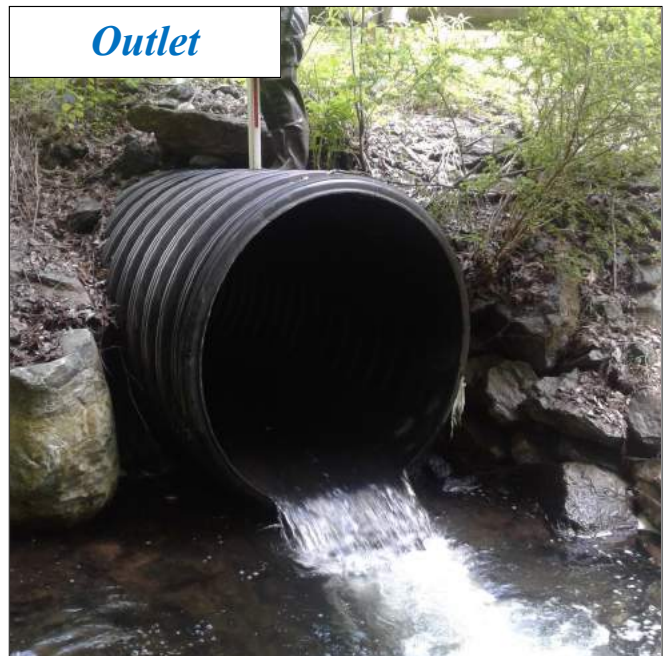
Outlet

Inlet Shape/Type: Round Culvert
Inlet Drop/Grade: At Stream Grade
Dimensions:
Width: 5.0, Height: 5.0
Substrate/Water Width: 2.6
Water Depth: 0.6
Abutment Height: No data

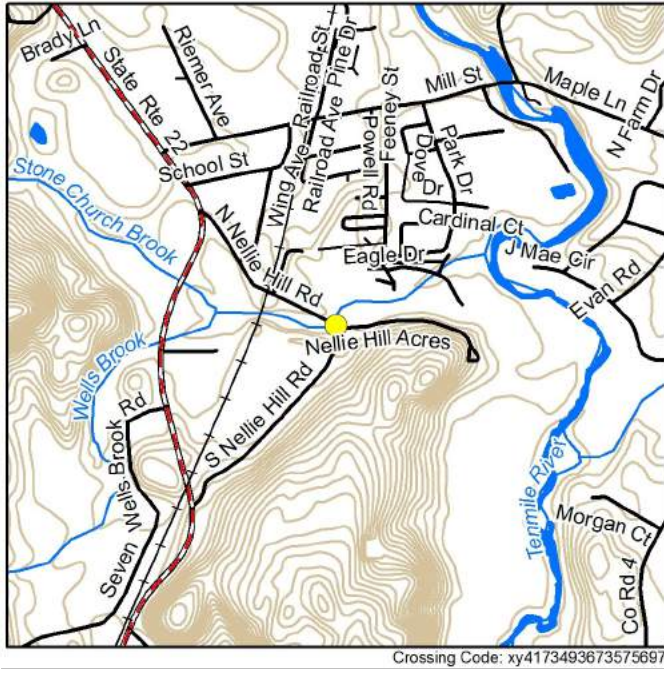
Outlet Shape: Round Culvert
Outlet Drop/Grade: Free Fall
Drop to Stream Surface/Bottom: 1.3/ 2.0
Dimensions:
Width: 4.9, Height: 5.0
Substrate/Water Width: 2.4
Water Depth: 0.4

Barrier Evaluation: Insignificant barrier

Town Comments on Condition/Maintenance: Town’s highest priority for replacement (public safety), has flooded in the past, with water over the road in 2007, in disrepair, debris jams, town water line on west side

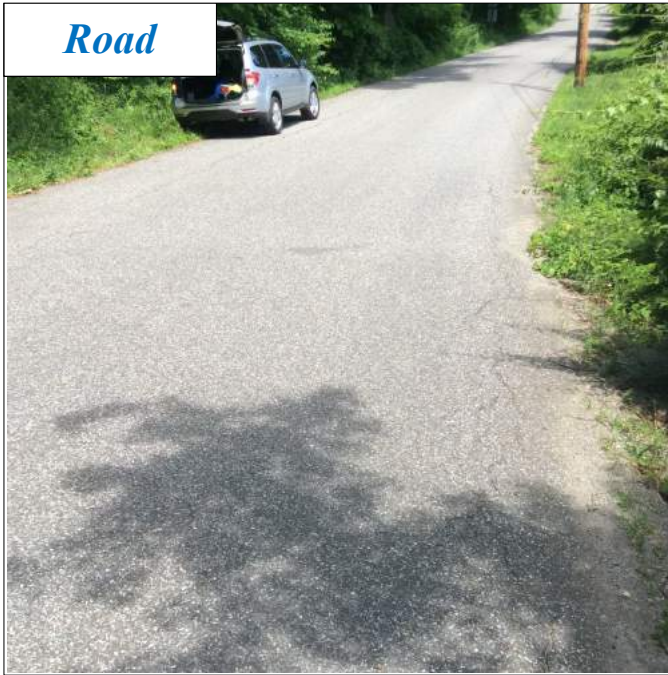
Road

Crossing Comments: Cannot get to outlet due to barbed wire

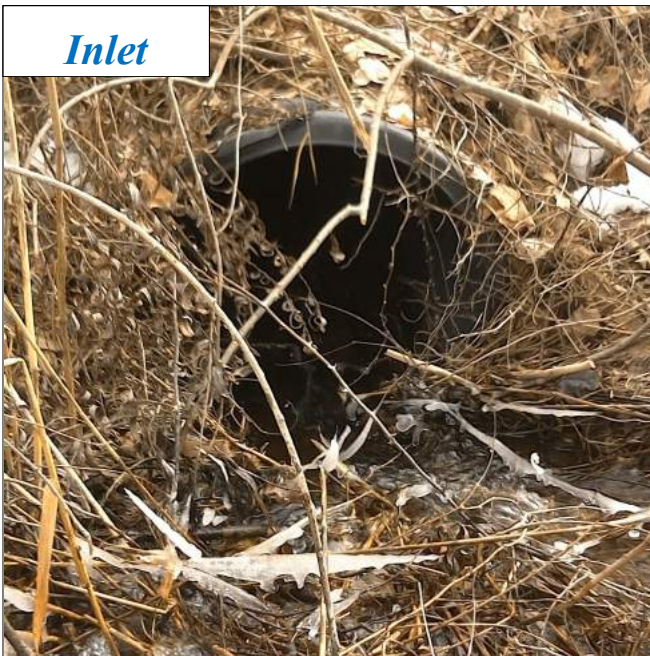
Inlet

Material: Plastic
Length (feet): 30.4
Internal Features/Structures: None
Dry Passage/Height: No

Physical Barrier(s)/Severity: None
Slope: 5.0%
Structure Comments: could not fully get to outlet to record outlet drop (free fall)-measurement is

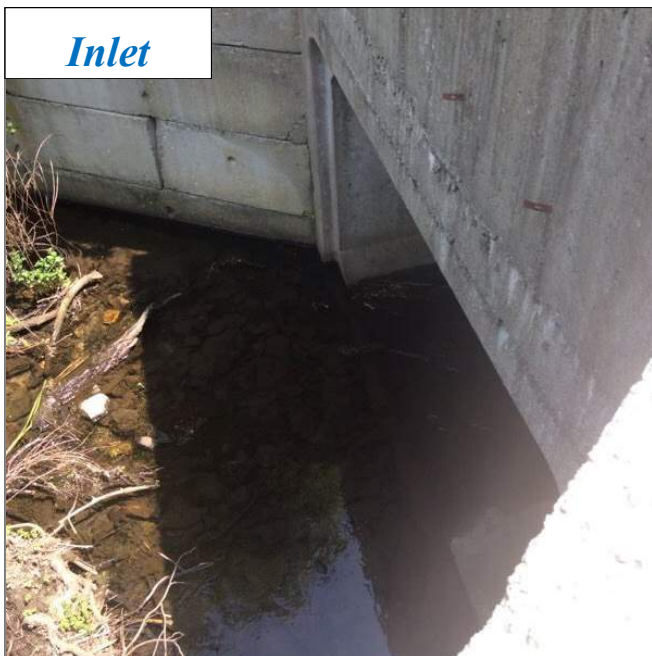
Inlet

Material: Concrete
 Length (feet): 42.4
 Internal Features/Structures: None
 Dry Passage/Height: No

Physical Barrier(s)/Severity: Debris/Sediment/
 Rock (Moderate)
 Slope: 1.7%
 Structure Comments: No data

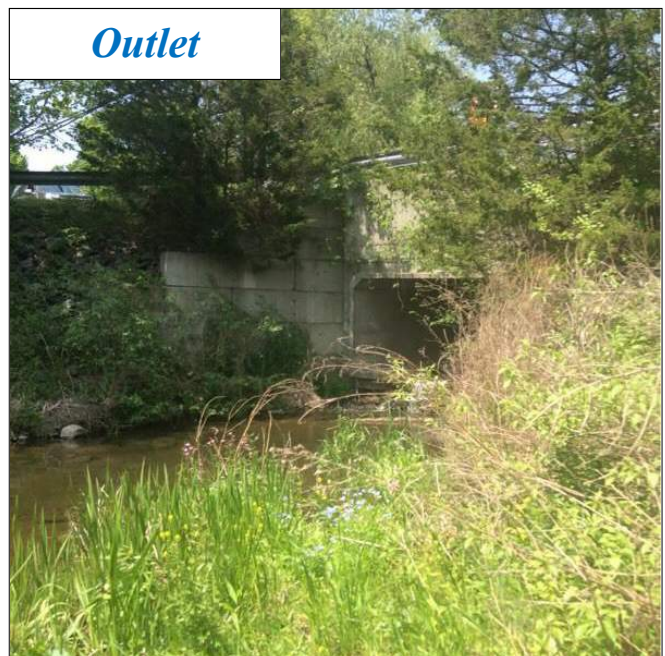
Outlet Shape: Box/Bridge with Abutments
 Outlet Drop/Grade: Free Fall
 Drop to Stream Surface/Bottom: 1.4/ 1.8
 Dimensions:
 Width: 10.4, Height: 5.9
 Substrate/Water Width: 5.9
 Water Depth: 0.2

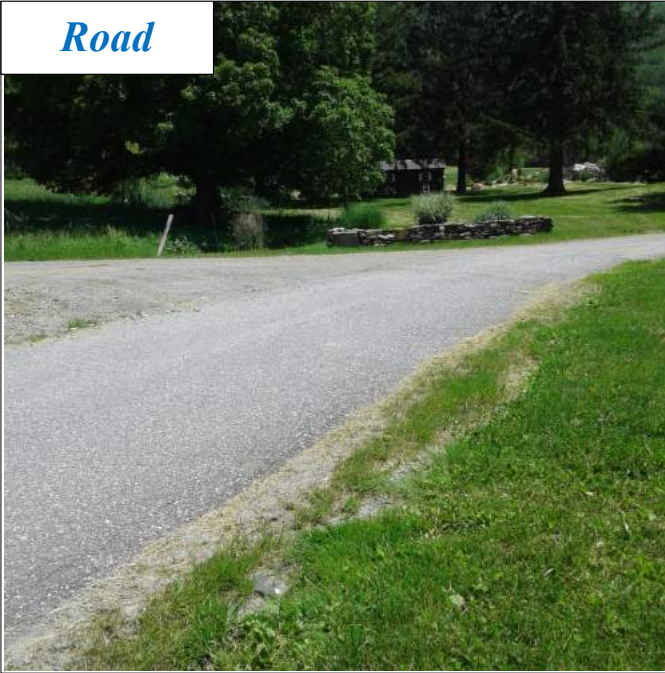
Road

Crossing Comments: Outlet goes into a pond

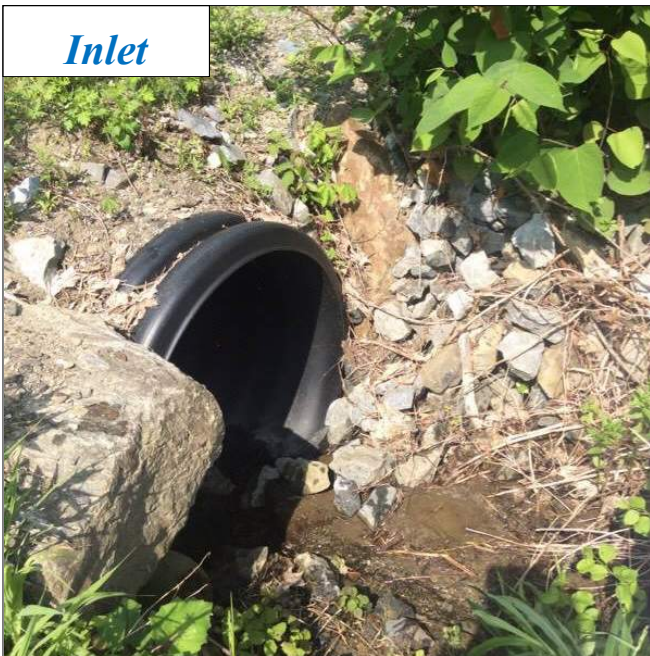
Physical Barrier(s)/Severity: Debris/Sediment/
Rock (Moderate)
Slope: 3.9%
Structure Comments: No data

Inlet Shape/Type: Round Culvert
Inlet Drop/Grade: Inlet Drop
Dimensions:
Width: 3.0, Height: 3.0
Substrate/Water Width: 1.5
Water Depth: 0.1
Abutment Height: No data

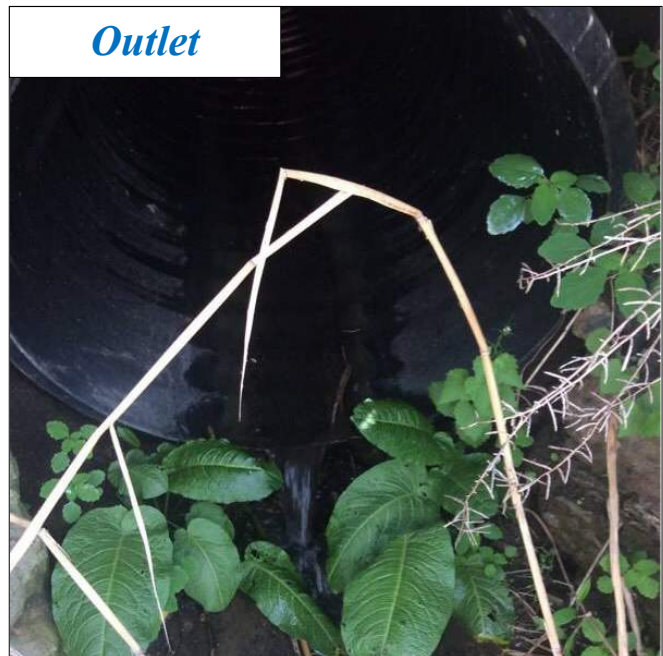
Outlet Shape: Round Culvert
Outlet Drop/Grade: Cascade
Drop to Stream Surface/Bottom: 0.0/ 0.0
Dimensions:
Width: 3.1, Height: 2.9
Substrate/Water Width: 0.5
Water Depth: 0.1

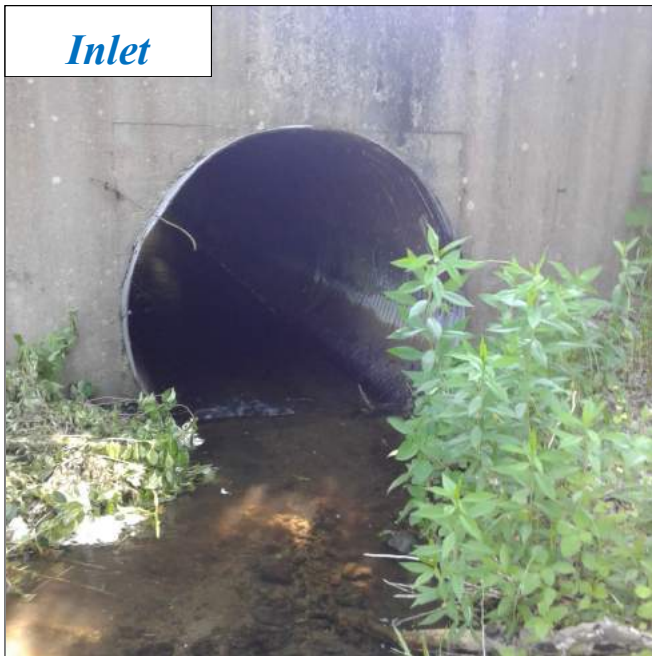
Inlet Shape/Type: Round Culvert
Inlet Drop/Grade: At Stream Grade
Dimensions:
Width: 5.8, Height: 6.1
Substrate/Water Width: 3.9
Water Depth: 0.9
Abutment Height: No data

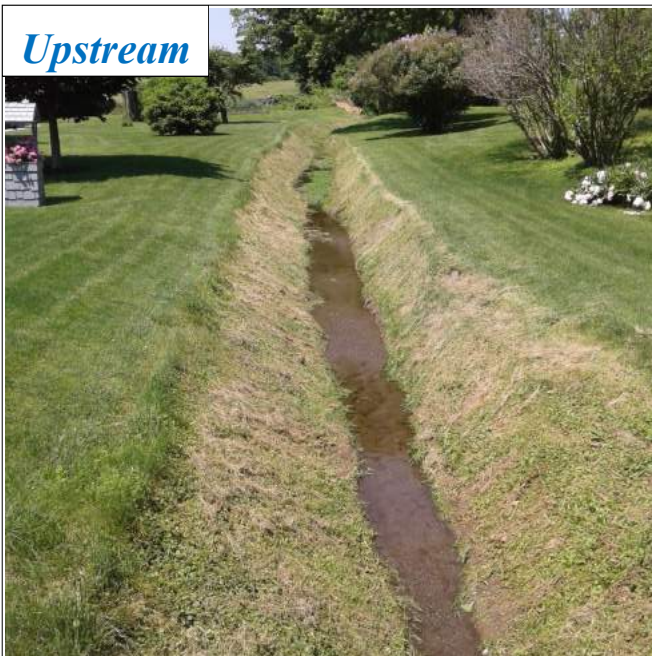
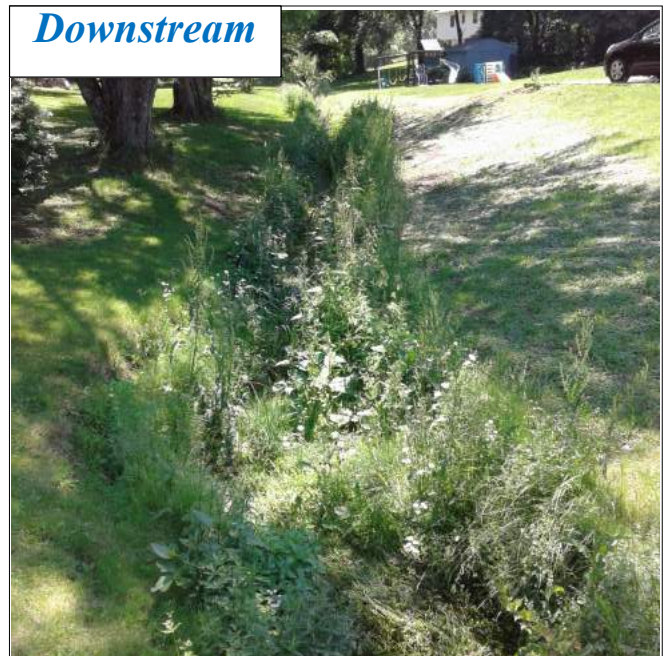
Scour Pool: Large
 Bankfull Width (feet): No data
 Bankfull Width Confidence: No data

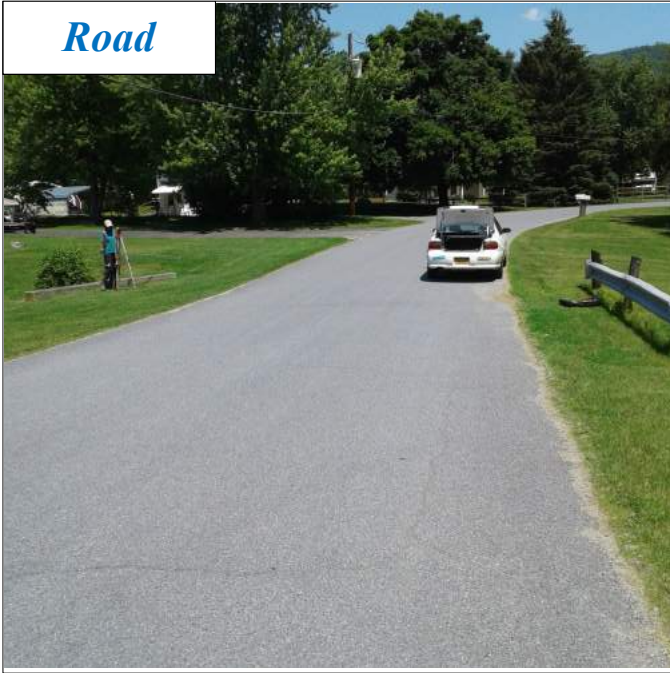
Road

Crossing Type: Culvert
 Number of structures/cells: 1
 Condition: Poor
 Constriction: Moderate
 Alignment: Flow-Aligned
 Internal Features/Structures: None

Crossing Comments: Caving in the middle of the road. Needs to be fixed or else possible cave-in soon. Has been an issue for many years

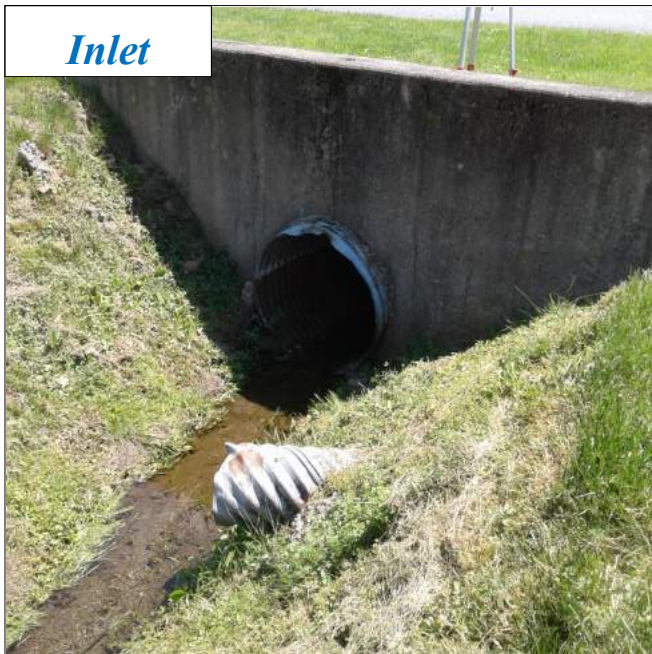
Inlet Shape/Type: Round Culvert
 Inlet Drop/Grade: At Stream Grade
 Dimensions:
 Width: 3.3, Height: 3.0
 Substrate/Water Width: 0.8
 Water Depth: 0.2
 Abutment Height: No data

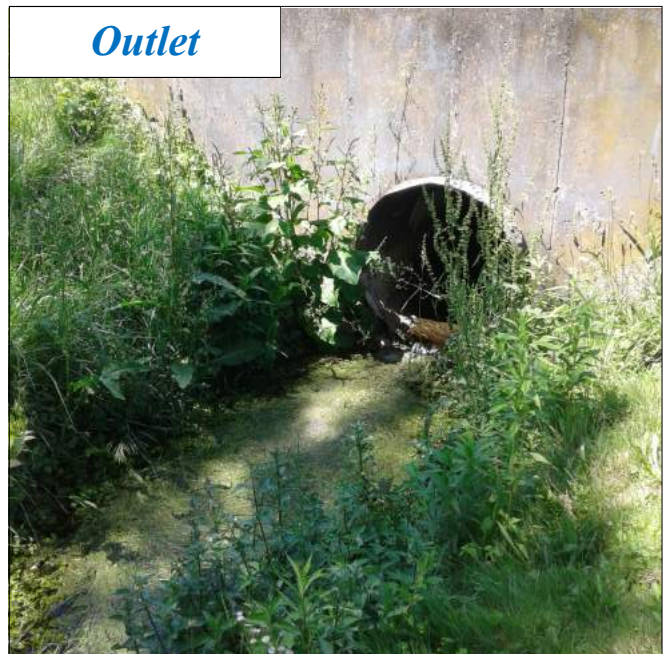
Outlet Shape: Round Culvert
 Outlet Drop/Grade: Free Fall
 Drop to Stream Surface/Bottom: 0.3/ 0.7
 Dimensions:
 Width: 3.0, Height: 3.1
 Substrate/Water Width: 1.1
 Water Depth: 0.1

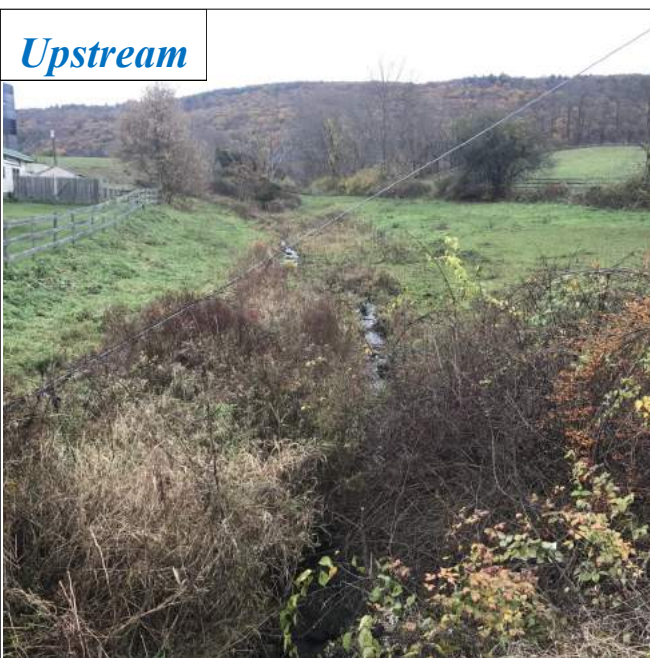
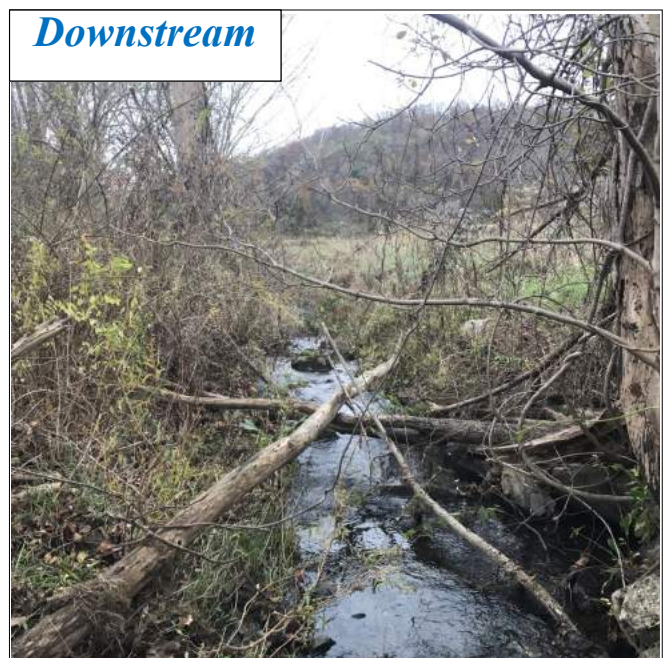
Crossing Comments: Stormwater outfalls at inlet and outlet

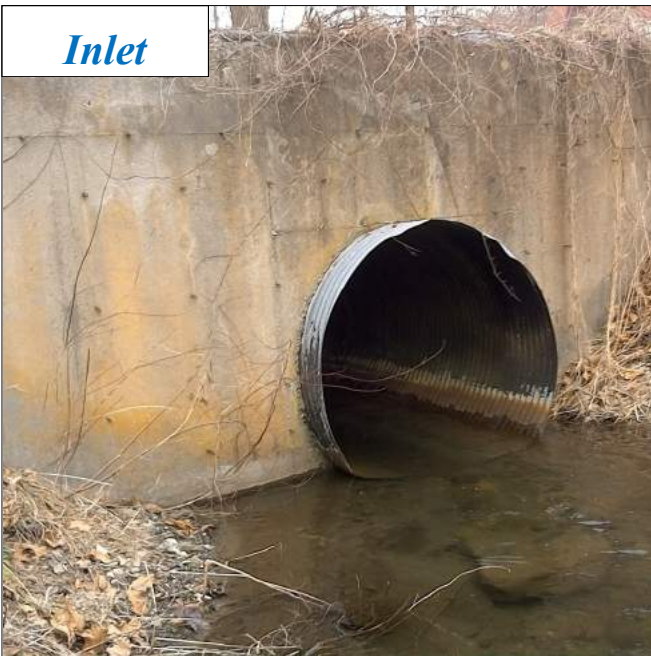
Inlet Shape/Type: Round Culvert
Inlet Drop/Grade: Perched
Dimensions:
Width: 5.8, Height: 6.2
Substrate/Water Width: 3.0
Water Depth: 0.6
Abutment Height: No data

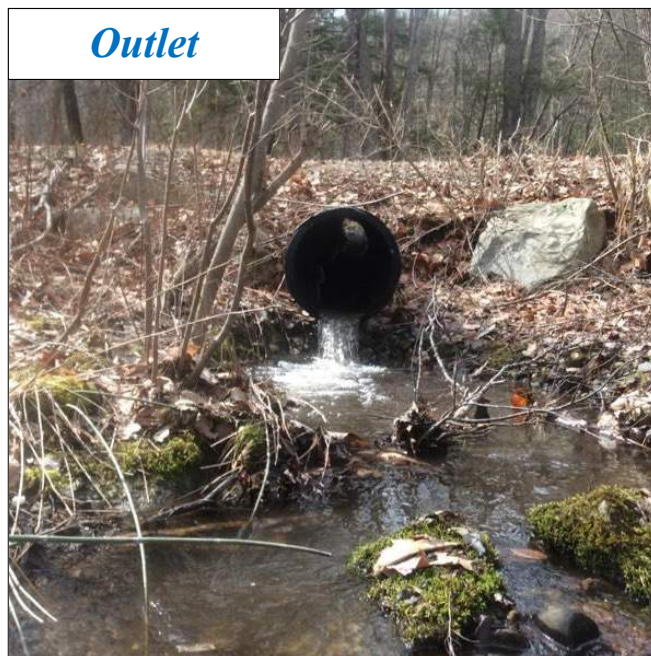
Outlet Shape: Round Culvert
 Outlet Drop/Grade: Free Fall
 Drop to Stream Surface/Bottom: 0.6/ 1.1
 Dimensions:
 Width: 1.5, Height: 1.5
 Substrate/Water Width: 0.8
 Water Depth: 0.1

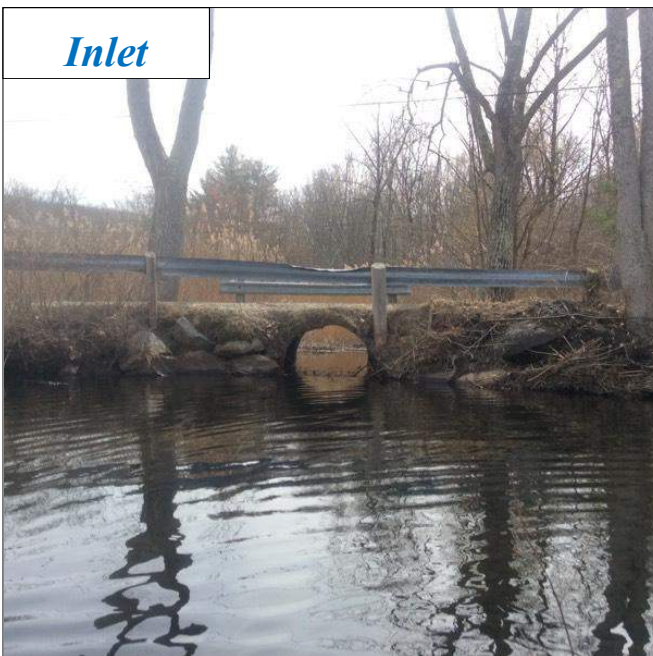
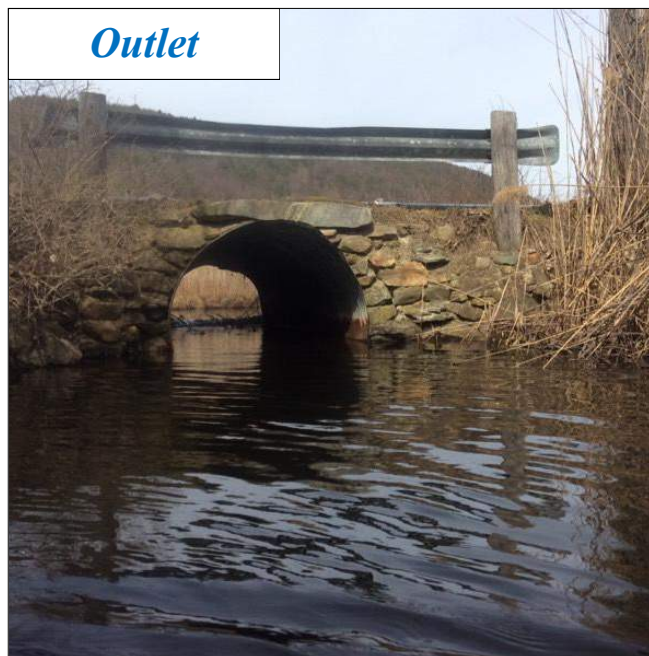
Physical Barrier(s)/Severity: Debris/Sediment/
Rock (Moderate)
Slope: 6.4%
Structure Comments: Vegetation and debris (due

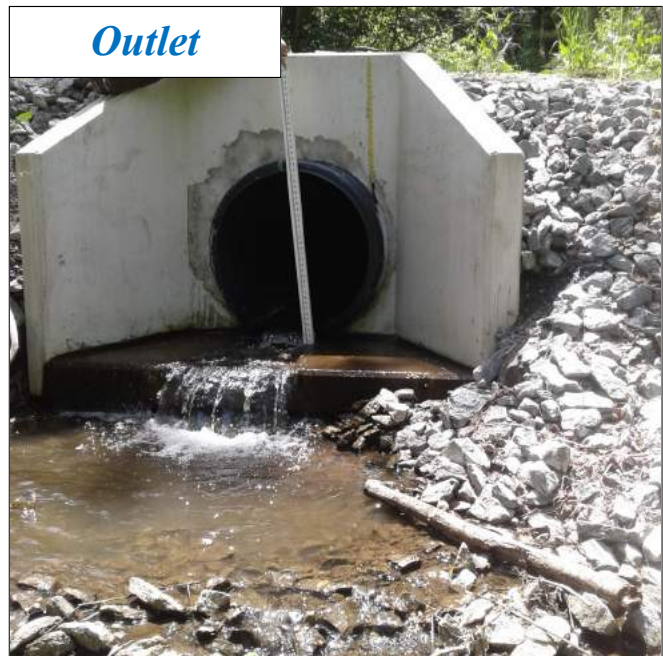
Outlet Shape: Round Culvert
Outlet Drop/Grade: Free Fall
Drop to Stream Surface/Bottom: 1.1/ 1.7
Dimensions:
Width: 2.9, Height: 3.1
Substrate/Water Width: 1.2
Water Depth: 0.3

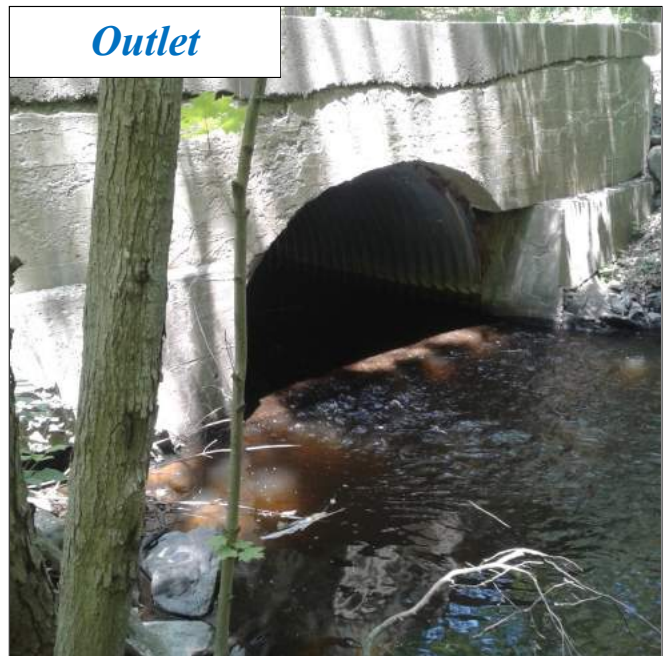
Outlet Shape: Pipe Arch/Elliptical Culvert

Substrate/Water Width: 9.2

Water Depth: 2.0

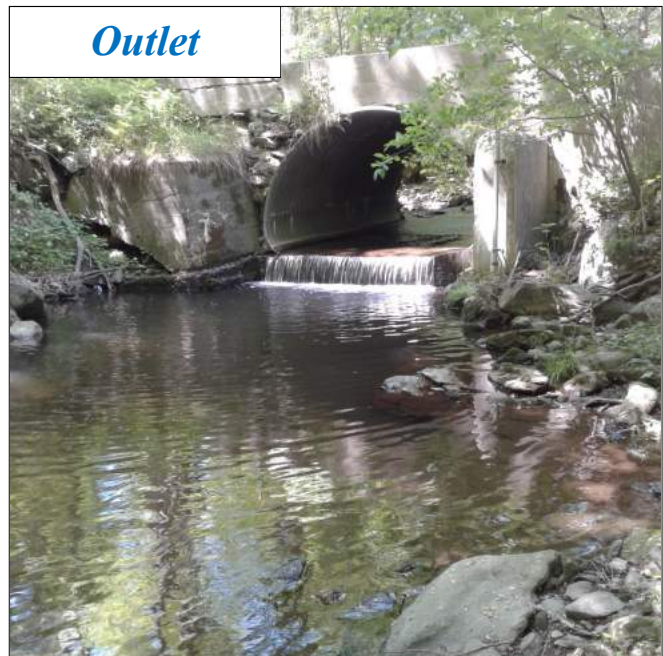
Outlet Shape: Open Bottom Arch Bridge/
 Culvert
 Outlet Drop/Grade: Free Fall
 Drop to Stream Surface/Bottom: 1.3/ 1.9
 Dimensions:
 Width: 9.8, Height: 6.7
 Substrate/Water Width: 8.7
 Water Depth: 0.2

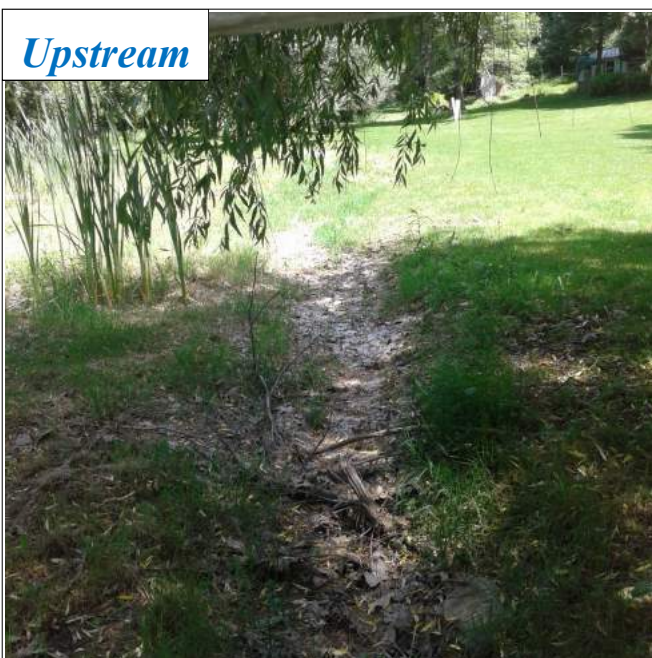
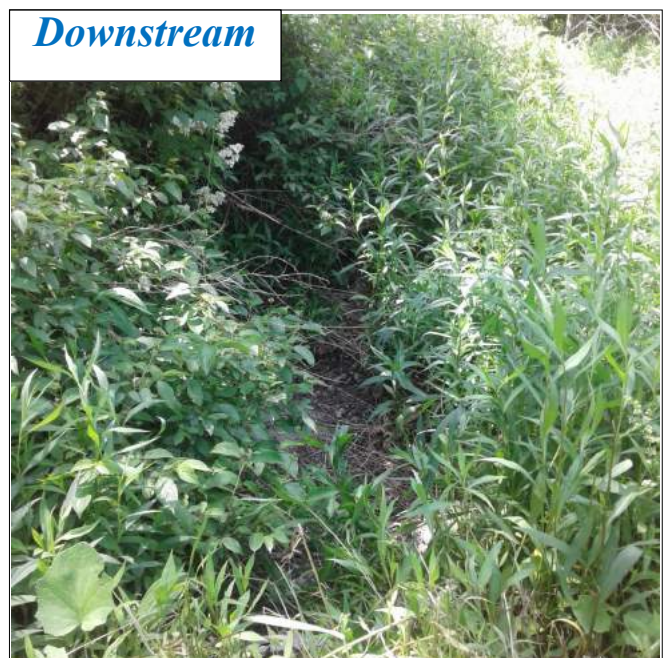
Crossing Comments: No flow; appears to be drainage for adjacent yard

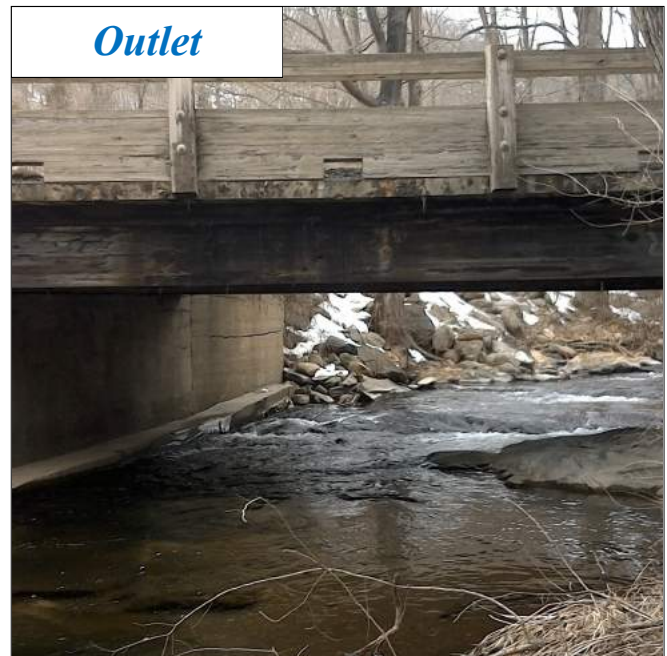
Physical Barrier(s)/Severity: None
 Slope: No data
 Structure Comments: Outlet too deep to take adequate picture of outlet

Outlet Shape: Bridge with Side Slopes
 Outlet Drop/Grade: At Stream Grade
 Drop to Stream Surface/Bottom: 0.0/ 0.0
 Dimensions:
 Width: 23.6, Height: 7.7
 Substrate/Water Width: 19.4
 Water Depth: 1.6
