Town of Dover

Road-Stream Crossing Management Plan

Produced by
The Housatonic Valley Association
2019

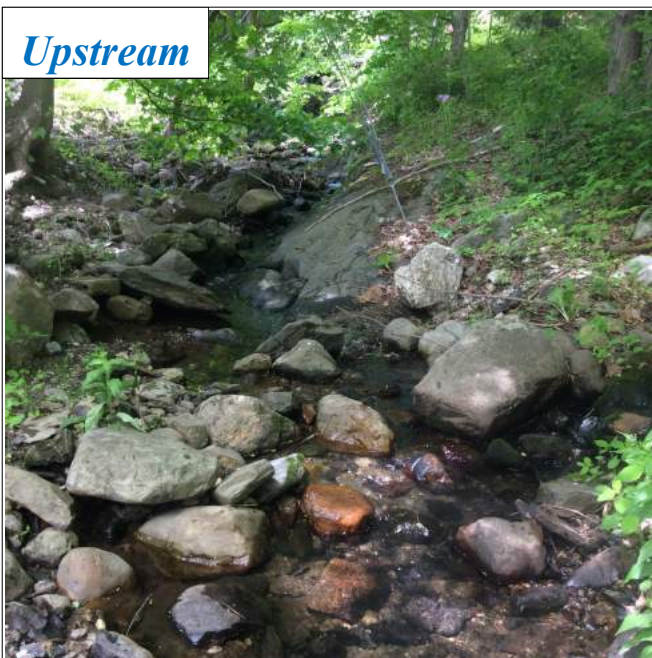
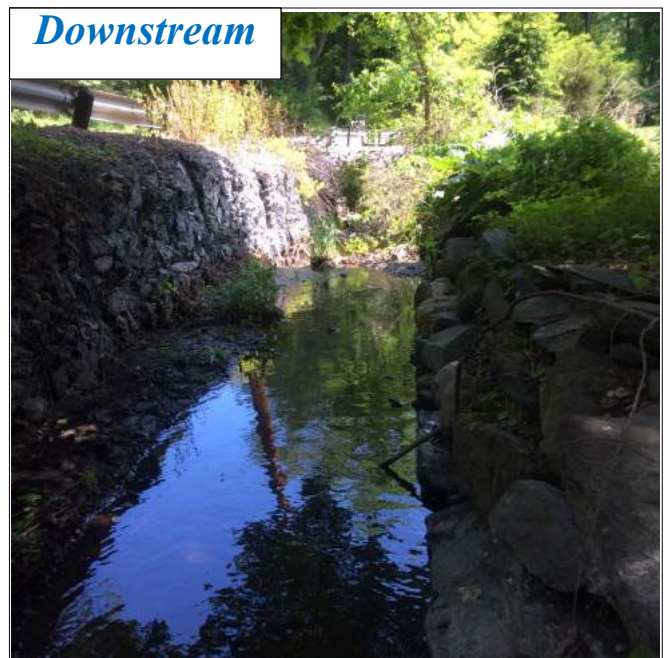
Crossing Comments: Gabions on both sides of the inlet..culverts are in close proximity of each other in the same stream..30' downstream is a natural cascade..downstream channel is

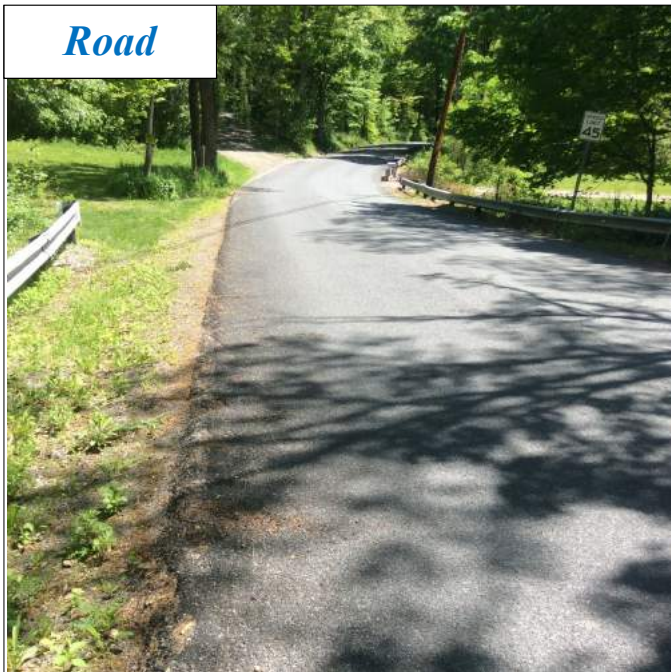
Road

Physical Barrier(s)/Severity: None
 Slope: 1.6%
 Structure Comments: Most of downstream left contains gabions

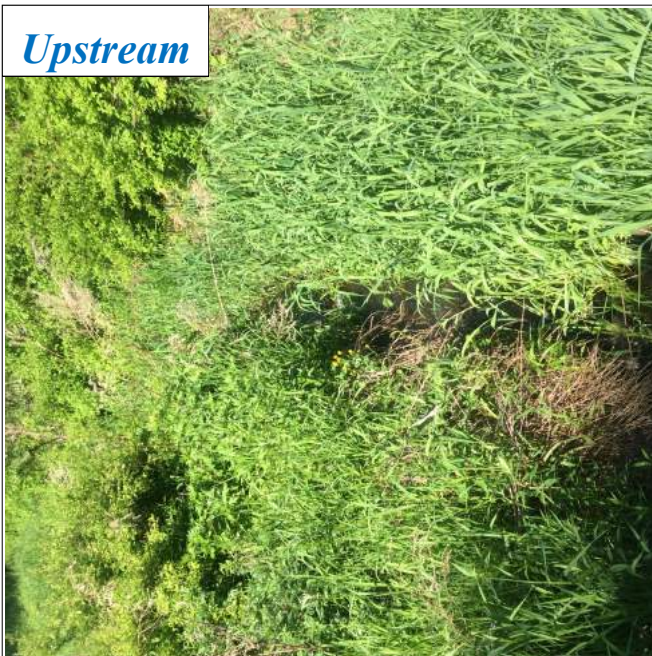
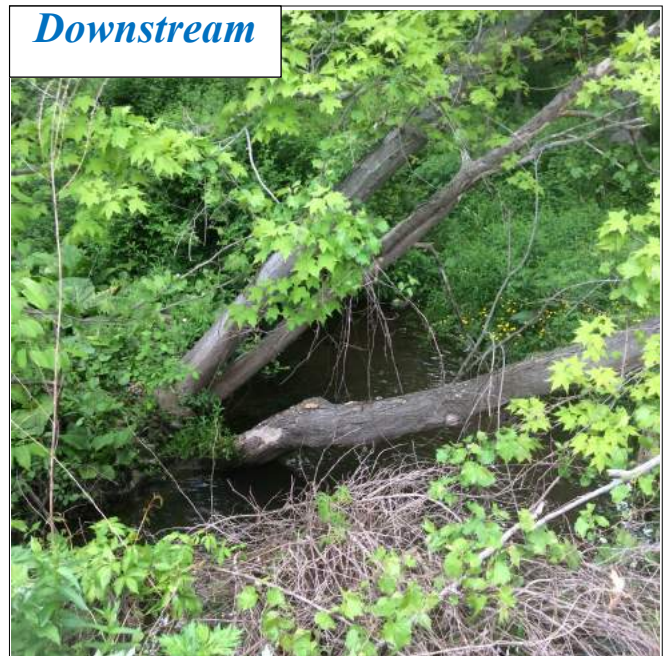
Crossing Comments: Upstream channel is densely populated with vegetation

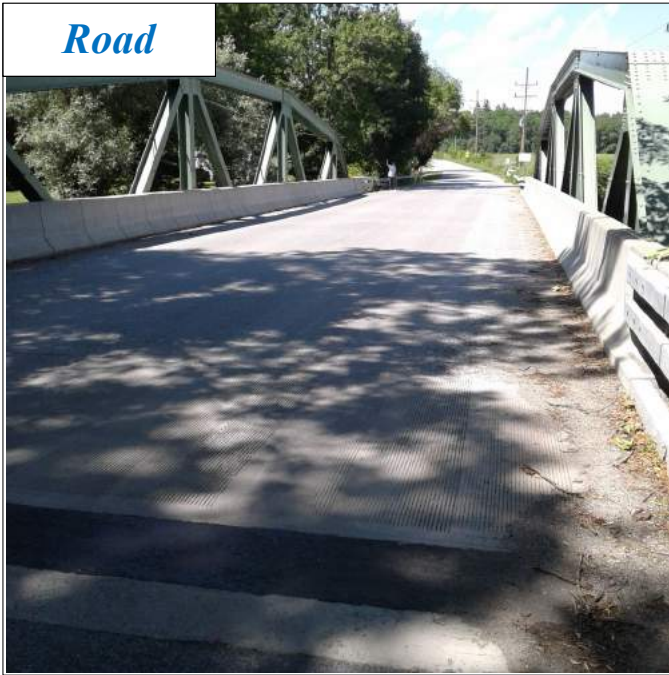
Road

Physical Barrier(s)/Severity: None
 Slope: No data
 Structure Comments: Ridge near vertical abutment water is deeper on both sides

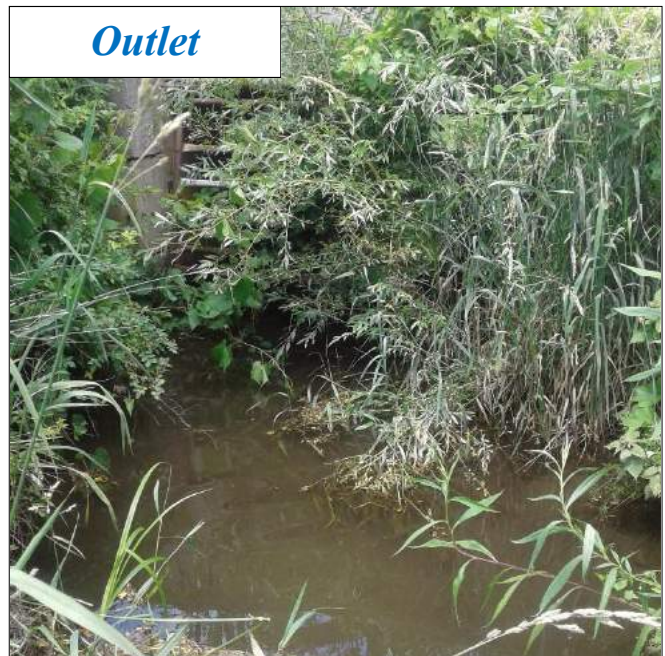
Outlet

Physical Barrier(s)/Severity: Fencing (Minor)
 Slope: No data
 Structure Comments: Fencing at outlet

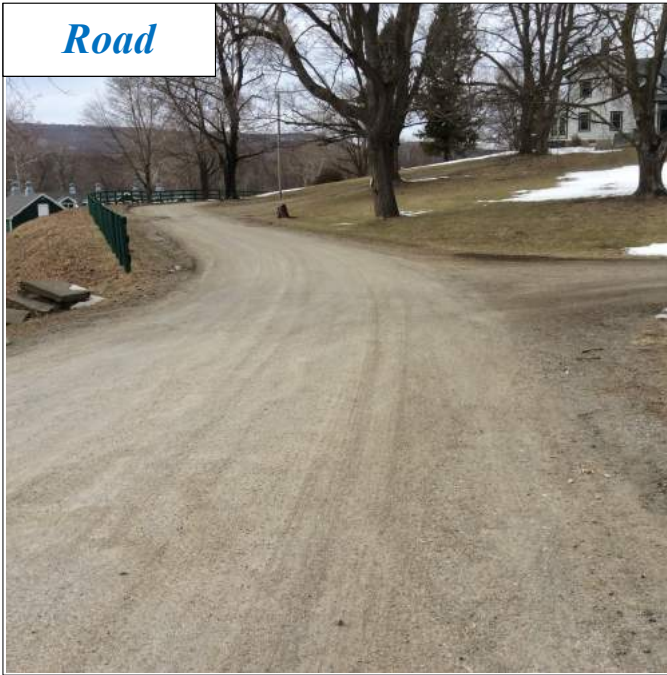
Road

Physical Barrier(s)/Severity: Debris/Sediment/
Rock (Moderate)
Slope: 5.7%
Structure Comments: No data

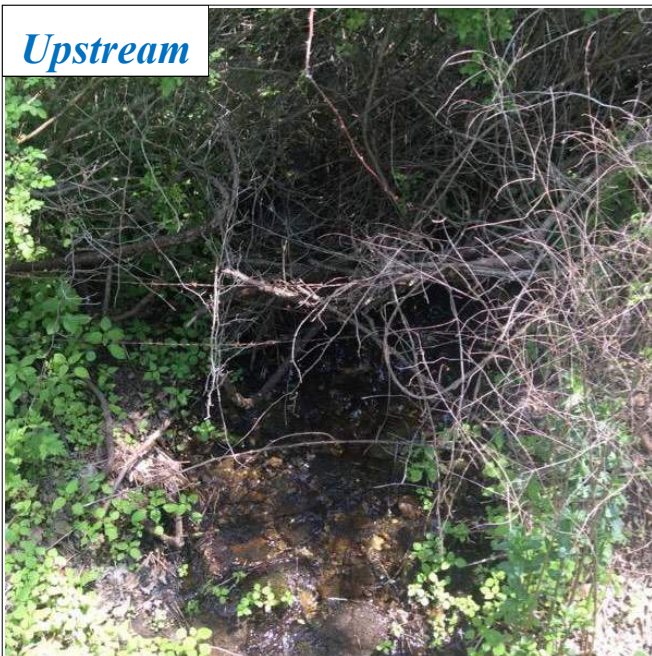
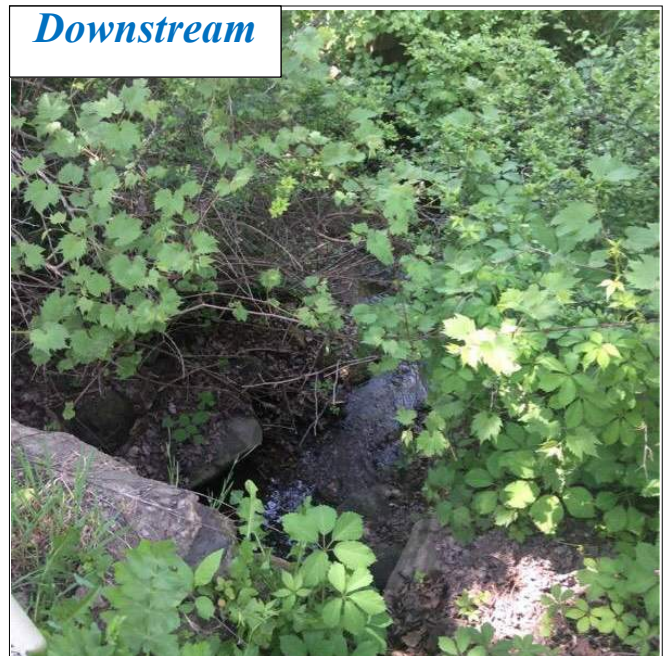
Crossing Comments: Barbed wire prevents animals from entering stream

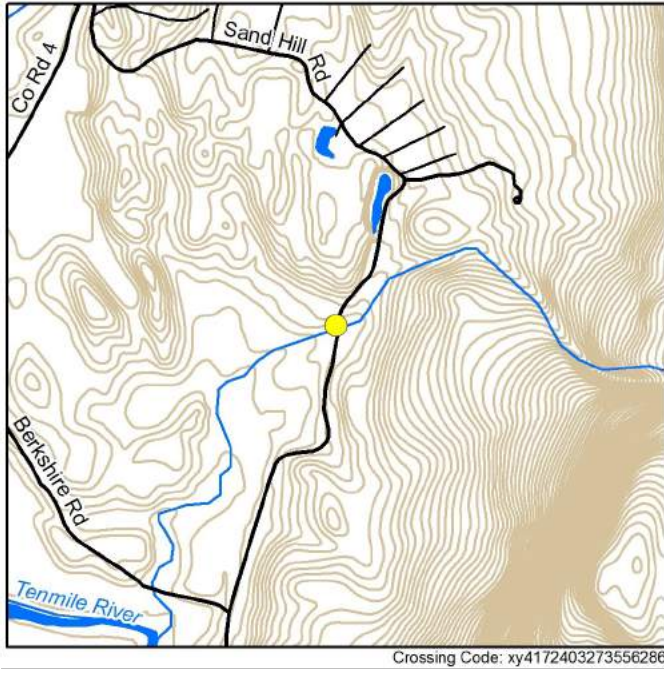
Crossing Type: Culvert
 Number of structures/cells: 1
 Condition: Poor
 Constriction: Moderate
 Alignment: Flow-Aligned
 Internal Features/Structures: None

Outlet Shape: Round Culvert
Outlet Drop/Grade: Free Fall
Drop to Stream Surface/Bottom: 0.7/ 1.0
Dimensions:
Width: 3.0, Height: 3.0
Substrate/Water Width: 1.1
Water Depth: 0.3

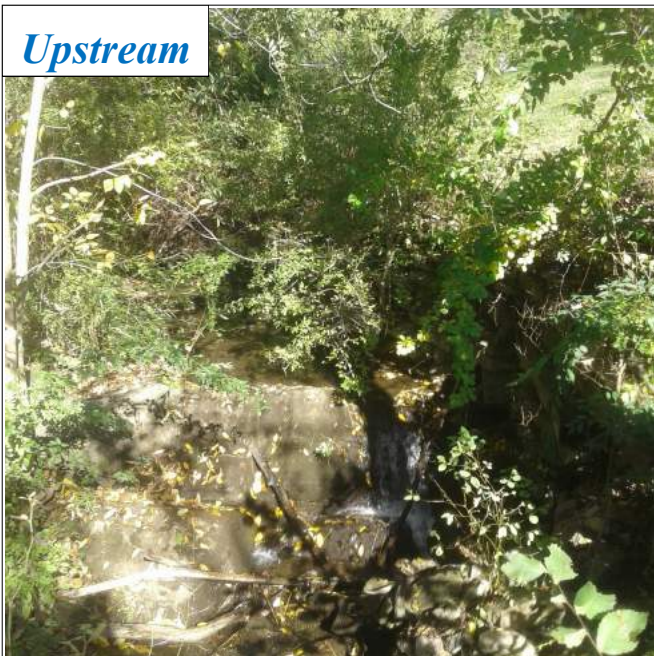
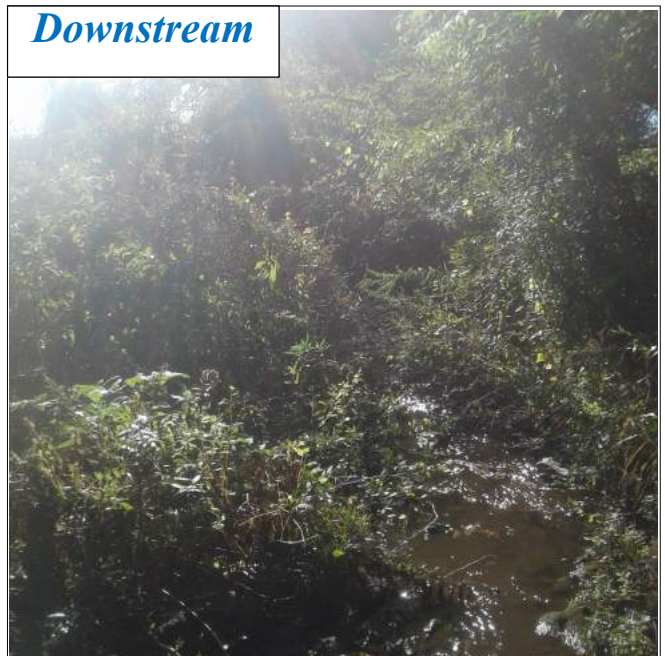
Crossing Comments: There's a natural barrier 10 feet upstream of inlet

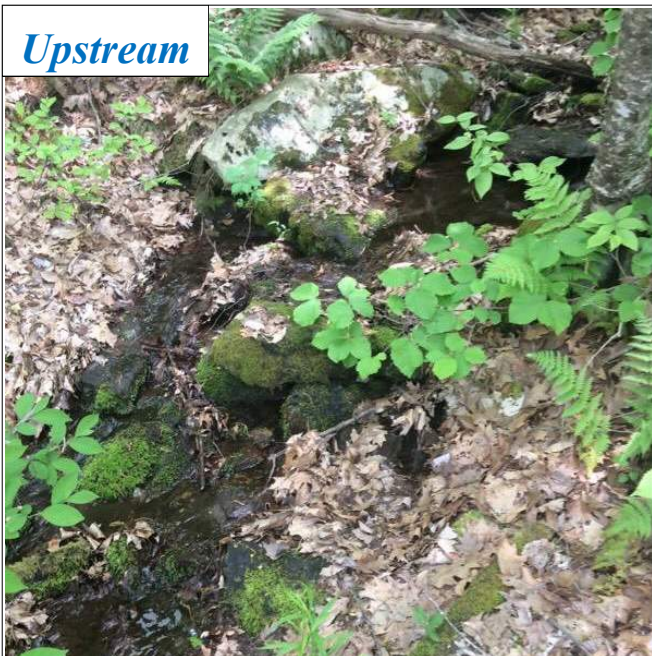
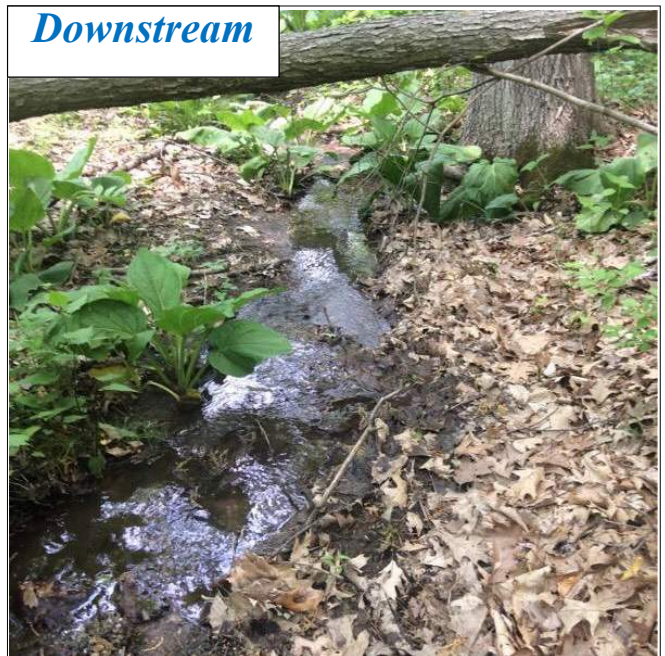
Crossing Type: Culvert
 Number of structures/cells: 1
 Condition: Poor
 Constriction: Moderate
 Alignment: Flow-Aligned
 Internal Features/Structures: None

Crossing Comments: Culvert is rotting

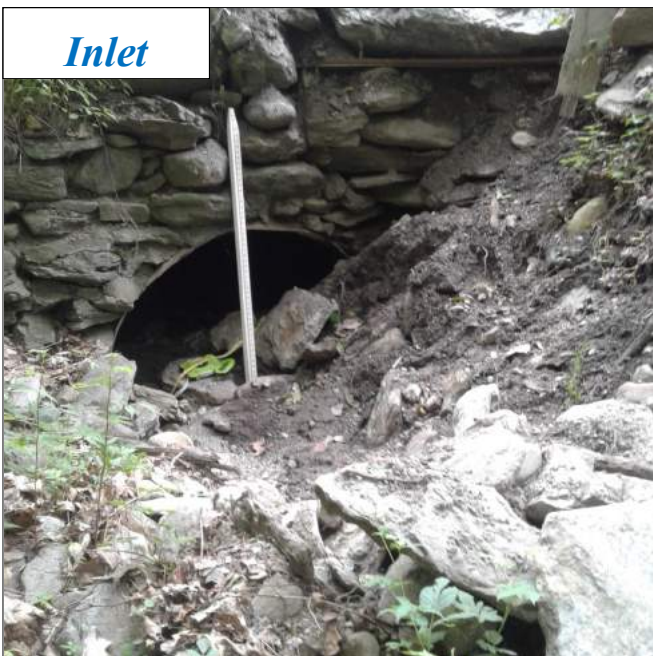
Road

Physical Barrier(s)/Severity: None
Slope: 3.8%
Structure Comments: No water is flowing though the structure

Barrier Evaluation: Minor barrier
 Town Comments on Condition/Maintenance: Washed out in Irene, structure will be replaced in 2018 and widened out
 Overall Ranking: Tier 5 (Ranked 10 of 86)

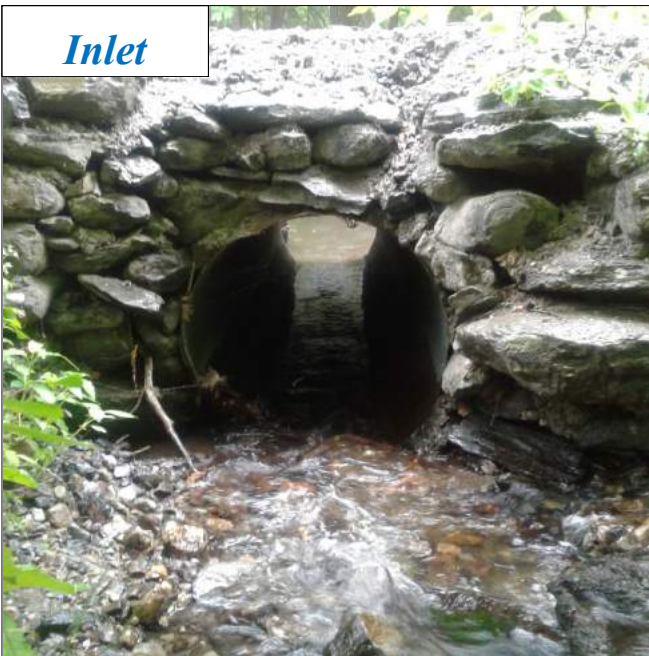
Road

Physical Barrier(s)/Severity: None
Slope: 5.6%
Structure Comments: Outlet bottom rusted out

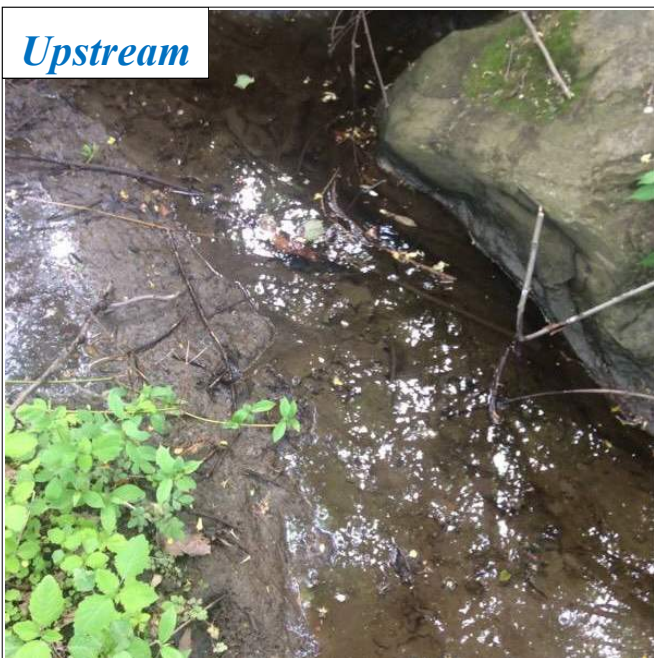
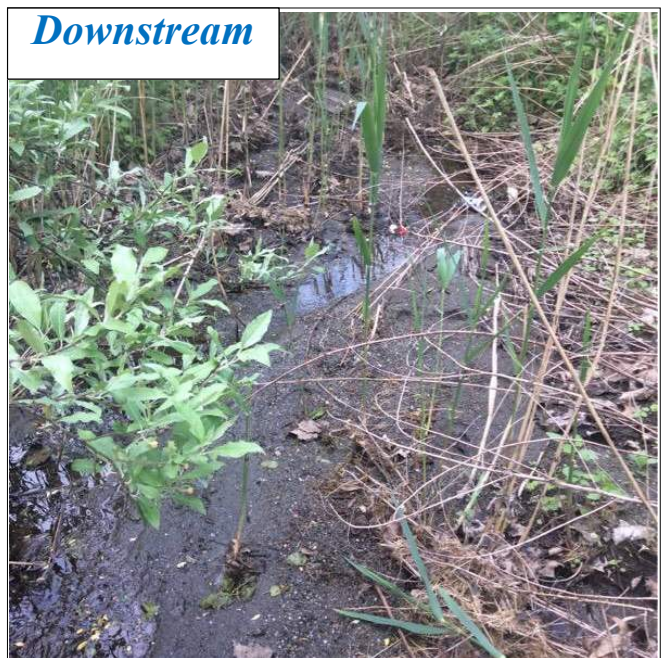
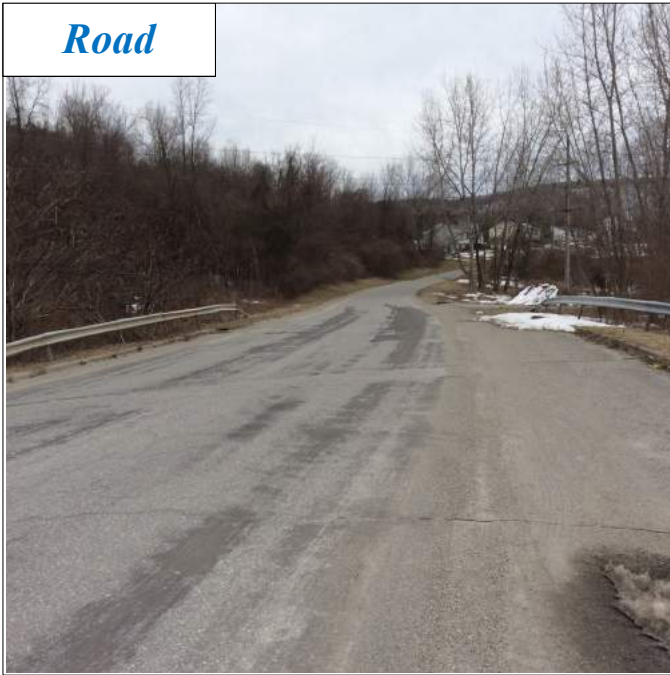
Crossing Comments: There are storm drains on the outlet side and another culvert going underground on the inlet side

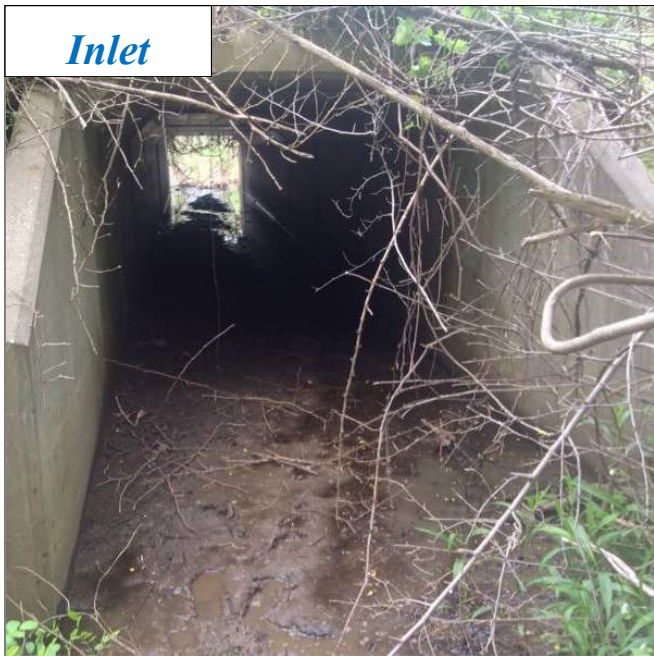
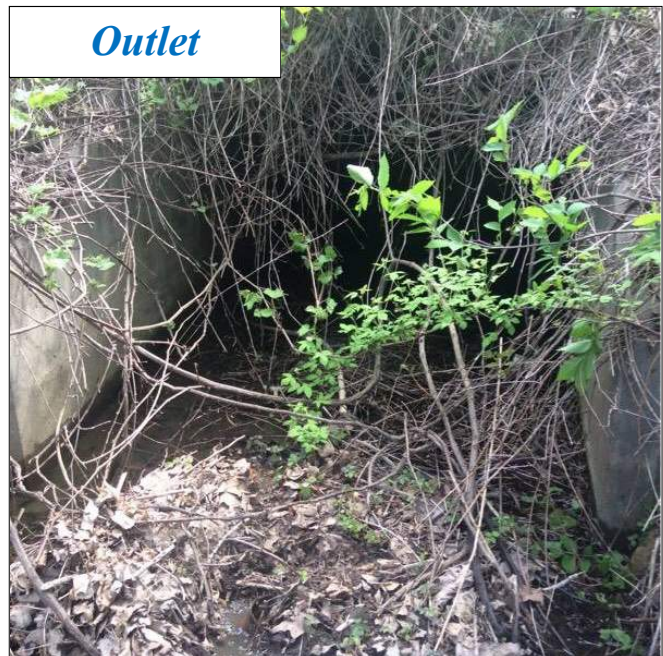
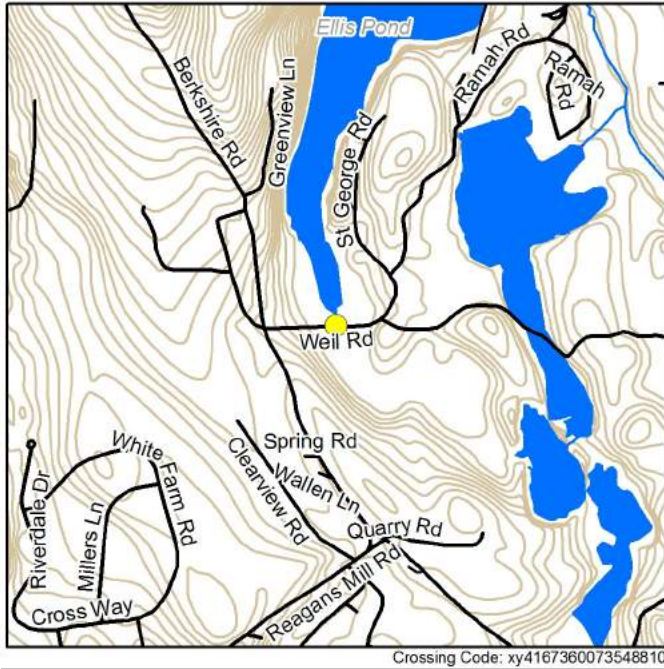
Physical Barrier(s)/Severity: Debris/Sediment/
Rock (Moderate)
Slope: 0.2%
Structure Comments: No data

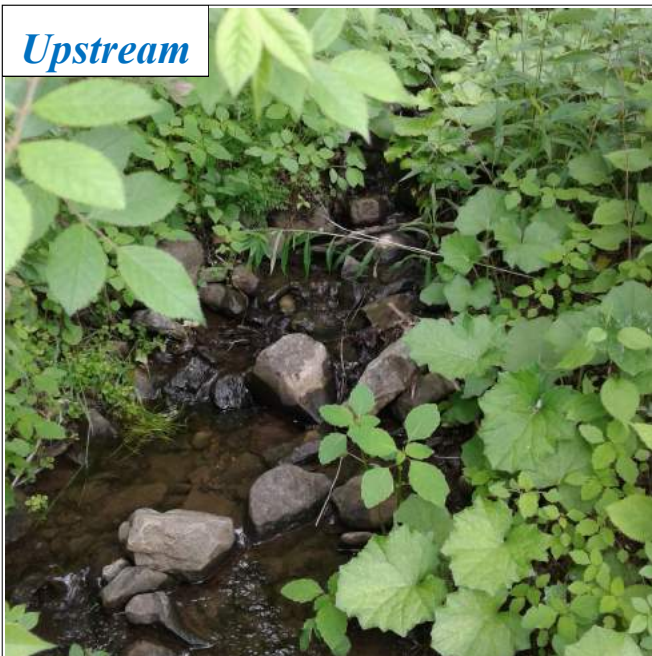
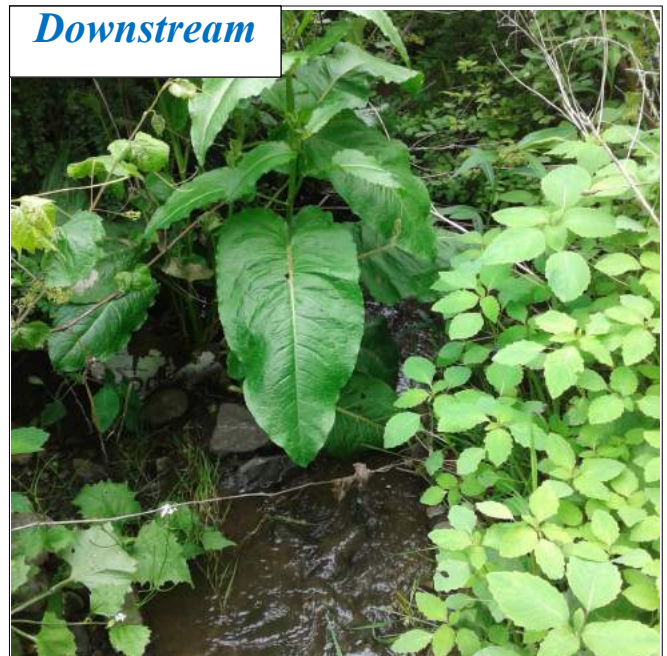
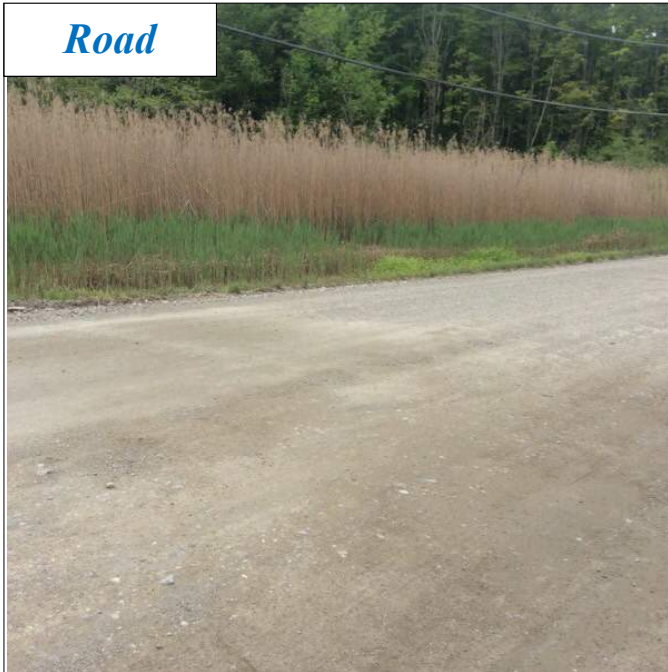
Crossing Comments: No upstream channel-Ellis pond

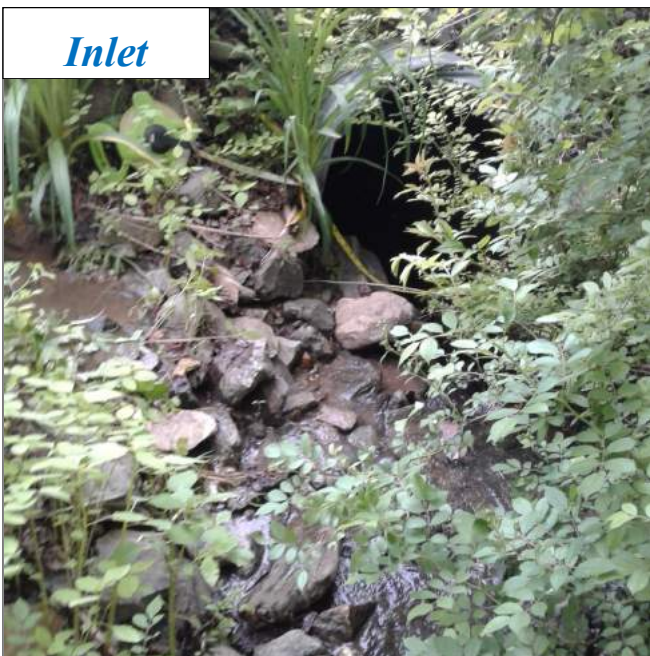
Inlet Shape/Type: Round Culvert
Inlet Drop/Grade: Perched
Dimensions:
Width: 1.2, Height: 1.2
Substrate/Water Width: 1.0
Water Depth: 0.2
Abutment Height: No data

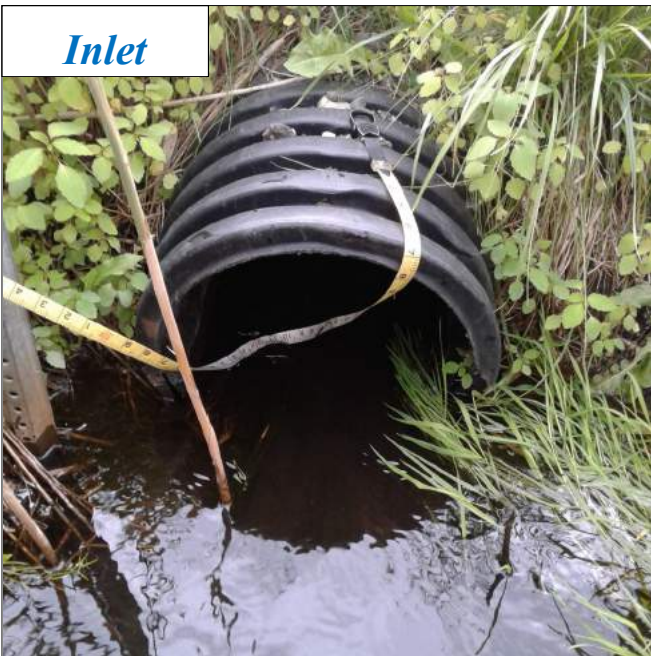
INLET

Inlet Shape/Type: Round Culvert
Inlet Drop/Grade: Perched
Dimensions:
Width: 1.2, Height: 1.3
Substrate/Water Width: 1.2
Water Depth: 0.6
Abutment Height: No data

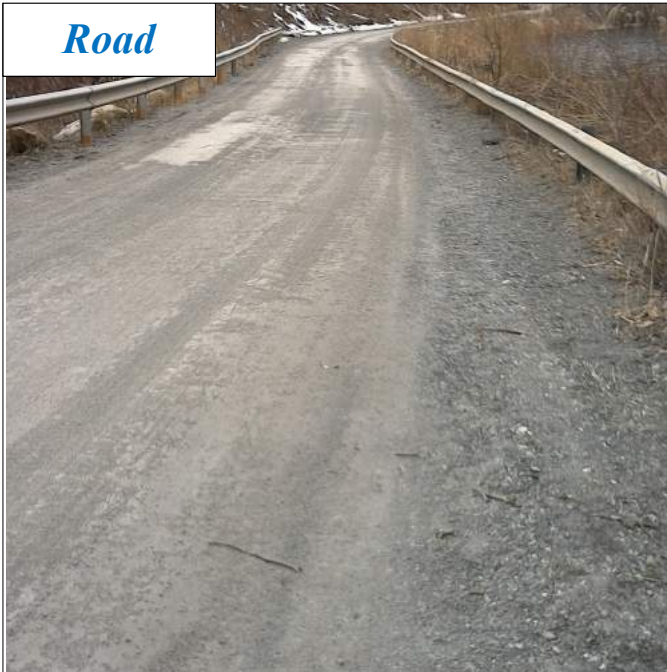
Road

Crossing Comments: No upstream channel

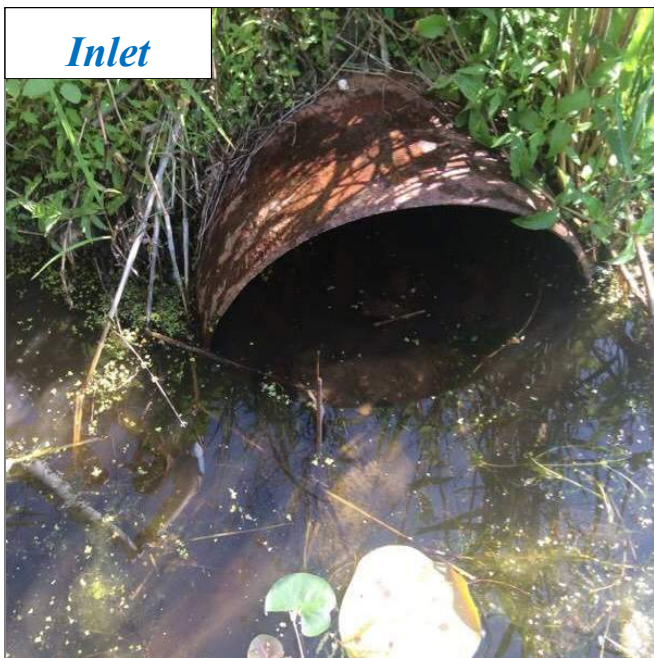
Physical Barrier(s)/Severity: Debris/Sediment/
Rock (Severe)
Slope: 1.3%
Structure Comments: No data

Inlet Shape/Type: Round Culvert
Inlet Drop/Grade: At Stream Grade
Dimensions:
Width: 1.5, Height: 1.3
Substrate/Water Width: 1.5
Water Depth: 0.6
Abutment Height: No data
