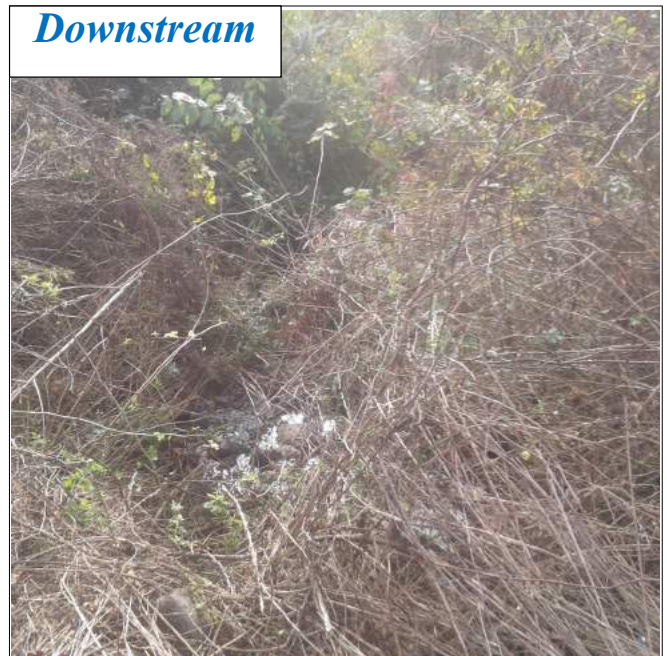
Downstream

Crossing Comments: Stormwater outfall at inlet and outlet

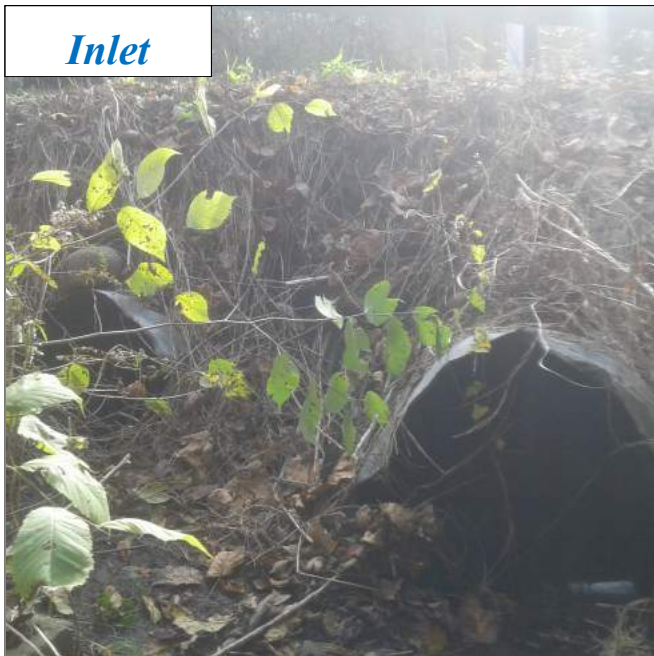
Inlet Shape/Type: Round Culvert
Inlet Drop/Grade: At Stream Grade
Dimensions:
Width: 2.4, Height: 2.3
Substrate/Water Width: 1.8
Water Depth: 0.2
Abutment Height: No data

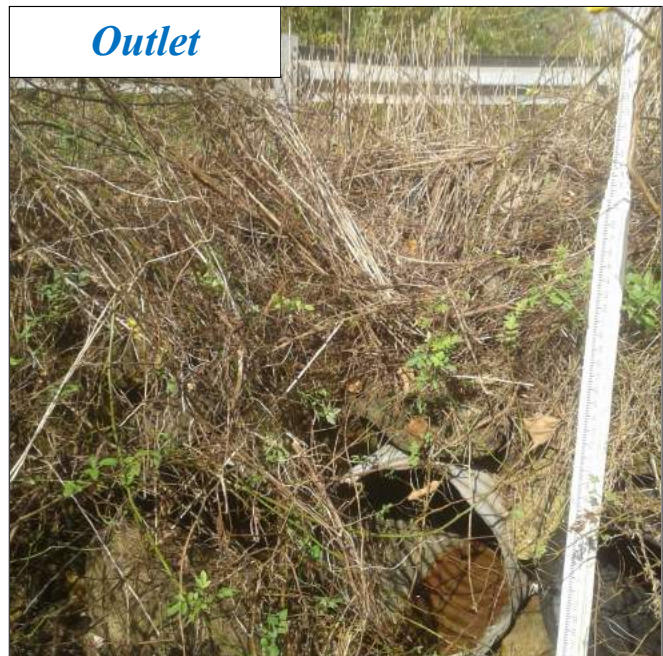
Outlet Shape: Round Culvert
Outlet Drop/Grade: At Stream Grade
Drop to Stream Surface/Bottom: 0.0/ 0.0
Dimensions:
Width: 2.6, Height: 2.6
Substrate/Water Width: 0.8
Water Depth: 0.1

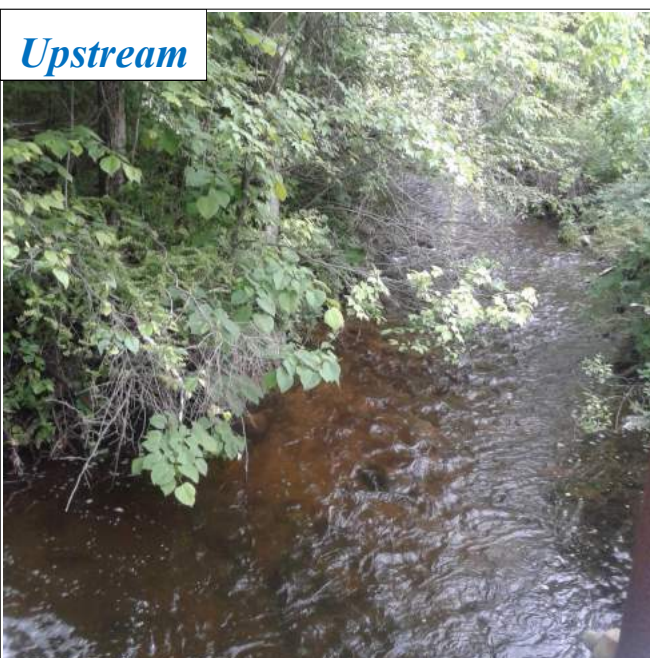
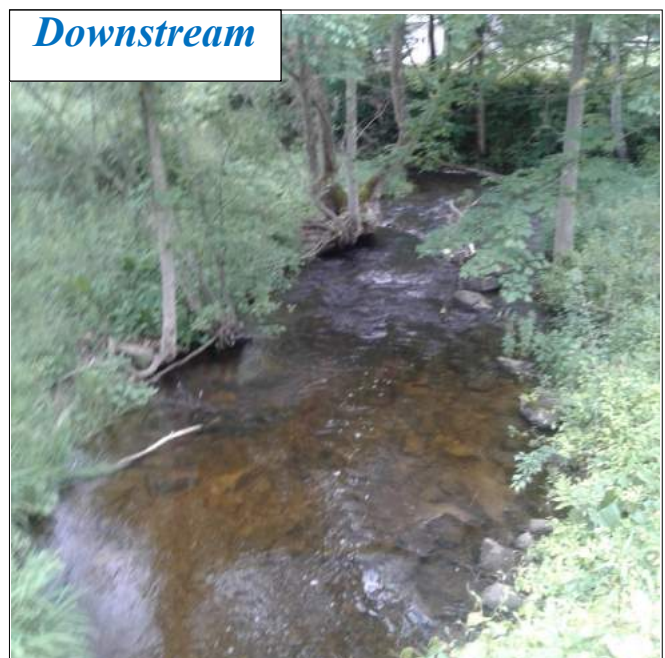
Crossing Comments: There is another stormwater outlet culvert dropping water into the inlet

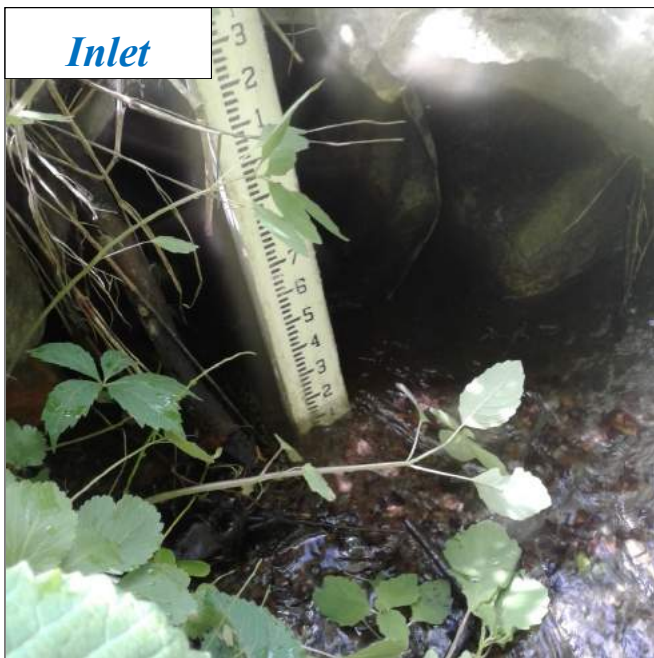
Physical Barrier(s)/Severity: Deformation (Moderate)
 Slope: 2.4%
 Structure Comments: No data

Inlet Shape/Type: Round Culvert
 Inlet Drop/Grade: At Stream Grade
 Dimensions:
 Width: 1.3, Height: 1.3
 Substrate/Water Width: 0.8
 Water Depth: 0.1
 Abutment Height: No data

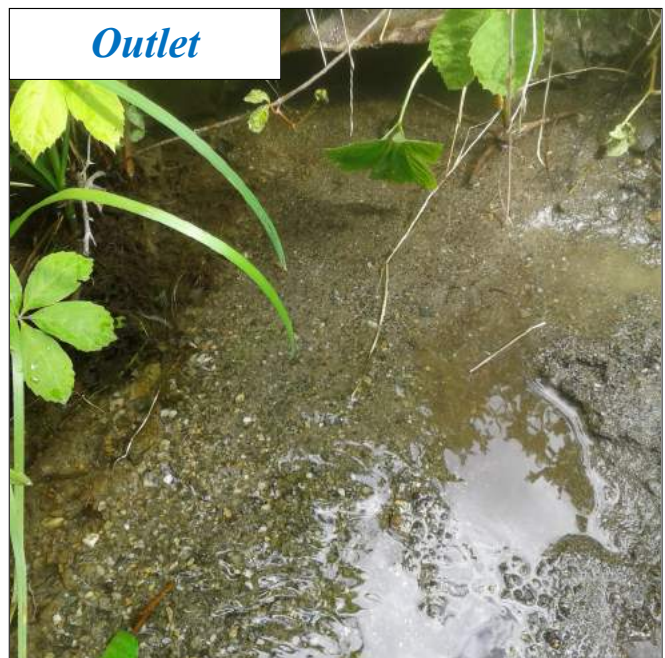
Outlet Shape: Round Culvert
 Outlet Drop/Grade: Clogged/Collapsed/Submerged
 Drop to Stream Surface/Bottom: 0.0/ 0.0
 Dimensions:
 Width: 1.2, Height: 1.0
 Substrate/Water Width: 1.2
 Water Depth: 0.5

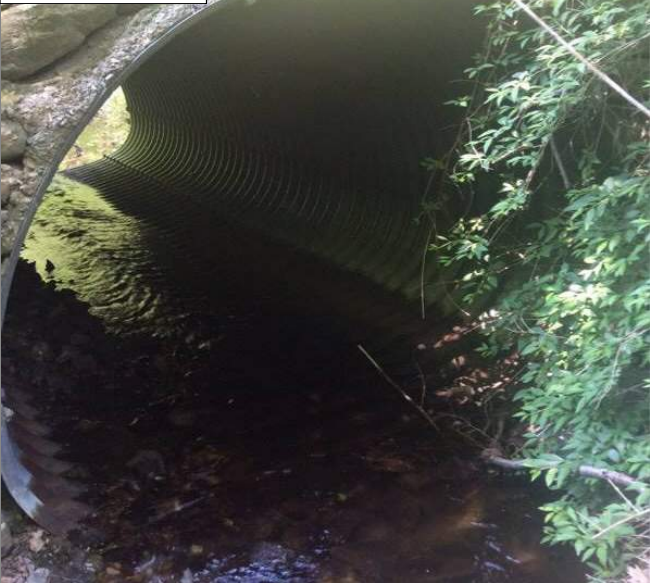
Inlet Shape/Type: Pipe Arch/Elliptical Culvert
 Inlet Drop/Grade: At Stream Grade
 Dimensions:

Width: 7.5, Height: 6.0
 Substrate/Water Width: 4.2
 Water Depth: 0.4
 Abutment Height: No data

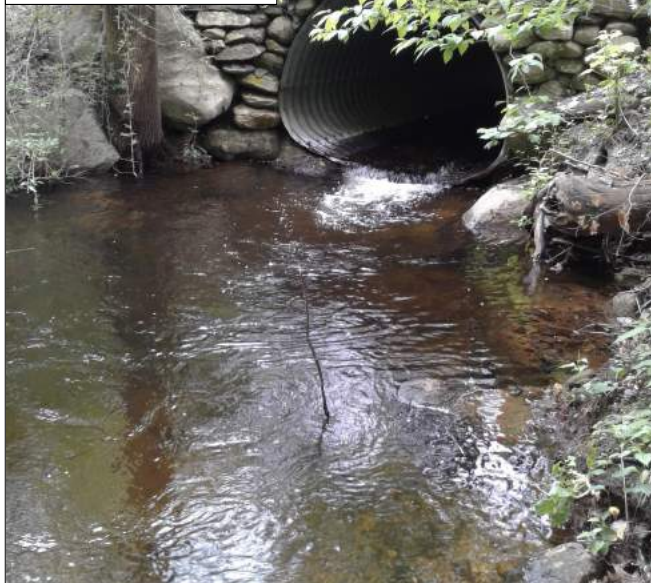
Outlet Shape: Pipe Arch/Elliptical Culvert
 Outlet Drop/Grade: Free Fall
 Drop to Stream Surface/Bottom: 0.5/ 2.3
 Dimensions:

Width: 7.5, Height: 6.0
 Substrate/Water Width: 4.2
 Water Depth: 0.2

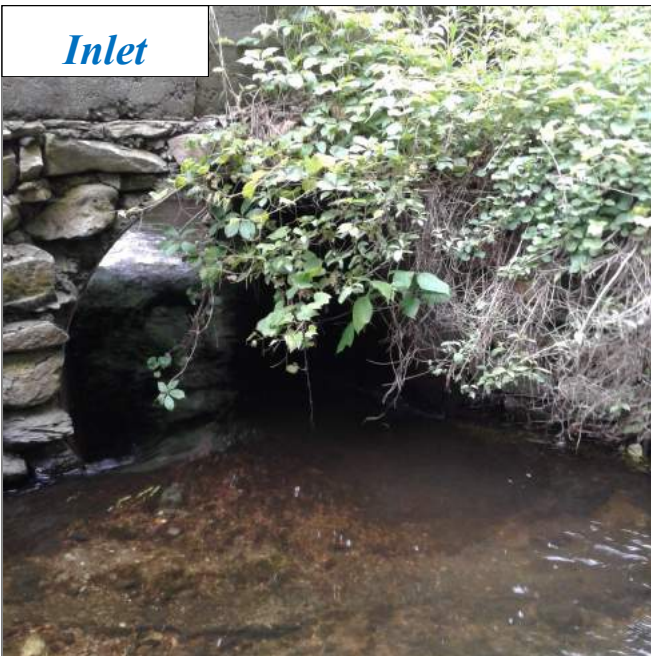
Inlet Shape/Type: Round Culvert
Inlet Drop/Grade: At Stream Grade
Dimensions:
Width: 5.9, Height: 4.3
Substrate/Water Width: 5.3
Water Depth: 0.4
Abutment Height: No data

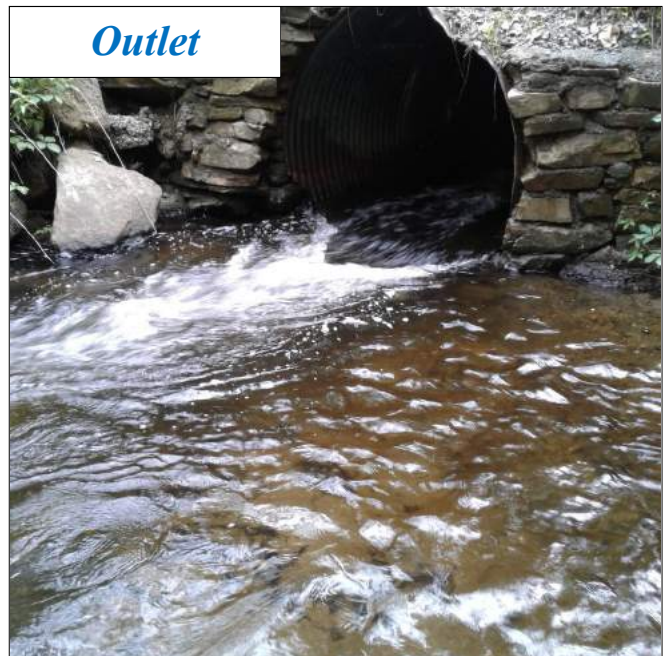
Outlet Shape: Round Culvert
Outlet Drop/Grade: At Stream Grade
Drop to Stream Surface/Bottom: 0.0/ 0.0
Dimensions:
Width: 6.0, Height: 5.1
Substrate/Water Width: 5.0
Water Depth: 0.7

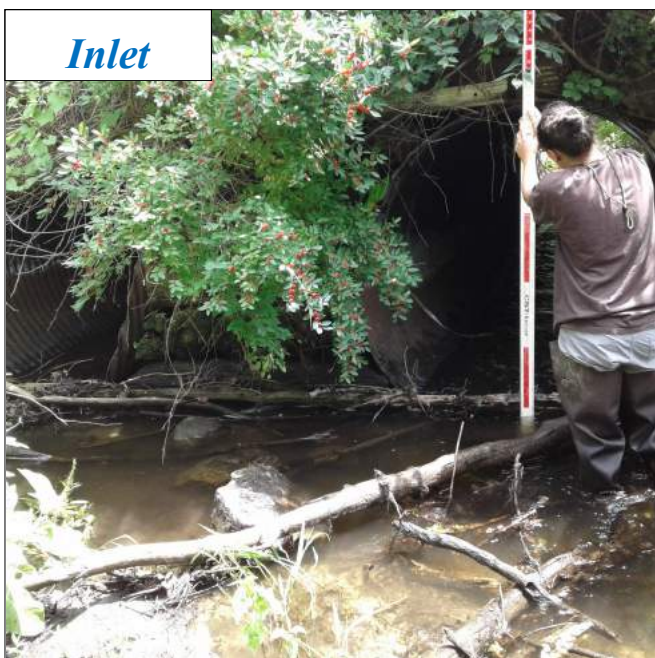
Physical Barrier(s)/Severity: Debris/Sediment/
 Rock (Minor)
 Slope: 2.3%
 Structure Comments: No data

Inlet Shape/Type: Round Culvert
 Inlet Drop/Grade: Unknown
 Dimensions:
 Width: 4.8, Height: 4.9
 Substrate/Water Width: 2.4
 Water Depth: 0.4
 Abutment Height: No data

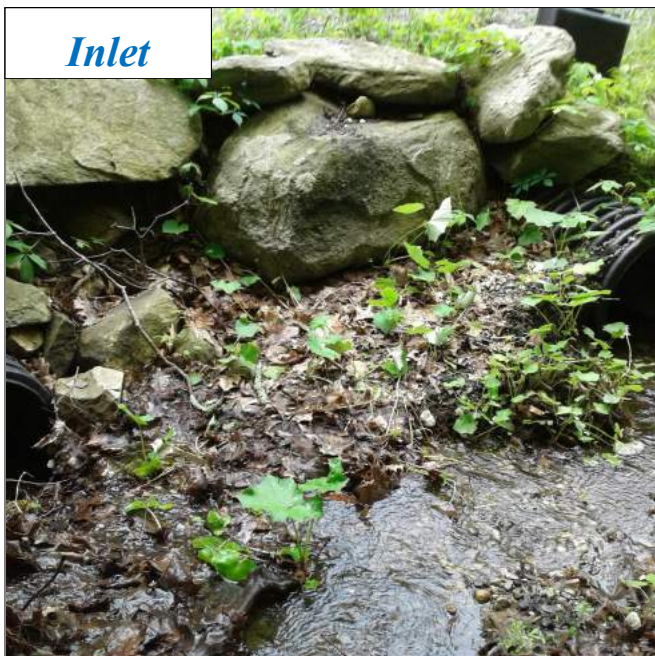
Inlet Shape/Type: Round Culvert
Inlet Drop/Grade: Inlet Drop
Dimensions:
Width: 1.1, Height: 1.3
Substrate/Water Width: 0.8
Water Depth: 0.1
Abutment Height: No data

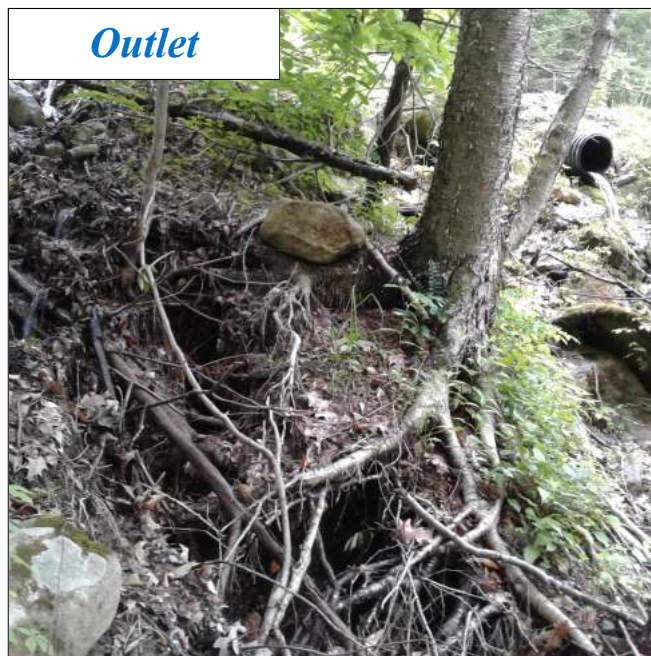
Outlet Shape: Round Culvert
Outlet Drop/Grade: Clogged/Collapsed/Submerged
Drop to Stream Surface/Bottom (feet): 0.0/0.0
Dimensions (feet):
Width: 1.5, Height: 1.6
Substrate/Water Width: 0.0
Water Depth: 0.00

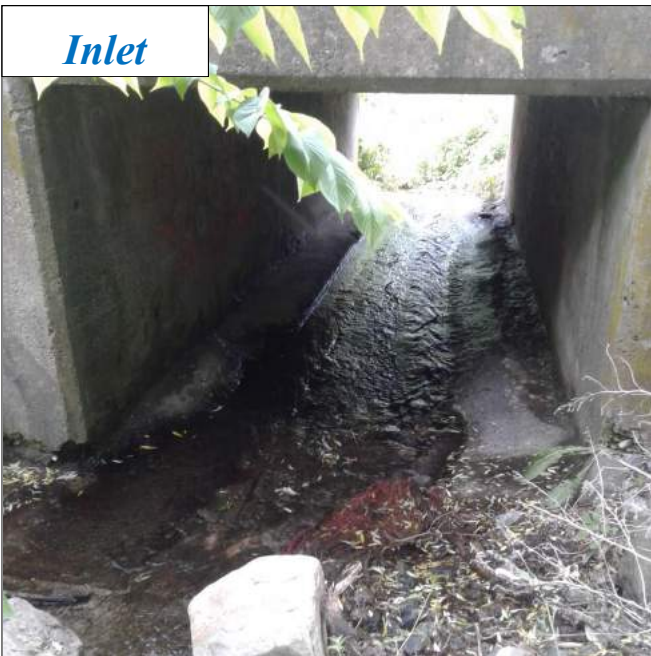
Inlet Shape/Type: Box Culvert
Inlet Drop/Grade: At Stream Grade
Dimensions:
Width: 7.8, Height: 5.4
Substrate/Water Width: 4.4
Water Depth: 0.1
Abutment Height: No data

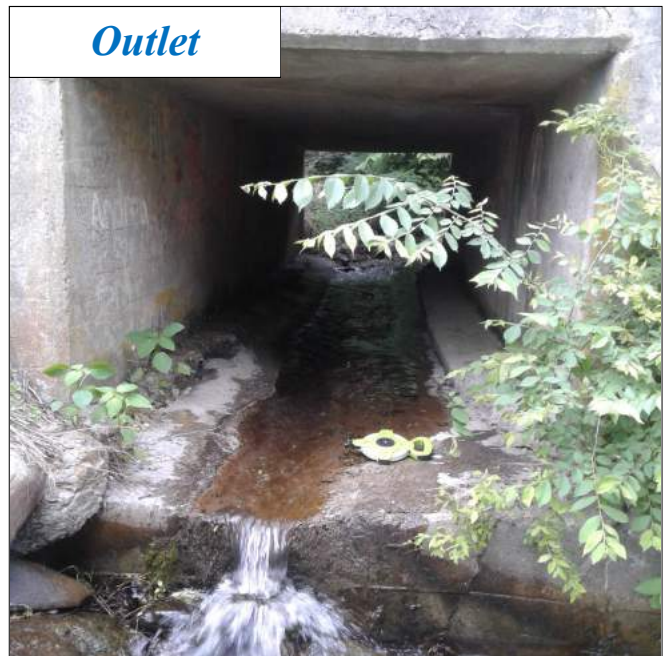
Outlet Shape: Box Culvert
Outlet Drop/Grade: Cascade
Drop to Stream Surface/Bottom: 2.0/ 2.1
Dimensions:
Width: 7.8, Height: 5.5
Substrate/Water Width: 1.5
Water Depth: 0.1

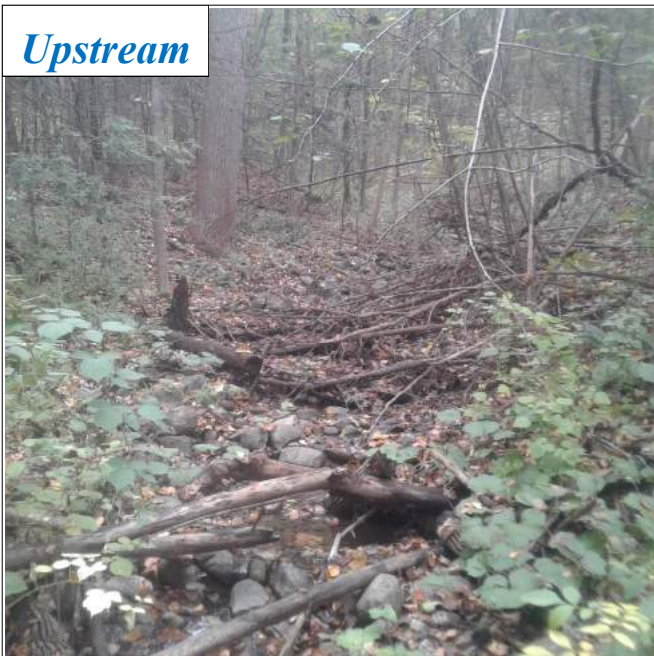
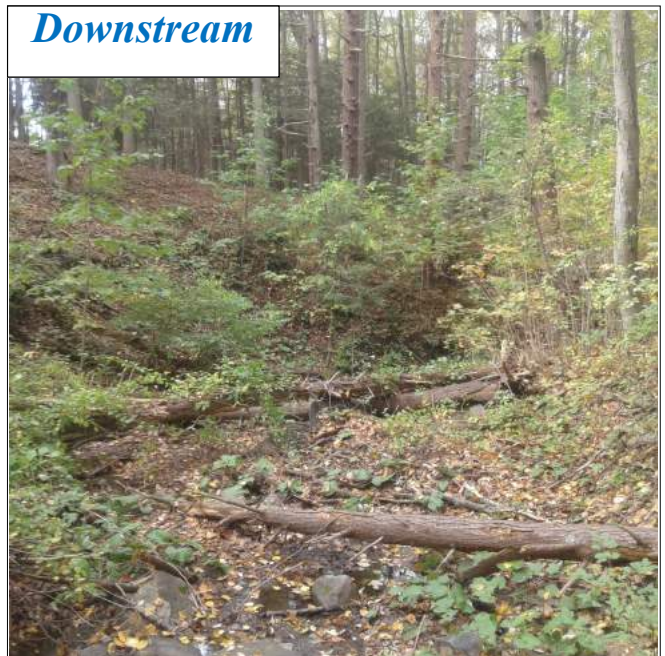
Crossing Comments: Tree fell onto section near out creating hole

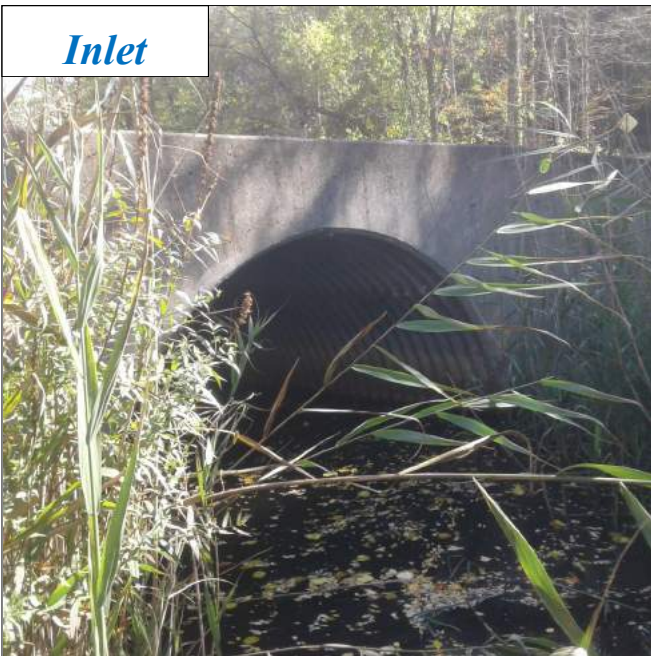
Inlet Shape/Type: Pipe Arch/Elliptical Culvert
Inlet Drop/Grade: At Stream Grade
Dimensions:
Width: 12.7, Height: 8.3
Substrate/Water Width: 12.7
Water Depth: 2.8
Abutment Height: No data

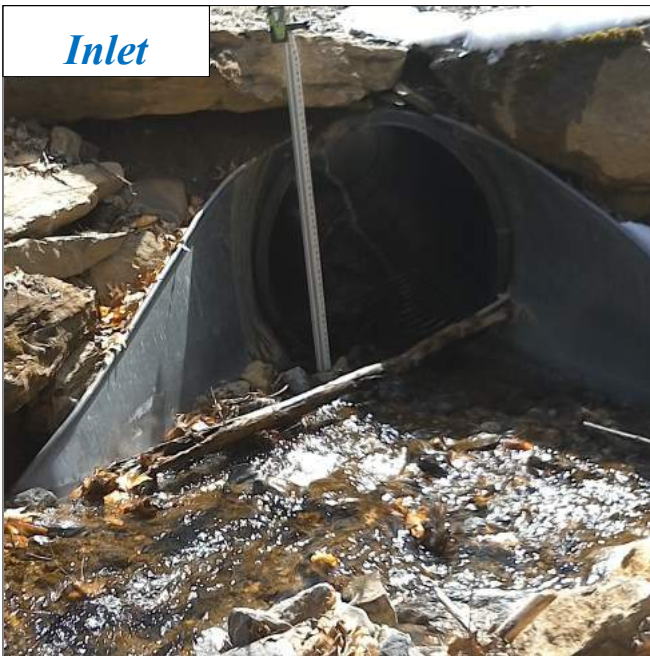
Inlet Shape/Type: Round Culvert
Inlet Drop/Grade: At Stream Grade
Dimensions:
Width: 2.7, Height: 4.0
Substrate/Water Width: 1.7
Water Depth: 0.1
Abutment Height: No data

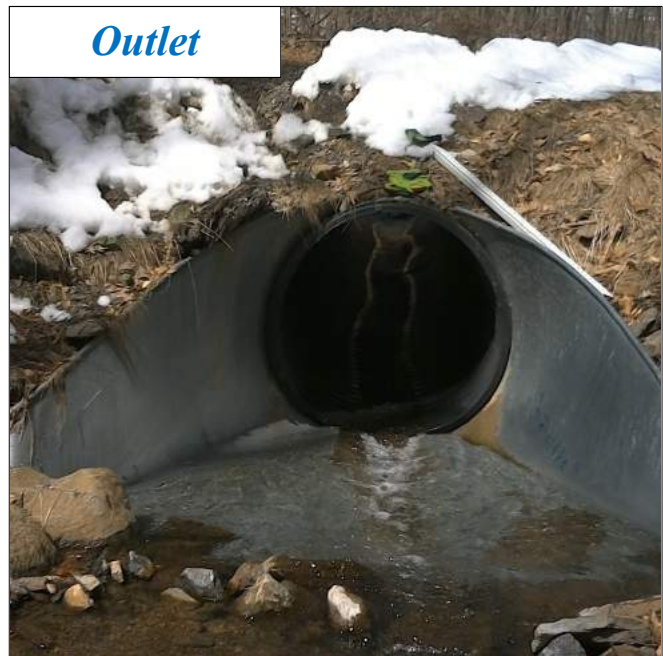
Outlet Shape: Round Culvert
Outlet Drop/Grade: At Stream Grade
Drop to Stream Surface/Bottom: 0.0/ 0.0
Dimensions:
Width: 3.9, Height: 4.0
Substrate/Water Width: 1.1
Water Depth: 0.05

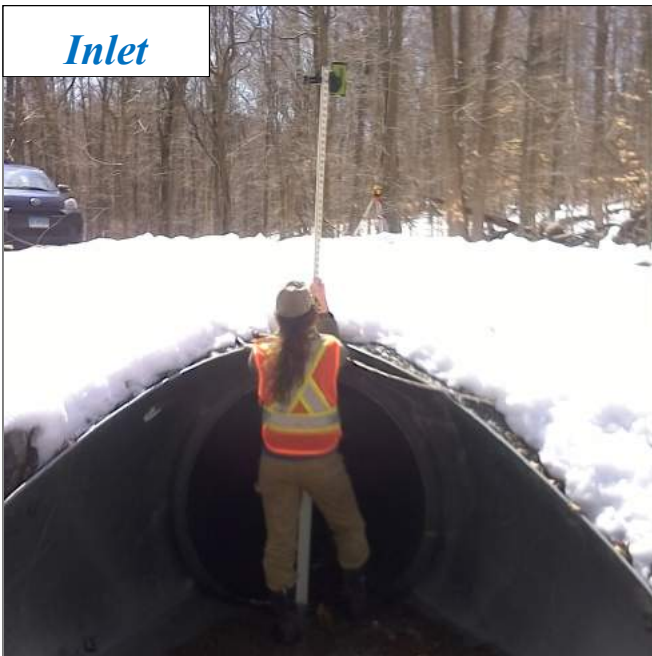
Inlet Shape/Type: Round Culvert
Inlet Drop/Grade: At Stream Grade
Dimensions:
Width: 3.9, Height: 4.0
Substrate/Water Width: 1.5
Water Depth: 0.2
Abutment Height: No data

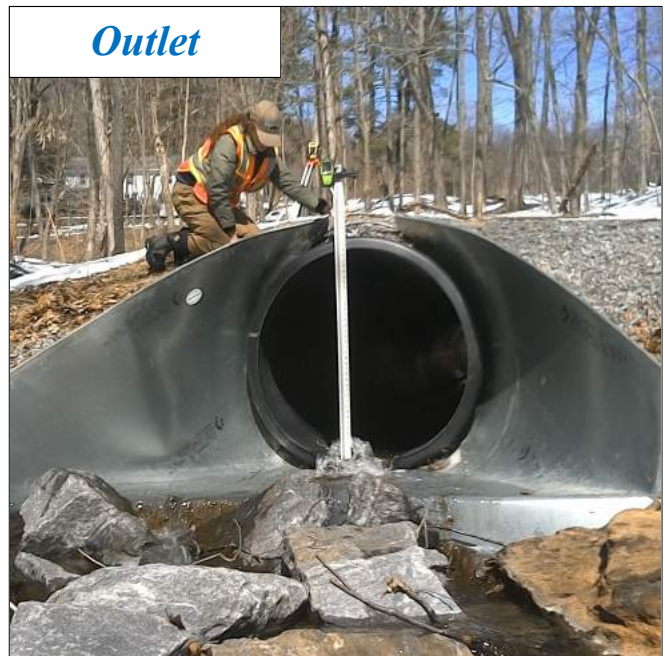
Outlet Shape: Round Culvert
Outlet Drop/Grade: Free Fall Onto Cascade
Drop to Stream Surface/Bottom: 0.5/ 0.9
Dimensions:
Width: 3.9, Height: 4.0
Substrate/Water Width: 1.3
Water Depth: 0.1

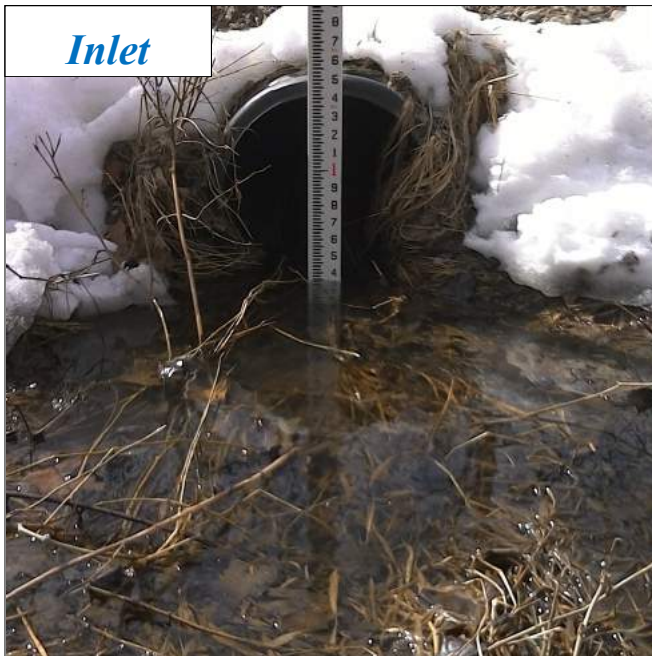
Inlet Shape/Type: Round Culvert
 Inlet Drop/Grade: At Stream Grade
 Dimensions:
 Width: 1.3, Height: 1.4
 Substrate/Water Width: 0.9
 Water Depth: 0.3
 Abutment Height: No data

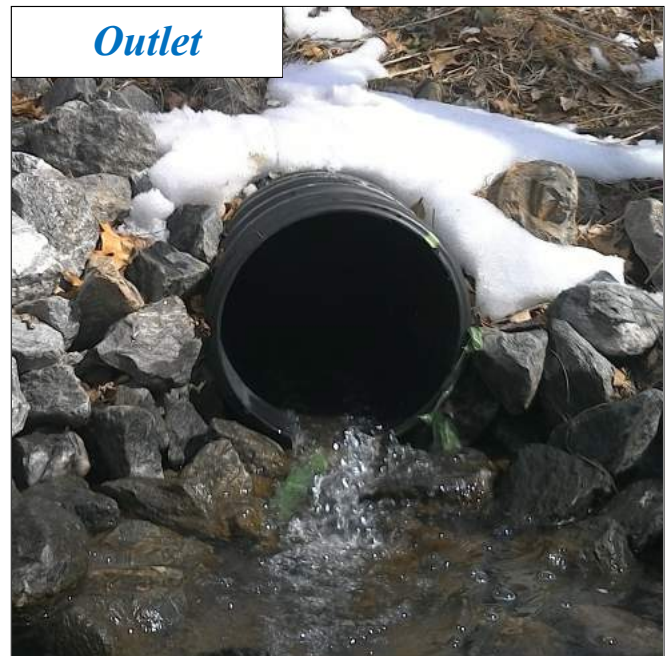
Outlet Shape: Round Culvert
 Outlet Drop/Grade: Free Fall
 Drop to Stream Surface/Bottom: 0.1/ 0.2
 Dimensions:
 Width: 1.3, Height: 1.3
 Substrate/Water Width: 0.5
 Water Depth: 0.0

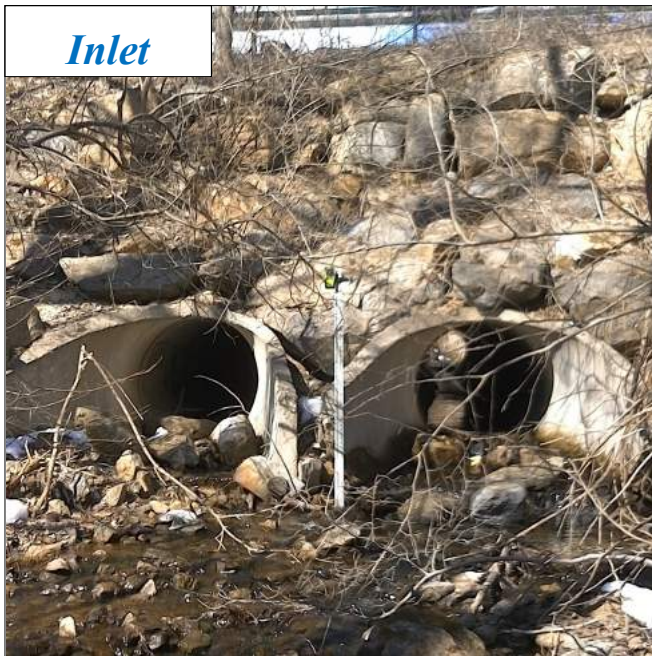
Inlet Shape/Type: Round Culvert
 Inlet Drop/Grade: At Stream Grade
 Dimensions:
 Width: 4.0, Height: 4.0
 Substrate/Water Width: 2.5
 Water Depth: 0.5
 Abutment Height: No data

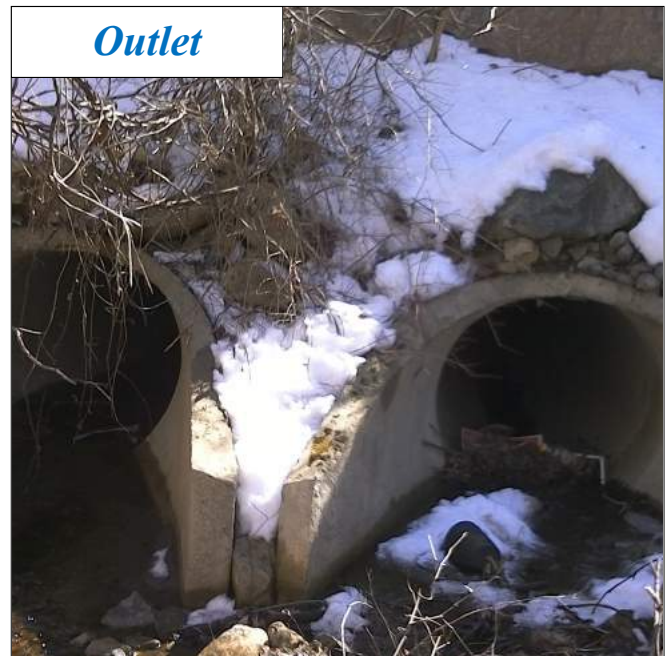
Outlet Shape: Round Culvert
Outlet Drop/Grade: Free Fall
Drop to Stream Surface/Bottom (feet): 0.5/0.5
Dimensions (feet):
Width: 3.9, Height: 4.0
Substrate/Water Width: 1.8
Water Depth: 0.00

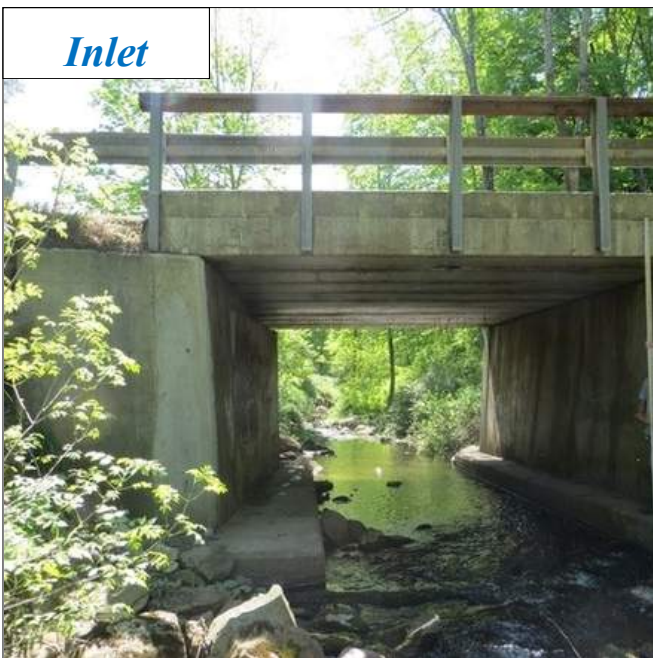
Inlet Shape/Type: Box/Bridge with Abutments
 Inlet Drop/Grade: At Stream Grade
 Dimensions:
 Width: 11.5, Height: 11.8
 Substrate/Water Width: 11.5
 Water Depth: 0.5
 Abutment Height: No data

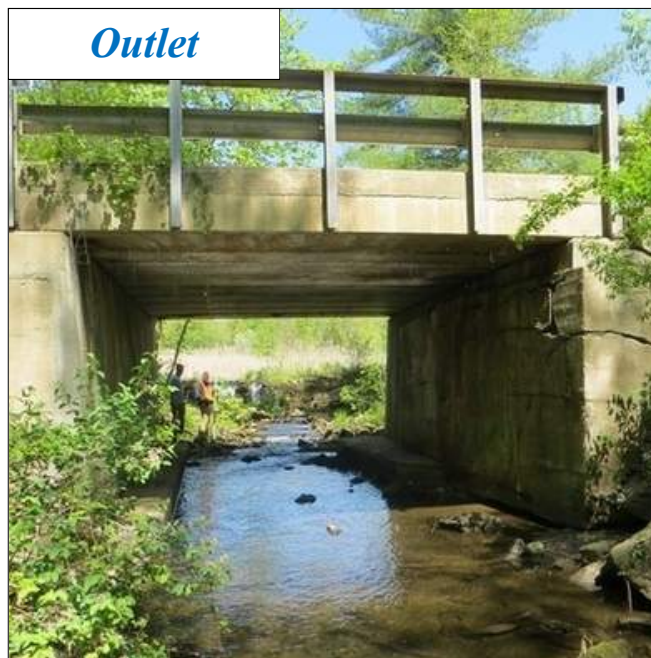
Outlet Shape: Box/Bridge with Abutments
 Outlet Drop/Grade: At Stream Grade
 Drop to Stream Surface/Bottom: 0.0/ 0.0
 Dimensions:
 Width: 14.0, Height: 11.8
 Substrate/Water Width: 14.0
 Water Depth: 1.4

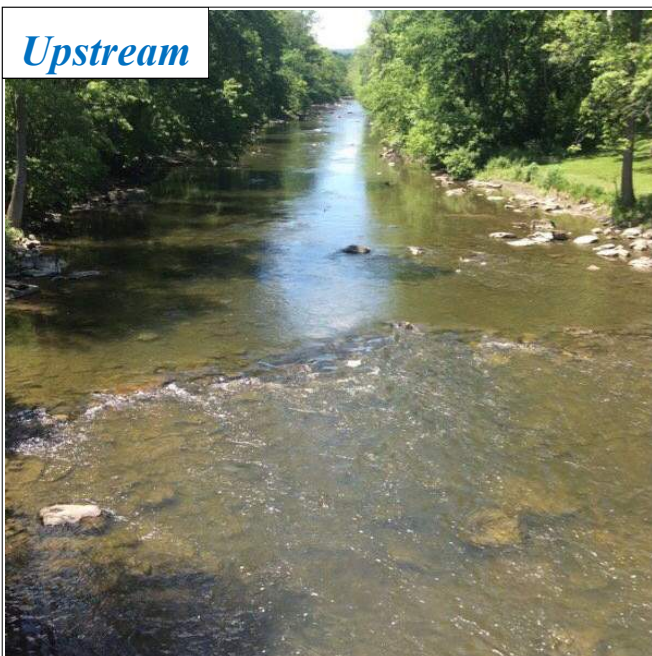
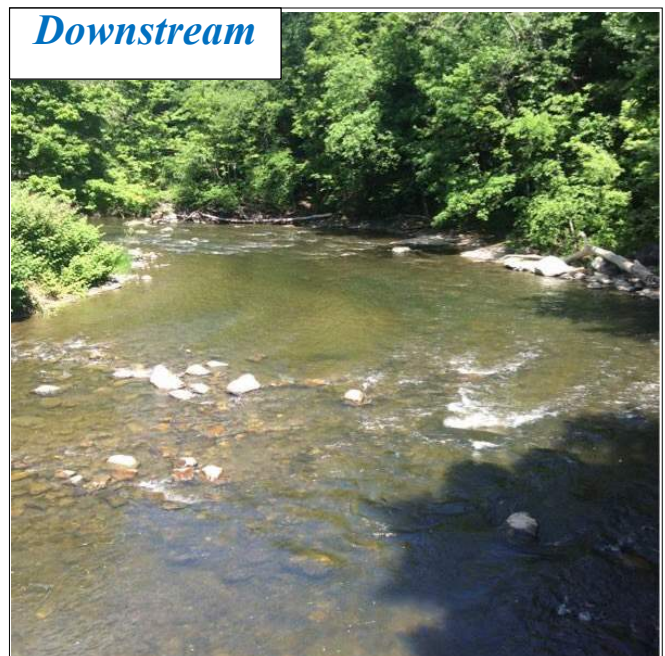
Crossing Comments: Bridge Adequate

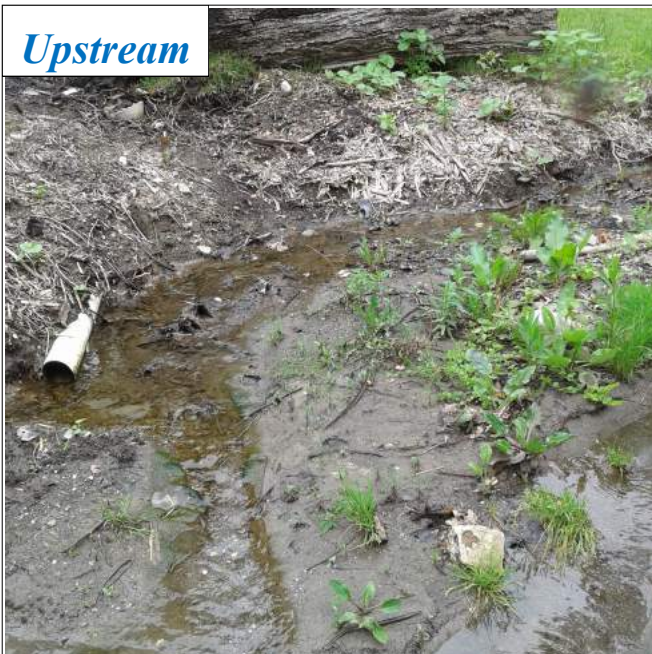
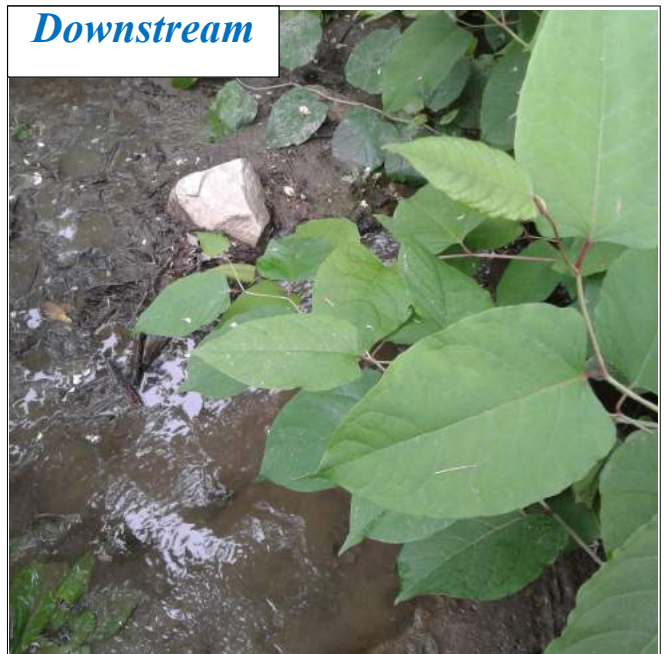
Crossing Comments: Poor Condition. Spoke to resident who believes guardrail should be added and said many accidents occur at this turn and the cars flip into the stream. Usually

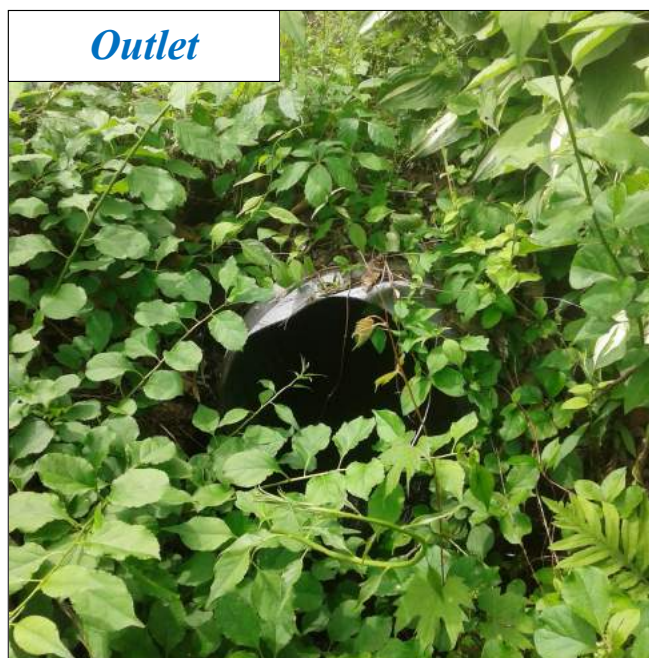
Outlet Shape: Round Culvert
Outlet Drop/Grade: Free Fall Onto Cascade
Drop to Stream Surface/Bottom: 1.5/ 1.6
Dimensions:
Width: 1.5, Height: 1.6
Substrate/Water Width: 0.4
Water Depth: 0.1

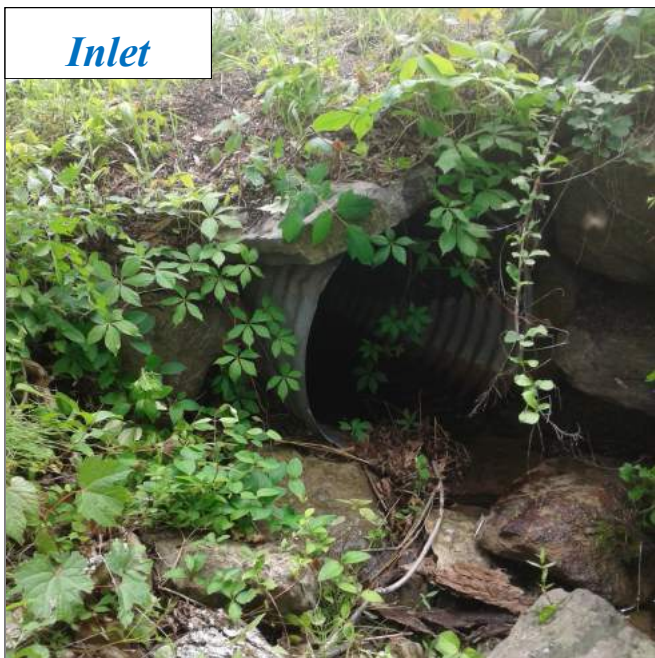
Inlet Shape/Type: Round Culvert
 Inlet Drop/Grade: Perched
 Dimensions:
 Width: 2.5, Height: 2.5
 Substrate/Water Width: 1.0
 Water Depth: 0.1
 Abutment Height: No data

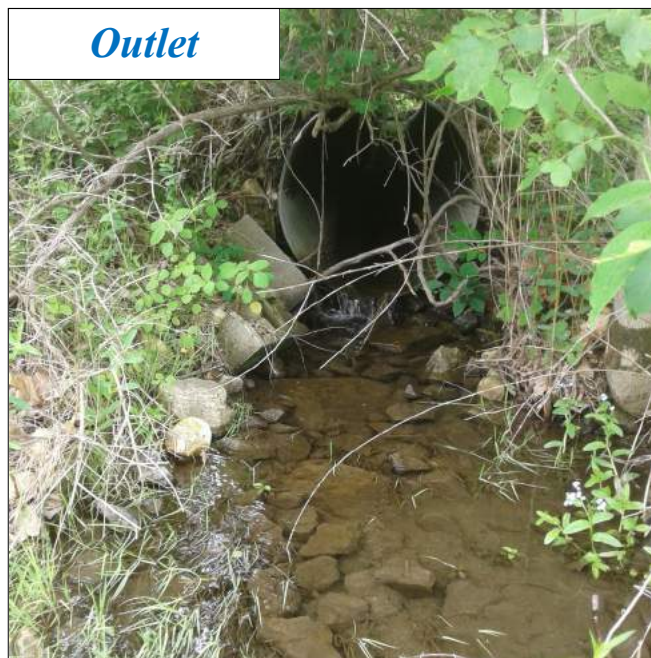
Outlet Shape: Round Culvert
 Outlet Drop/Grade: Free Fall
 Drop to Stream Surface/Bottom: 0.8/ 0.9
 Dimensions:
 Width: 2.5, Height: 2.5
 Substrate/Water Width: 0.9
 Water Depth: 0.1

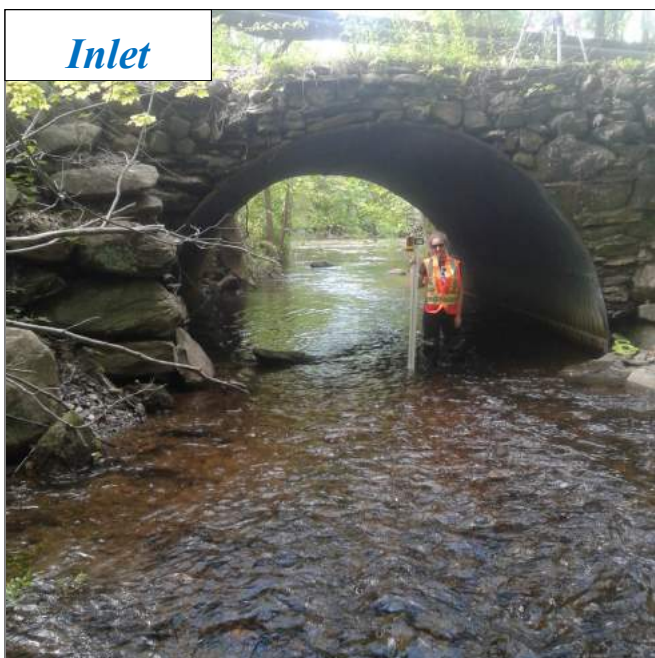
Inlet

Physical Barrier(s)/Severity: Debris/Sediment/
 Rock (Moderate)
 Slope: 0.8%
 Structure Comments: No data

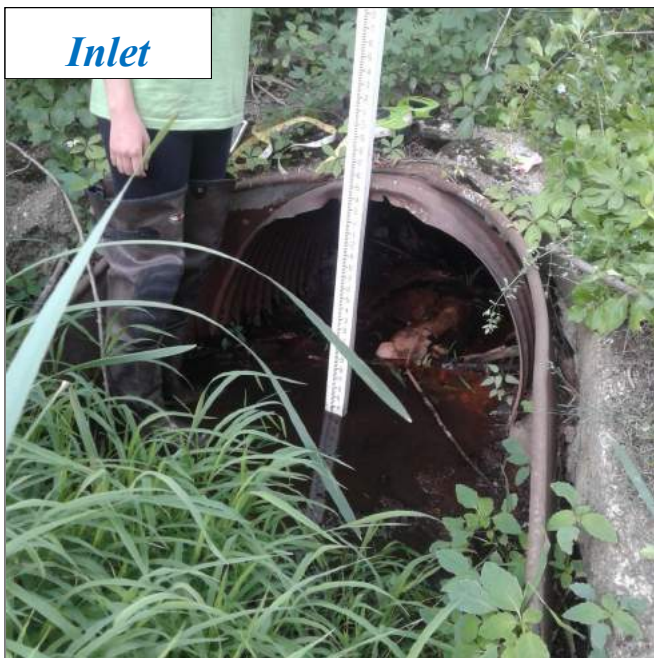
Physical Barrier(s)/Severity: None
Slope: 0.6%
Structure Comments: Bottom of structure is completely rusted out

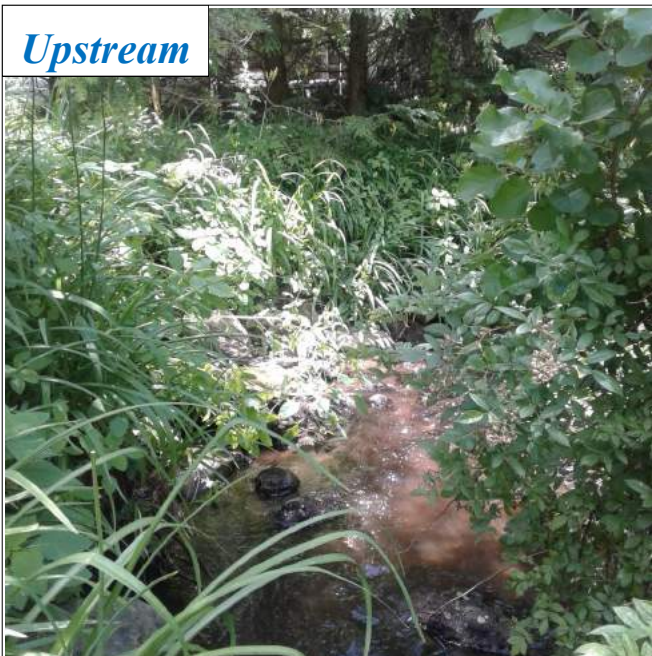
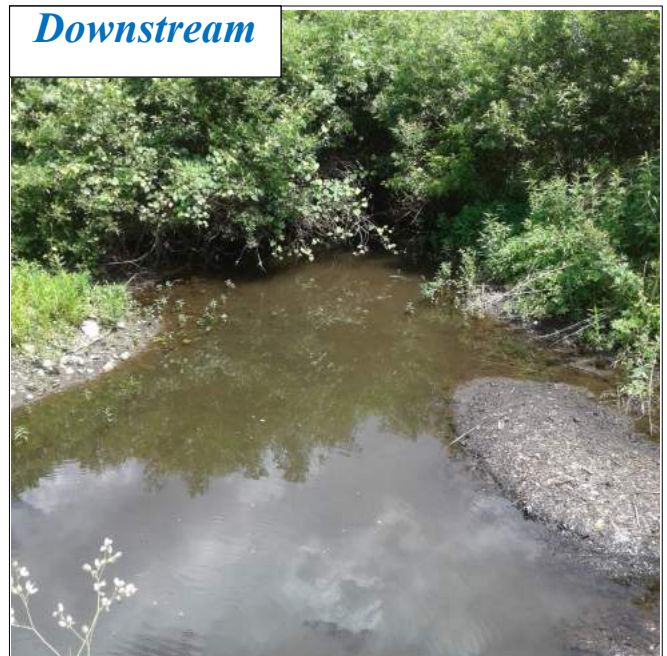
Crossing Comments: Build up of sediment throughout structure causing water to pool at the inlet

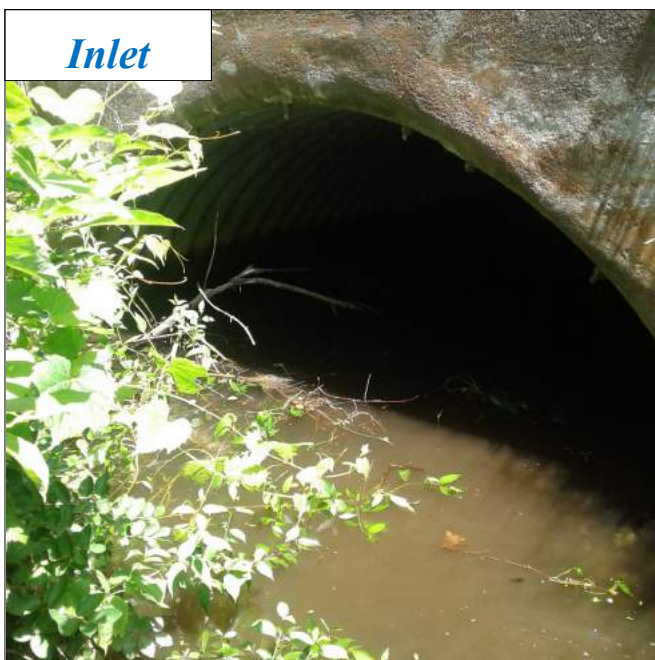
Inlet

Physical Barrier(s)/Severity: Debris/Sediment/
 Rock (Moderate)
 Slope: No data
 Structure Comments: No data

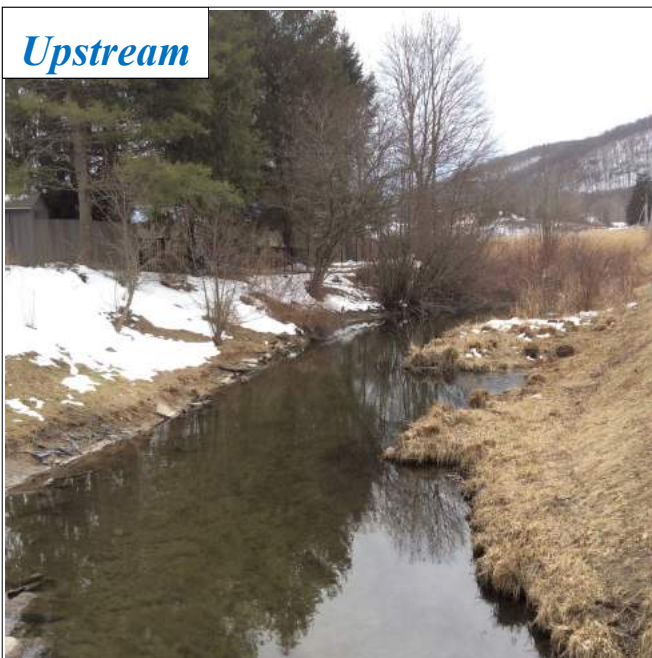
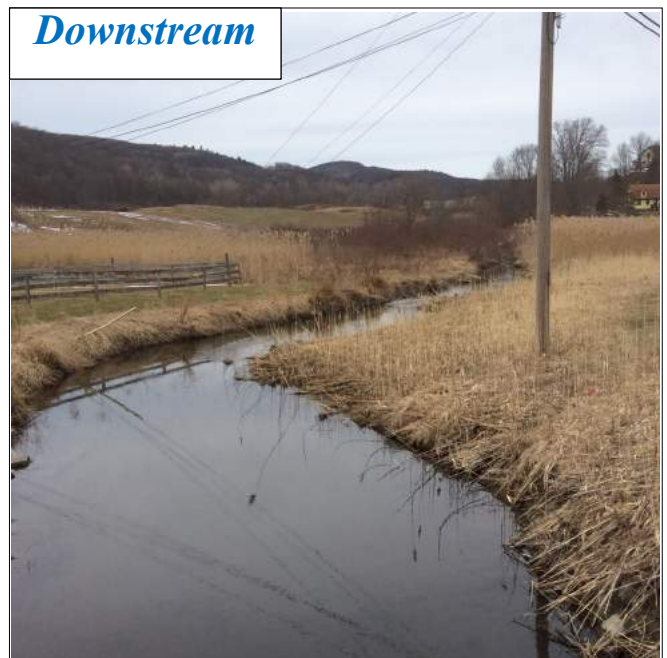
Crossing Comments: Limited access to property, spoke to adjacent landowners who noted beaver damage, bridge did flood in 1955

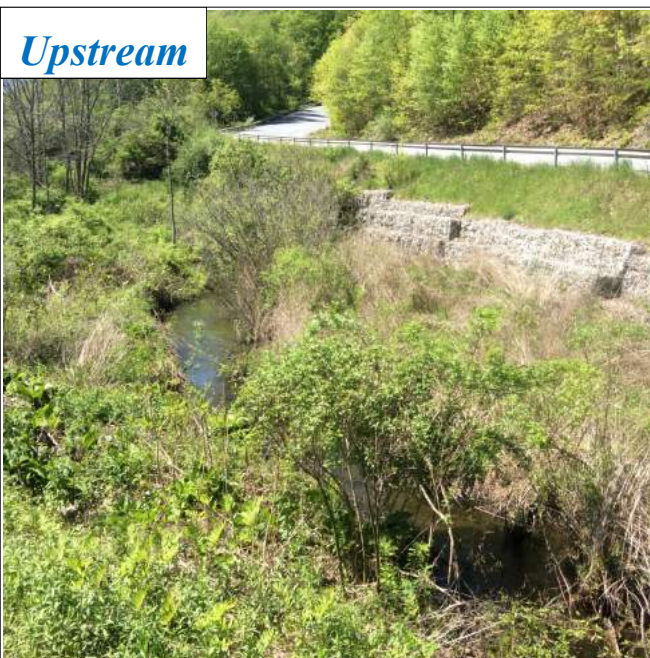
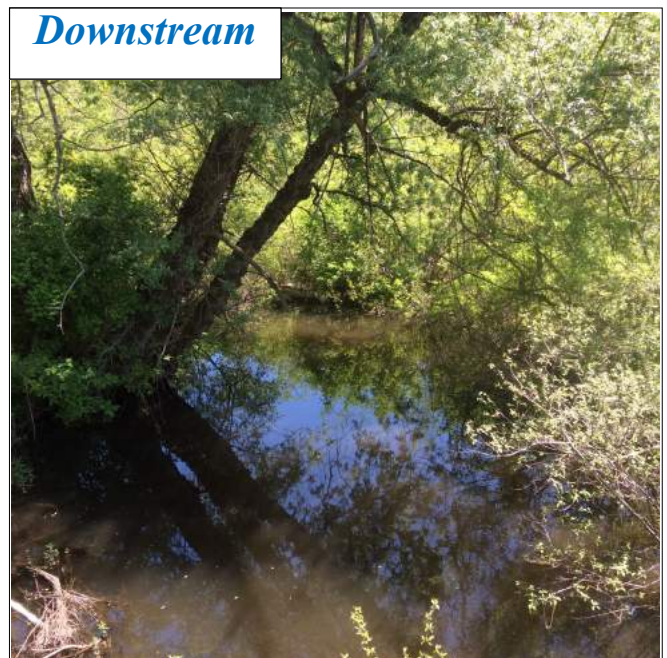
Crossing Comments: Downstream beaver dam pounding at outlet

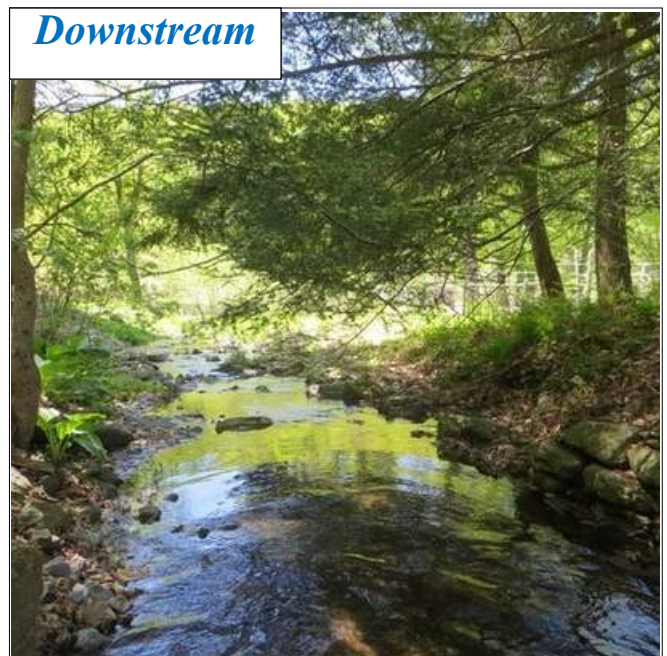
Downstream

Crossing Comments: No data

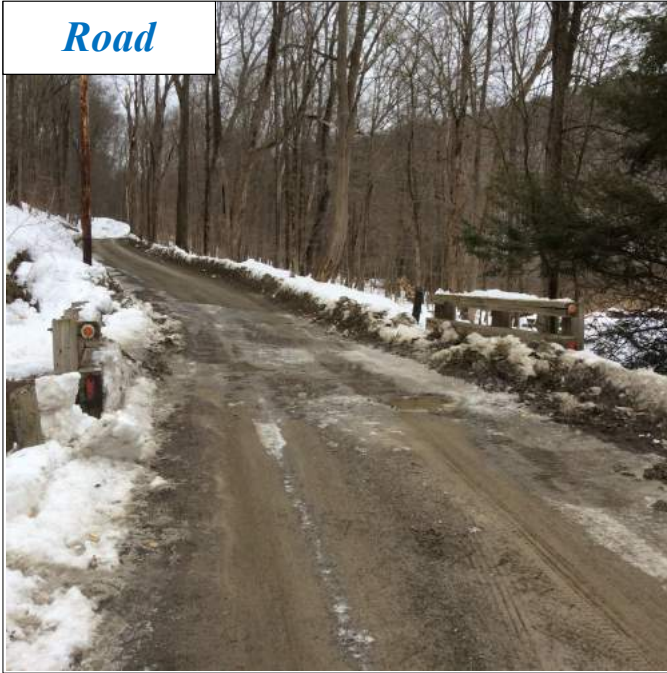
Road Type/Surface: Paved
Road Fill Height (feet): 0.7

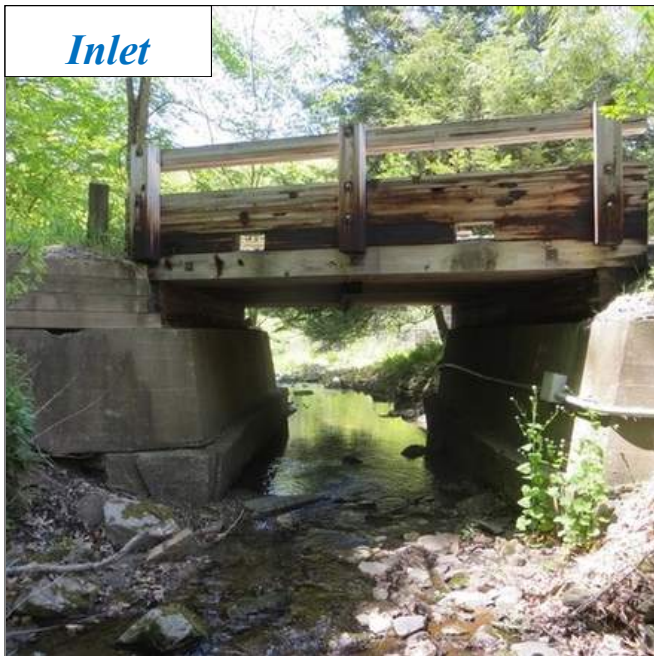
Inlet Shape/Type: Box/Bridge with Abutments
Inlet Drop/Grade: At Stream Grade
Dimensions:
Width: 8.0, Height: 6.7
Substrate/Water Width: 5.4
Water Depth: 0.2
Abutment Height: No data

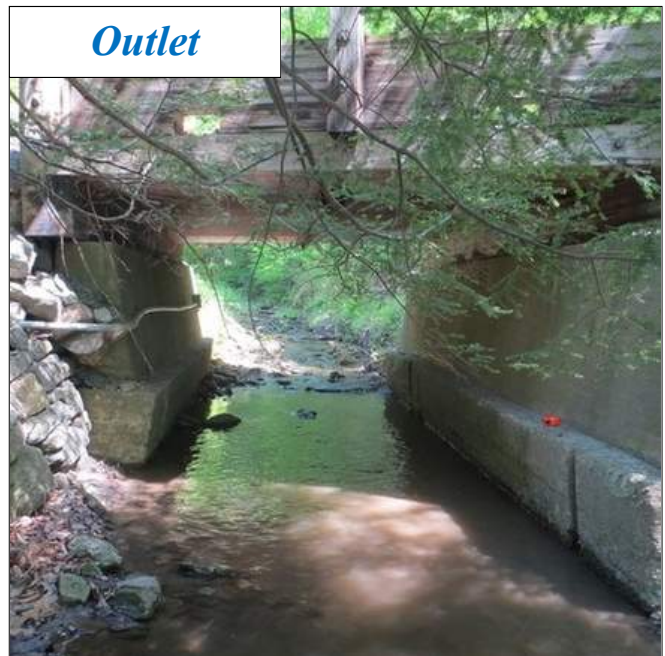
Outlet Shape: Box/Bridge with Abutments
Outlet Drop/Grade: At Stream Grade
Drop to Stream Surface/Bottom: 0.0/ 0.0
Dimensions:
Width: 7.8, Height: 7.2
Substrate/Water Width: 7.8
Water Depth: 0.9
