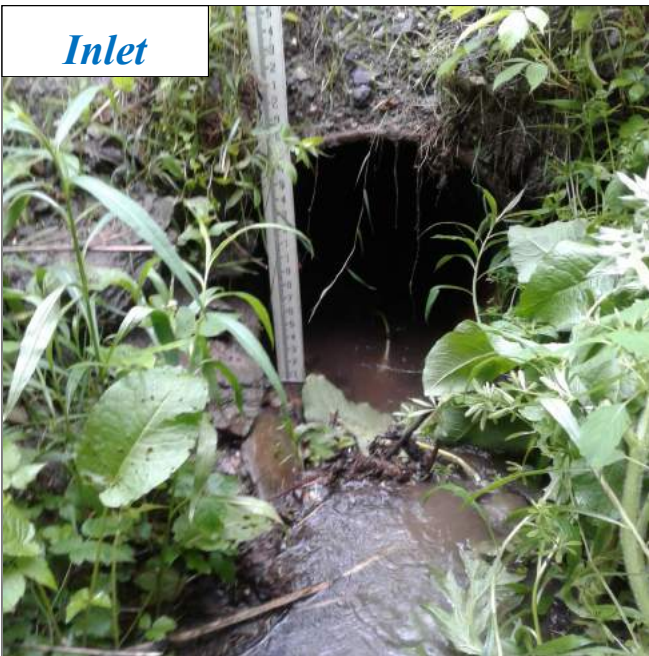
Inlet Shape/Type: Round Culvert
Inlet Drop/Grade: At Stream Grade
Dimensions:
Width: 2.0, Height: 2.0
Substrate/Water Width: 0.9
Water Depth: 0.1
Abutment Height: No data

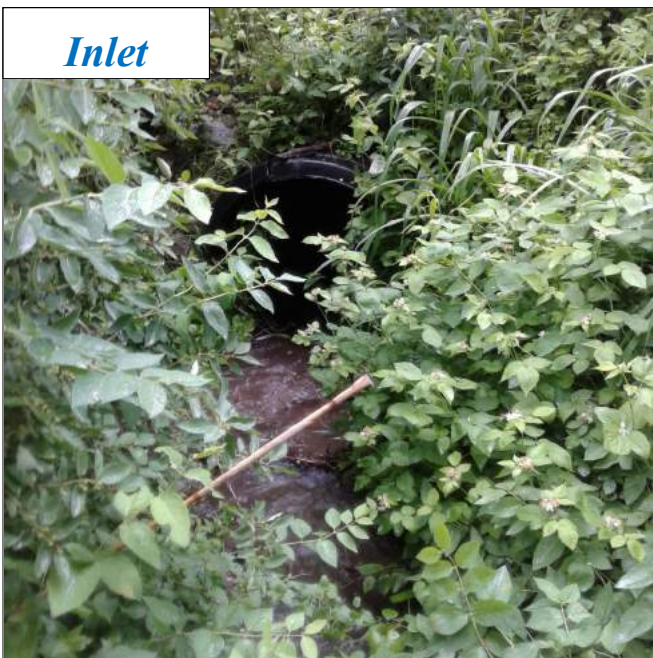
Inlet Shape/Type: Round Culvert
Inlet Drop/Grade: Inlet Drop
Dimensions:
Width: 2.9, Height: 3.1
Substrate/Water Width: 1.1
Water Depth: 0.2
Abutment Height: No data

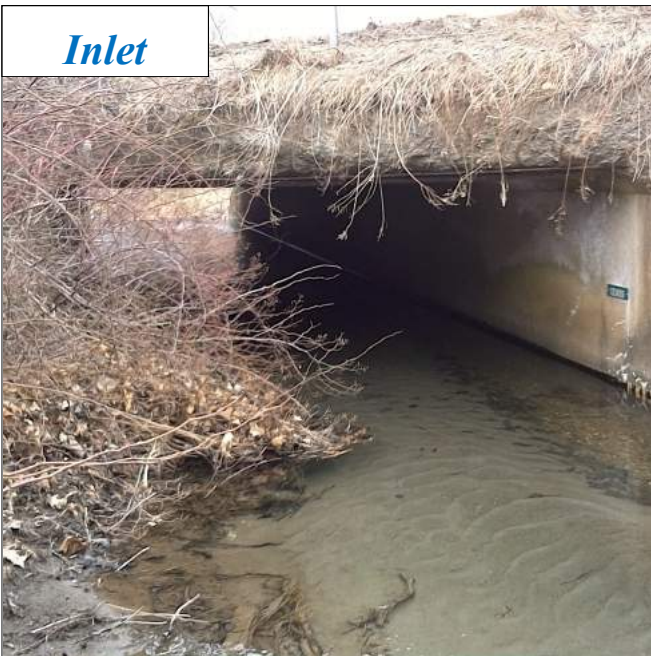
Inlet Shape/Type: Box/Bridge with Abutments
Inlet Drop/Grade: At Stream Grade
Dimensions:
Width: 12.0, Height: 4.5
Substrate/Water Width: 12.0
Water Depth: 0.9
Abutment Height: No data

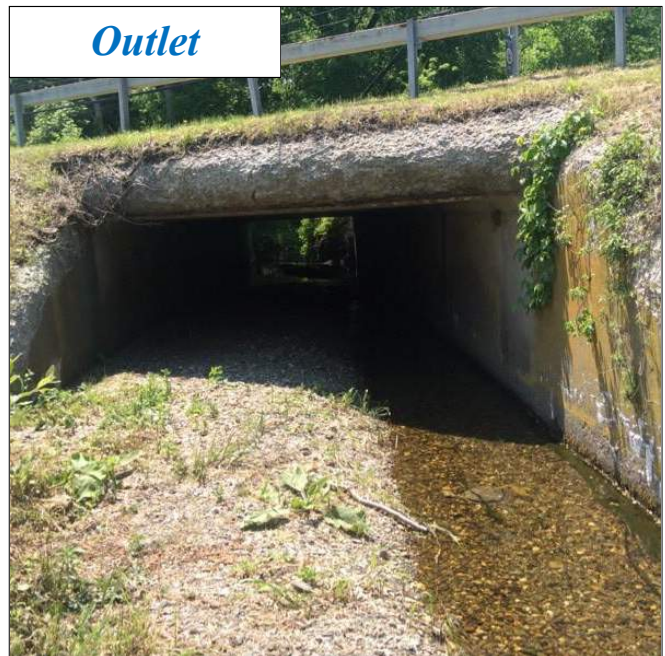
Outlet Shape: Box/Bridge with Abutments
Outlet Drop/Grade: At Stream Grade
Drop to Stream Surface/Bottom: 0.0/ 0.0
Dimensions:
Width: 12.0, Height: 6.5
Substrate/Water Width: 12.0
Water Depth: 0.3

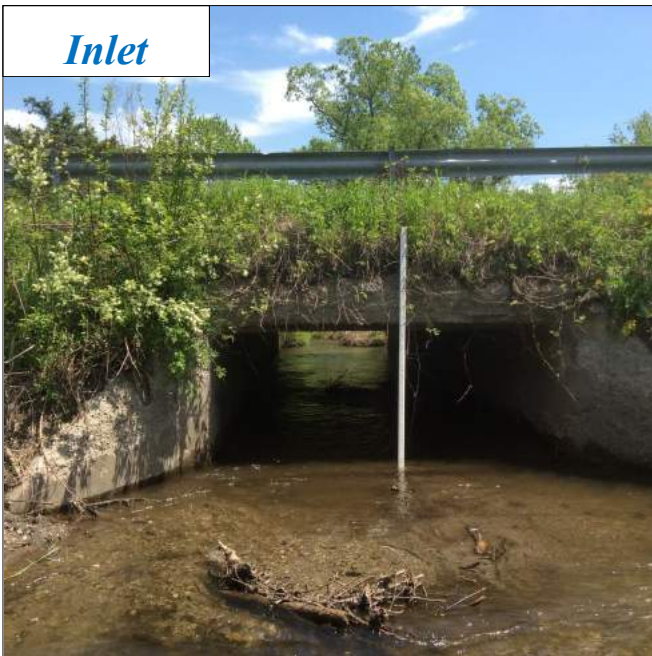
Inlet Shape/Type: Box/Bridge with Abutments
 Inlet Drop/Grade: At Stream Grade
 Dimensions:
 Width: 12.1, Height: 5.2
 Substrate/Water Width: 12.1
 Water Depth: 0.8
 Abutment Height: No data

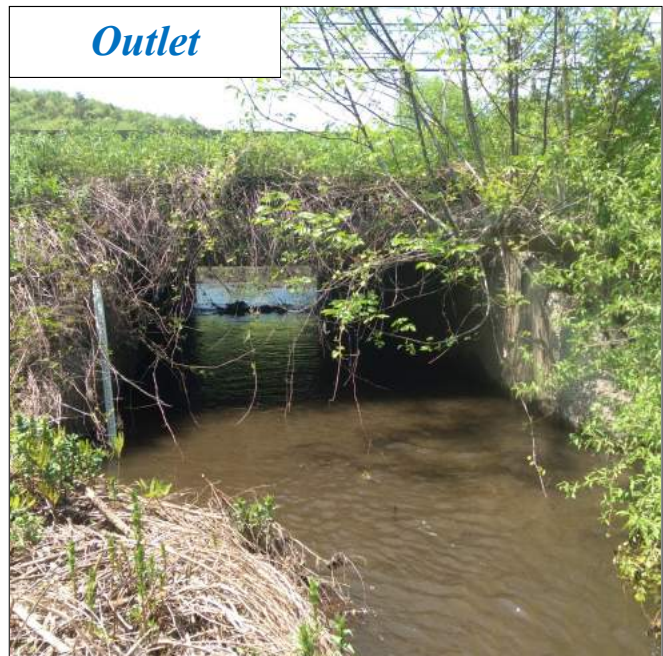
Outlet Shape: Box/Bridge with Abutments
 Outlet Drop/Grade: At Stream Grade
 Drop to Stream Surface/Bottom: 0.0/ 0.0
 Dimensions:
 Width: 12.1, Height: 4.8
 Substrate/Water Width: 12.1
 Water Depth: 0.5

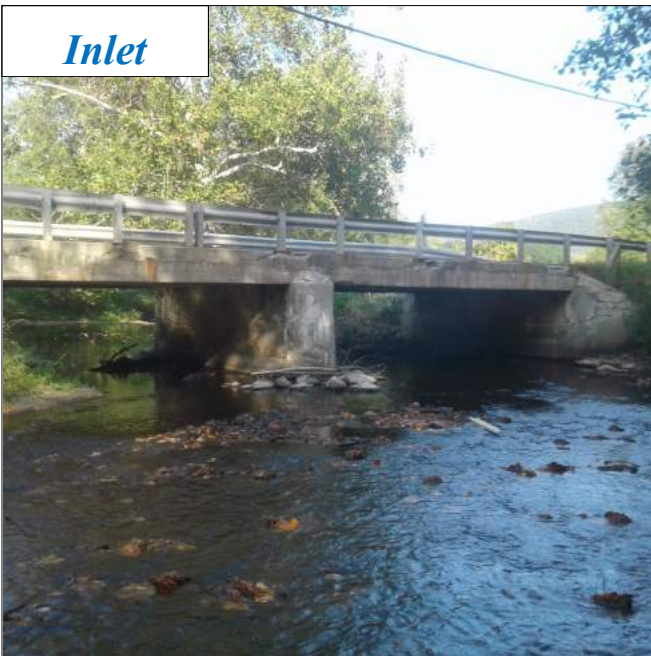
Inlet Shape/Type: Box/Bridge with Abutments
 Inlet Drop/Grade: At Stream Grade
 Dimensions:
 Width: 26.8, Height: 8.3
 Substrate/Water Width: 26.8
 Water Depth: 1.9
 Abutment Height: No data

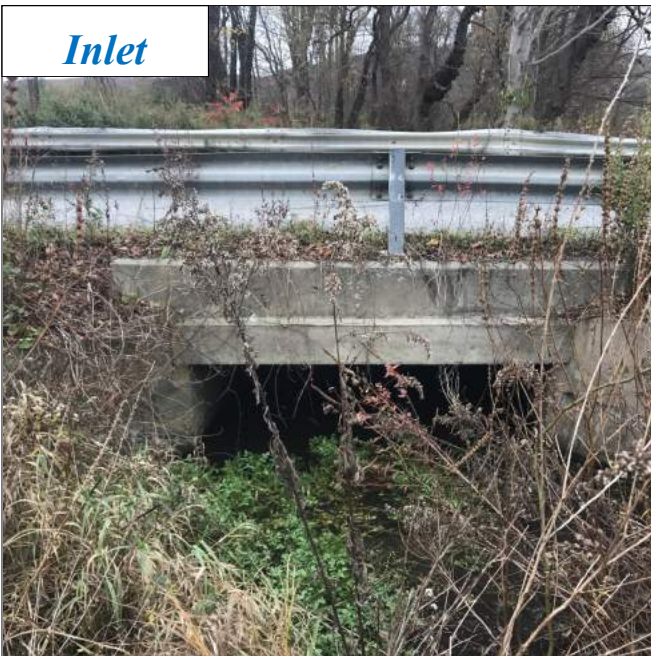
Inlet Shape/Type: Box/Bridge with Abutments
Inlet Drop/Grade: At Stream Grade
Dimensions:
Width: 8.0, Height: 4.4
Substrate/Water Width: 8.0
Water Depth: 2.2
Abutment Height: No data

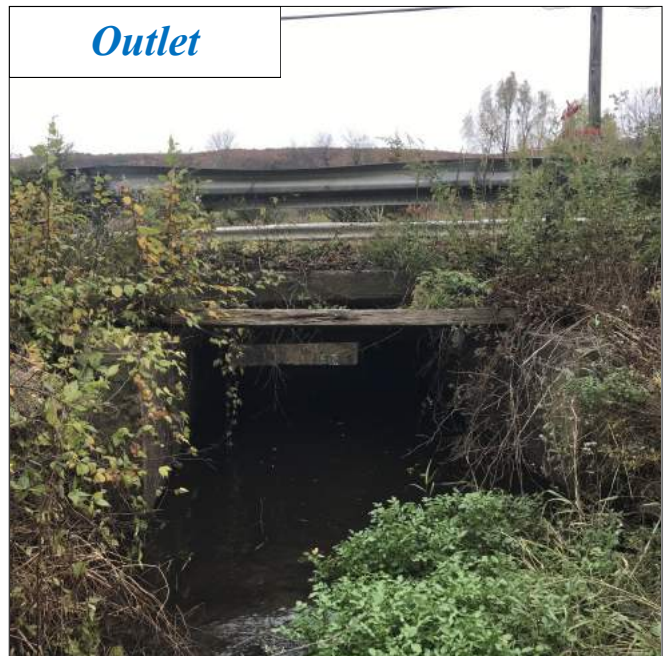
Outlet Shape: Box/Bridge with Abutments
Outlet Drop/Grade: At Stream Grade
Drop to Stream Surface/Bottom: 0.0/ 0.0
Dimensions:
Width: 8.0, Height: 3.6
Substrate/Water Width: 8.0
Water Depth: 0.7

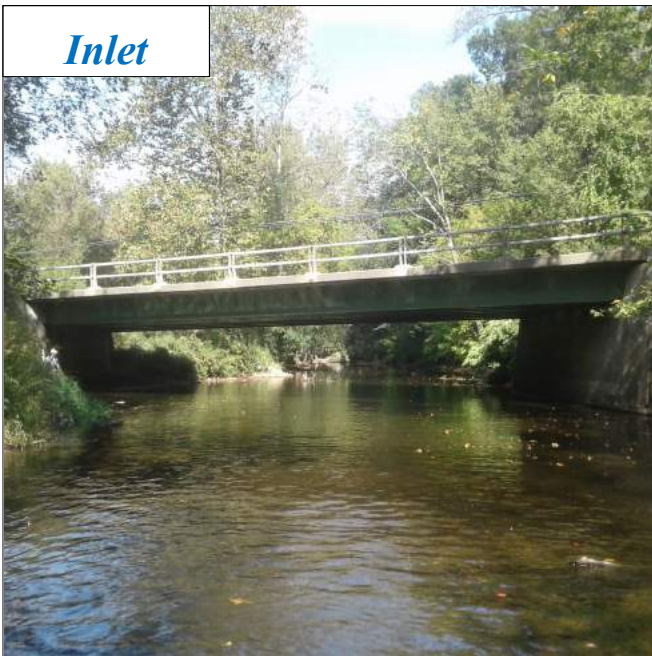
Inlet Shape/Type: Box/Bridge with Abutments
 Inlet Drop/Grade: At Stream Grade
 Dimensions:
 Width: 69.2, Height: 9.3
 Substrate/Water Width: 69.2
 Water Depth: 0.8
 Abutment Height: No data

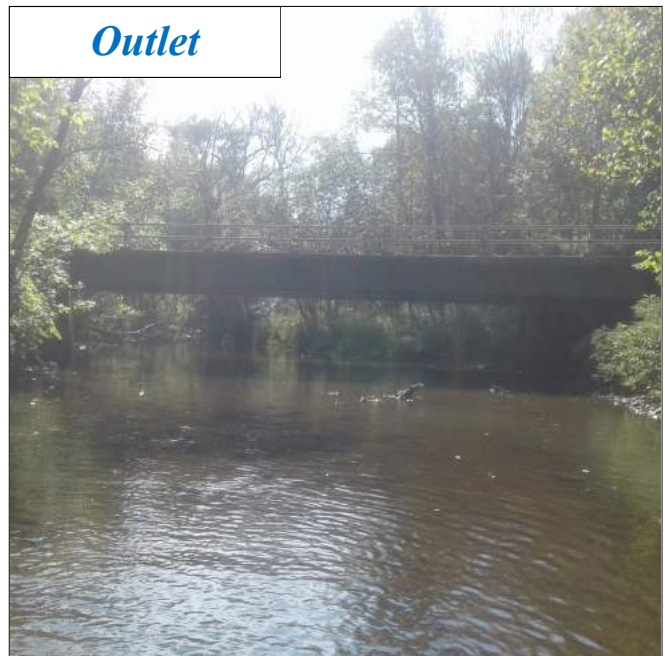
Outlet Shape: Box/Bridge with Abutments
 Outlet Drop/Grade: At Stream Grade
 Drop to Stream Surface/Bottom: 0.0/ 0.0
 Dimensions:
 Width: 70.4, Height: 9.7
 Substrate/Water Width: 70.4
 Water Depth: 0.7

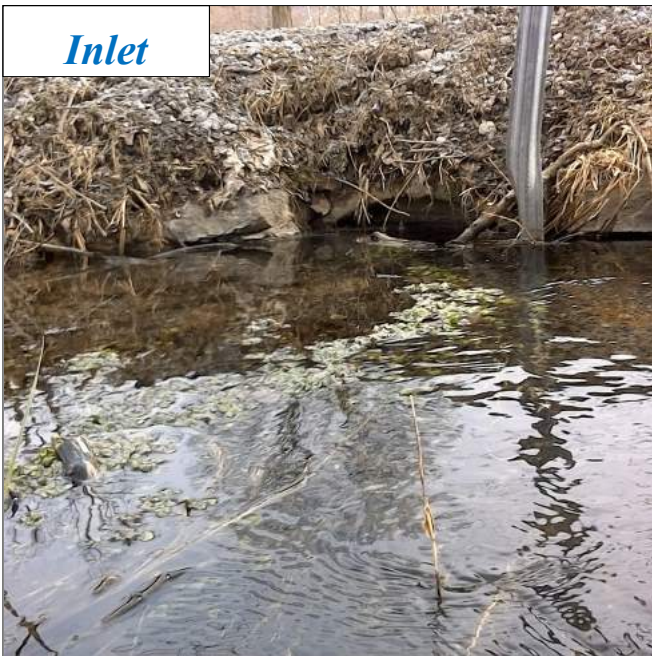
Inlet Shape/Type: Round Culvert
 Inlet Drop/Grade: At Stream Grade
 Dimensions:
 Width: 1.2, Height: 1.6
 Substrate/Water Width: 1.2
 Water Depth: 1.1
 Abutment Height: No data

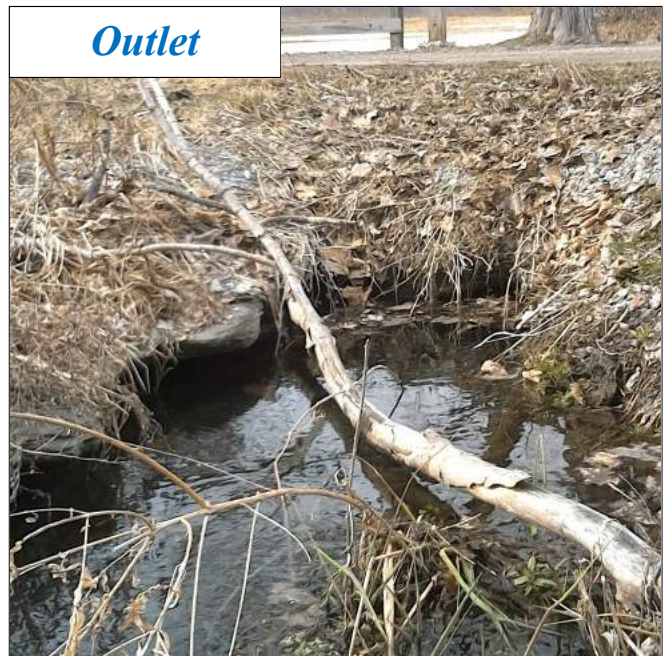
Outlet Shape: Round Culvert
 Outlet Drop/Grade: At Stream Grade
 Drop to Stream Surface/Bottom: 0.0/ 0.0
 Dimensions:
 Width: 1.0, Height: 1.1
 Substrate/Water Width: 1.0
 Water Depth: 1.0

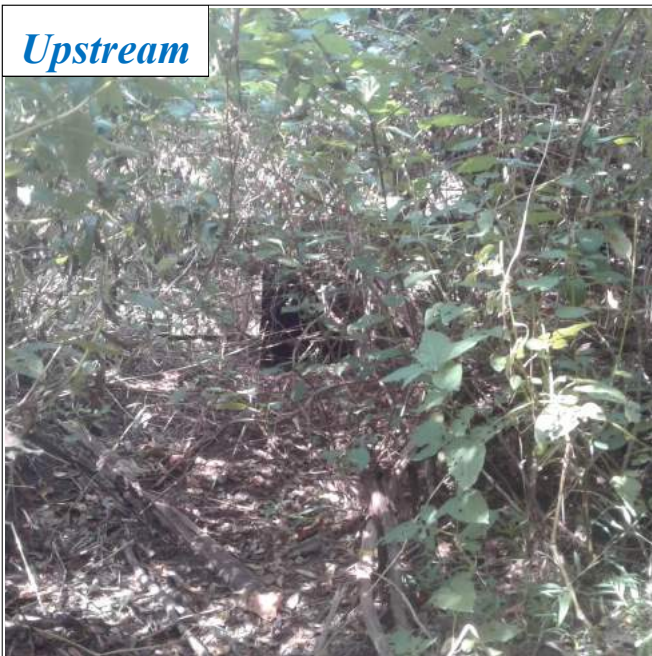
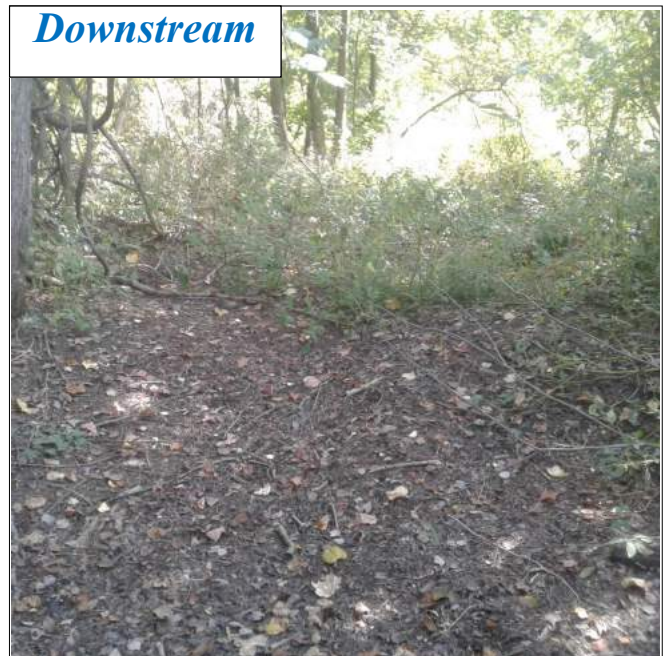
Crossing Comments: Railroad crossing 20 ft upstream

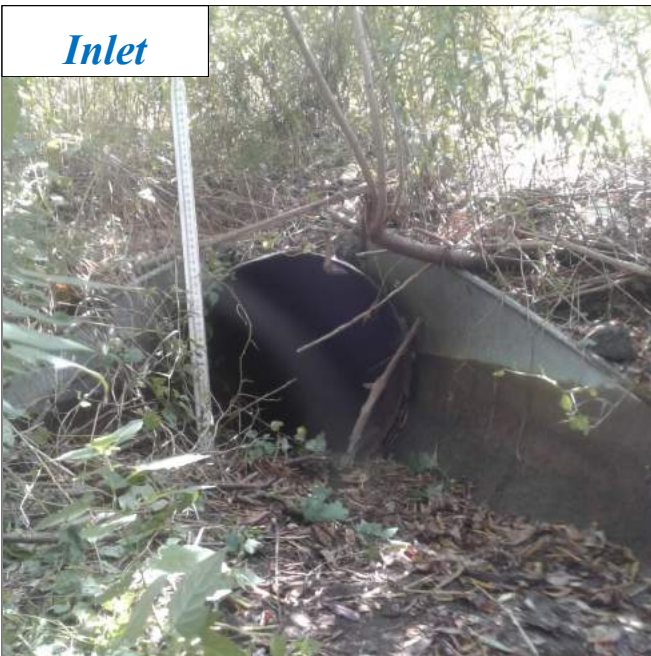
Inlet Shape/Type: Round Culvert
Inlet Drop/Grade: At Stream Grade
Dimensions:
Width: 3.0, Height: 3.0
Substrate/Water Width: 0.0
Water Depth: 0.0
Abutment Height: No data

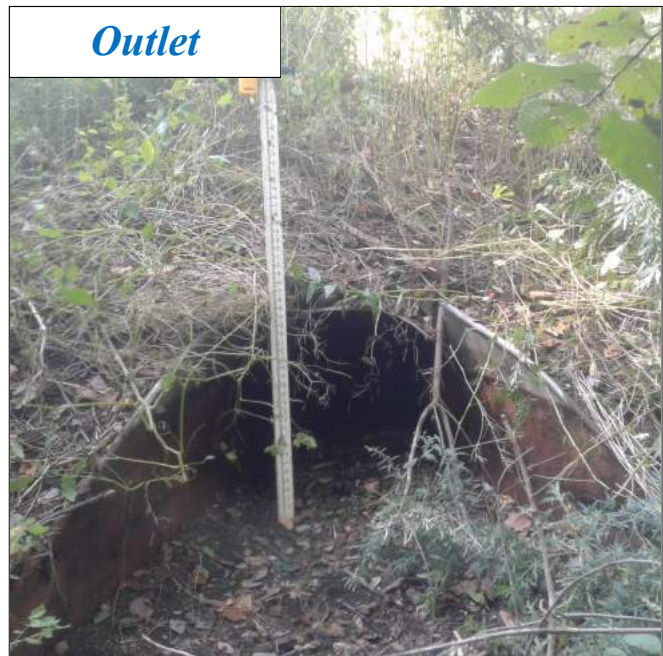
Outlet Shape: Round Culvert
Outlet Drop/Grade: At Stream Grade
Drop to Stream Surface/Bottom: 0.0/ 0.0
Dimensions:
Width: 2.8, Height: 2.4
Substrate/Water Width: 2.6
Water Depth: 0.0

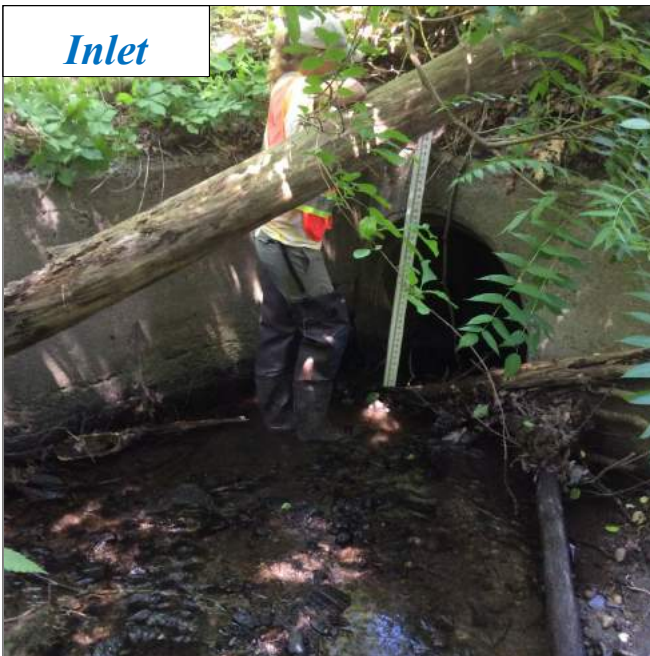
Inlet Shape/Type: Round Culvert
Inlet Drop/Grade: At Stream Grade
Dimensions:
Width: 3.0, Height: 3.0
Substrate/Water Width: 1.5
Water Depth: 0.1
Abutment Height: No data

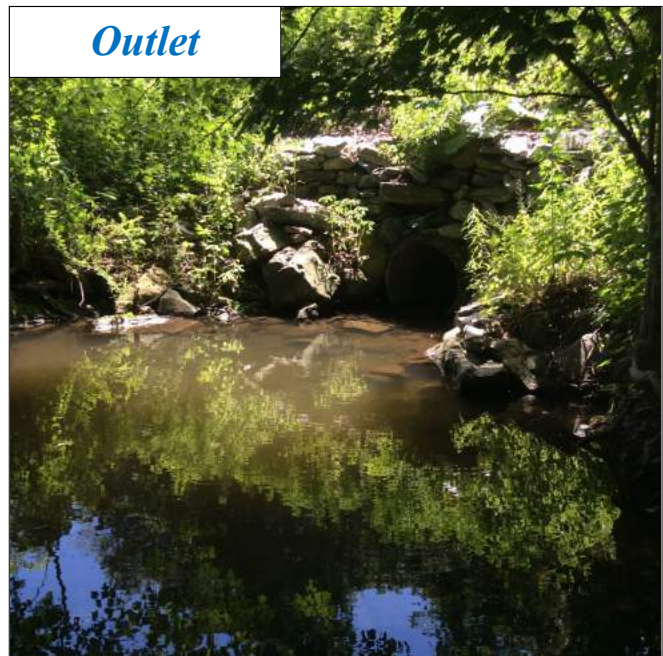
Outlet Shape: Round Culvert
Outlet Drop/Grade: At Stream Grade
Drop to Stream Surface/Bottom: 0.0/ 0.0
Dimensions:
Width: 3.0, Height: 3.0
Substrate/Water Width: 2.0
Water Depth: 0.3

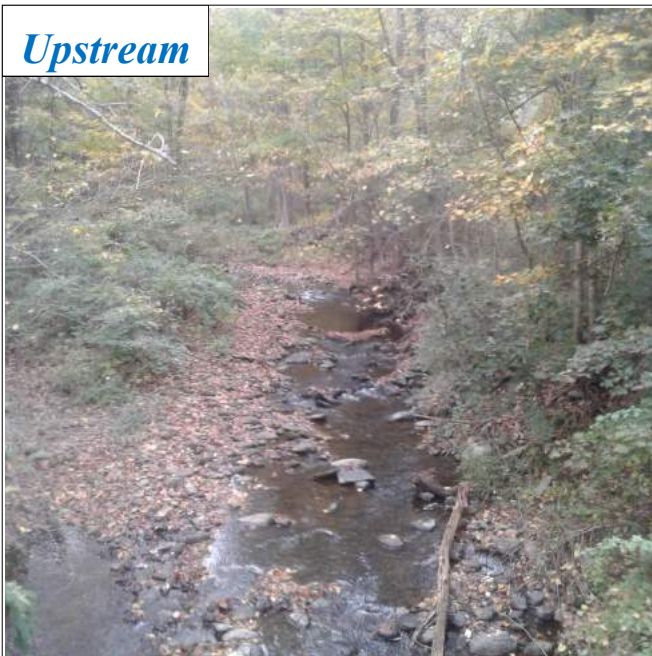
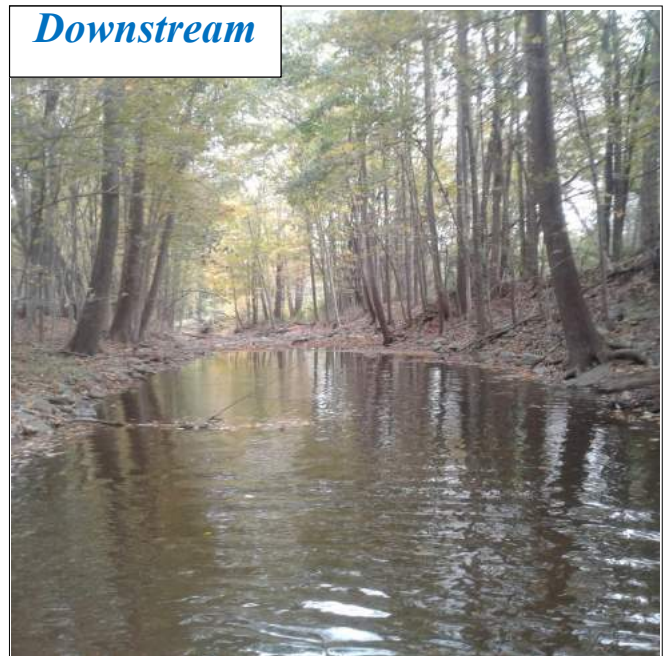
Crossing Comments: Old Bridge support in stream.

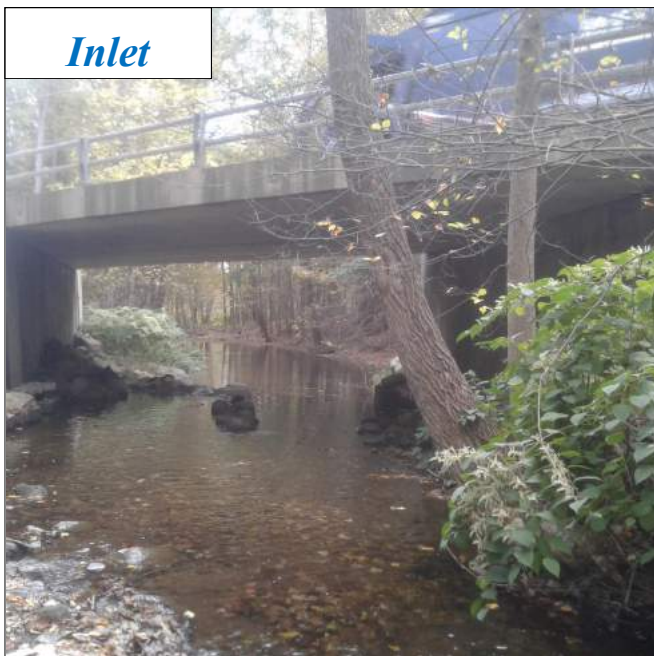
Inlet Shape/Type: Box/Bridge with Abutments
Inlet Drop/Grade: At Stream Grade
Dimensions:
Width: 45.5, Height: 13.5
Substrate/Water Width: 45.5
Water Depth: 1.2
Abutment Height: No data

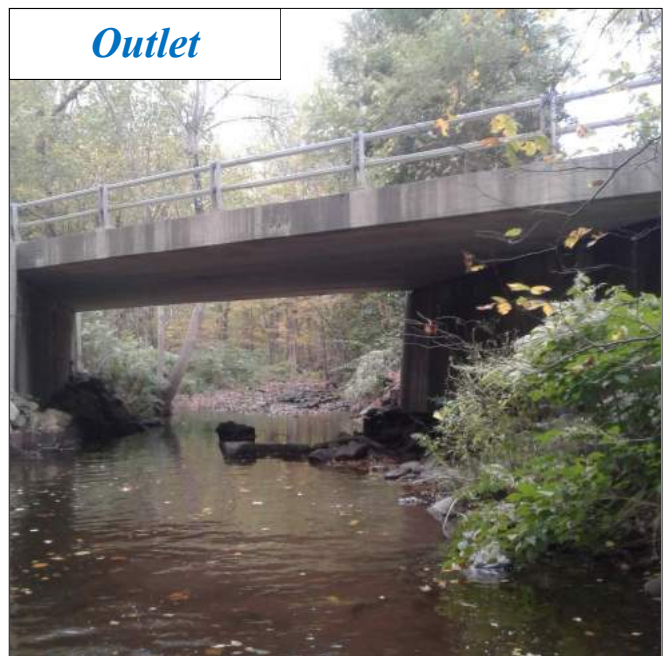
Outlet Shape: Box/Bridge with Abutments
Outlet Drop/Grade: At Stream Grade
Drop to Stream Surface/Bottom: 0.0/ 0.0
Dimensions:
Width: 45.6, Height: 14.6
Substrate/Water Width: 45.6
Water Depth: 2.8

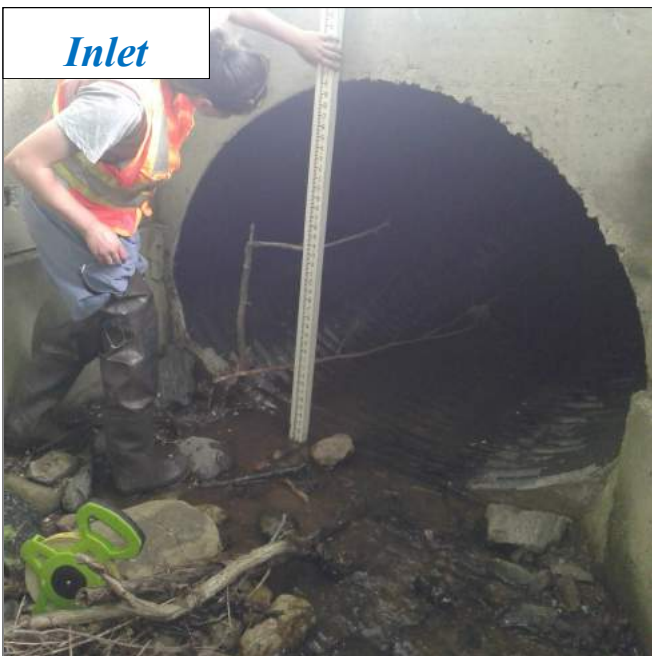
Inlet Shape/Type: Pipe Arch/Elliptical Culvert
Inlet Drop/Grade: At Stream Grade
Dimensions:
Width: 5.1, Height: 4.2
Substrate/Water Width: 2.0
Water Depth: 0.1
Abutment Height: No data

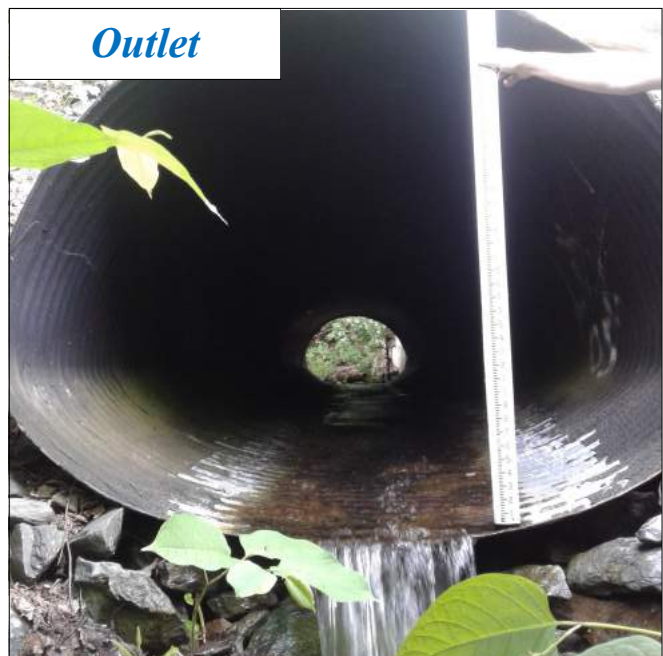
Outlet Shape: Pipe Arch/Elliptical Culvert
Outlet Drop/Grade: Free Fall Onto Cascade
Drop to Stream Surface/Bottom: 2.6/ 3.2
Dimensions:
Width: 5.1, Height: 4.2
Substrate/Water Width: 2.0
Water Depth: 0.1

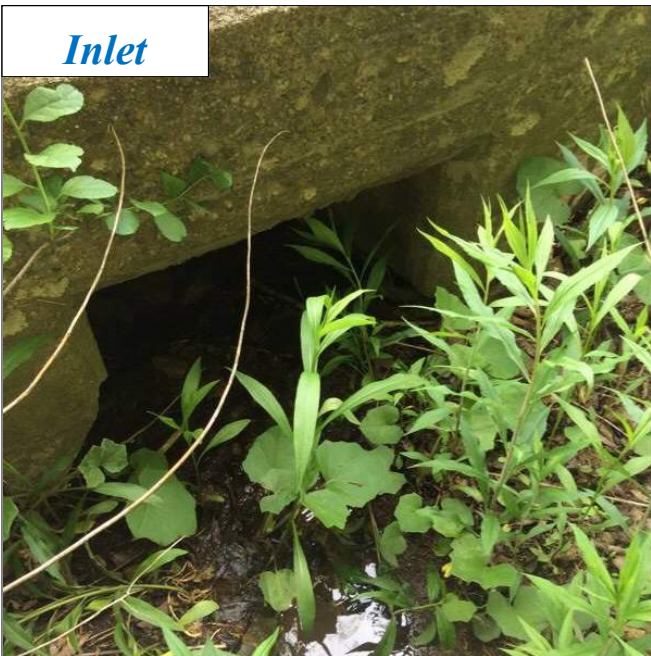
Inlet Shape/Type: Box/Bridge with Abutments
 Inlet Drop/Grade: At Stream Grade
 Dimensions:
 Width: 2.0, Height: 1.5
 Substrate/Water Width: 2.0
 Water Depth: 0.1
 Abutment Height: No data

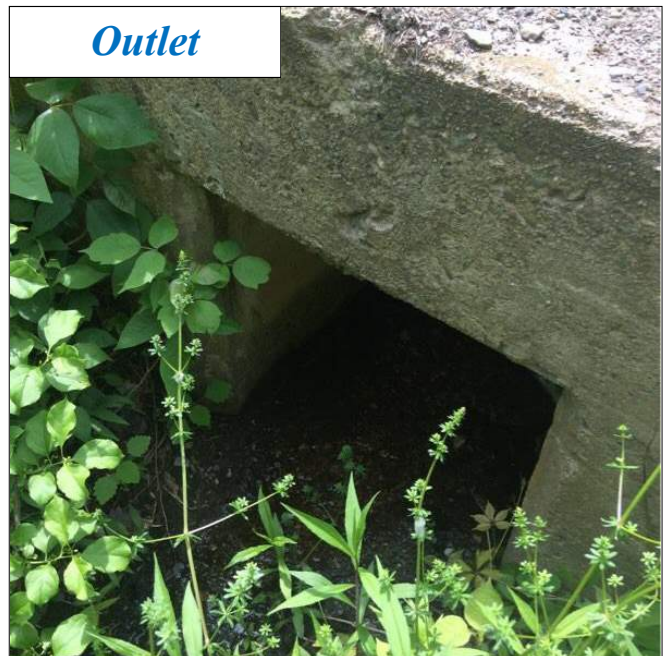
Outlet Shape: Box/Bridge with Abutments
 Outlet Drop/Grade: At Stream Grade
 Drop to Stream Surface/Bottom: 0.0/ 0.0
 Dimensions:
 Width: 2.0, Height: 2.0
 Substrate/Water Width: 2.0
 Water Depth: 0.1

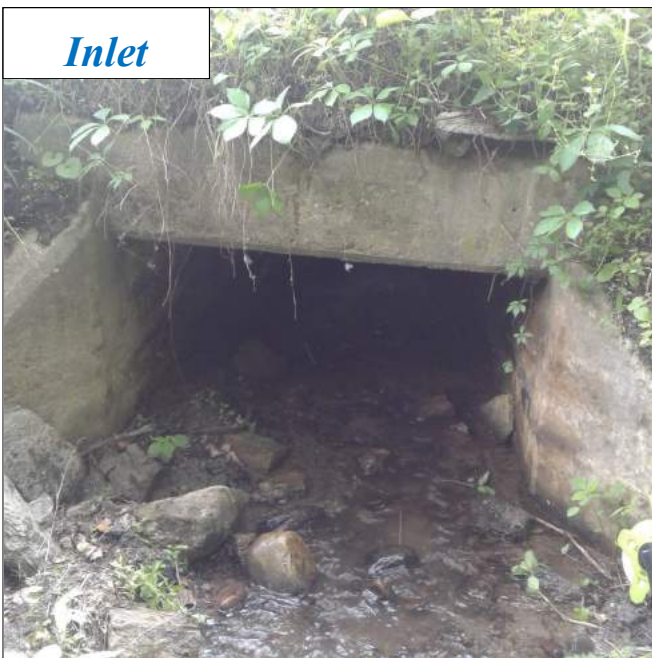
Inlet Shape/Type: Box/Bridge with Abutments
 Inlet Drop/Grade: At Stream Grade
 Dimensions:
 Width: 5.0, Height: 3.0
 Substrate/Water Width: 5.0
 Water Depth: 0.2
 Abutment Height: No data

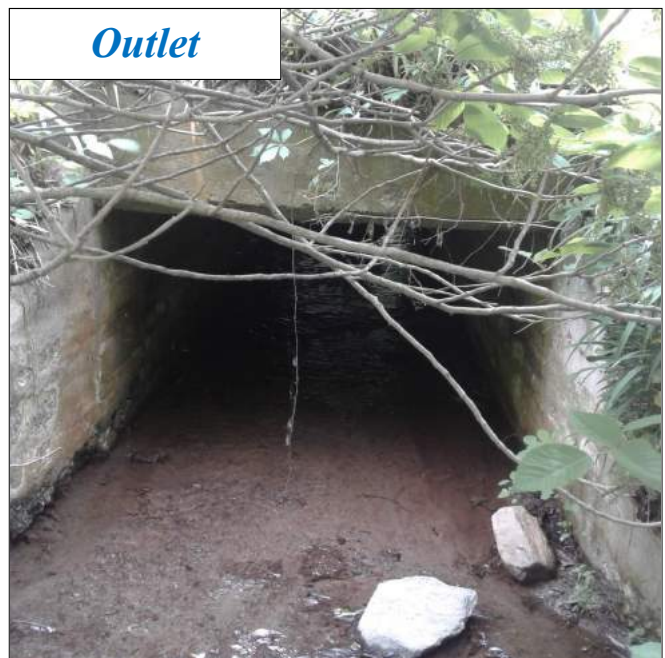
Outlet Shape: Box/Bridge with Abutments
 Outlet Drop/Grade: At Stream Grade
 Drop to Stream Surface/Bottom: 0.0/ 0.0
 Dimensions:
 Width: 5.0, Height: 3.0
 Substrate/Water Width: 3.0
 Water Depth: 0.1

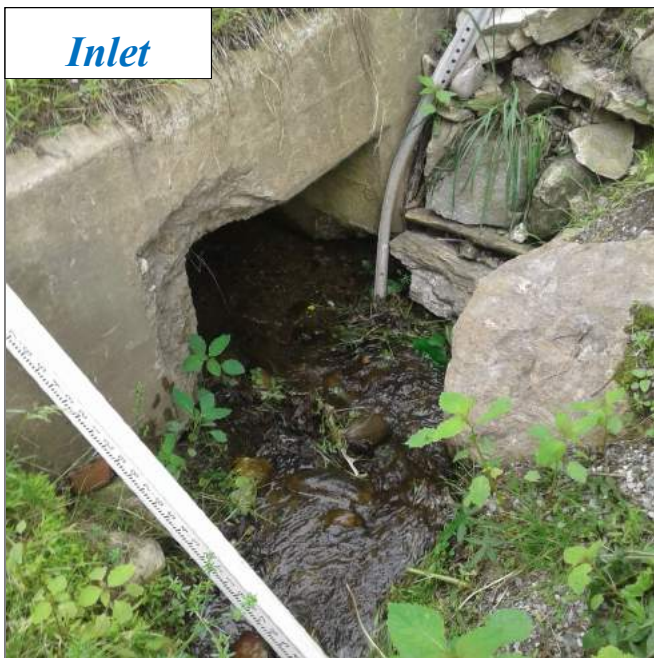
Inlet Shape/Type: Box/Bridge with Abutments
Inlet Drop/Grade: At Stream Grade
Dimensions:
Width: 2.0, Height: 2.0
Substrate/Water Width: 2.0
Water Depth: 0.2
Abutment Height: No data

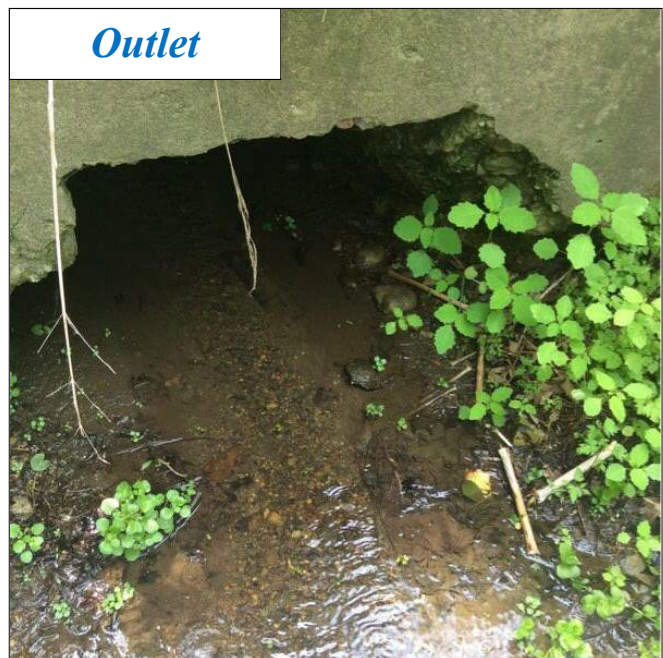
Outlet Shape: Box/Bridge with Abutments
Outlet Drop/Grade: At Stream Grade
Drop to Stream Surface/Bottom: 0.0/ 0.0
Dimensions:
Width: 2.1, Height: 2.0
Substrate/Water Width: 2.1
Water Depth: 0.2

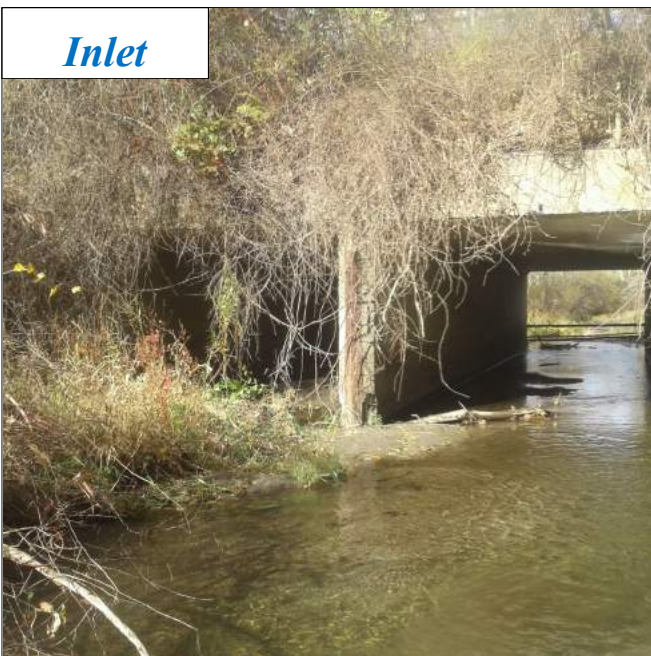
Inlet Shape/Type: Box/Bridge with Abutments
Inlet Drop/Grade: At Stream Grade
Dimensions:
Width: 12.0, Height: 9.0
Substrate/Water Width: 12.0
Water Depth: 0.6
Abutment Height: No data

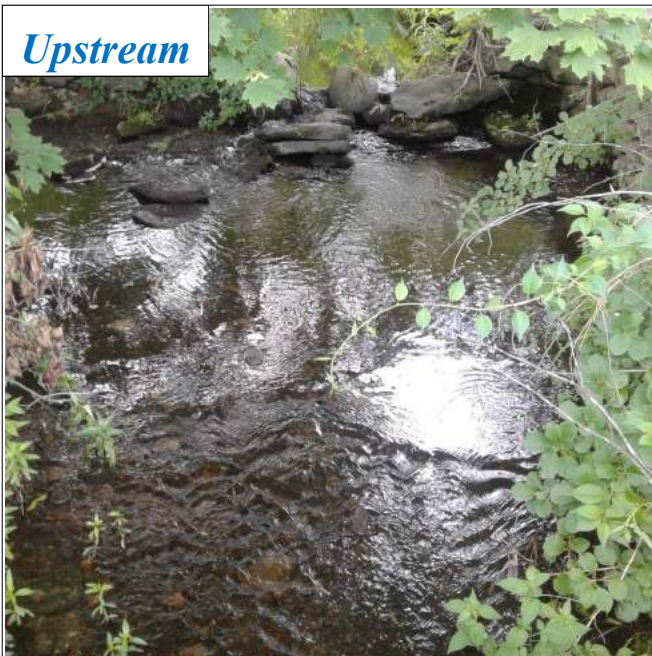
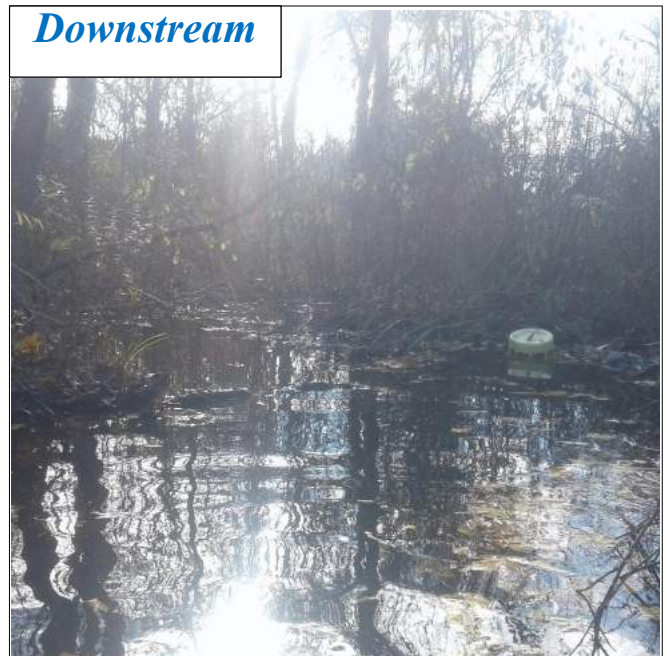
Crossing Comments: Upstream flows through stone wall

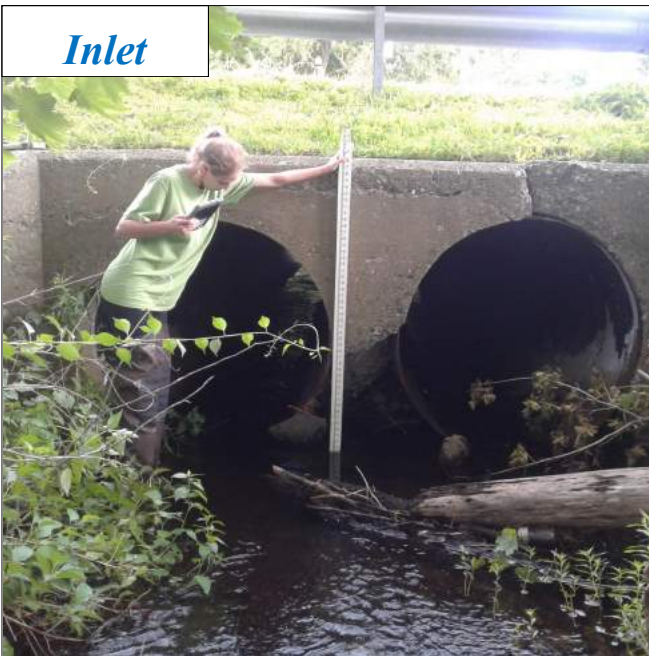
Inlet Shape/Type: Round Culvert
Inlet Drop/Grade: At Stream Grade
Dimensions:
Width: 4.0, Height: 3.8
Substrate/Water Width: 1.5
Water Depth: 0.5
Abutment Height: No data

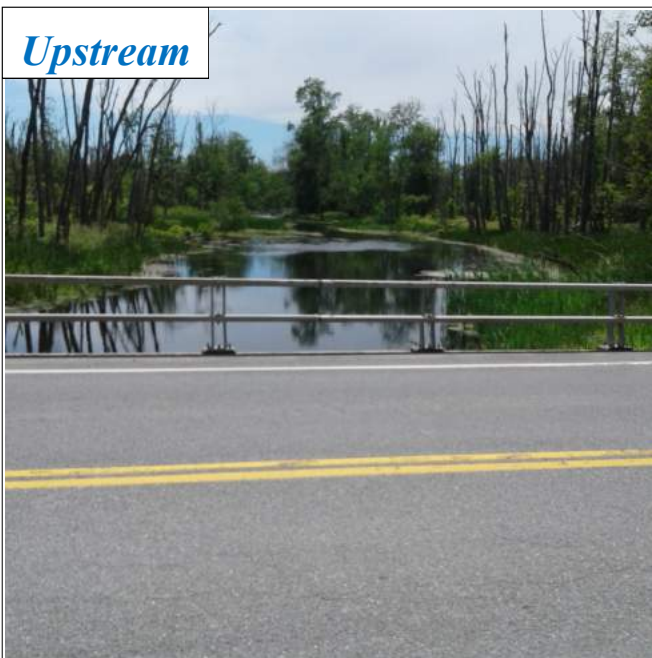
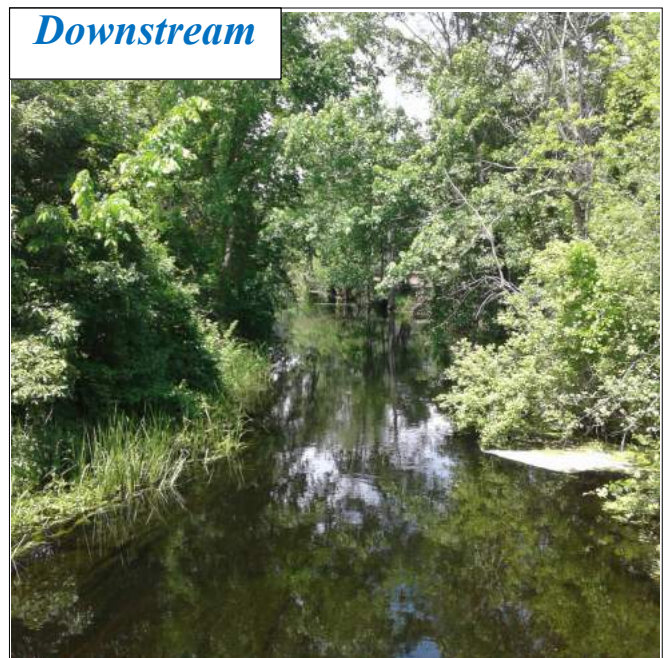
Crossing Comments: Upstream area is a swamp, bankfull width is estimated

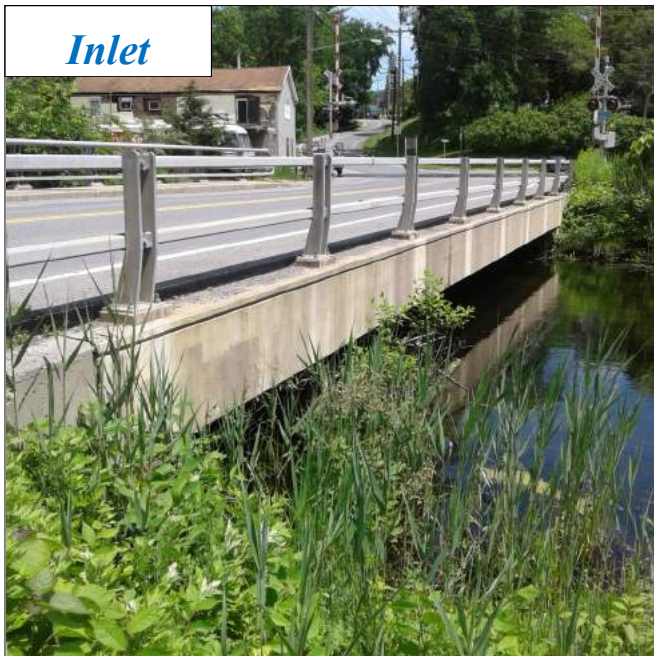
Inlet Shape/Type: Box/Bridge with Abutments
 Inlet Drop/Grade: At Stream Grade
 Dimensions:
 Width: 63.0, Height: 5.1
 Substrate/Water Width: 63.0
 Water Depth: 3.1
 Abutment Height: No data

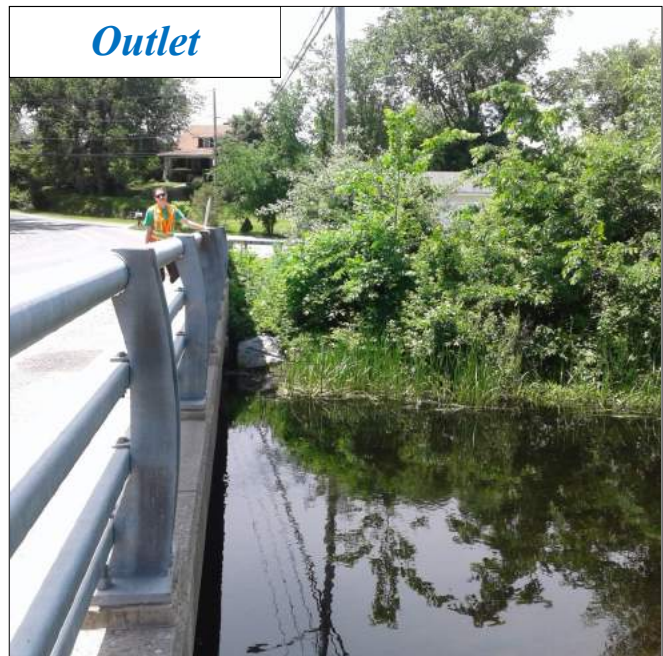
Outlet Shape: Box/Bridge with Abutments
 Outlet Drop/Grade: At Stream Grade
 Drop to Stream Surface/Bottom: 0.0/ 0.0
 Dimensions:
 Width: 52.7, Height: 7.4
 Substrate/Water Width: 52.7
 Water Depth: 3.4

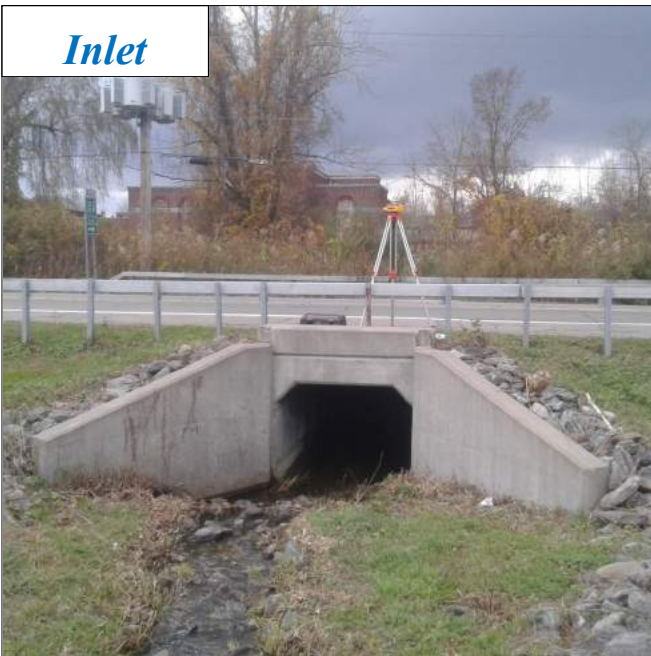
Inlet Shape/Type: Box Culvert
Inlet Drop/Grade: At Stream Grade
Dimensions:
Width: 5.0, Height: 4.0
Substrate/Water Width: 5.0
Water Depth: 0.3
Abutment Height: No data

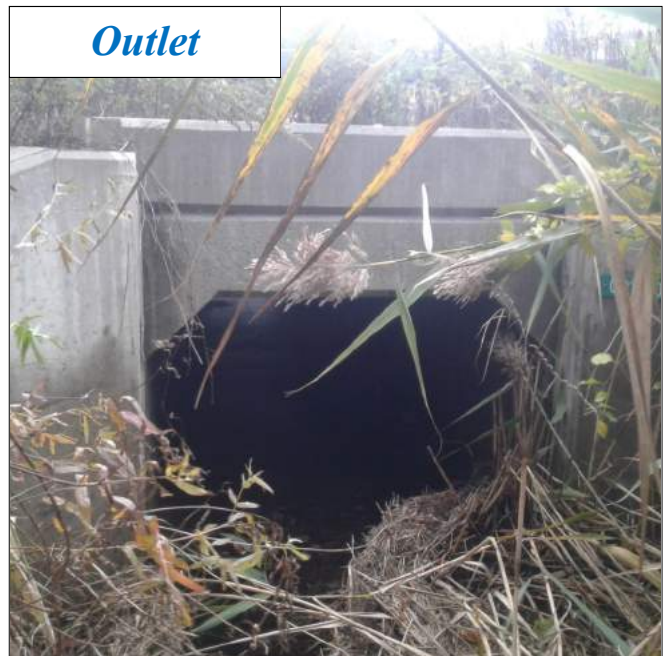
Outlet Shape: Box Culvert
Outlet Drop/Grade: At Stream Grade
Drop to Stream Surface/Bottom: 0.0/ 0.0
Dimensions:
Width: 5.0, Height: 4.0
Substrate/Water Width: 5.0
Water Depth: 0.3

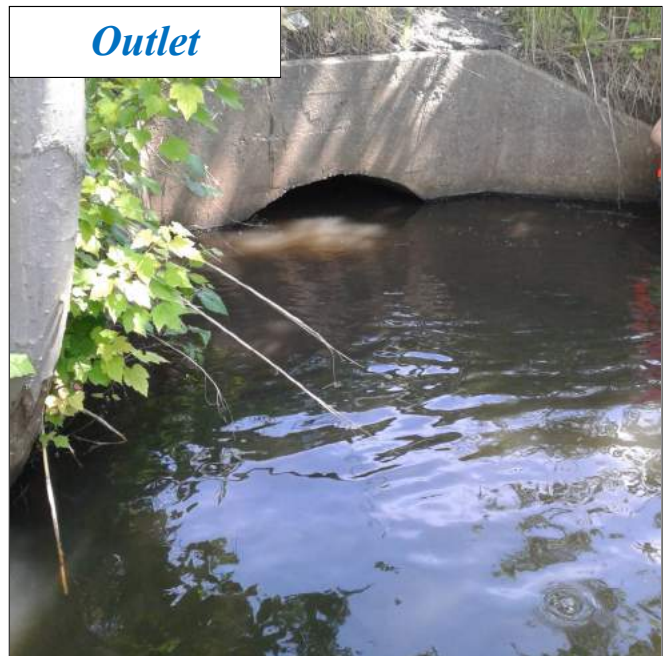
Outlet Shape: Round Culvert
Outlet Drop/Grade: At Stream Grade
Drop to Stream Surface/Bottom: 0.0/ 0.0
Dimensions:
Width: 5.4, Height: 3.2
Substrate/Water Width: 3.8
Water Depth: 2.7

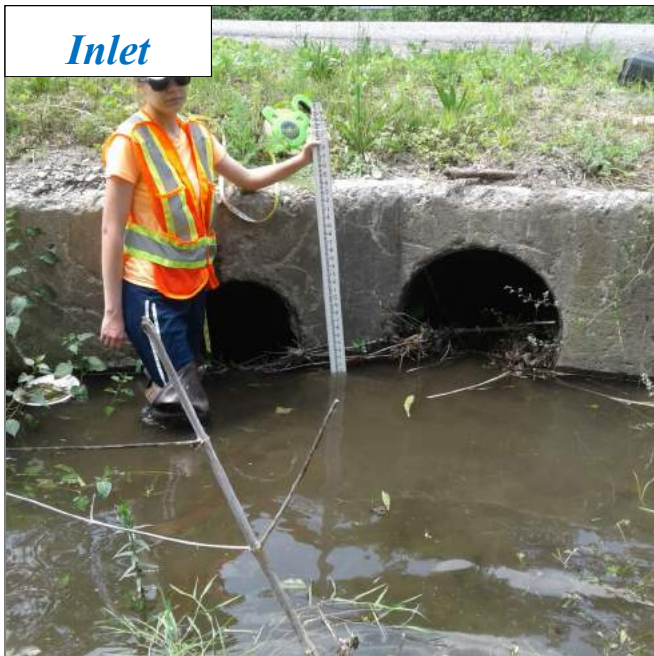
Physical Barrier(s)/Severity: Debris/Sediment/
Rock (Moderate)
Slope: 3.9%
Structure Comments: No data

Inlet Shape/Type: Round Culvert
Inlet Drop/Grade: Perched
Dimensions:
Width: 1.5, Height: 1.6
Substrate/Water Width: 0.9
Water Depth: 0.1
Abutment Height: No data

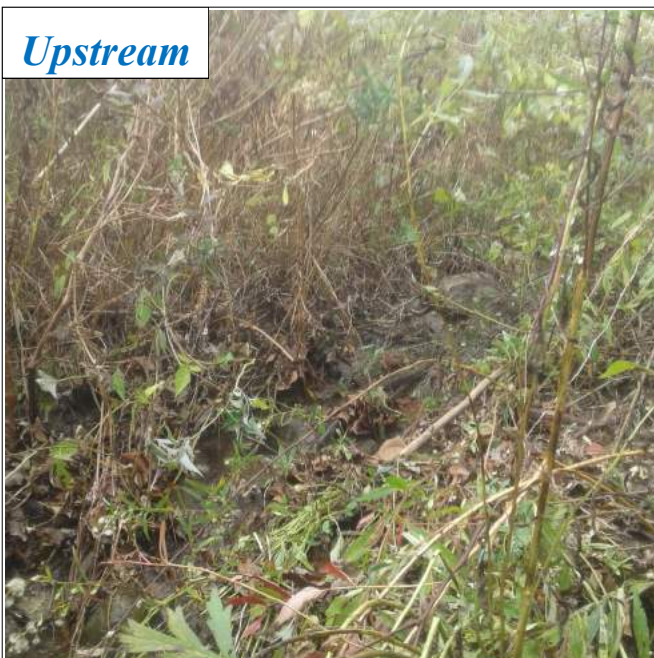
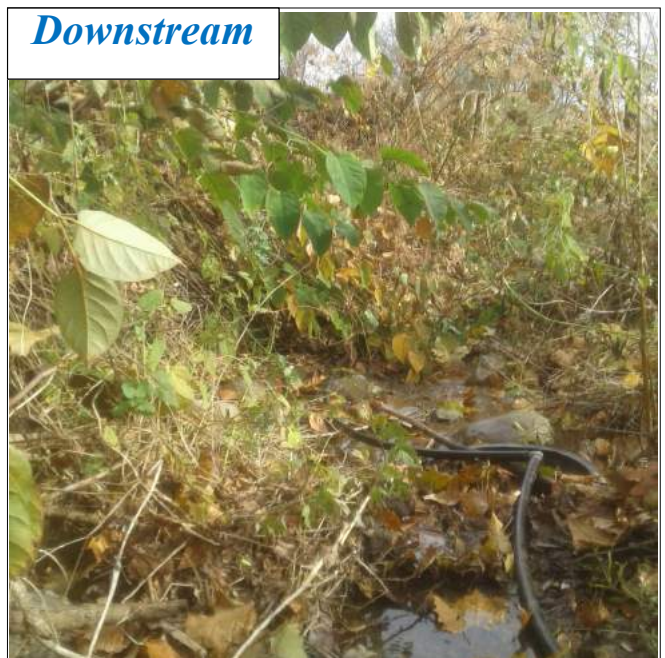
Crossing Comments: Electric fence and plastic pipe outfall 50 upstream. rubber hose runs through culvert

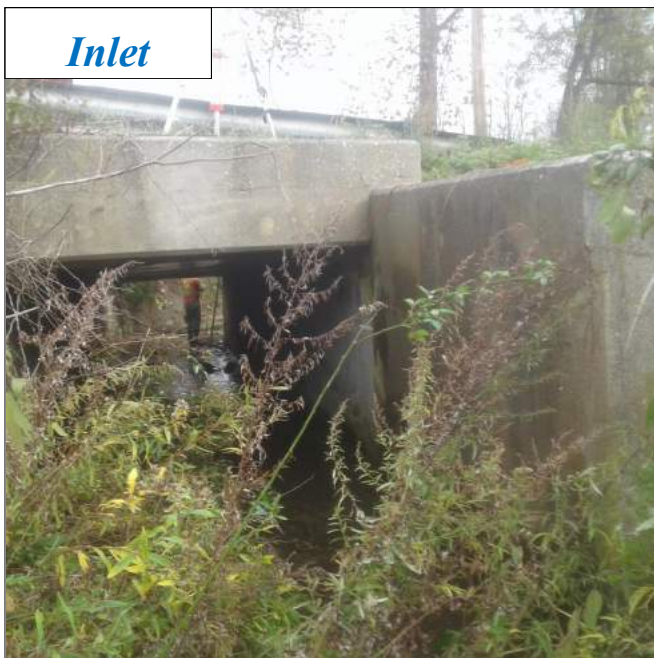
Inlet Shape/Type: Box Culvert
Inlet Drop/Grade: At Stream Grade
Dimensions:
Width: 7.9, Height: 5.2
Substrate/Water Width: 4.7
Water Depth: 5.0000000000000003E-2
Abutment Height: No data

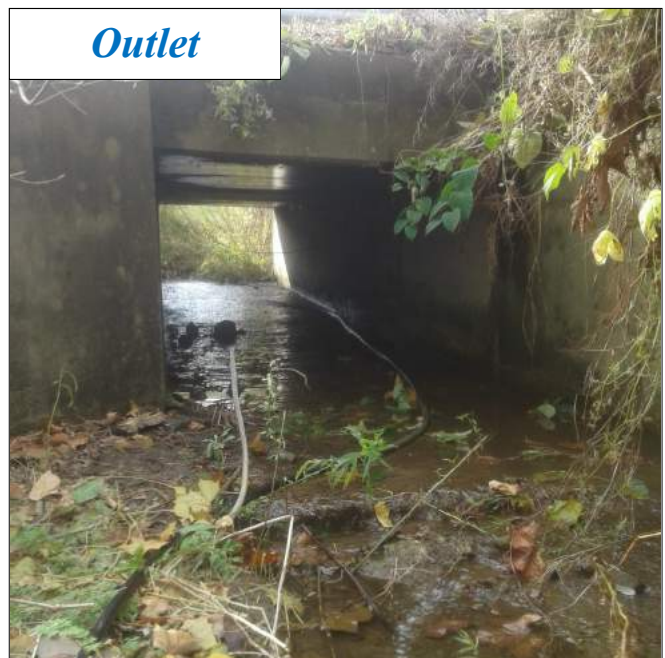
Outlet Shape: Box Culvert
Outlet Drop/Grade: At Stream Grade
Drop to Stream Surface/Bottom: 0.0/ 0.0
Dimensions:
Width: 8.1, Height: 5.0
Substrate/Water Width: 7.5
Water Depth: 5.0000000000000003E-2

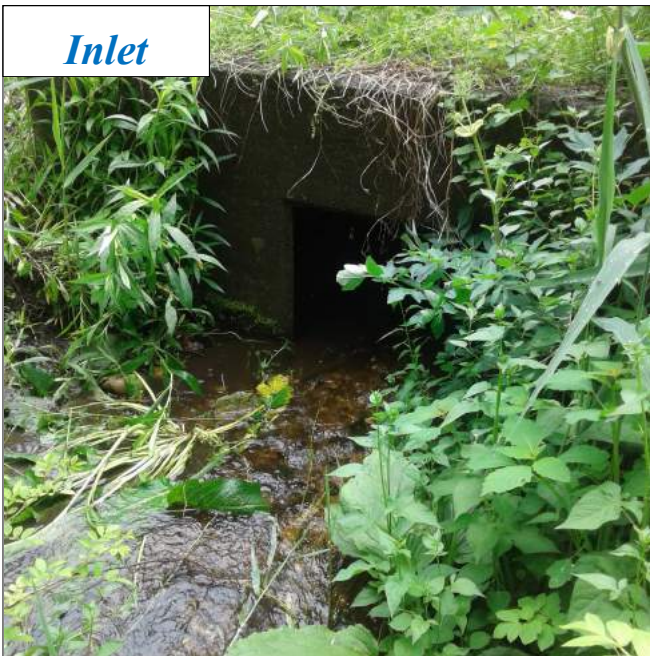
Inlet Shape/Type: Box/Bridge with Abutments
Inlet Drop/Grade: At Stream Grade
Dimensions:
Width: 6.2, Height: 2.0
Substrate/Water Width: 6.2
Water Depth: 0.2
Abutment Height: No data
