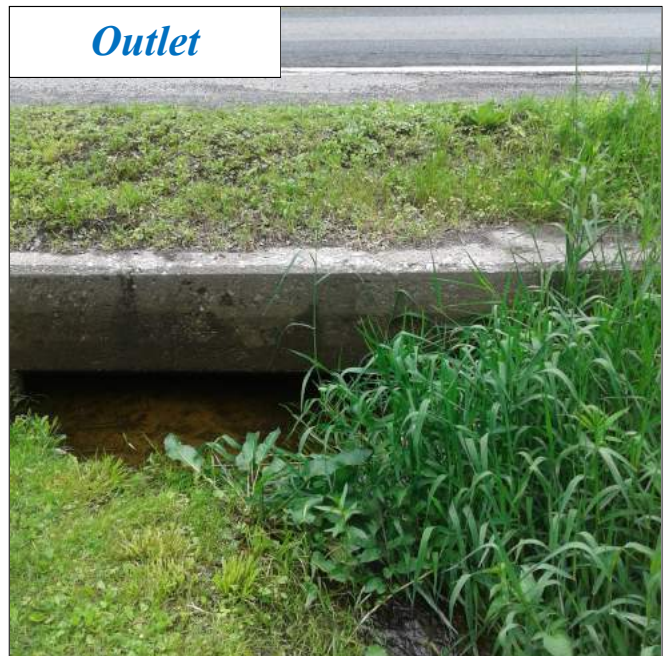
Outlet Shape: Box/Bridge with Abutments
Outlet Drop/Grade: At Stream Grade
Drop to Stream Surface/Bottom: 0.0/ 0.0
Dimensions:
Width: 6.2, Height: 1.0
Substrate/Water Width: 6.2
Water Depth: 0.1

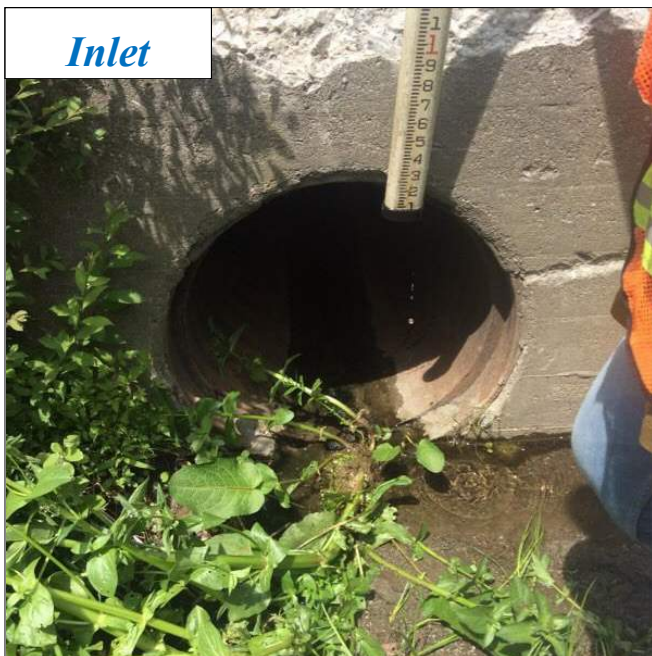
Inlet Shape/Type: Round Culvert
Inlet Drop/Grade: Perched
Dimensions:
Width: 2.0, Height: 2.0
Substrate/Water Width: 0.6
Water Depth: 0.1
Abutment Height: No data

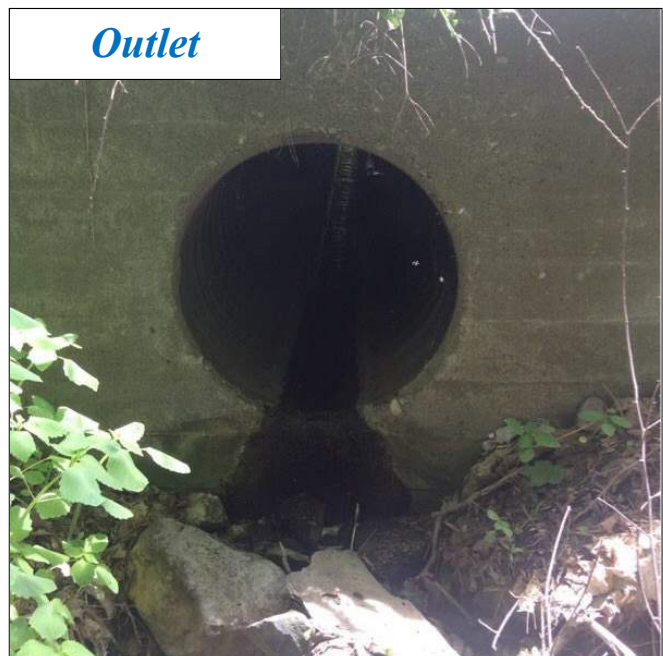
Outlet Shape: Round Culvert
Outlet Drop/Grade: Free Fall Onto Cascade
Drop to Stream Surface/Bottom: 2.0/ 2.1
Dimensions:
Width: 2.0, Height: 2.0
Substrate/Water Width: 0.5
Water Depth: 0.1

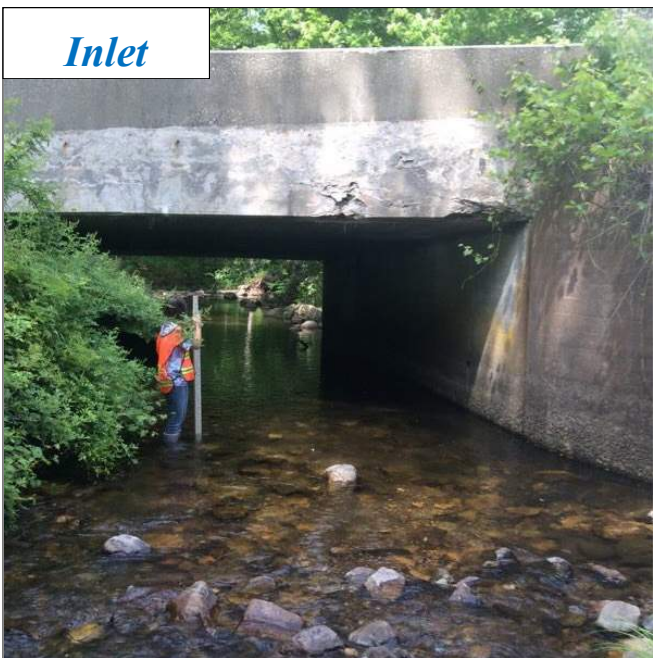
Inlet Shape/Type: Box/Bridge with Abutments
 Inlet Drop/Grade: At Stream Grade
 Dimensions:
 Width: 23.0, Height: 8.0
 Substrate/Water Width: 23.0
 Water Depth: 1.3
 Abutment Height: No data

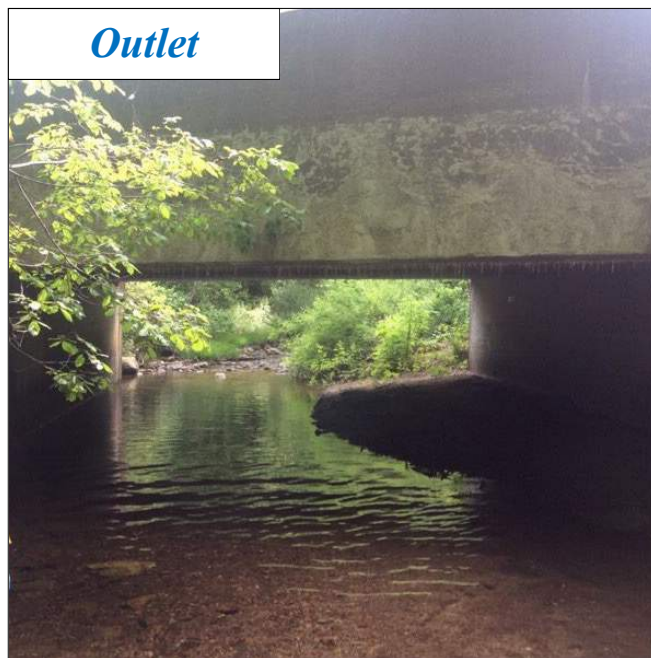
Outlet Shape: Box/Bridge with Abutments
 Outlet Drop/Grade: At Stream Grade
 Drop to Stream Surface/Bottom: 0.0/ 0.0
 Dimensions:
 Width: 23.0, Height: 6.4
 Substrate/Water Width: 23.0
 Water Depth: 1.0

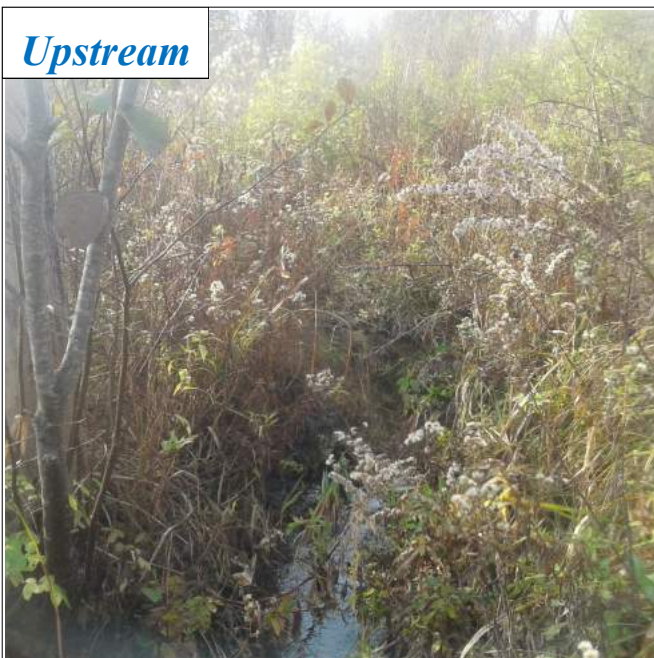
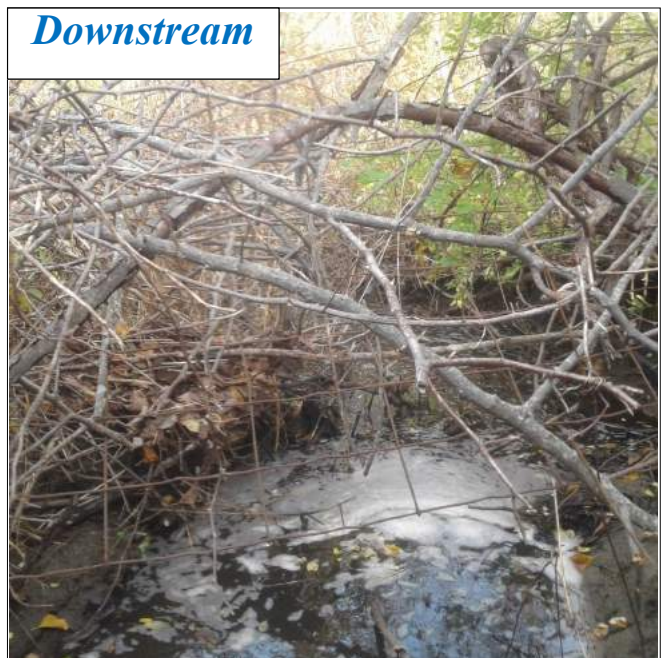
Crossing Comments: Stormwater outfall just upstream of inlet river right.

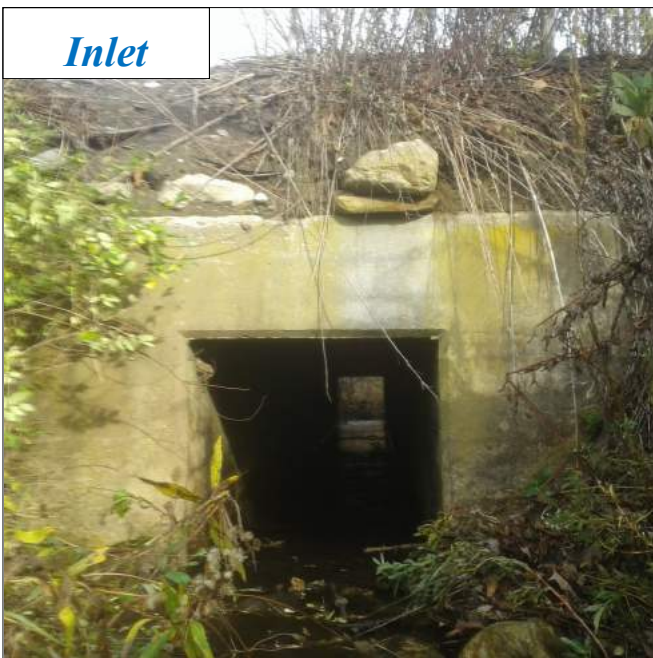
Inlet Shape/Type: Box Culvert
 Inlet Drop/Grade: At Stream Grade
 Dimensions:
 Width: 3.0, Height: 3.0
 Substrate/Water Width: 3.0
 Water Depth: 0.1
 Abutment Height: No data

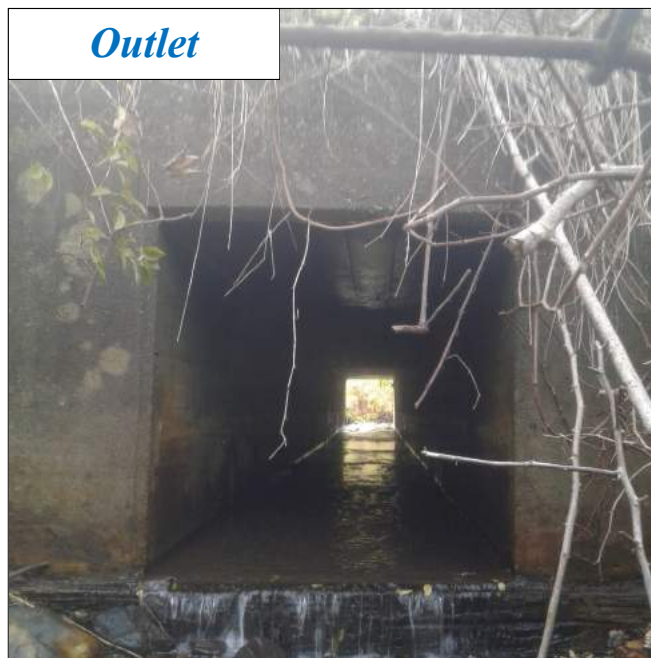
Outlet Shape: Box Culvert
 Outlet Drop/Grade: Free Fall
 Drop to Stream Surface/Bottom: 0.6/ 0.8
 Dimensions:
 Width: 3.0, Height: 3.0
 Substrate/Water Width: 3.0
 Water Depth: 0.1

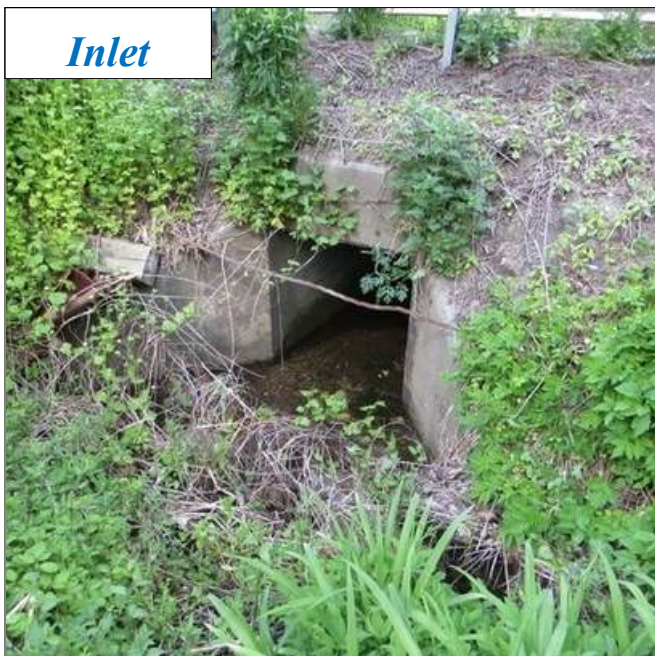
Inlet Shape/Type: Box Culvert
 Inlet Drop/Grade: At Stream Grade
 Dimensions:
 Width: 3.0, Height: 3.0
 Substrate/Water Width: 3.0
 Water Depth: 0.1
 Abutment Height: No data

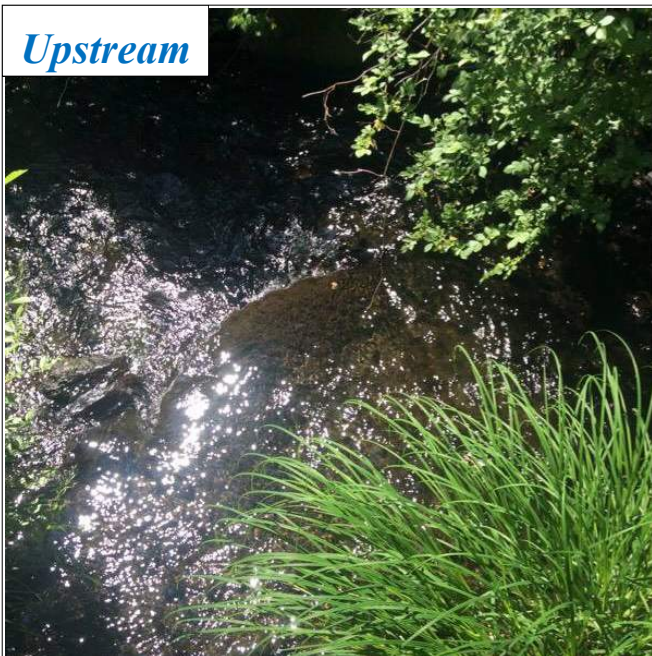
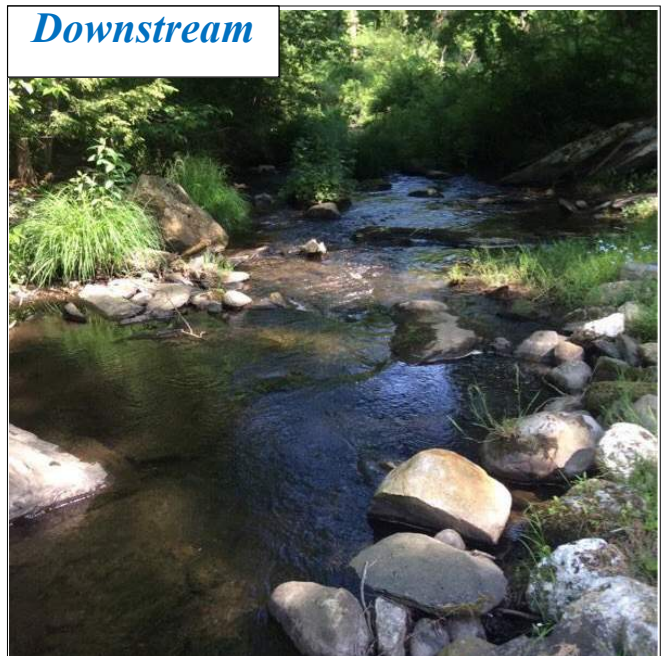
Crossing Comments: Collapsing

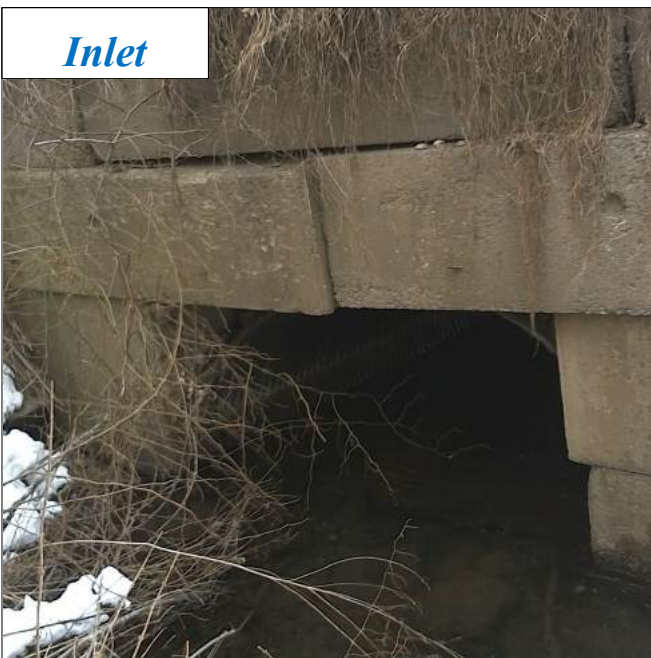
Inlet Shape/Type: Pipe Arch/Elliptical Culvert
Inlet Drop/Grade: Perched
Dimensions:
Width: 7.0, Height: 4.0
Substrate/Water Width: 6.8
Water Depth: 0.8
Abutment Height: No data

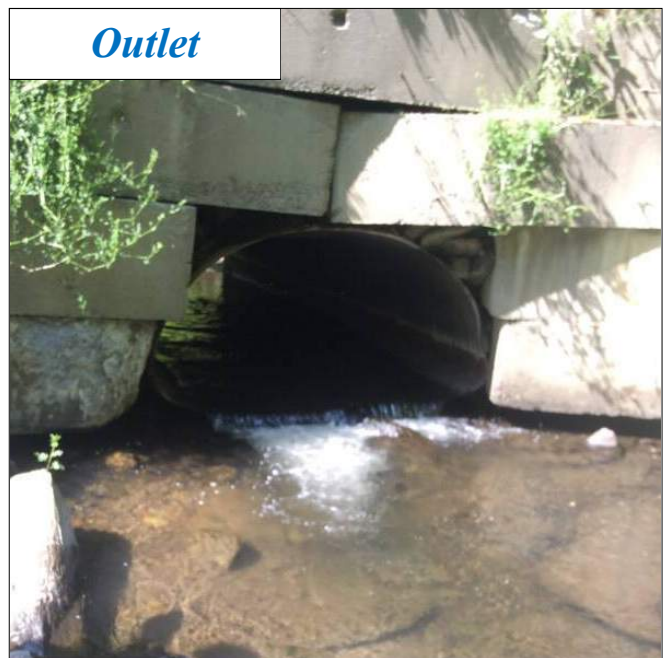
Outlet Shape: Pipe Arch/Elliptical Culvert
Outlet Drop/Grade: Free Fall
Drop to Stream Surface/Bottom: 1.2/ 1.3
Dimensions:
Width: 7.0, Height: 4.0
Substrate/Water Width: 5.5
Water Depth: 0.3

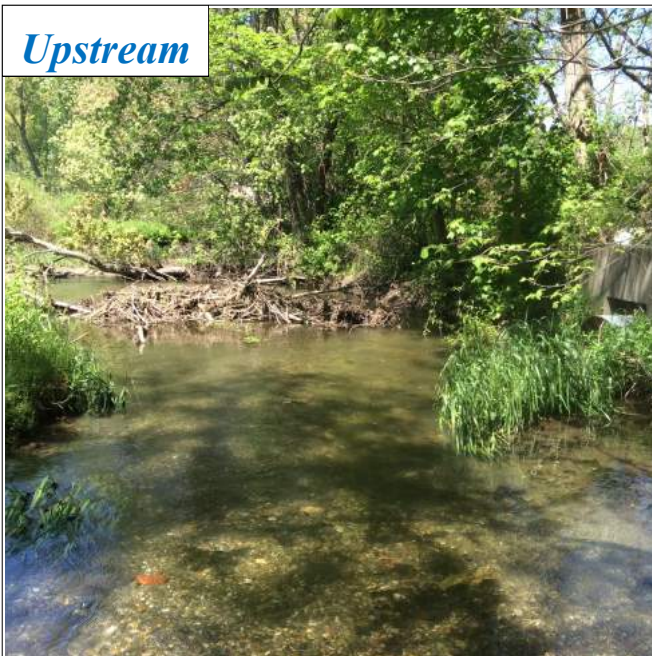
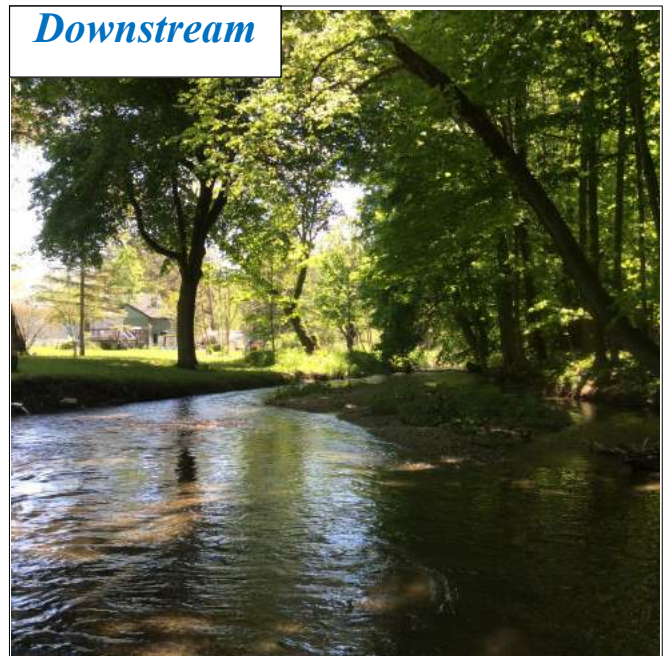
Crossing Comments: Possible illegal connection downstream river left. See downstream photo. Breached beaver dam upstream.

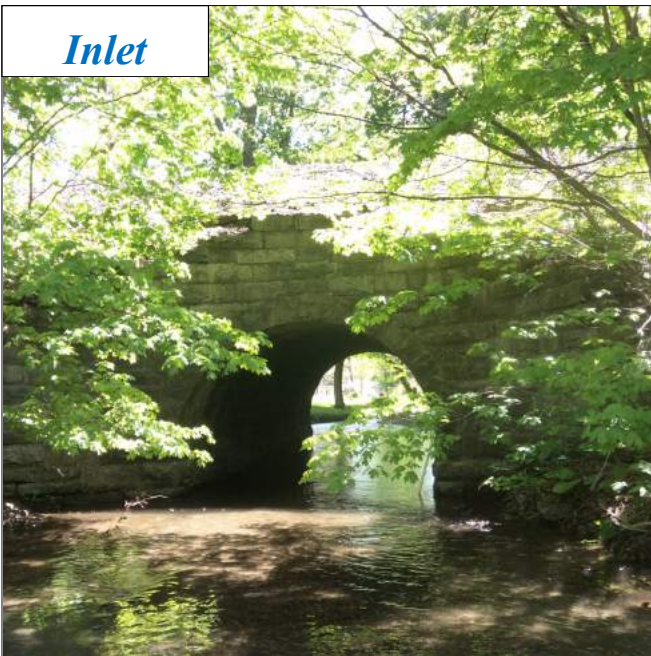
Inlet Shape/Type: Open Bottom Arch Bridge/
 Culvert
 Inlet Drop/Grade: At Stream Grade
 Dimensions:
 Width: 14.7, Height: 10.8
 Substrate/Water Width: 14.7
 Water Depth: 1.3
 Abutment Height: No data

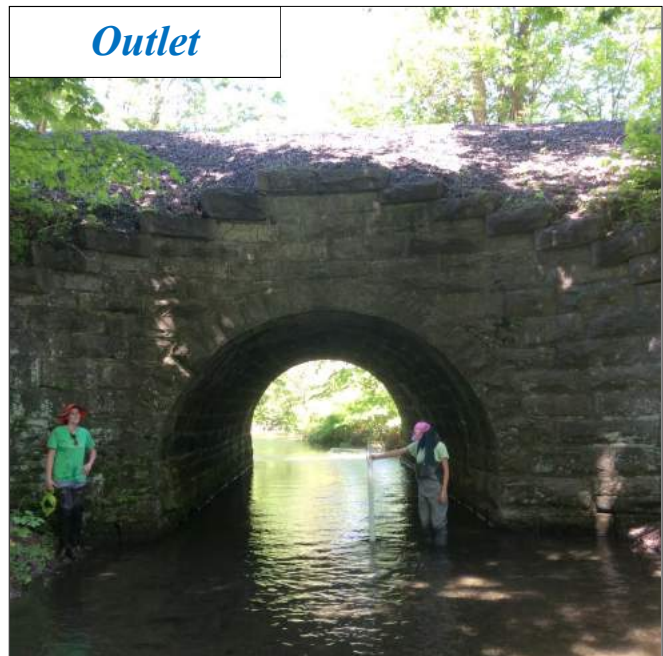
Outlet Shape: Open Bottom Arch Bridge/
 Culvert
 Outlet Drop/Grade: At Stream Grade
 Drop to Stream Surface/Bottom: 0.0/ 0.0
 Dimensions:
 Width: 14.5, Height: 10.8
 Substrate/Water Width: 14.5
 Water Depth: 1.1

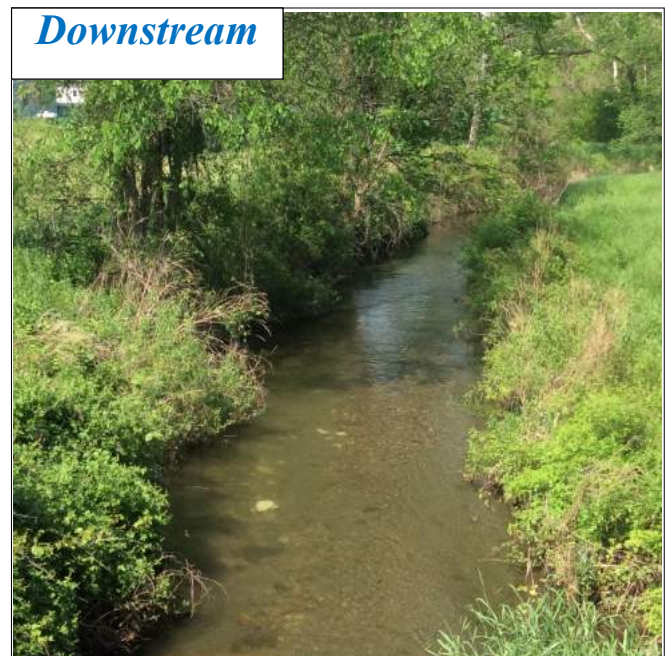
Downstream

Crossing Comments: Old bridge abutment upstream.

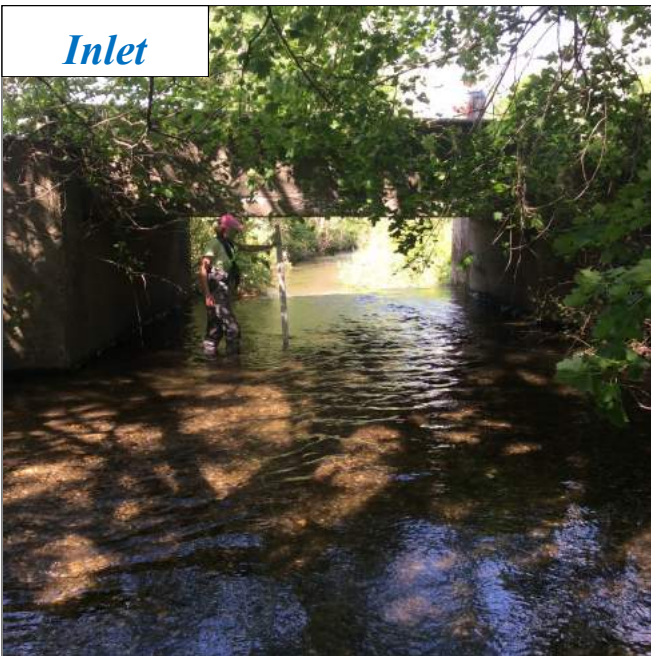
Physical Barrier(s)/Severity: None
 Slope: No data
 Structure Comments: Armor creates free fall

Inlet Shape/Type: Box/Bridge with Abutments
 Inlet Drop/Grade: At Stream Grade
 Dimensions:
 Width: 16.2, Height: 5.5
 Substrate/Water Width: 16.2
 Water Depth: 1.0
 Abutment Height: No data

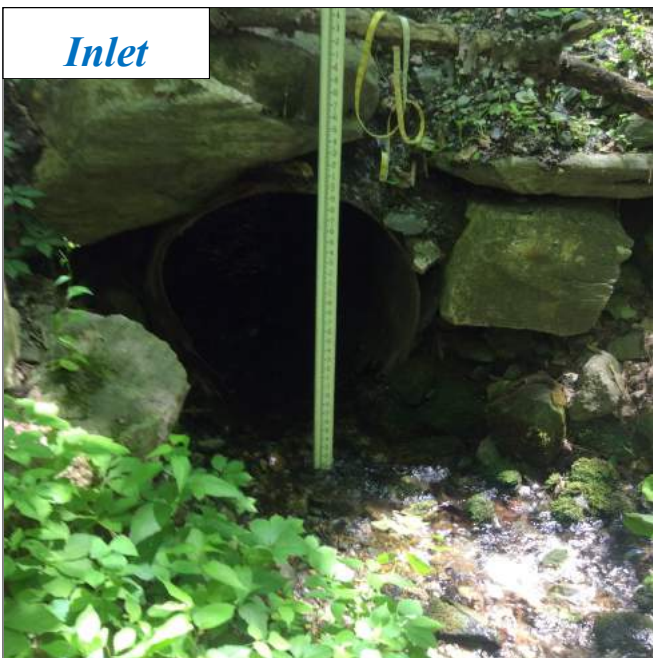
Inlet Shape/Type: Round Culvert
 Inlet Drop/Grade: At Stream Grade
 Dimensions:
 Width: 3.0, Height: 3.0
 Substrate/Water Width: 1.6
 Water Depth: 0.2
 Abutment Height: No data

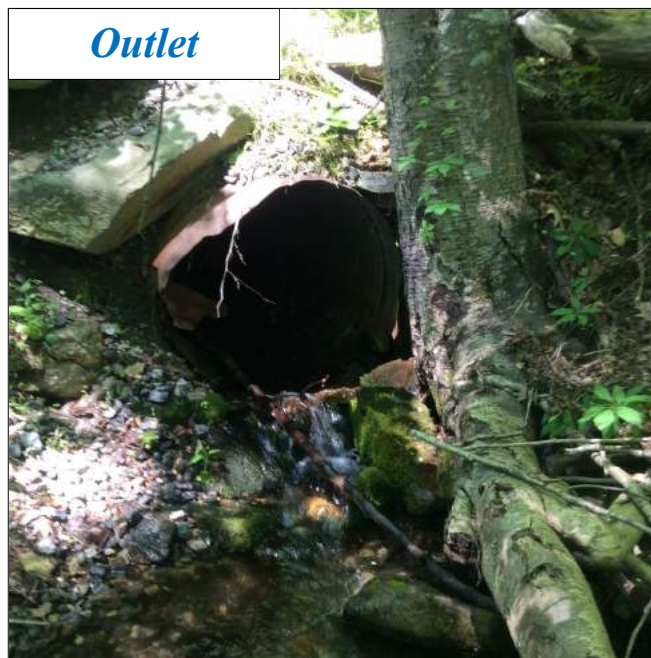
Outlet Shape: Round Culvert
 Outlet Drop/Grade: Cascade
 Drop to Stream Surface/Bottom: 0.4/ 0.8
 Dimensions:
 Width: 3.0, Height: 3.0
 Substrate/Water Width: 1.3
 Water Depth: 0.2

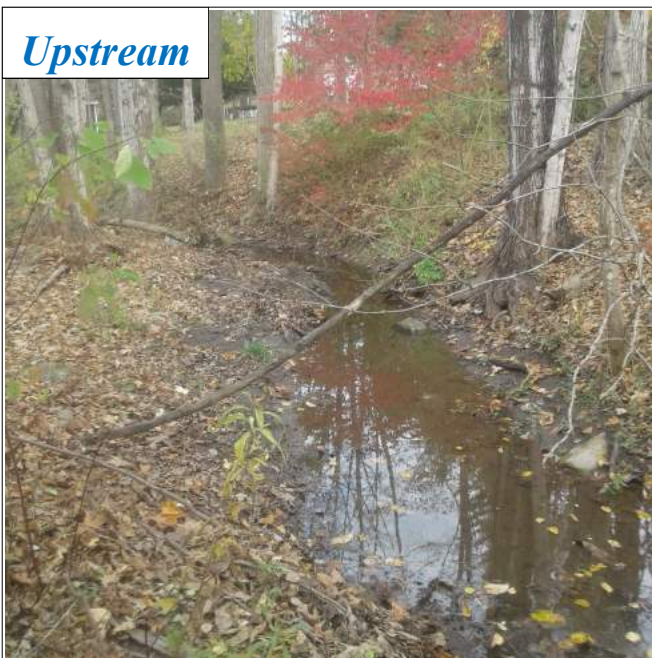
Crossing Comments: Large tree and rock upstream of inlet with debris jam

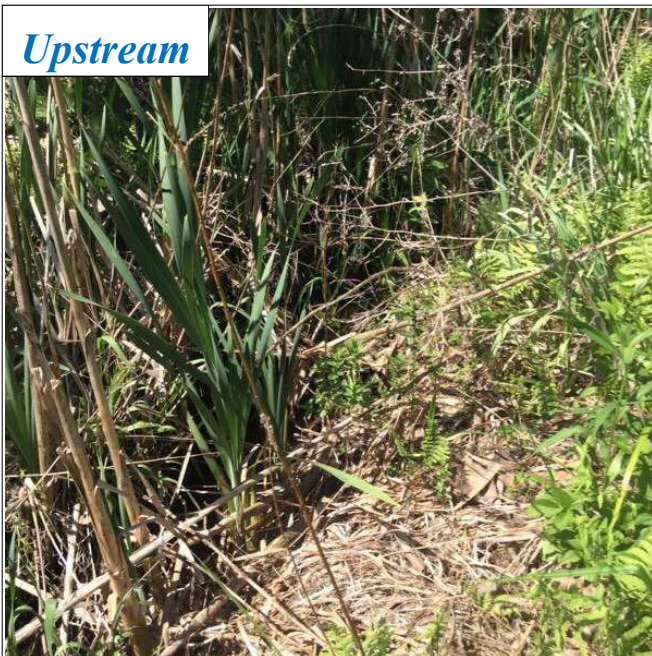
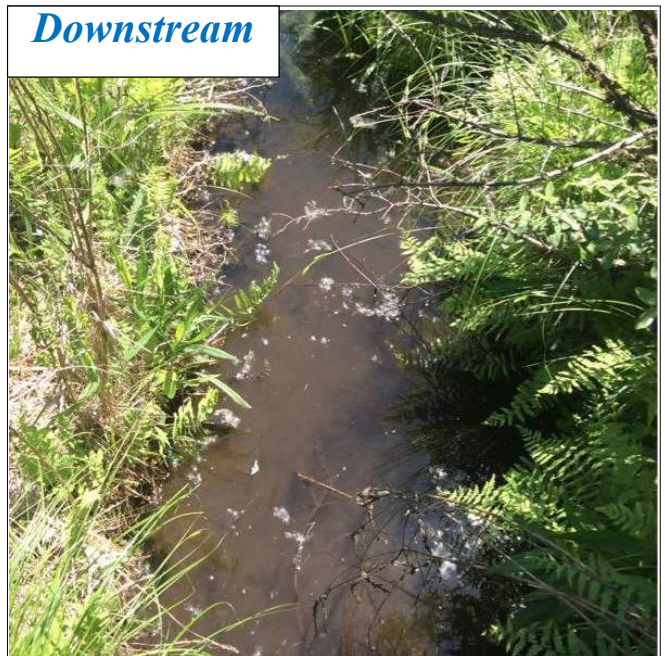
Crossing Comments: Random pipe placed underneath the bridge

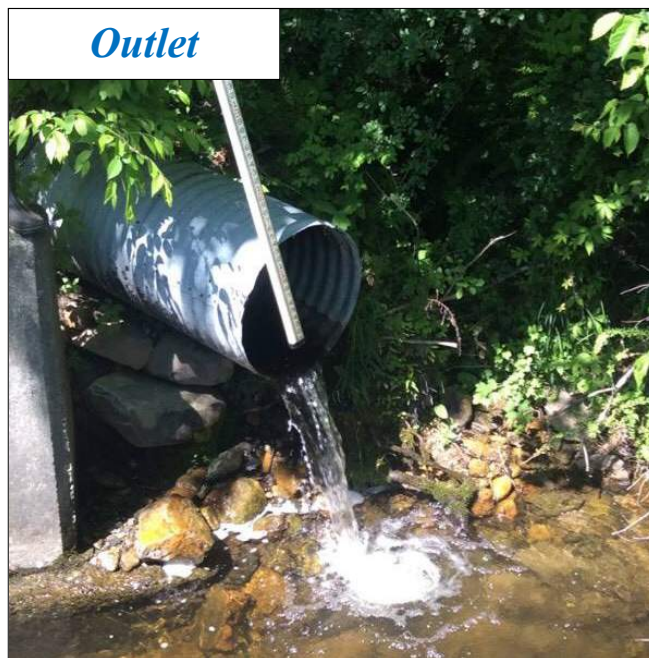
Outlet Shape: Round Culvert
 Outlet Drop/Grade: Free Fall
 Drop to Stream Surface/Bottom: 2.7/ 2.9
 Dimensions:

Width: 2.0, Height: 2.0
 Substrate/Water Width: 1.0
 Water Depth: 1.0

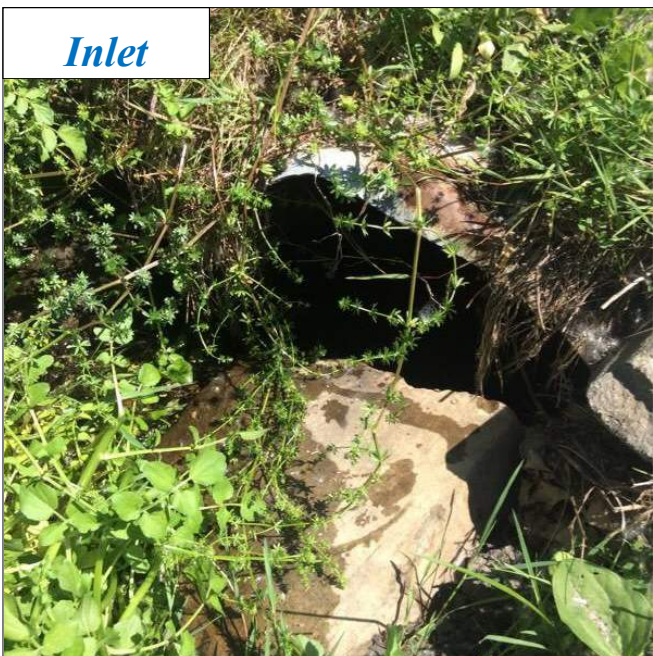
INLET

Physical Barrier(s)/Severity: Debris/Sediment/
 Rock (Minor)
 Slope: 1.8%
 Structure Comments: No data

Inlet Shape/Type: Round Culvert
 Inlet Drop/Grade: Inlet Drop
 Dimensions:
 Width: 1.5, Height: 1.6
 Substrate/Water Width: 1.0
 Water Depth: 0.3
 Abutment Height: No data

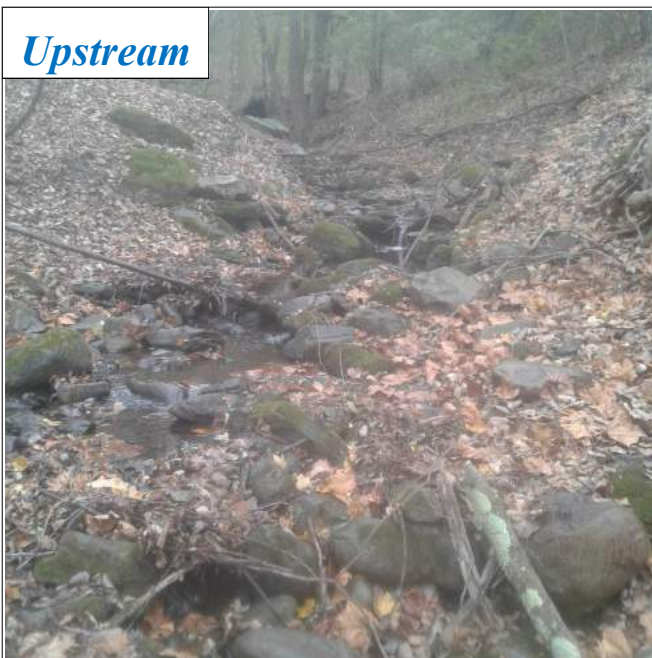
Upstream

Scour Pool: Large
 Bankfull Width (feet): 14
 Bankfull Width Confidence: Low/
 Estimated

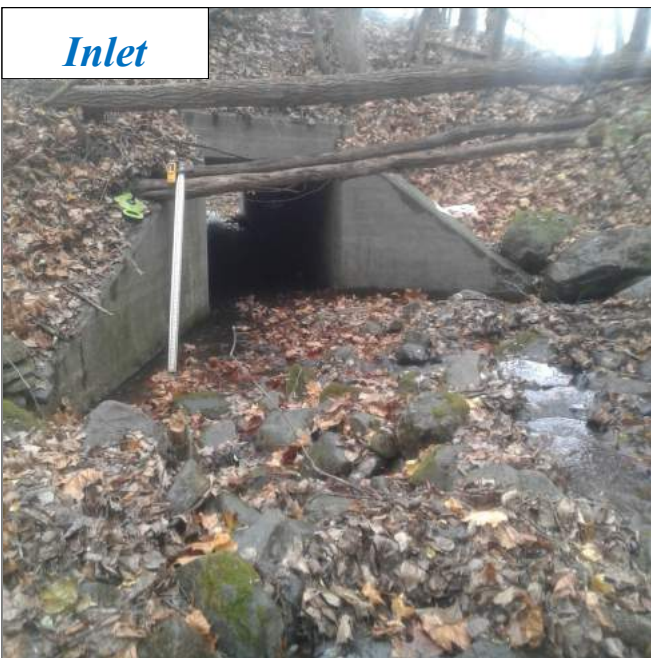
INLET

Inlet Shape/Type: Box Culvert
Inlet Drop/Grade: At Stream Grade
Dimensions:
Width: 6.5, Height: 5.0
Substrate/Water Width: 6.5
Water Depth: 0.1
Abutment Height: No data

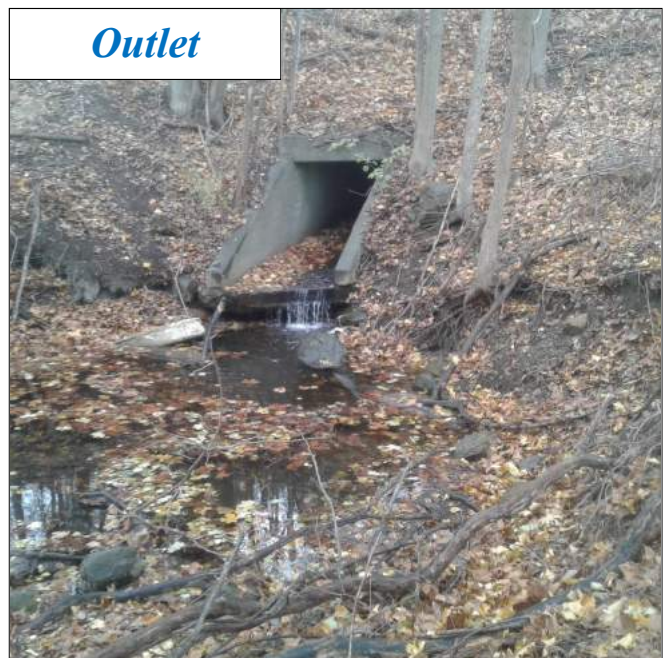
OUTLET

Outlet Shape: Box Culvert
Outlet Drop/Grade: Free Fall
Drop to Stream Surface/Bottom: 1.8/ 2.4
Dimensions:
Width: 5.6, Height: 5.1
Substrate/Water Width: 3.4
Water Depth: 0.2

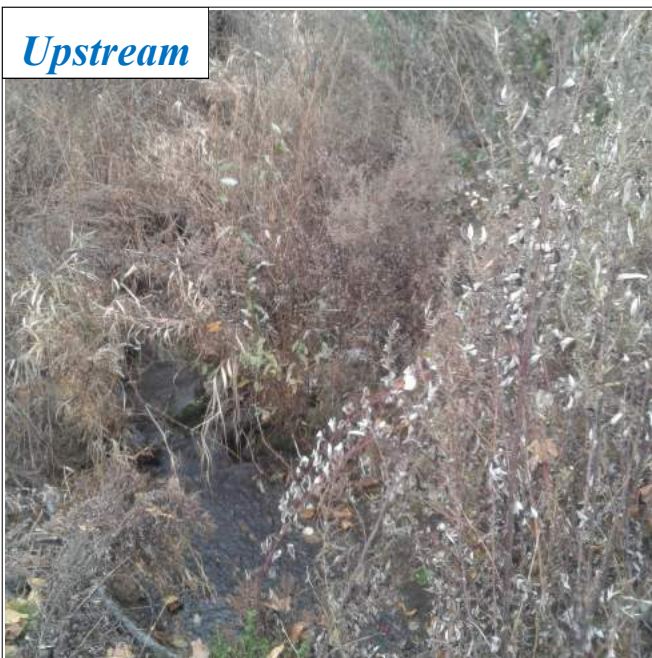
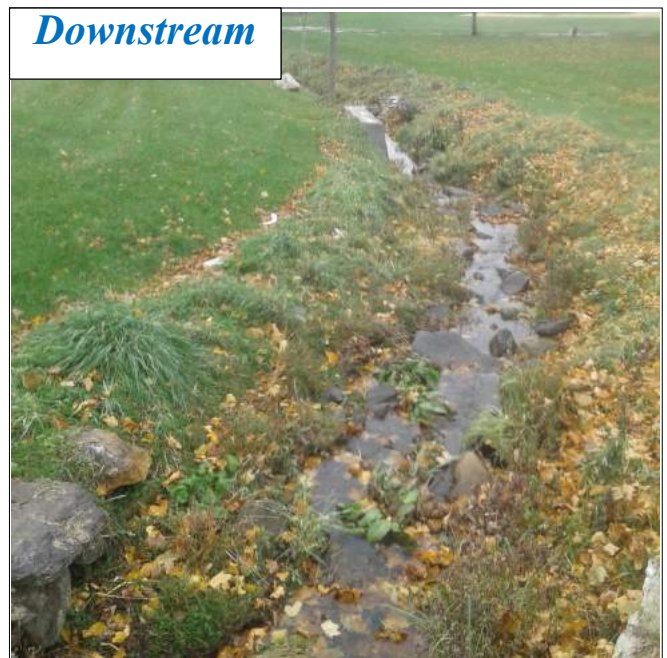
Crossing Comments: Series (3) of large (4-5') corrugated steel pipes culverts under trails up-stream of crossing

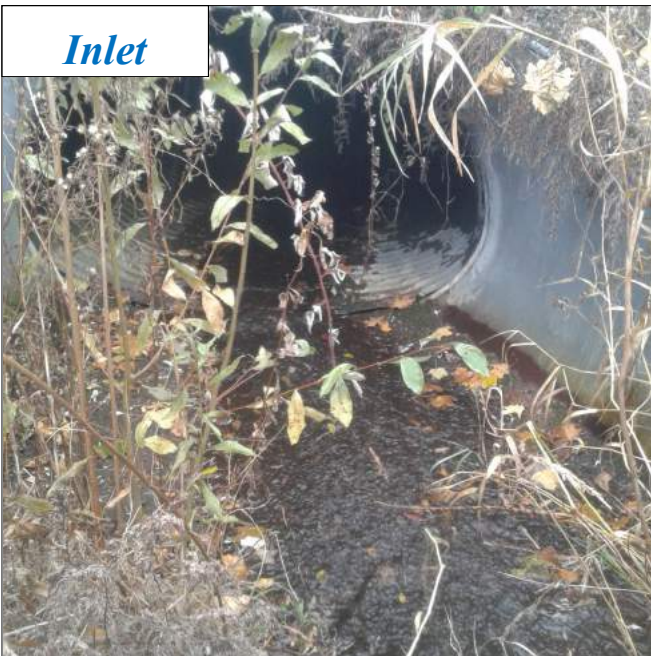
Inlet Shape/Type: Pipe Arch/Elliptical Culvert
 Inlet Drop/Grade: At Stream Grade
 Dimensions:
 Width: 5.8, Height: 3.8
 Substrate/Water Width: 2.1
 Water Depth: 0.1
 Abutment Height: No data

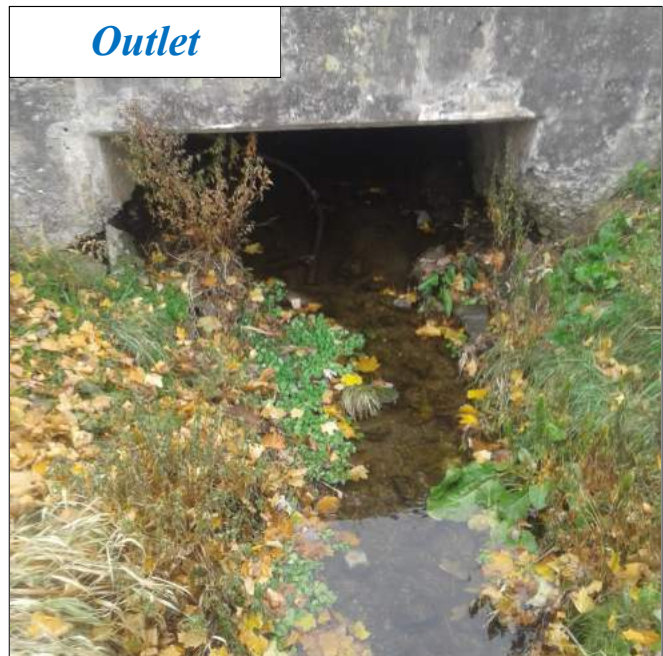
Outlet Shape: Box/Bridge with Abutments
 Outlet Drop/Grade: At Stream Grade
 Drop to Stream Surface/Bottom: 0.0/ 0.0
 Dimensions:
 Width: 7.3, Height: 3.4
 Substrate/Water Width: 4.0
 Water Depth: 0.3
