Village of Irvington Flood Study March 2011

for the
Village Board
&
Community

Prepared by
Hahn Engineering
Brewster, NY

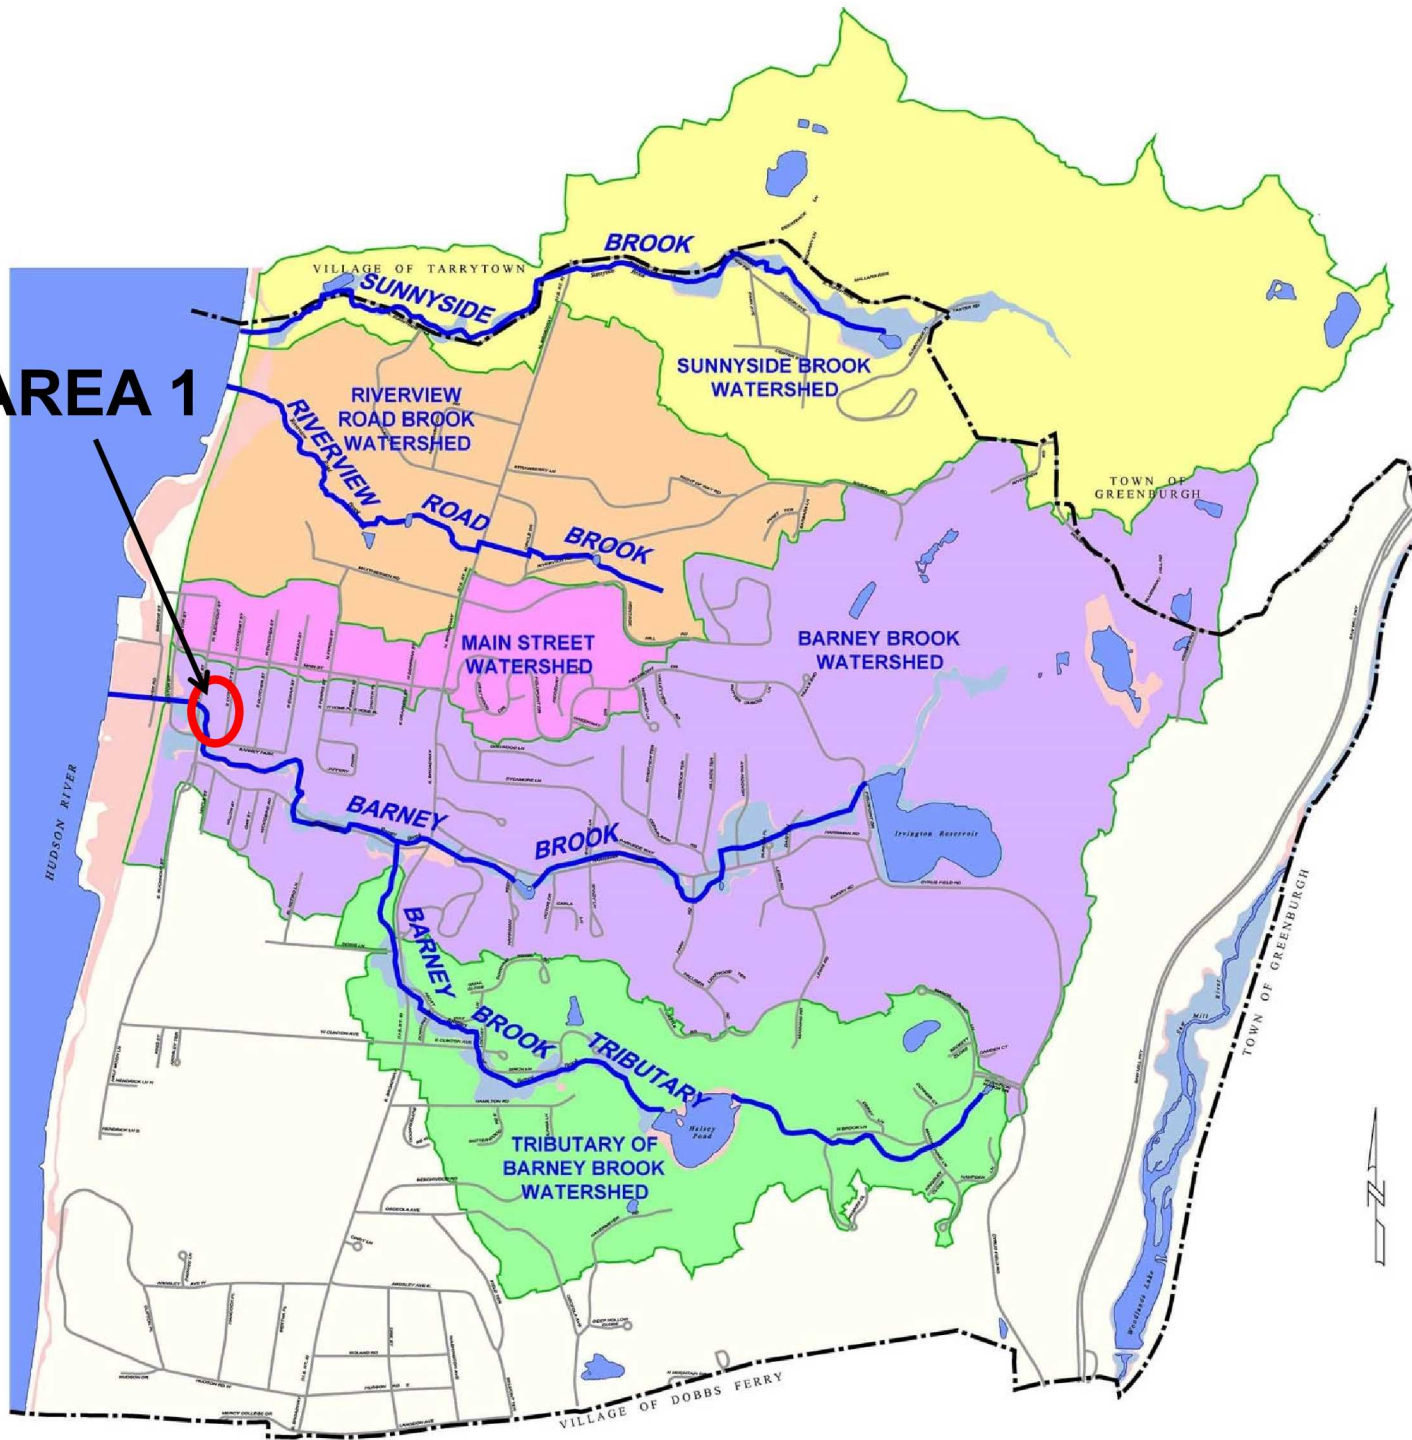
(ALTERNATIVE #1)	SCALE 1" = 60'	DATE 08/27/10
STUDY STCHESTER COUNTY, NY	DRAWING NO. 1A	SHEET NO. OF

- ESTIMATE \$300,000.
- CULVERT TO BE SURVEYED TO VERIFY CAPACITY.

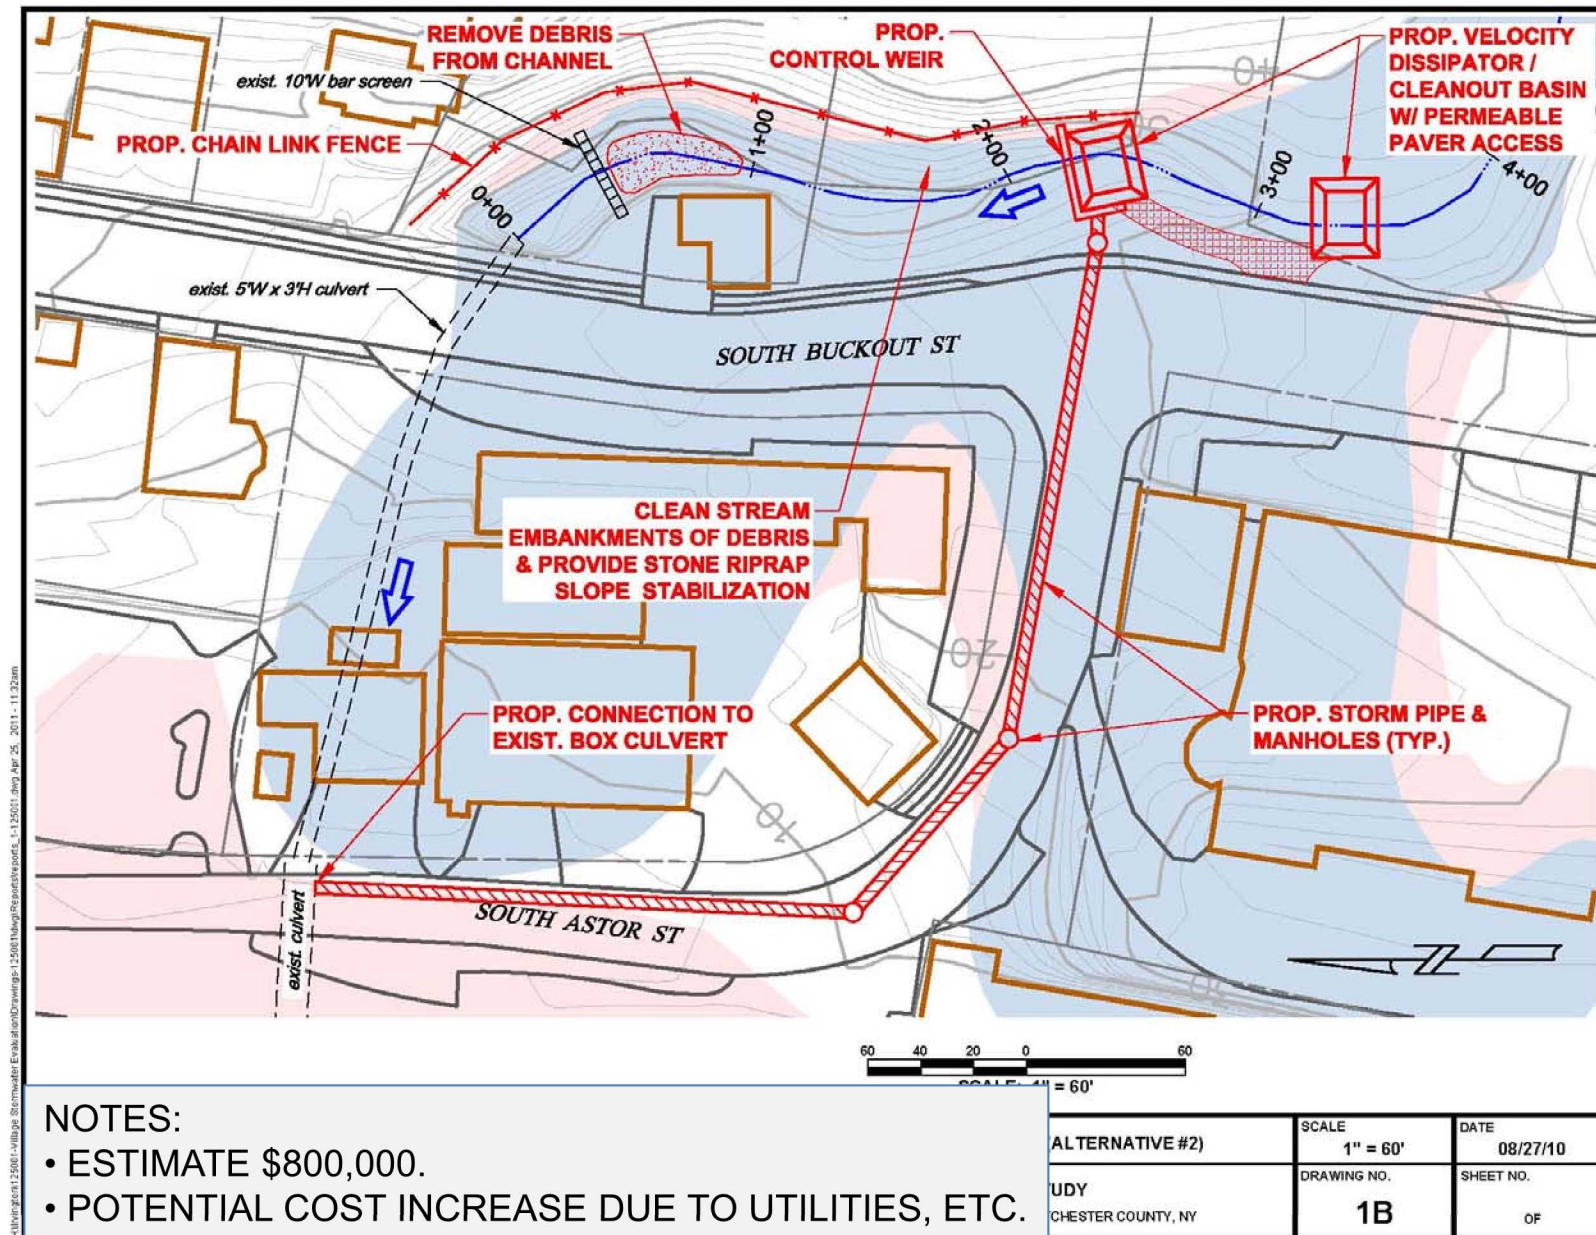
Improvement 1A – South Buckout Street

**DEBRIS
FROM
SLOPE**

**SEDIMENT
ACCUMULATION**

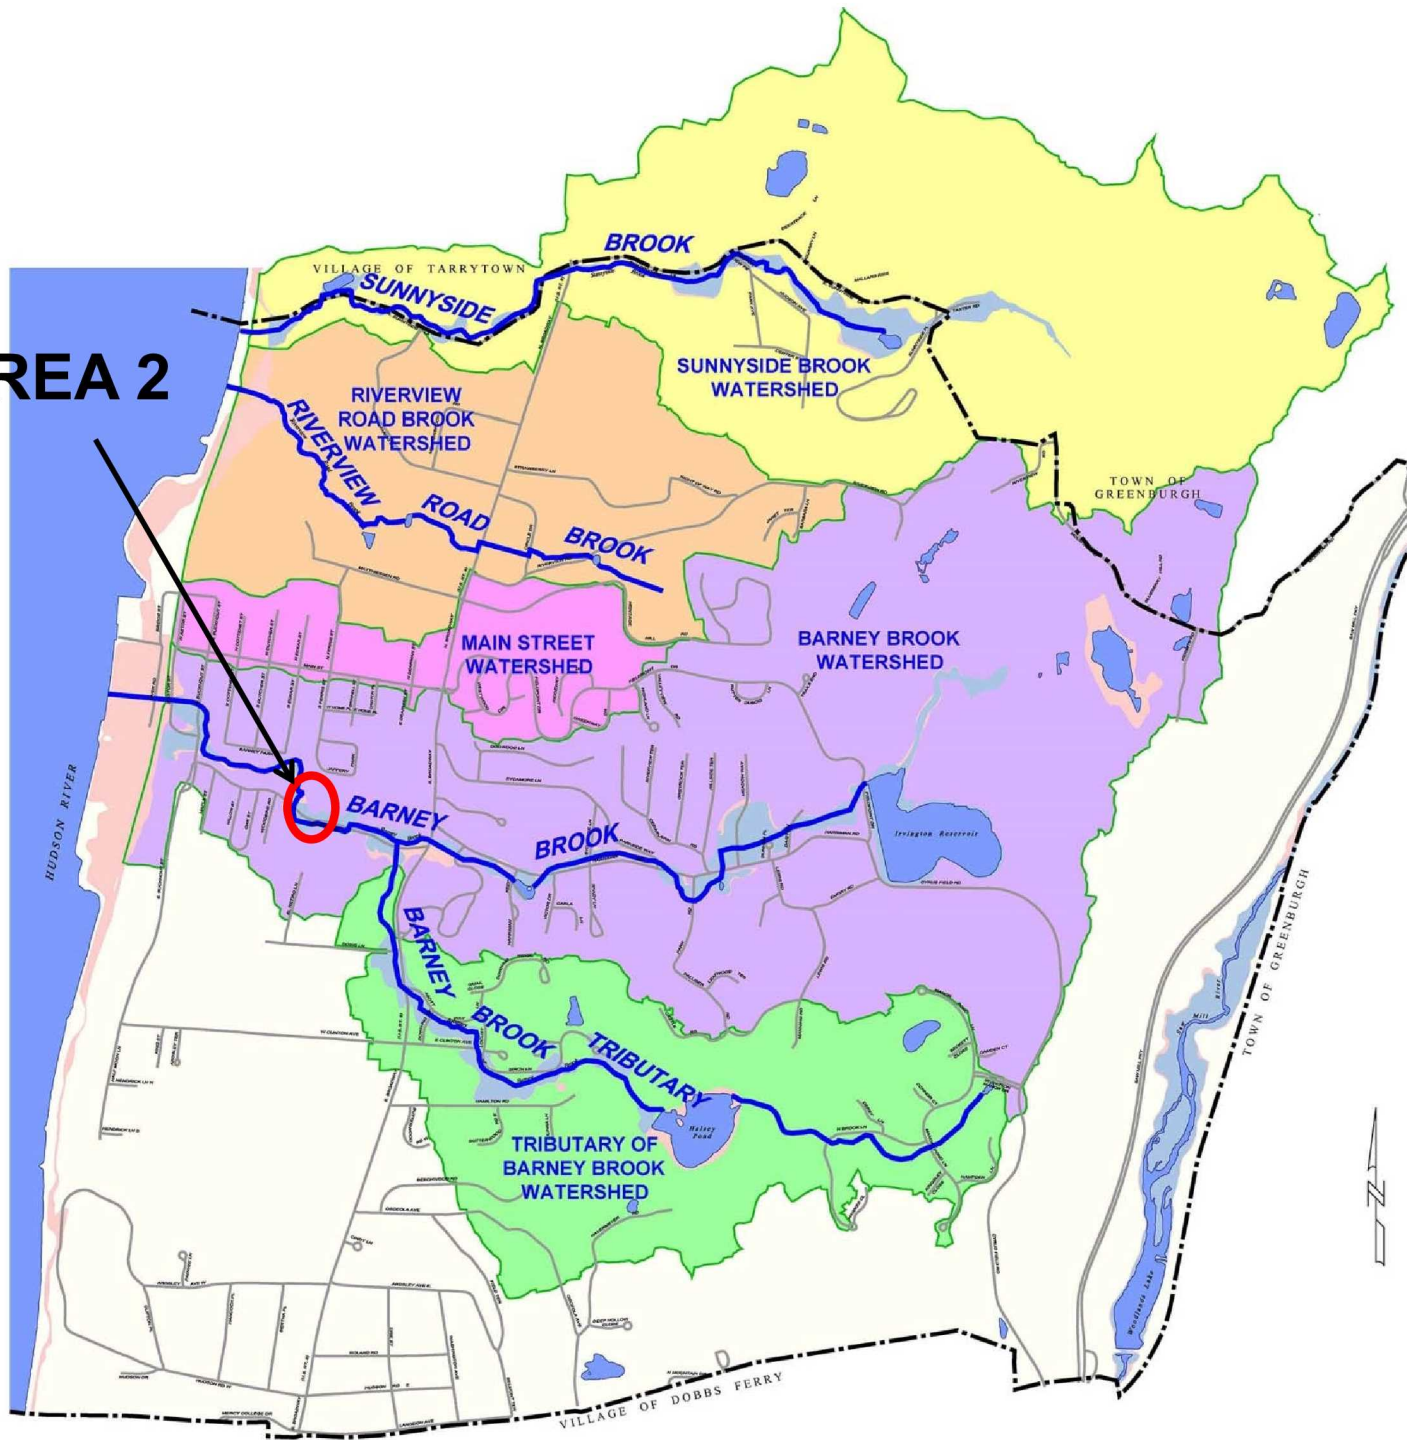
PLAN #2	SCALE 1" = 40'	DATE 08/27/10
UDY CHESTER COUNTY, NY	DRAWING NO. 2	SHEET NO. OF

- ESTIMATE \$220,000.
- POTENTIAL DOWNSTREAM IMPACT, SURVEY AND ADDITIONAL ANALYSIS REQUIRED.

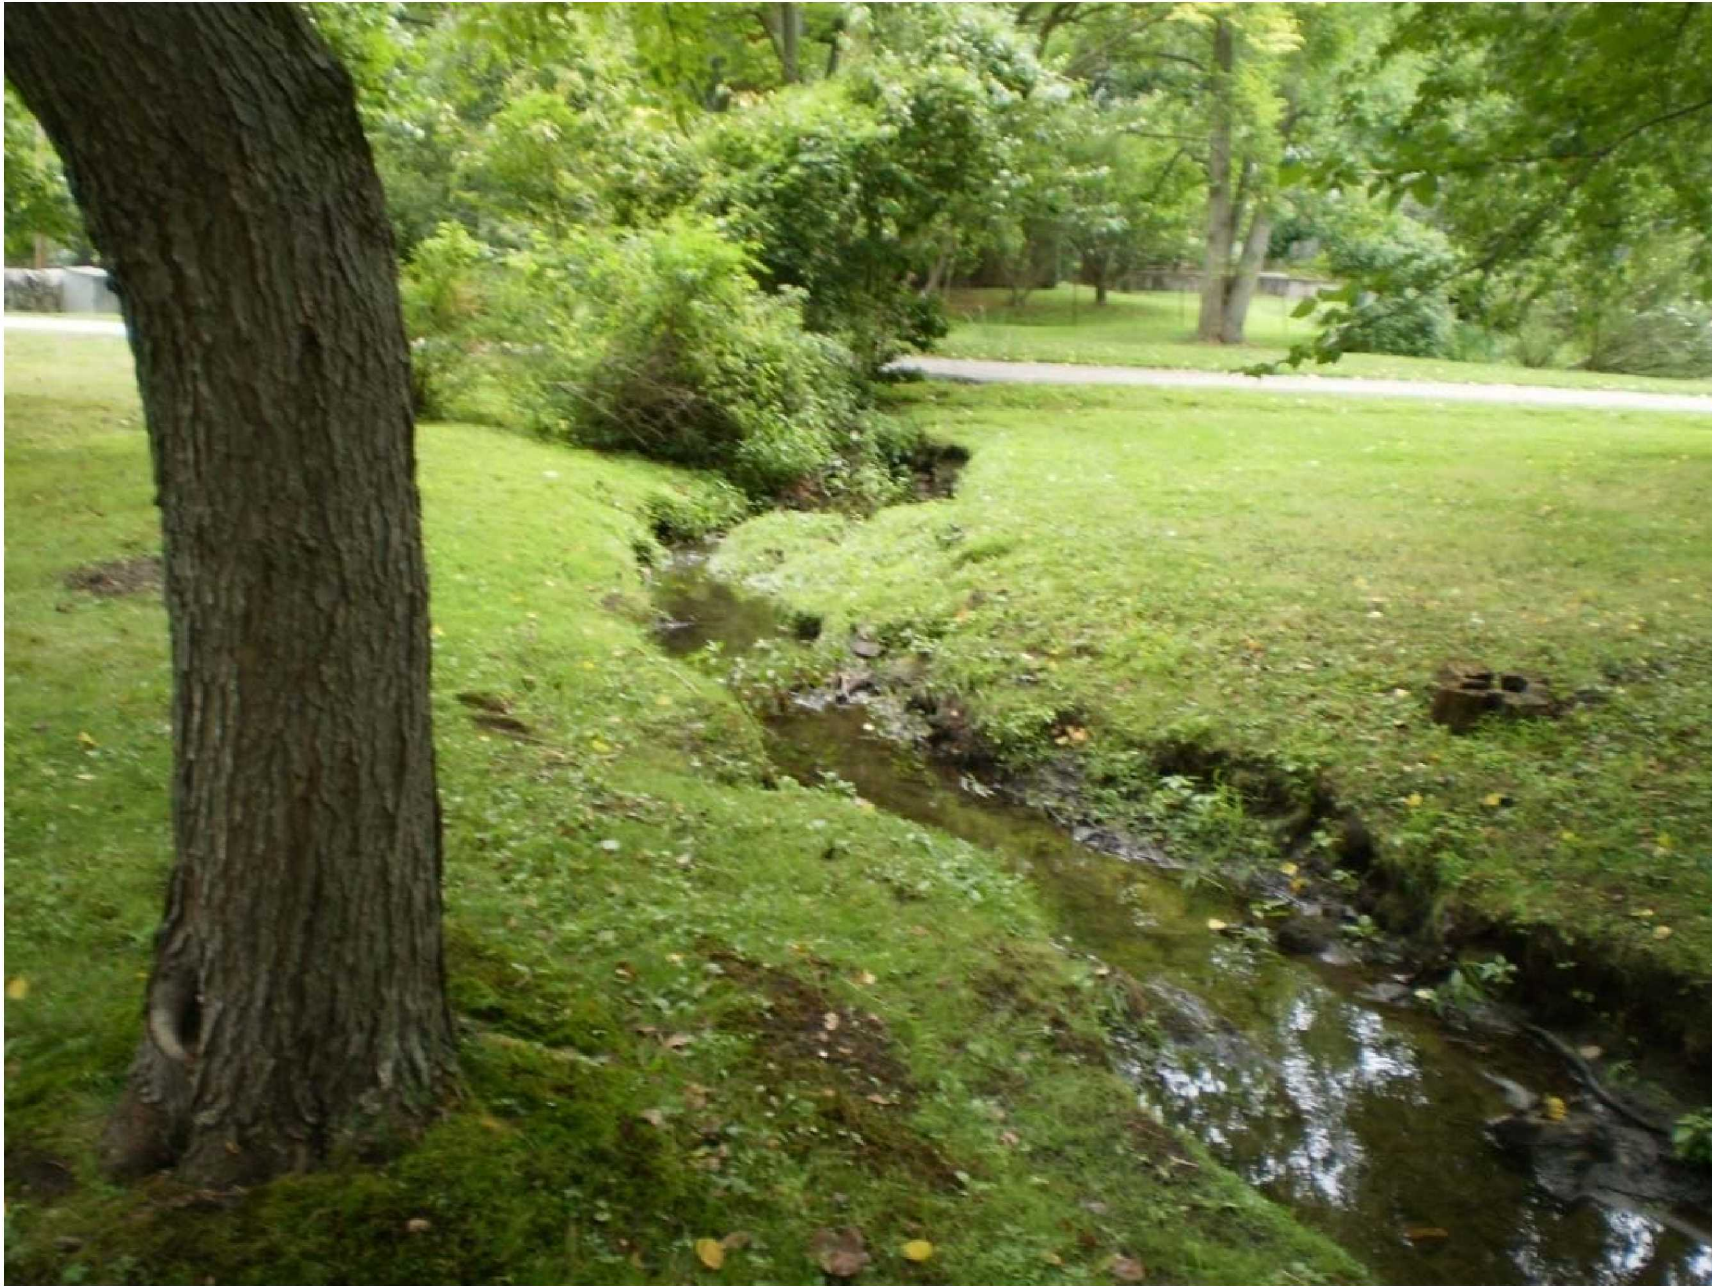
SEDIMENT ACCUMULATION IMPEDES FLOW.

**RECONSTRUCT CONTROL STRUCTURE AT
MEADOW WAY.**

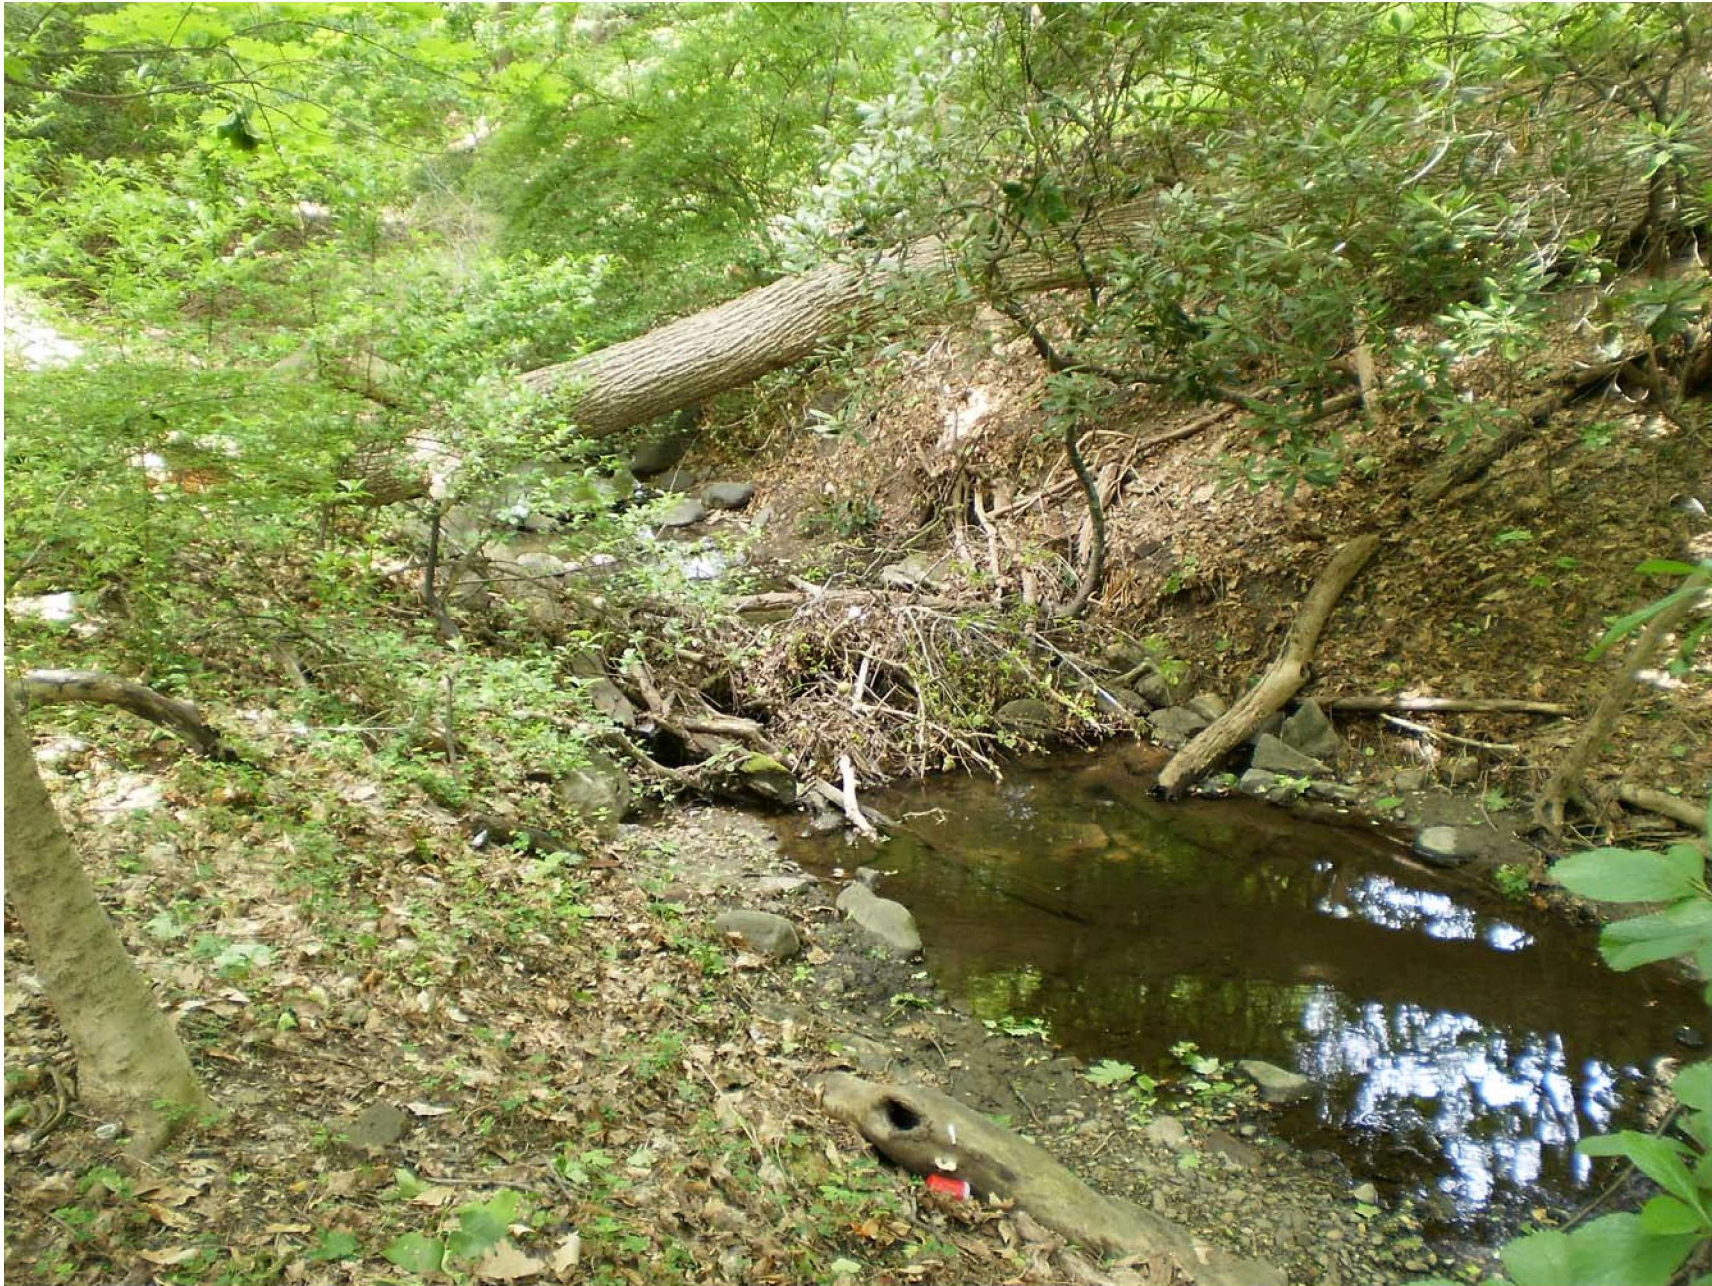
Sediment Accumulation Reduces Pipe Capacity
