## Irvington Village Hall – Energy Audit

Village of Irvington

85 Main St, Irvington, NY

Re:     Irvington Village Hall, Irvington, NY 105331  
       Energy Audit Report

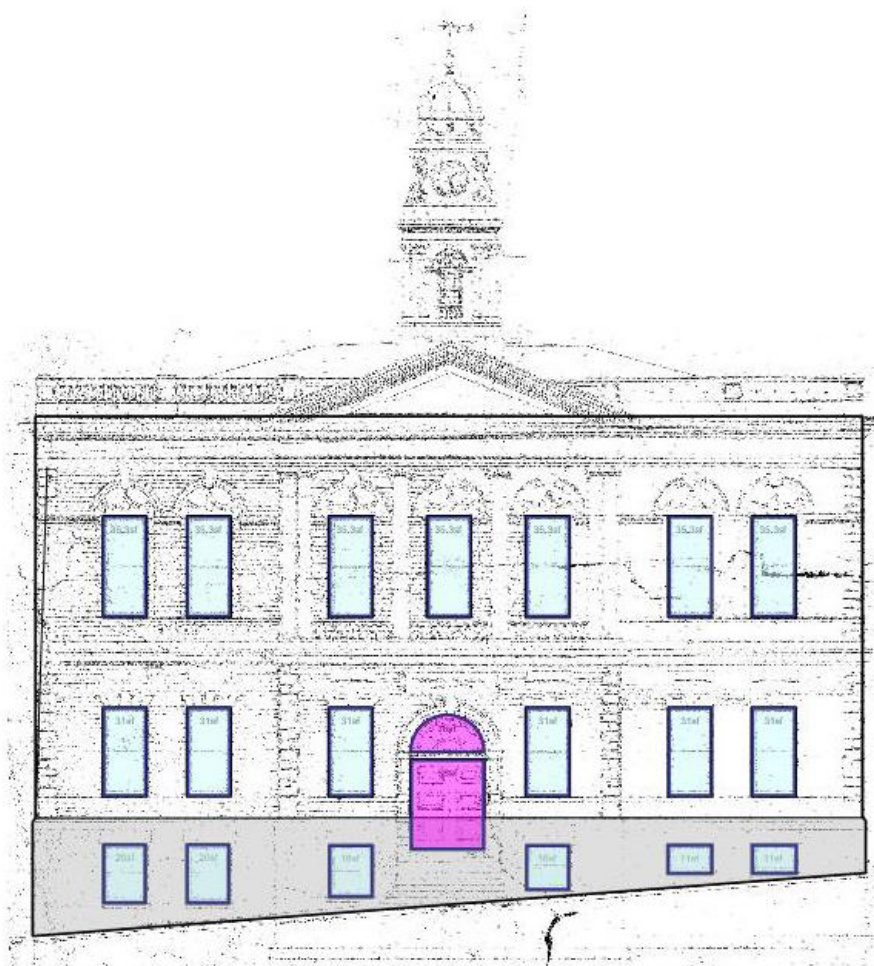
AREA OF FACADE=3218SF  
PERCENTAGE OF WINDOWS=17%  
PERCENTAGE OF DOORS=2%  
PERCENTAGE OF MASONRY WALL=81%

ASSUMPTIONS MADE:  
DOORS AND WINDOWS SHALL HAVE SAME R VALUE  
WEATHERSTRIPPING NOT TAKEN INTO CONSIDERATION  
TWO SLIDING WINDOWS IN BREAKOUT ROOM NOT CONSIDERED DUE TO LIMITED  
SIZE AND IMPACT ON LOAD

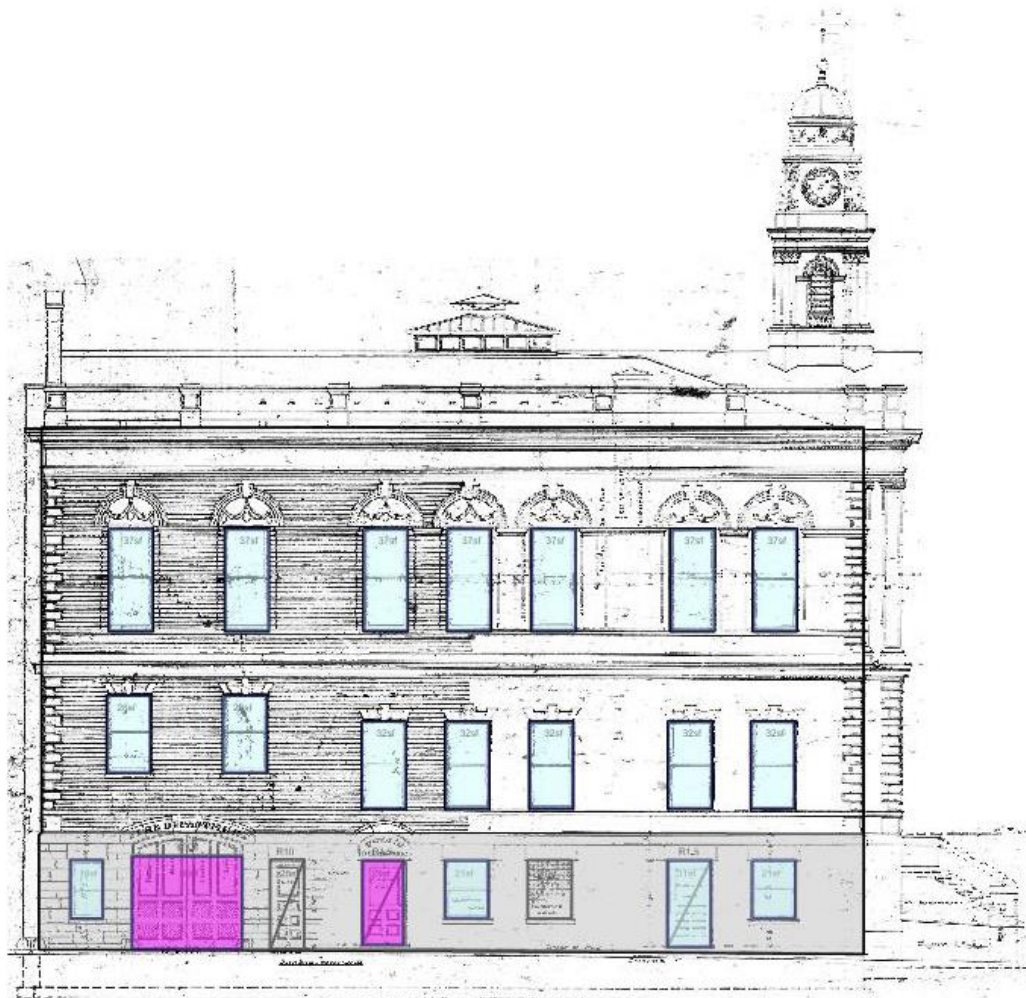
AREA OF FACADE=3536SF  
PERCENTAGE OF WINDOWS=15.4%  
PERCENTAGE OF DOORS=3.2%  
PERCENTAGE OF MASONRY WALL=81.4%

ASSUMPTIONS MADE:  
DOORS AND WINDOWS SHALL HAVE SAME R VALUE  
WEATHERSTRIPPING NOT TAKEN INTO CONSIDERATION

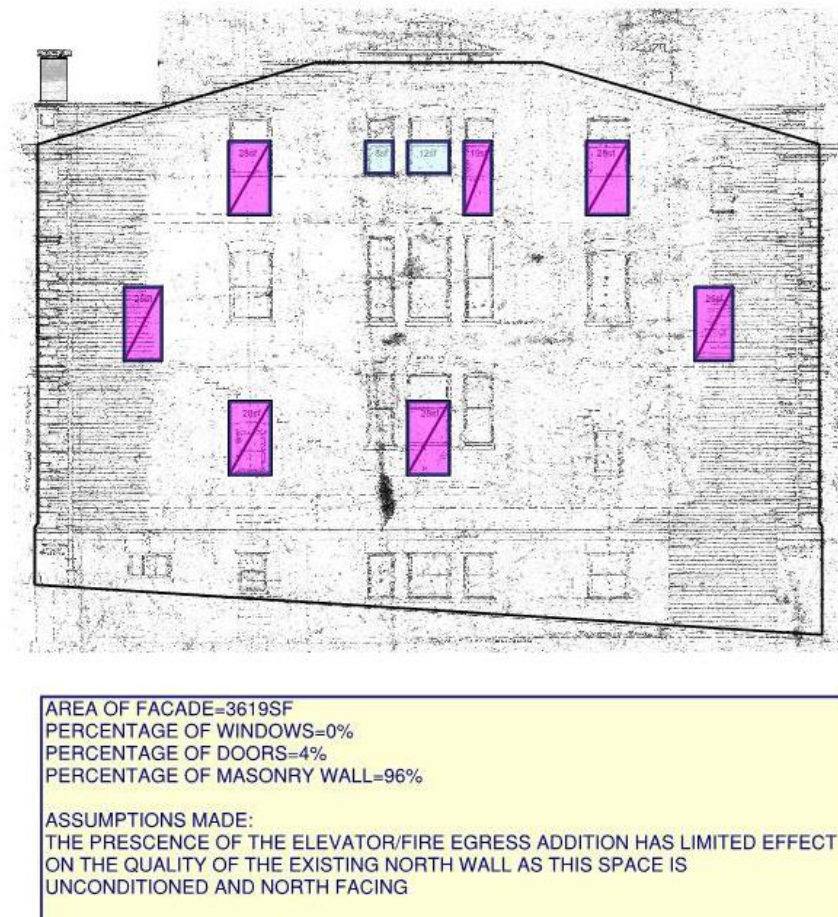
Figure 9: North Elevation (Derived from Original Drawings by Architect)

Area of walls	3619 SF	R value=6.4
Area of windows/doors	145 SF	R value=1.79

Note—as previously noted, the fire stair and elevator addition is not calculated as having a sizable effect on energy performance of building.

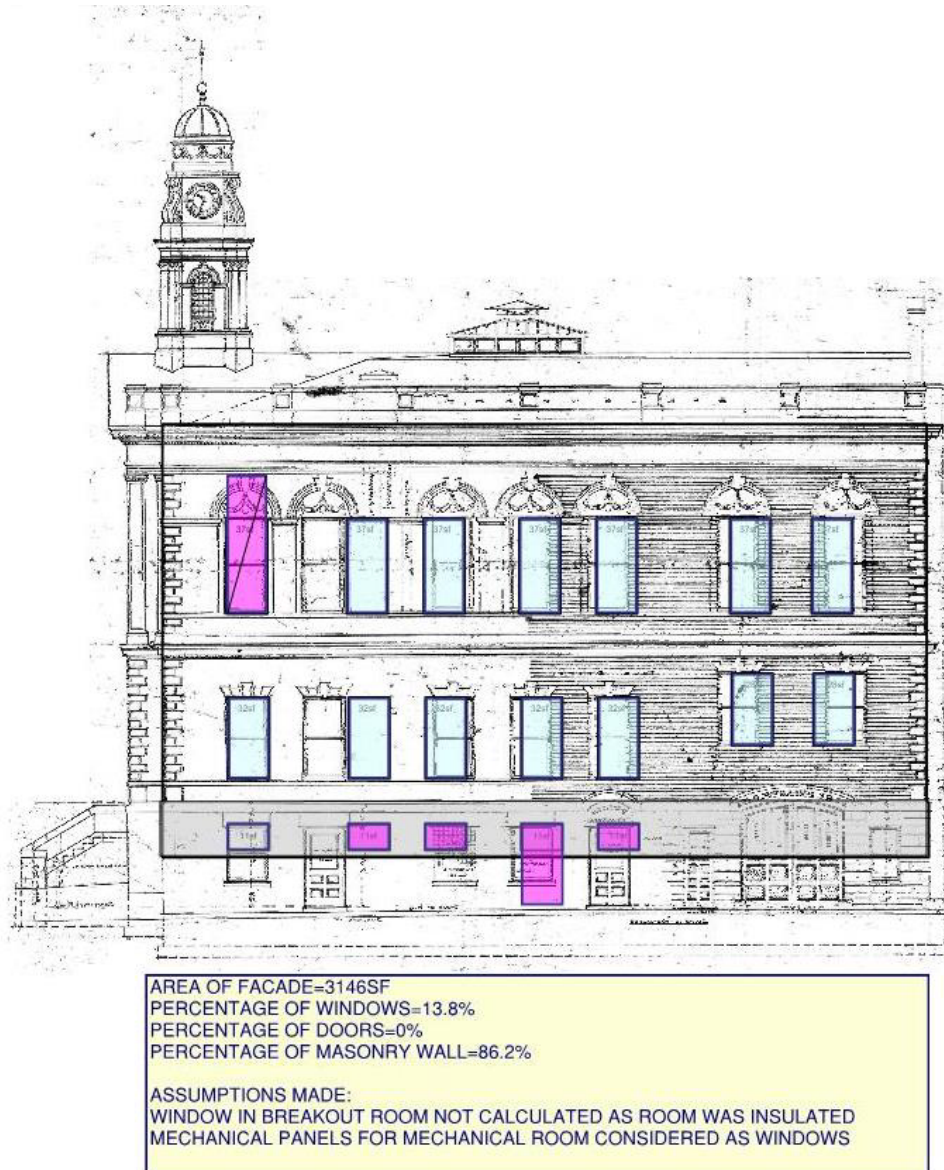
Figure 10: East Elevation (Derived from Original Drawings by Architect)

Area of walls	3146 SF	R value=6.4
Area of windows/doors	436 SF	R value=1.79

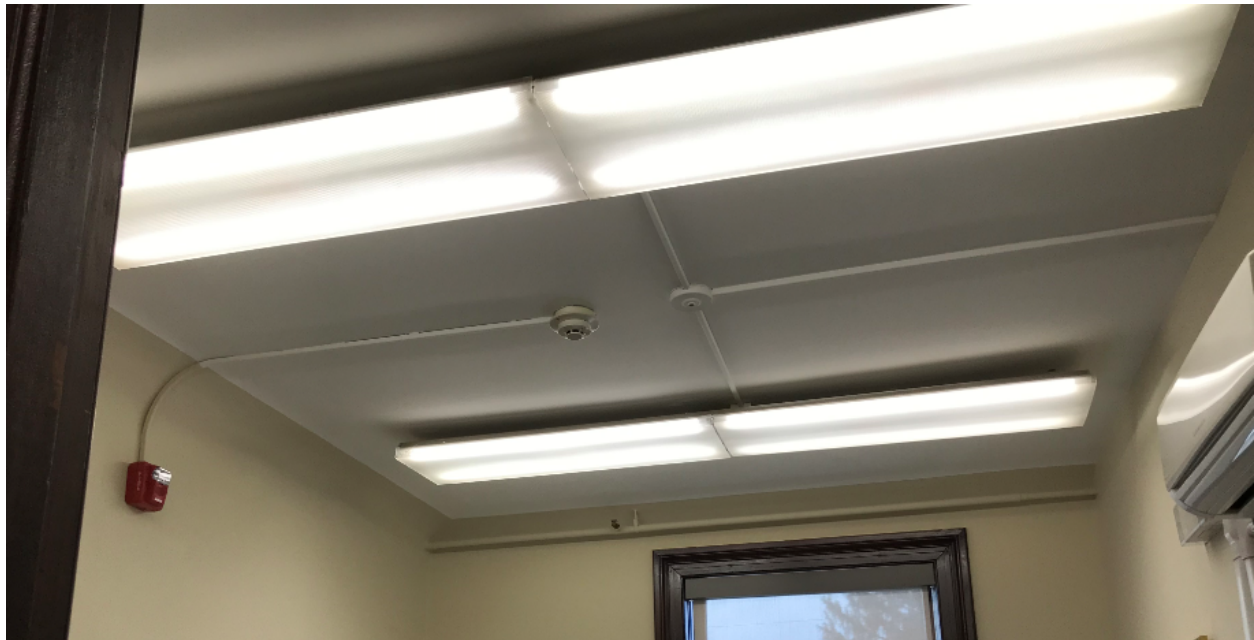
The existing building lighting fixtures were retrofit to be all LED in 2016. Lighting in each space is controlled by on/off switches. An inventory of existing fixtures, including make and model, quantities and power usage is shown in **Appendix C**.

Photo 16: Typical T8 LED Fixtures
