Town of Pittsford

Energy Efficiency Measures in Town Owned and Operated Buildings

February 7, 2020

Building Re-Tuning Walk-down Observations for Pittsford Town Hall

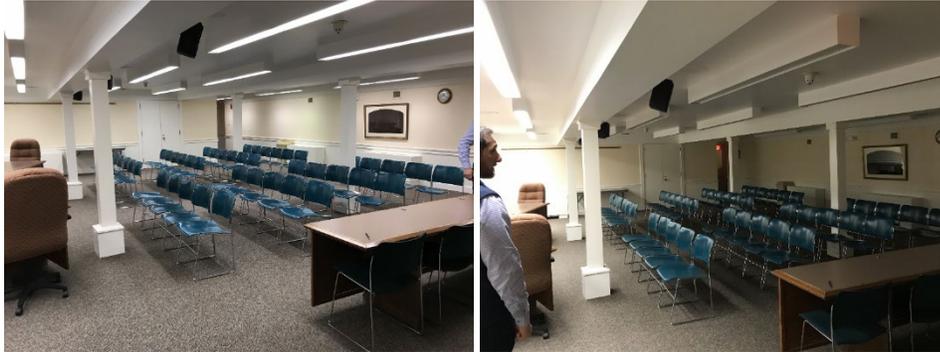
- Basement meeting room lights are fully on all day (8 am to 8 pm) even though the room is only occasionally used during normal working hours. Staff members pass through on the way to and from offices so some light is needed.
 - Lights in that space are on three circuits. Consider turning two off unless there is a meeting in progress. Leave one on for occupants that need to pass through that space. The photos below show the room with all lights on and just the front lights on. Note that the front light circuit also covers the elevator and stairwell entrance.

- Install signage to instruct staff on proper light use.
 - Install occupancy sensors on the two rear (south) circuits.
- Most lights are on manual switches.
 - Consider occupancy sensors in low use areas
- Mix of lamp types: T-5, T-8, and T-12
 - Consider full LED retrofit
- Second floor office lighting level was over 80 ft.-candles.
 - Guidelines for open office lighting levels are 30-50 ft.-candles. Consider reducing overall light levels with an LED conversion from the existing T-5 fluorescents. See Table 1 for more information.

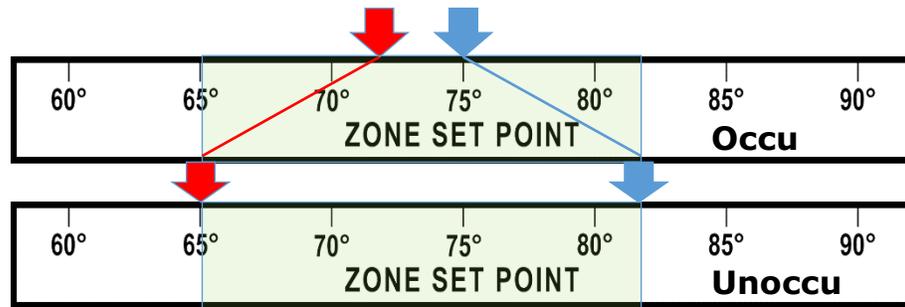
- Mix of programmable and manual (mercury type) thermostats
 - Switch to all programmable or smart thermostats.
 - Utilize programmed set-backs and auto adaptive start/stop features.
 - Utilize auto start feature to calculate optimum time to switch to occupied mode.
- Not currently using set-backs on current programmable thermostats
 - Set-backs are known to reduce energy use when ASHRAE guidelines are followed.
 - 70-72°F occupied set-point is comfortable for most office staff
 - Minimum of 5°F heating set-back for unoccupied times
 - Minimum of 2°F difference between heating and cooling occupied set-points (3°F is better). 75-78°F is recommended cooling set-point for cooling season.
 - Minimum of 5°F increase for unoccupied cooling set-point

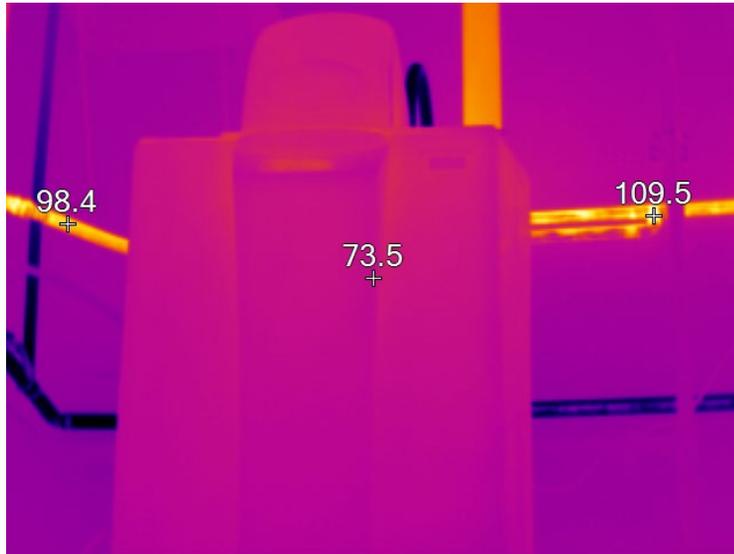
- Women's Lounge
 - Uses electric baseboard heat
 - Also has an aluminum framed window
- Utility Room between locker room and repair shop
 - Two full sized refrigerators

- Two water heaters
 - Hot water pipes
