Town of Geneva

Energy Efficiency Measures in Town Owned and Operated Buildings

August 10, 2020

Building Re-Tuning Walk-down Observations for Geneva Town Hall

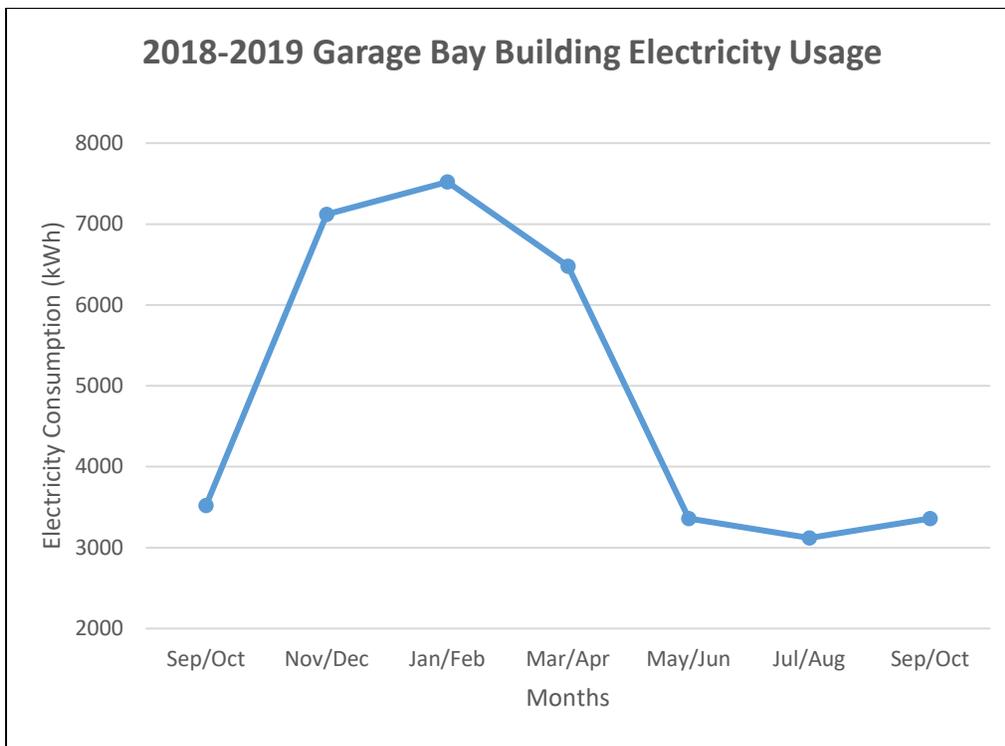
Figure 1, Electricity Consumption in Garage Bay Building

Figure 1 shows the electricity use of the Garage Bay Building from September 2018 to October 2019. The electrical energy use more than doubles during the cooler months and is likely from the electric baseboard heaters in the office since the garage bays are heated with natural gas radiant heaters. An electric heat pump should be considered as a replacement for the baseboard heaters since they are significantly more efficient and can easily cut heating energy costs by 50%. Because there was no electric billing information for Highway Office building, it is assumed that it is included in the Garage Bay Building meter.

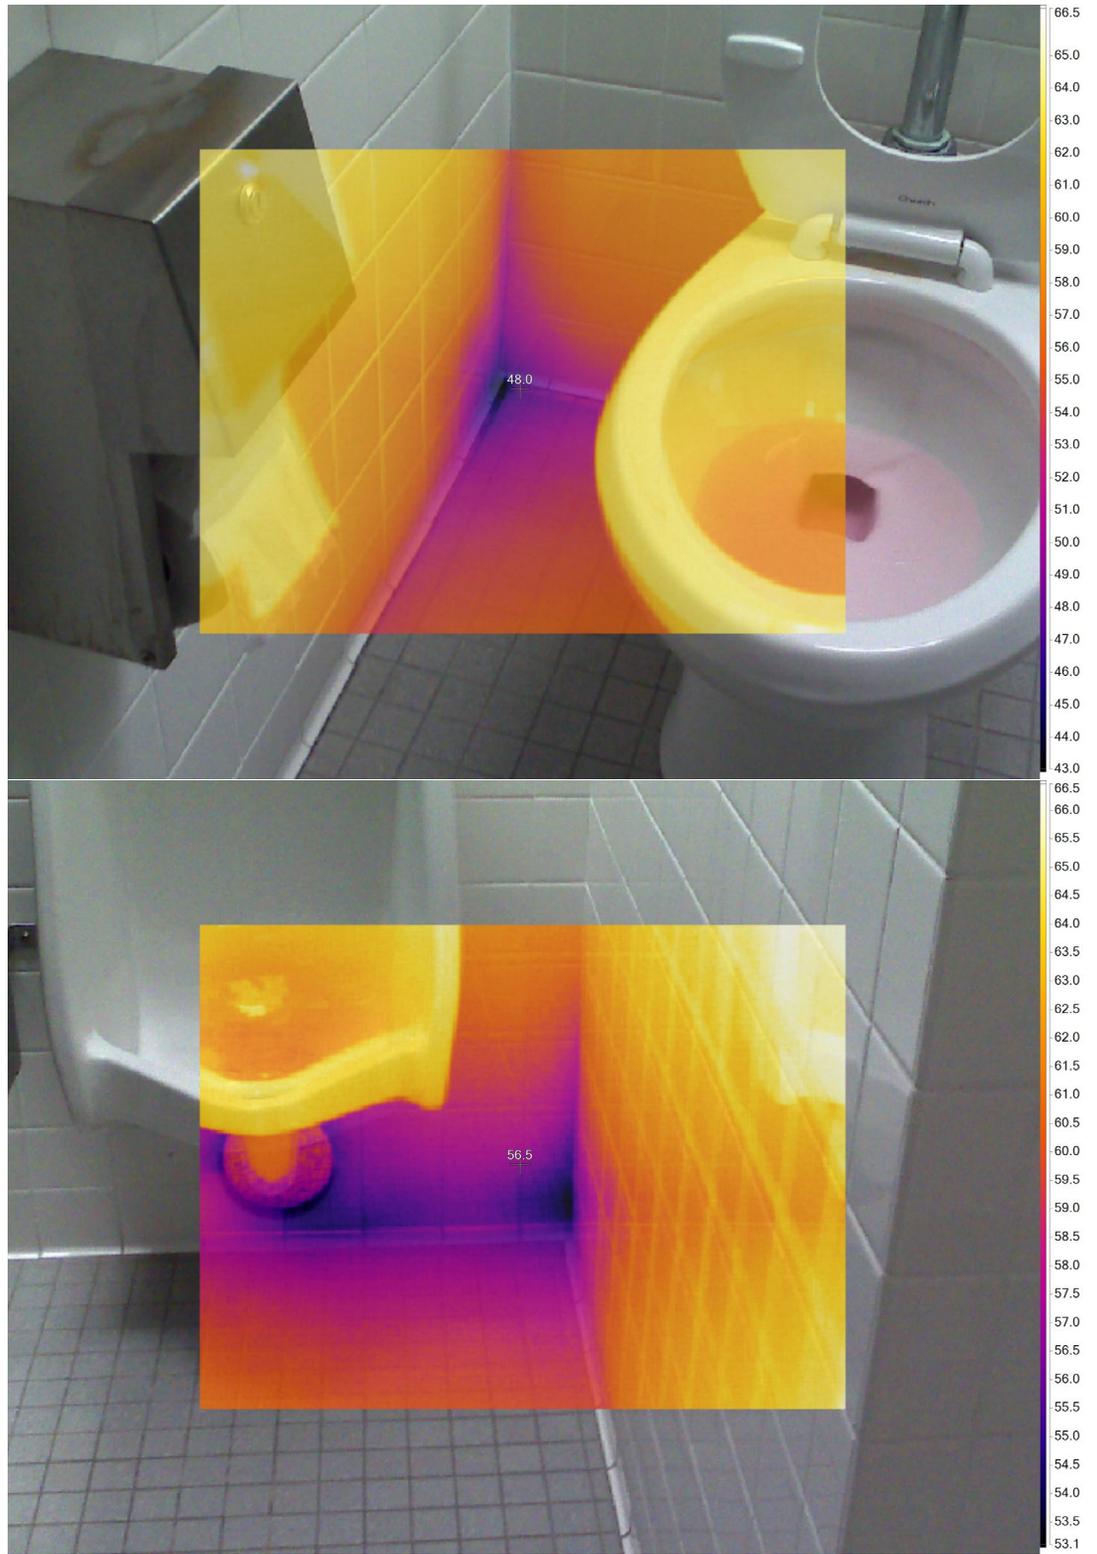
- Women's Restroom
 - Gross floor area 135 sqft
 - Air temperature 70°F

- Reception
 - Gross floor area 121 sqft
 - Air temperature 70°F
 - Weekly hours: Monday – Friday, 7am-4pm
 - Heater under desk because wall feels cold
 - Cold spots high on the wall indicate lack of insulation in portions of the attic space

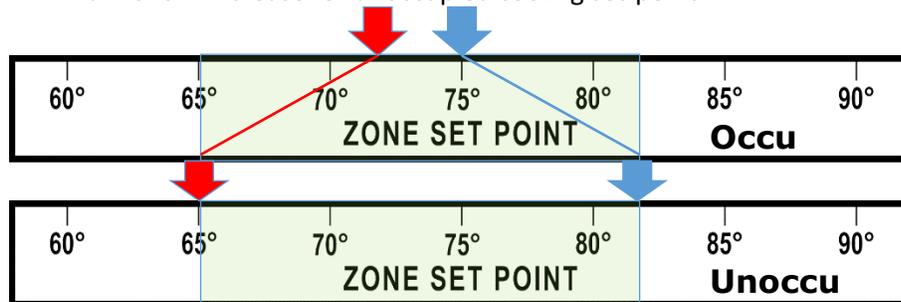
- Thermostats distributed across many rooms
 - It is unclear which thermostat controls a given room

- Not currently using set-backs on current programmable thermostats
 - Set-backs are known to reduce energy use when ASHRAE guidelines are followed.
 - 70-72°F occupied set-point is comfortable for most office staff
 - Minimum of 5°F heating set-back for unoccupied times
 - Minimum of 2°F difference between heating and cooling occupied set-points (3°F is better). 75-78°F is recommended cooling set-point for cooling season.
 - Minimum of 5°F increase for unoccupied cooling set-point
