Riparian Corridor Management Plan

**Sammet Property – 68-69 Silver Hollow Road
Chichester, NY 12416**

2013

A plan to address the management, restoration and preservation of riparian zones found on the Sammet property, Chichester, NY.

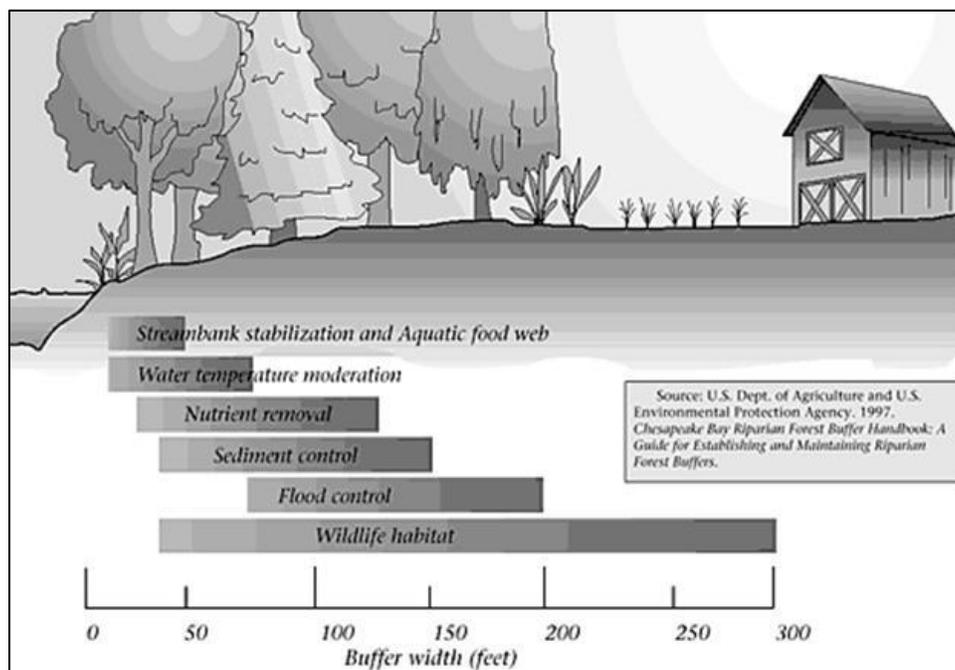
Figure 1: Buffer function is dependent on width.

The ecological functions provided by a riparian buffer are related directly to the width of the buffer (Figure 1).

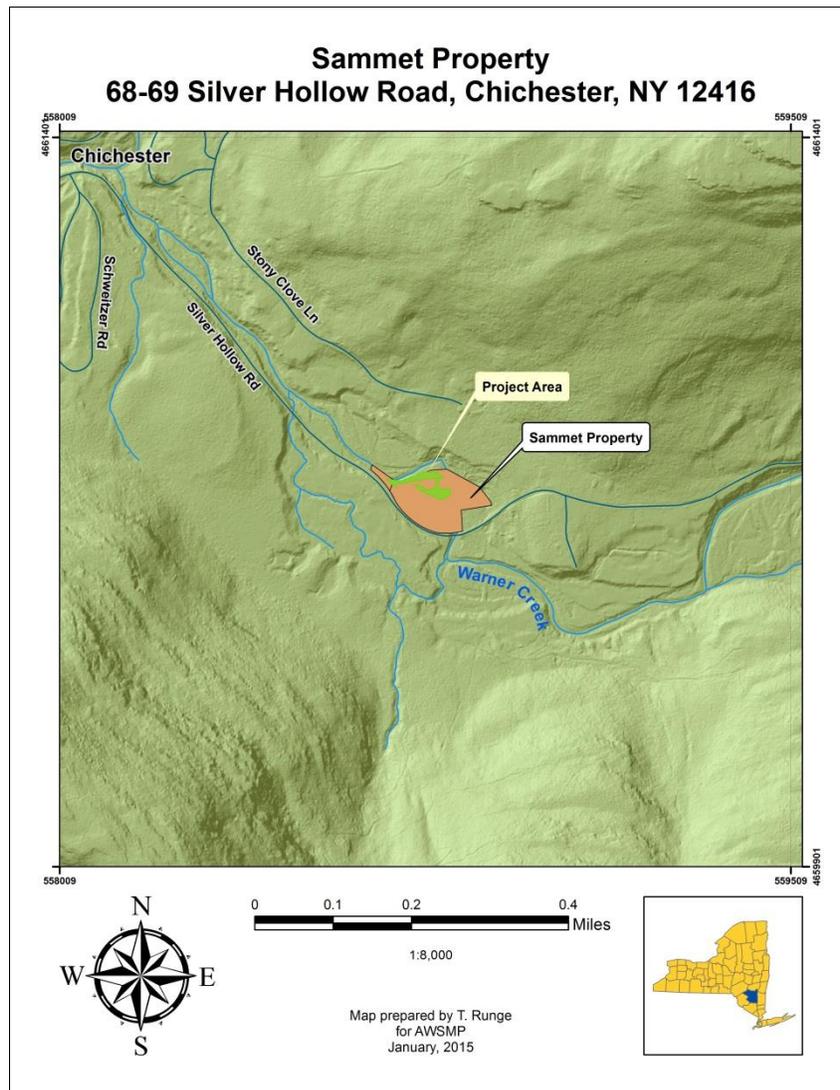
Figure 3: The Sammet property and project location.

The project site is located at the northern fringe of the parcel and adjacent to the left bank (facing downstream). The total project area is 24,000 square feet or 0.56 acres and includes approximately 550 feet of streambank.

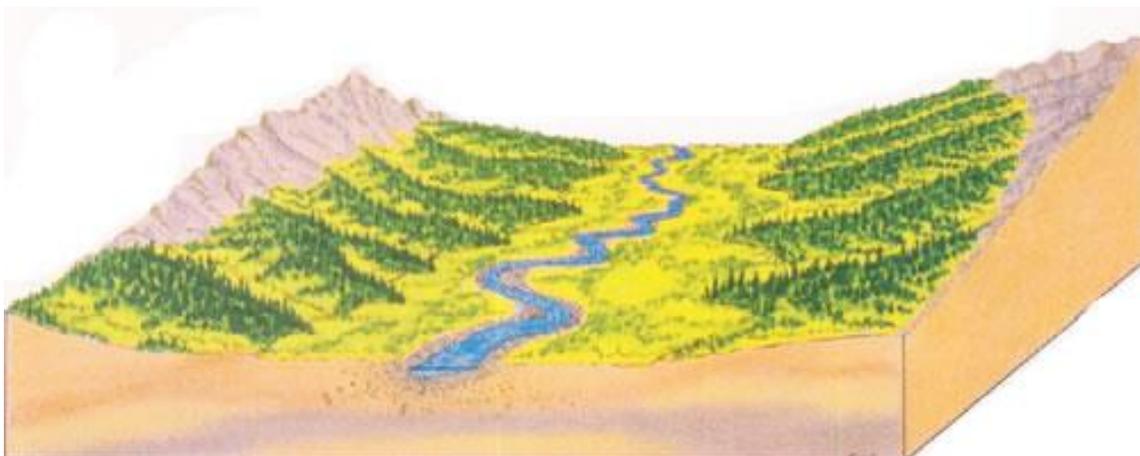
Figure 4: Rendering of the Rosgen "C" stream type.

Management Implications: The C3b stream type is moderately sensitivity to disturbance and has a good recovery potential. Recovery potential assumes natural recovery once the cause of instability is corrected. The 2013 stream restoration project was intended to correct channel instabilities. Human intervention can help accelerate recovery response.

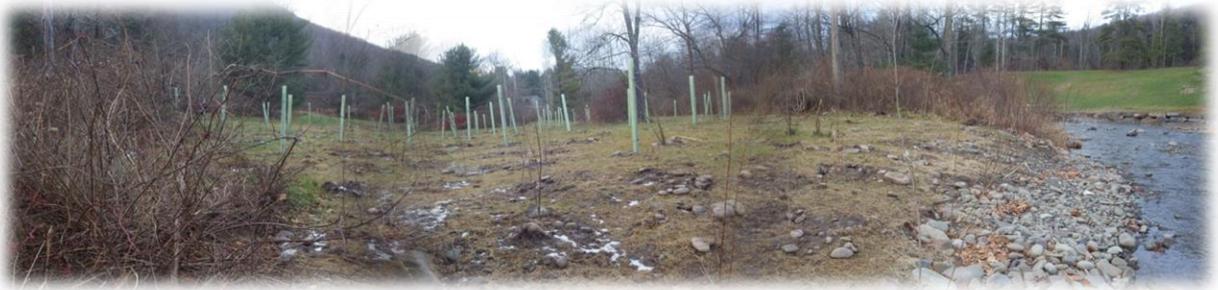
Figure 6: Barbour loam soil on Sammet property with alluvial deposits from Warner Creek.

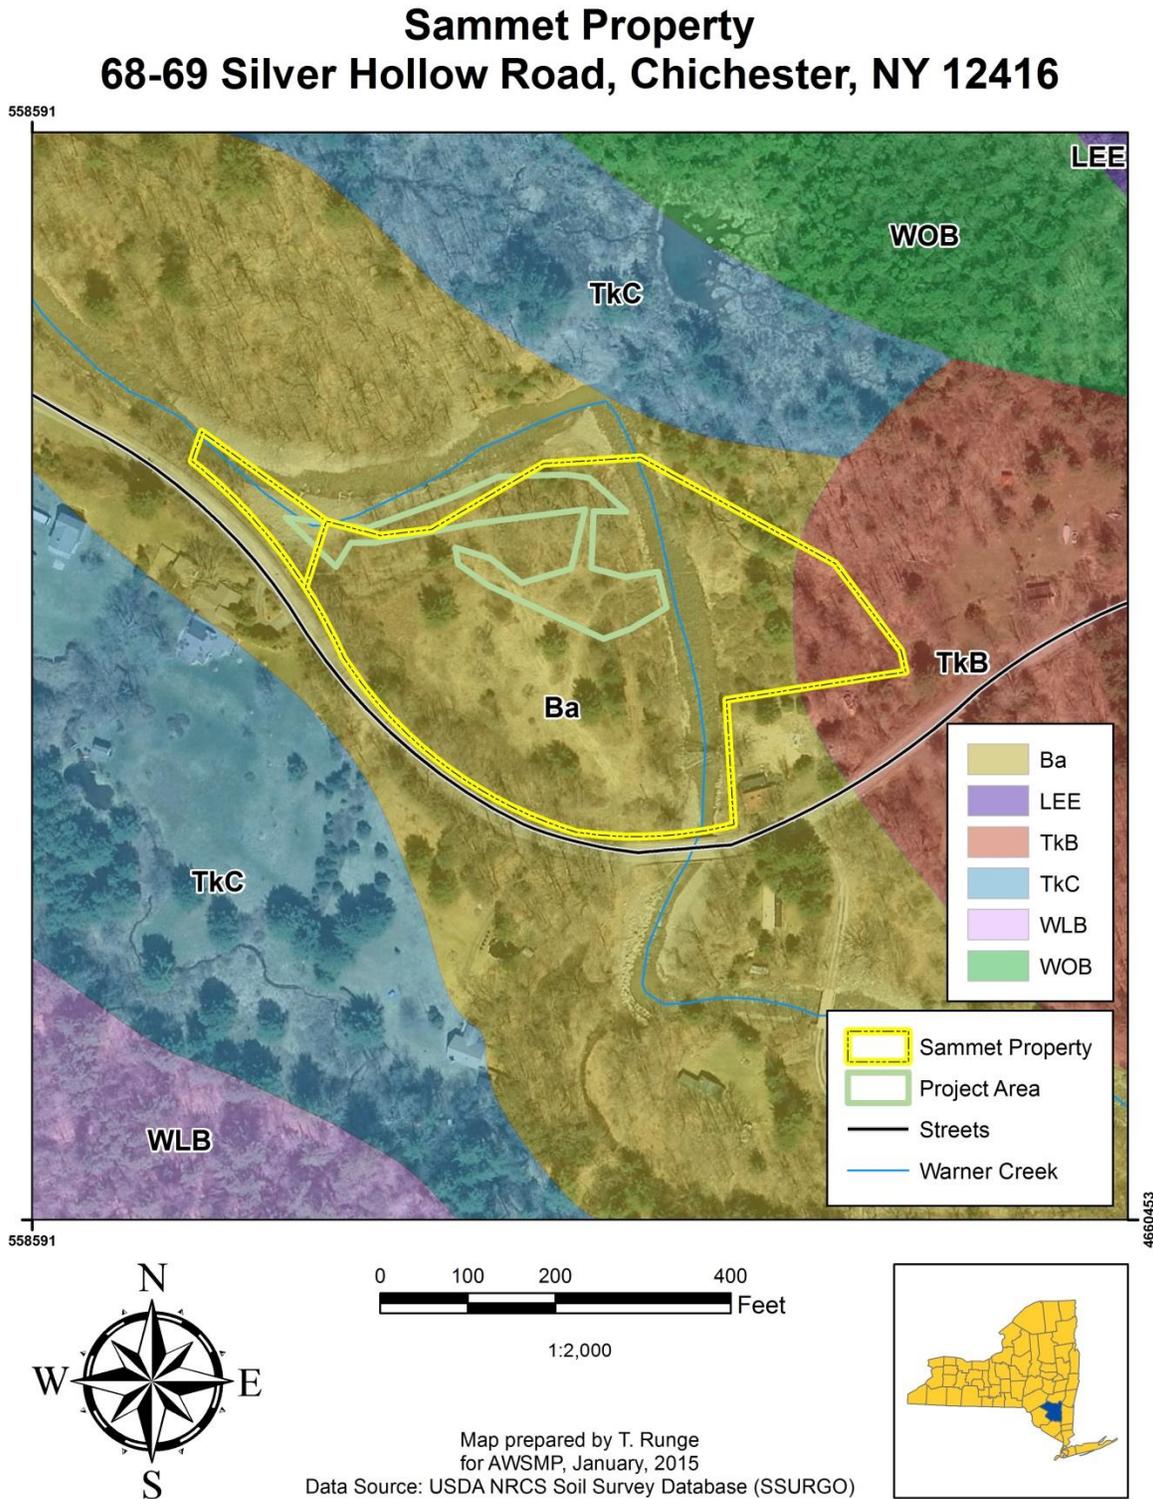
Figure 7: Map of soil types found on the Sammet property.

Two different soil types were identified on the Sammet property (Figure 5 & Figure 7) with Barbour loam (Ba) comprising 93% of the total area. The majority of riparian vegetation found on the property occupies this soil type.

Dominant Soil Type: Barbour loam is the most common soil found at the Sammet property and is associated with flood plains. As is expected for a flood plain, slope is nearly level at 0-2%. Ba soils often overlay alluvial land and are richer in gravel and sand. Tunkhannock gravelly loam (TkB) is associated with valley trains (glacial outwash) and terraces with a slope of 3-8%.

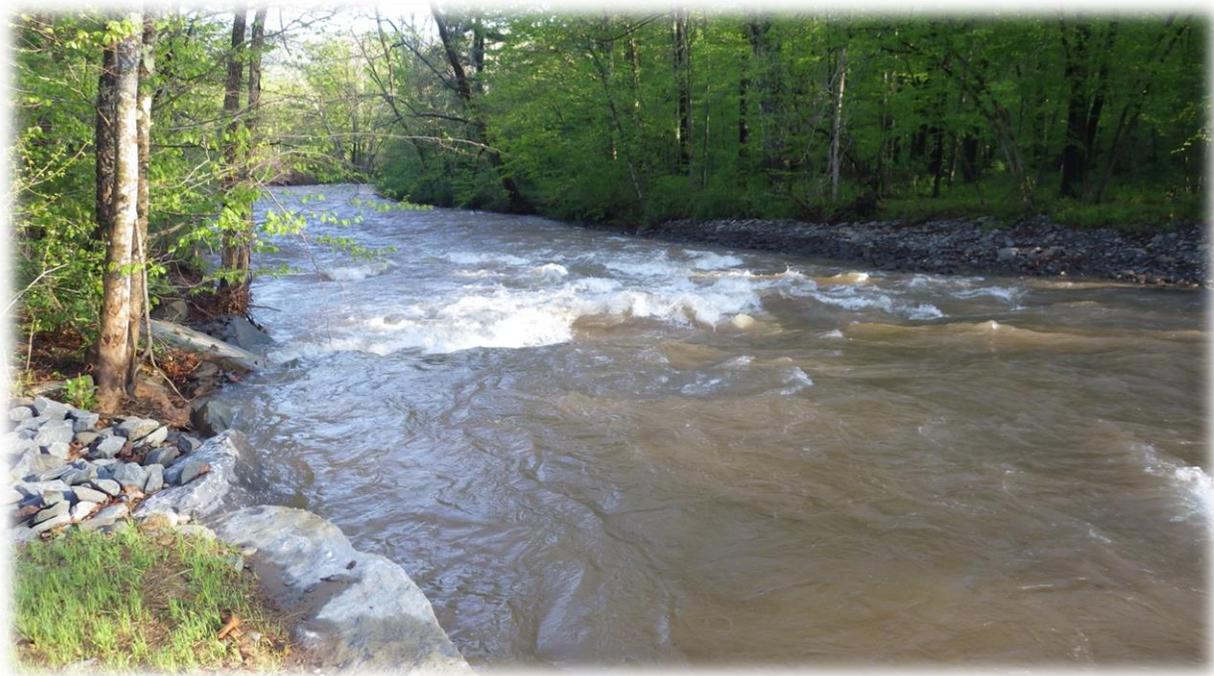
Figure 8: Forested floodplain on right bank across from Sammet property. 2014.

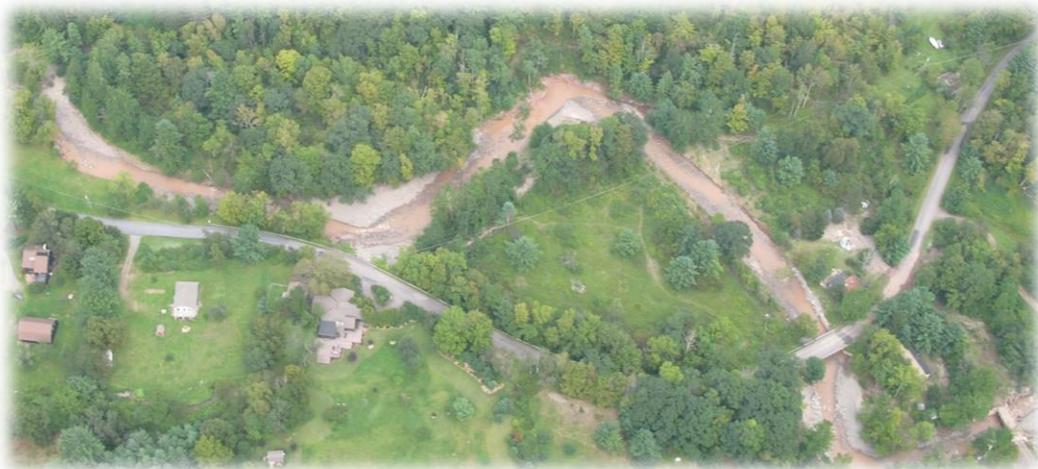
Figure 9: Aerial image of Silver Hollow Road and Sammet property post Irene, September 2011.

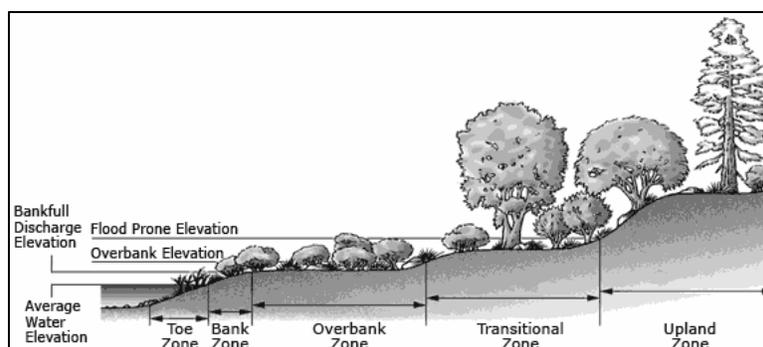
Figure 10: Stylized drawing of vegetation zones relative to water levels.

Toe/Bank Zone Management: As a result of regular disturbance associated with flooding, the toe (or bottom of streambank) and bank zones (Figure 10) are especially susceptible to erosion from vegetation loss. It is important to protect these areas by limiting human disturbance to these zones. The toe and bank zone should be protected from vegetation removal, livestock access, improper access paths, etc.

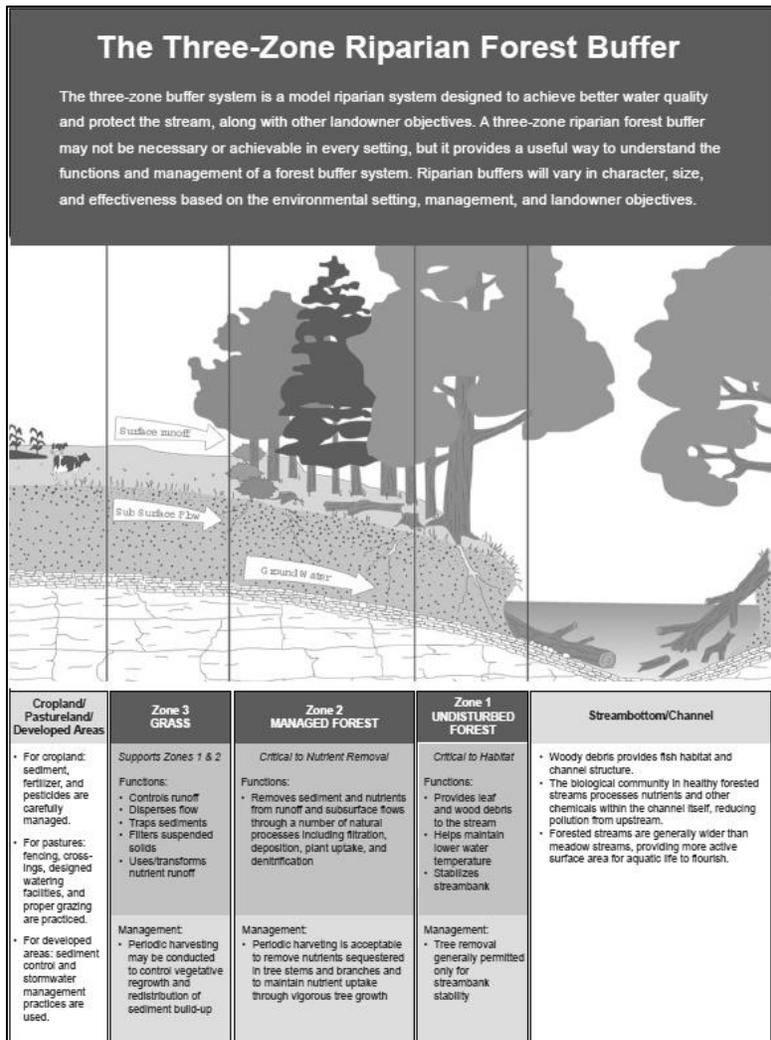
Figure 11: The three-zone riparian buffer.

The Three-Zone Riparian Forest Buffer: The diagram (Figure 11) on the following page provides good general guidelines for how to effectively manage for a healthy riparian buffer that provides a number of benefits to not only the landowner but also the stream itself.

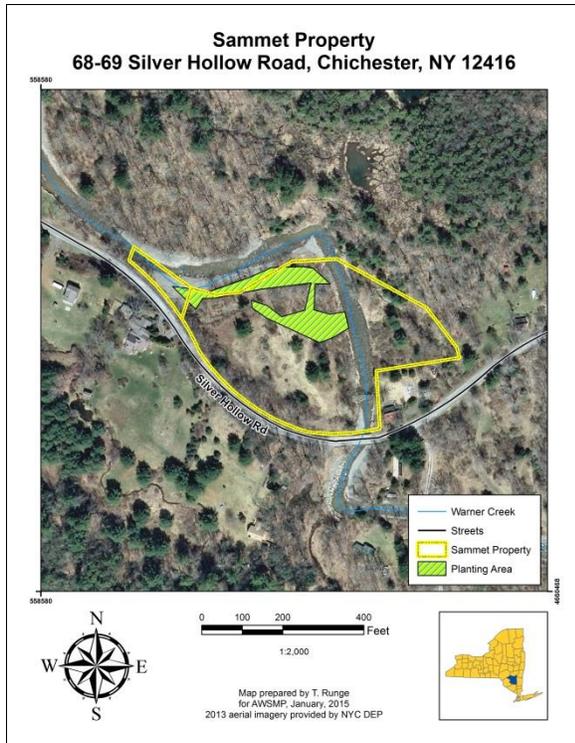
Figure 12: Sammet project site.

Project Site Overview: The project site is located on the northern edge of the property. The site involved 550 feet of streambank and ranged from 18 to 50 feet wide. Total area is approximately 0.56 acres or 24,000 square feet.

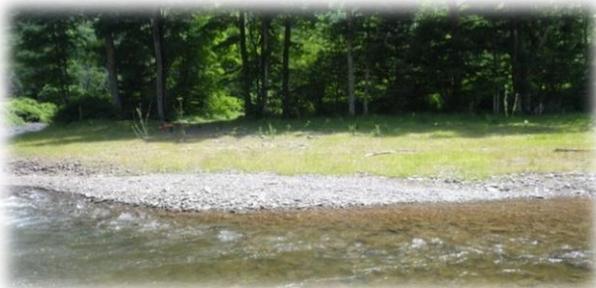
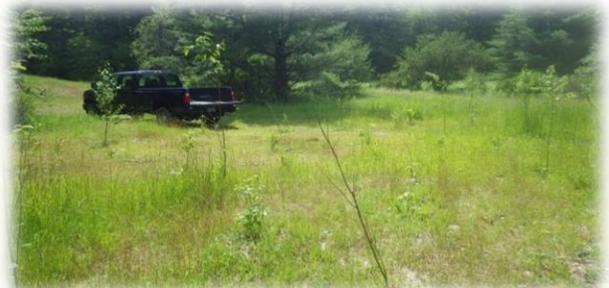
Figure 13: Two photos show plants at Sammet's after one year of establishment. Left photo from June 27, 2014 and right photo from July 9, 2014.
