## Seneca Bluffs Natural Habitat Park

<b>Site Owner</b>	Erie County
<b>Project Manager</b>	U.S. Army Corps of Engineers
<b>Funder/Source</b>	USEPA/GLRI
<b>Design Consultant</b>	U.S. Army Corps of Engineers
<b>Construction Contractor</b>	Tidewater (prime)/Cardno (sub) / AES (sub)
<b>Date of Completion</b>	2016 (All earthwork) 2020 (All invasive treatments and plantings)
<b>Area Restored</b>	3000 Linear Feet; 4 acres
<b>Coordinates</b>	42.865582, -78.819531

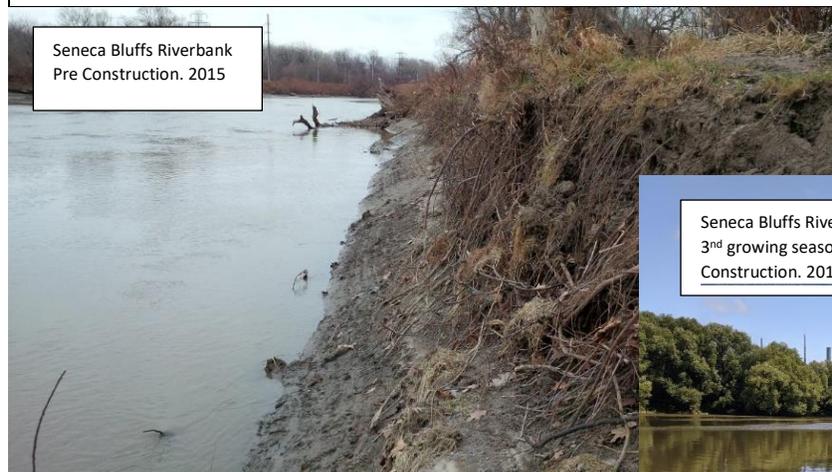
Seneca Bluffs Riverbank  
Pre Construction. 2015

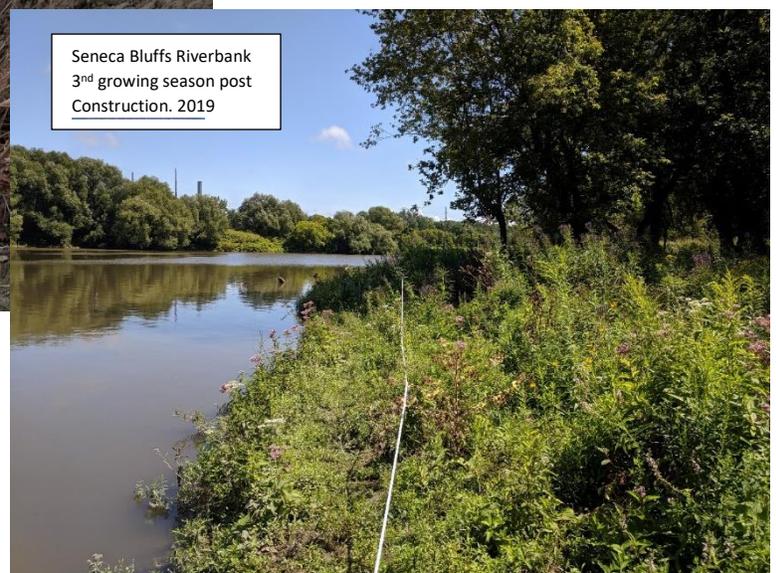
Seneca Bluffs Riverbank  
3<sup>rd</sup> growing season post  
Construction. 2019
